## Wiltshire Council Planning Consultation Response

**Application No: PL/2026/02983 (LBC) and PL/2026/02709**

Conversion and change of use of existing building to facilitate the provision of two (Use Class C3) residential units, and the demolition of existing building and erection of one (Use Class C3) residential dwelling with associated works  
47 Blue Boar Row, Salisbury, SP1 1DA

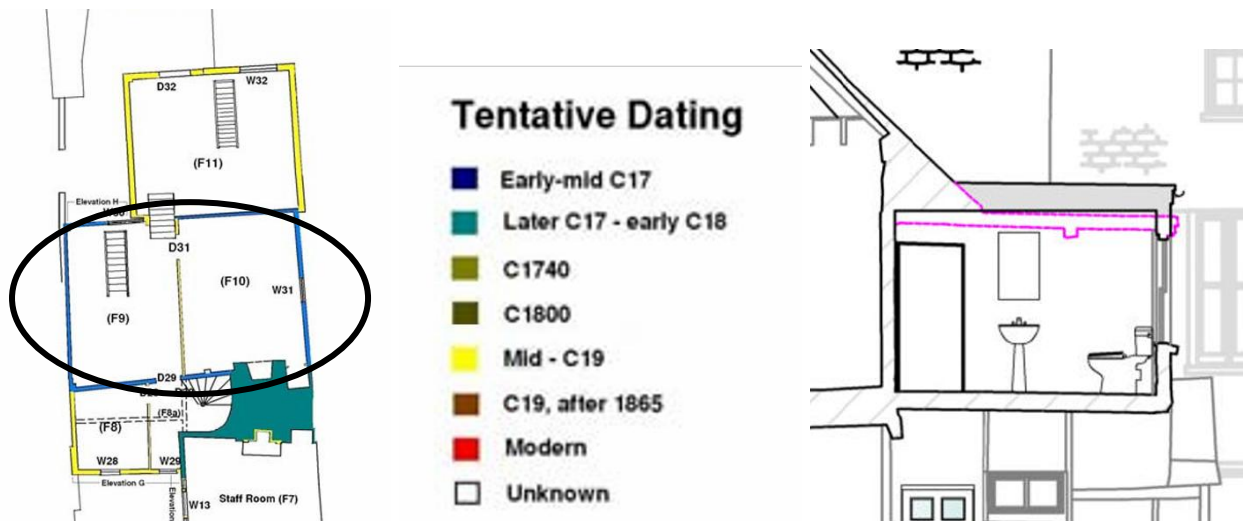
At first floor, the existing flat roof, the plans say, will be 'replaced at a high level' (see above snip). What impact will this have on the historic fabric? We needed a greater level of detail for this proposed element.

What happens to windows W8 and W9?

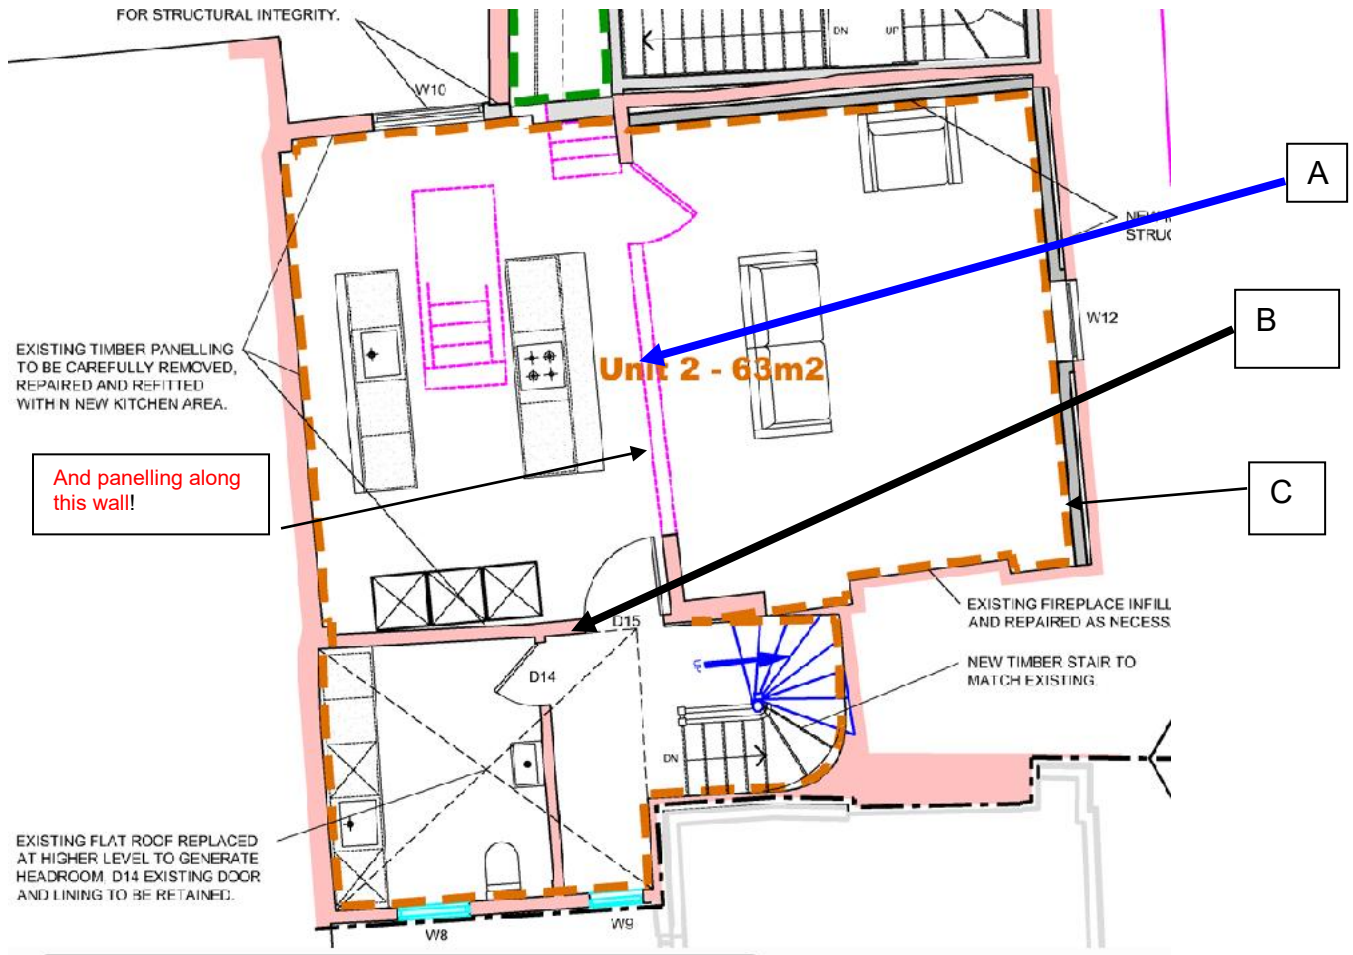
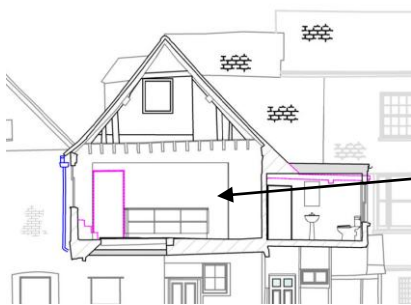
The demolition of the spine wall (A on my plan below) is proposed. I do not support the extent of demolition (and, I said so in previous comments and at the site meeting). It is clear that this is the line of an original wall and as such, what ever the age of the existing fabric, it is a significant element of the building. It is also a wall against which the panelling (when it was a coffee shop) was erected. As such, the removal of the wall would also remove the ability to rehang the panelling (removed without consent by previous owners). I believe we discussed an enlarged opening ie double-door size.

And I also require clarification in respect of wall B.

Too large an opening. Entails the loss of too much wall

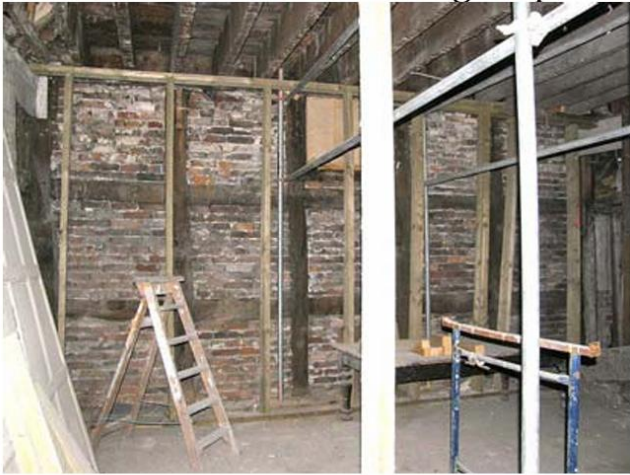
East wall (F10)

In respect of the eastern wall (C) – I can see that it would not be possible to have this wall exposed as it is built up against on the outside by the neighbouring building (and I note the engineer's assessment). The following is taken from a 2010 report:

I would still want a detailed record of this wall and a repair schedule.

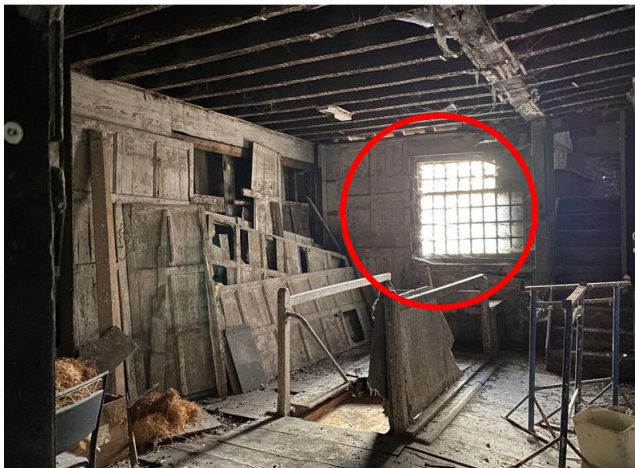
W10 – which is an early 18<sup>th</sup> century window ie of more than usual significance, the proposed floor plan says ‘existing over built window remade and repositioned for structural integrity’. What does that actually mean/entail? The heritage statement actually says: *‘Repair and relocate 16 over 32 pane window so that it is not overlain by adjacent structure’*. Which is it and where is it relocated to? This window should be retained and repaired, unless otherwise agreed in writing. I recommend they provide additional detail in respect of this item.

Figure 23: Room in central structure, historic panelling stacked an in situ. Early 18<sup>th</sup> century window, modern stair down to side alley in centre.

At first floor level, the intention is to rehang the panelling (or one assumes some of it). We should have a condition requiring a details of what is to go where.

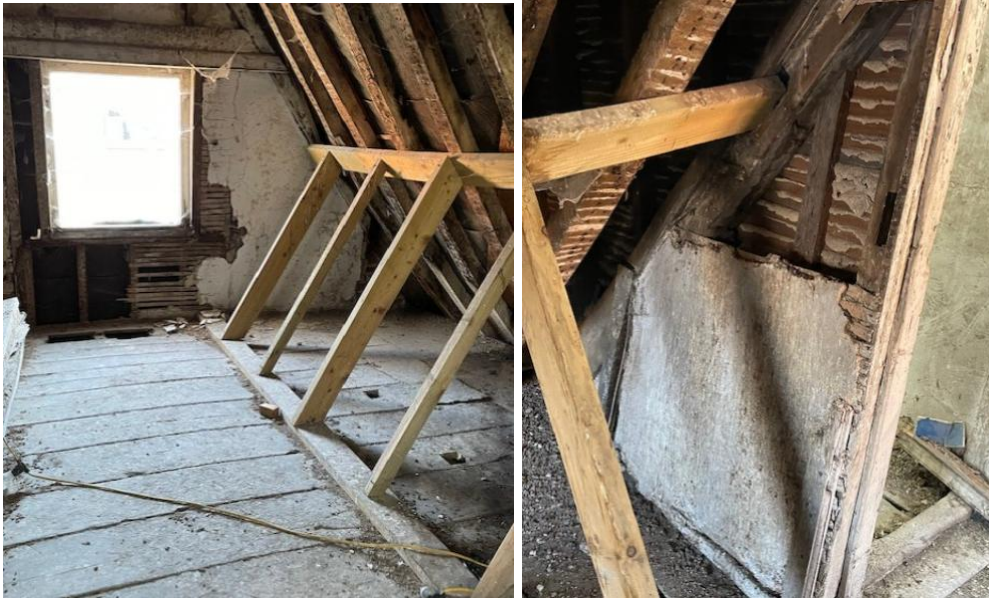
At attic level, there are areas of historic plaster which survive. Also it is clear that the sloping ceilings were once lathe and plaster. Areas of L&P should be repaired. Where boarding is introduced (to introduce stability) that it is finished with a coat of lime plaster (or decorating plaster – to be agreed) in order to retain the original character of the space.

Photos in attic showing survival of L&P which should be repaired.

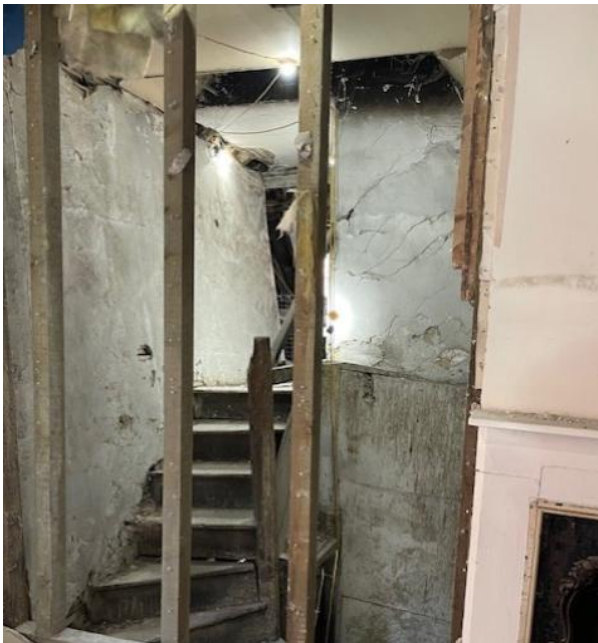
Lathe and plaster lining the hall sides

Wall to attic alongside stairs should be retained and repaired (L&P)

That the walls of the downstairs hallway will be lathe and plaster and that elsewhere the hallside walls (being L&P) shall be repaired;

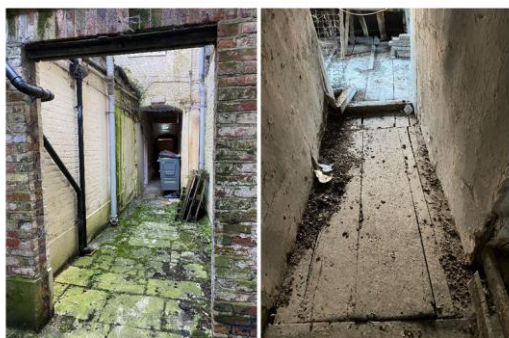
Figure 34-35: flag stones within the side passage, well squared and set; wide floor boards, perhaps oak or elm, within the central structure.

I would like more information on the proposed hard landscaping at ground floor level. I strongly recommend that a detailed plan is provided at an appropriate scale.
