# Supporting Images - Former Fence and Boundary Context

These photographs support the retrospective planning application by showing the previous timber fence, its approximate overall height, its collapse, the former outside boundary condition as seen from the road, and the replacement fence being installed alongside the collapsed boundary.

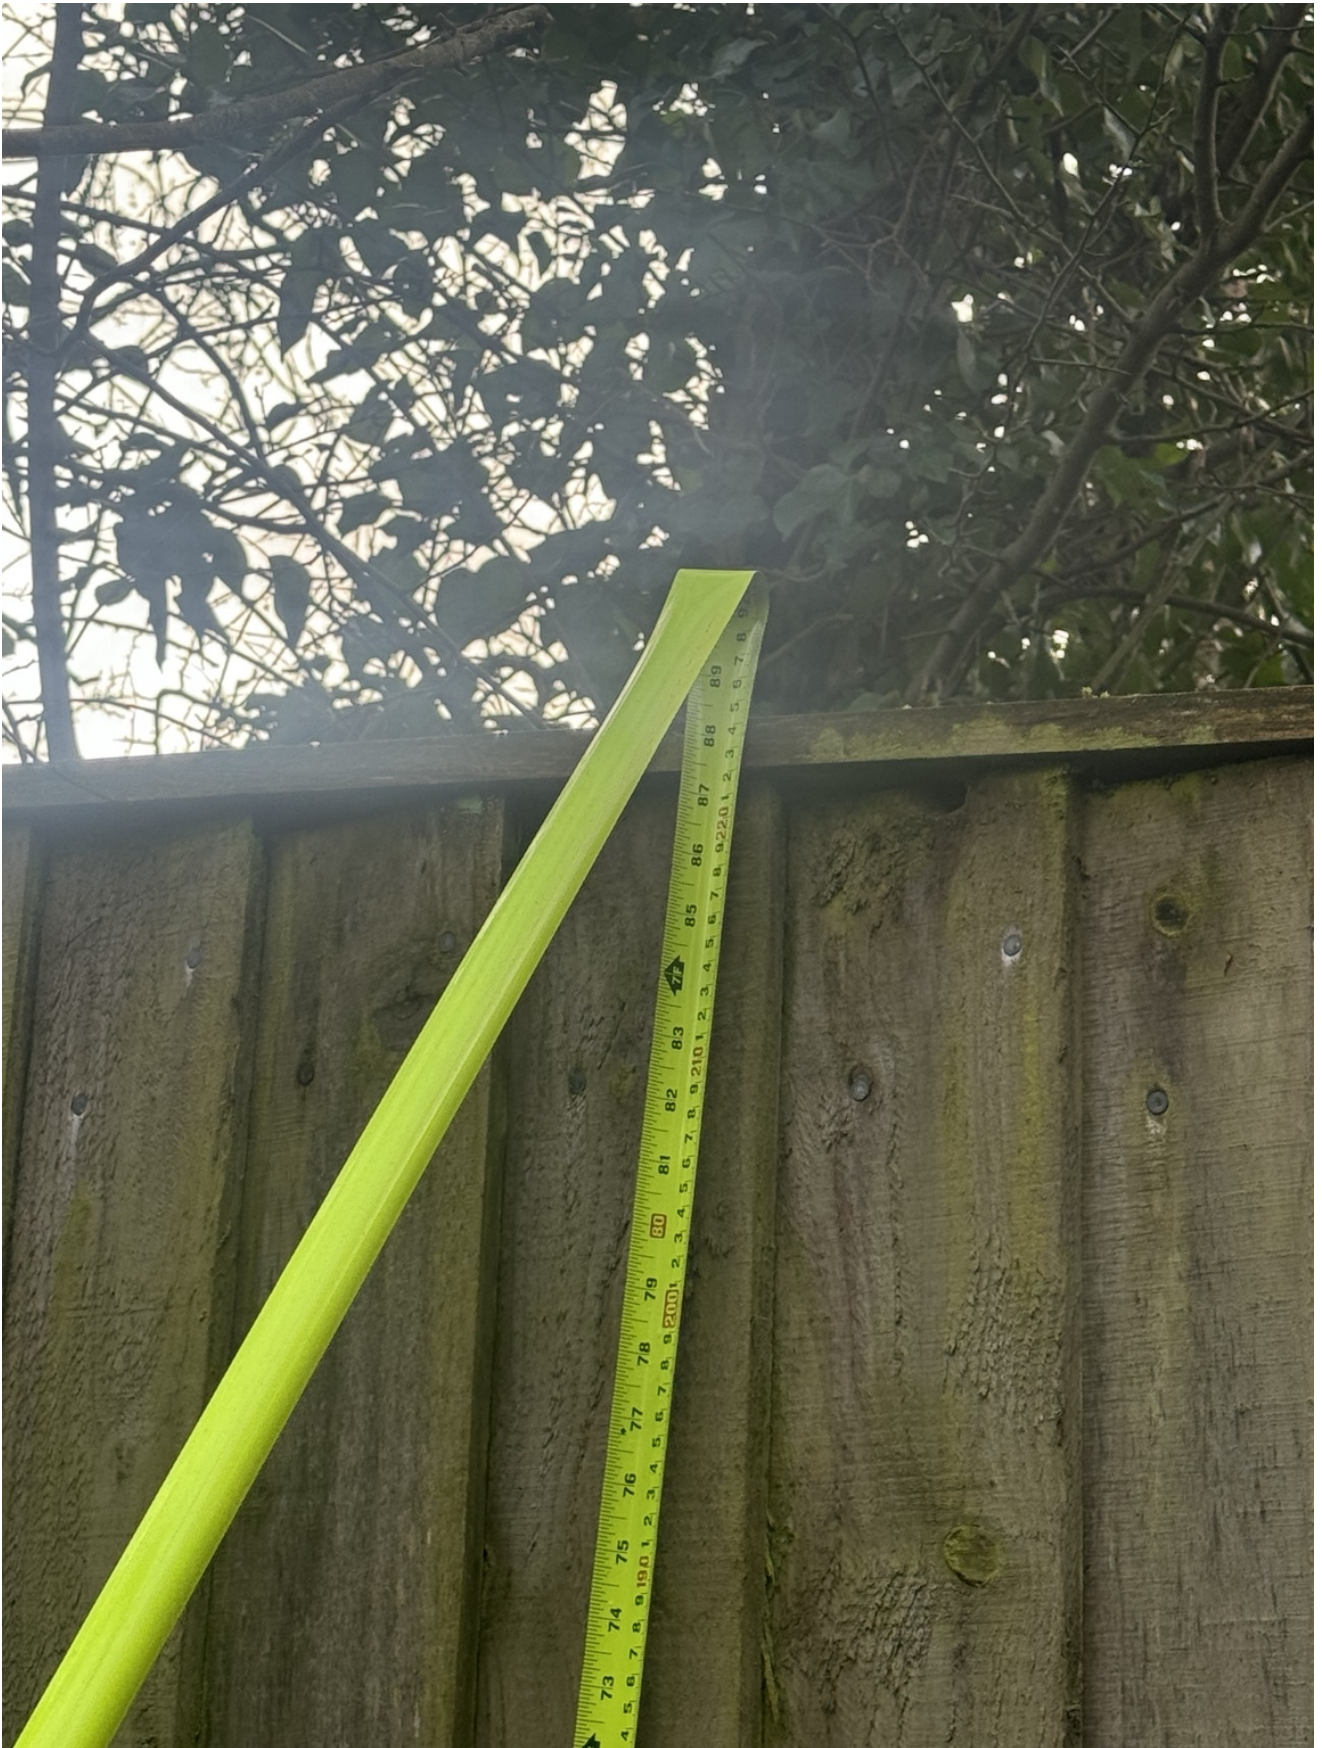
Image 1

Former timber fence - close-up measurement showing the approximate overall height of the previous fence.

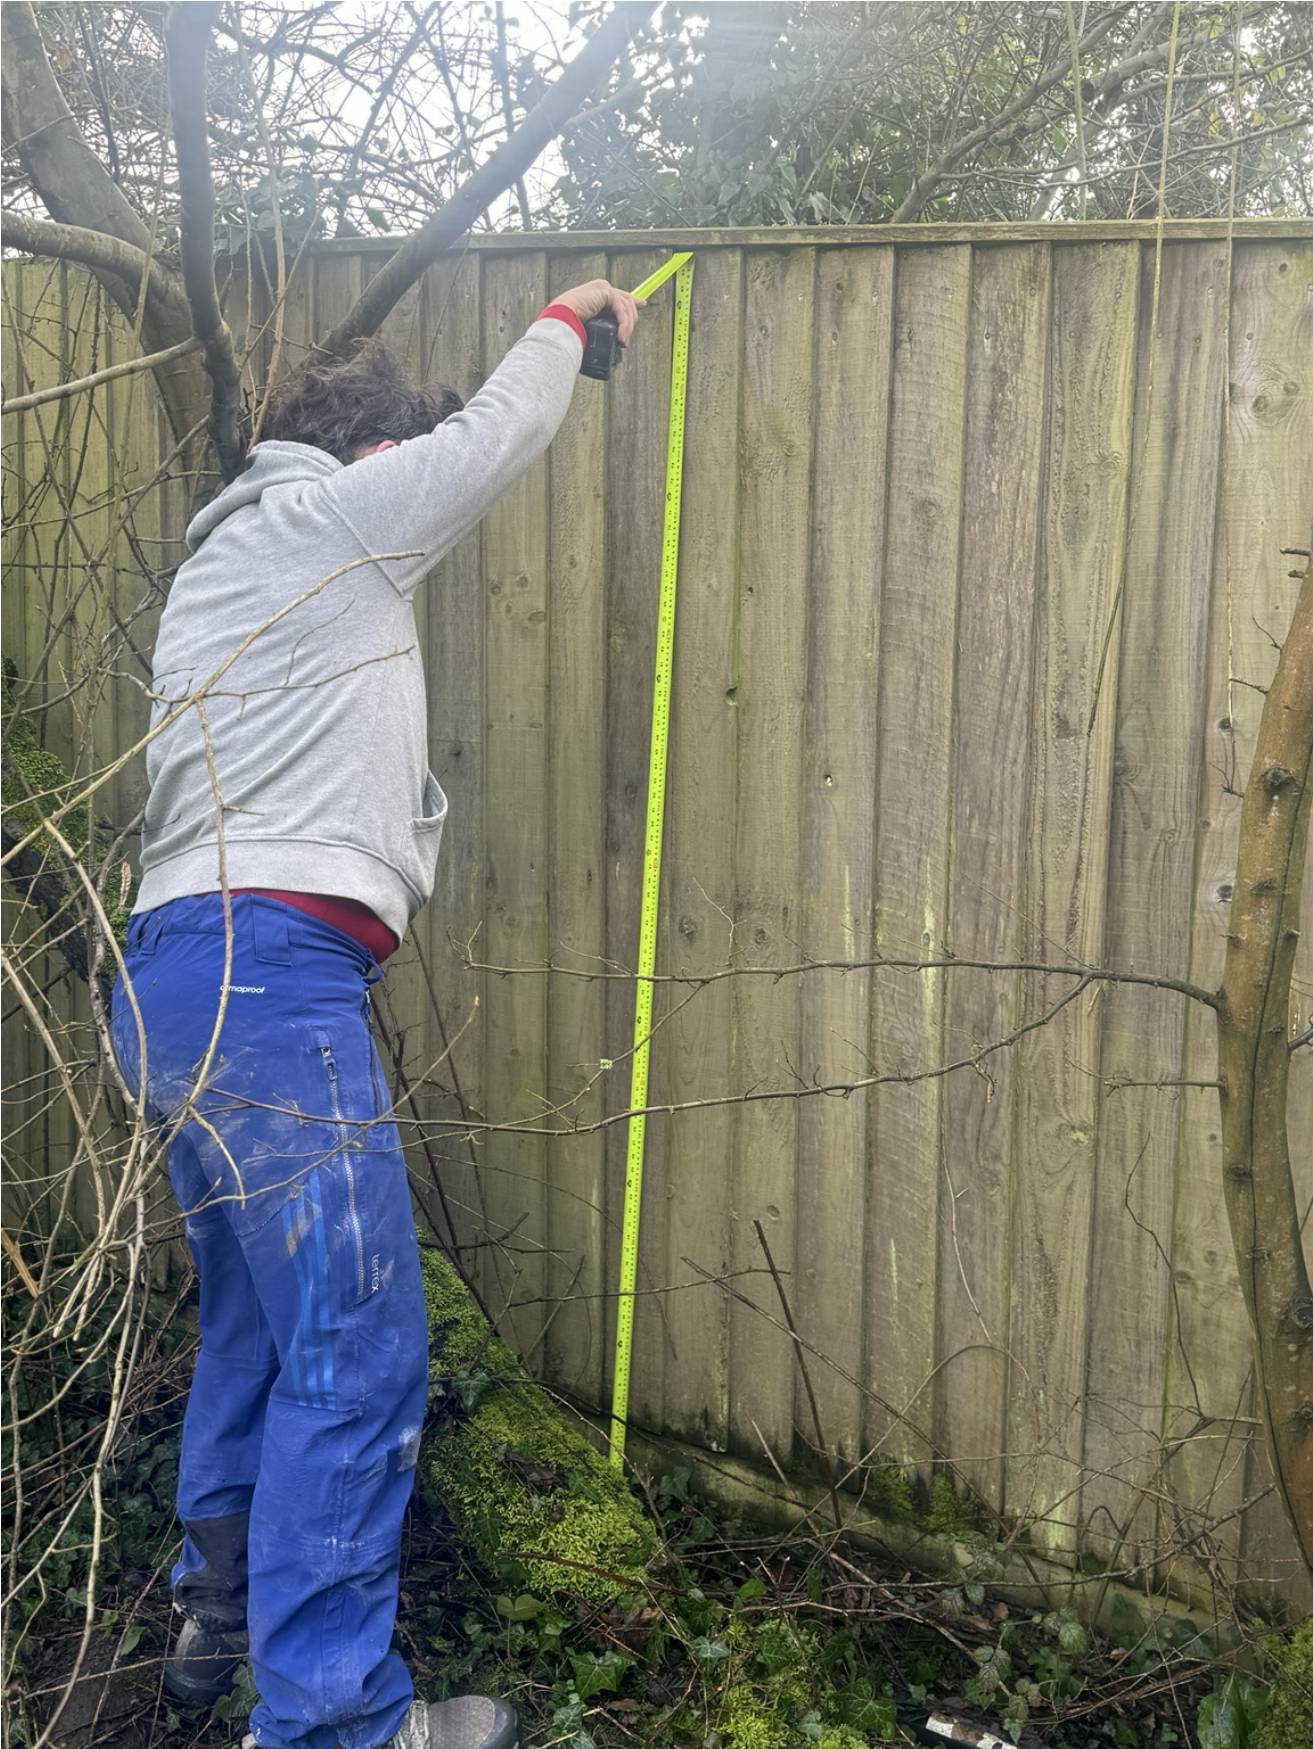
Image 2

Former timber fence - wider measurement view showing the previous fence at approximately 2.2 to 2.35 metres in overall height.

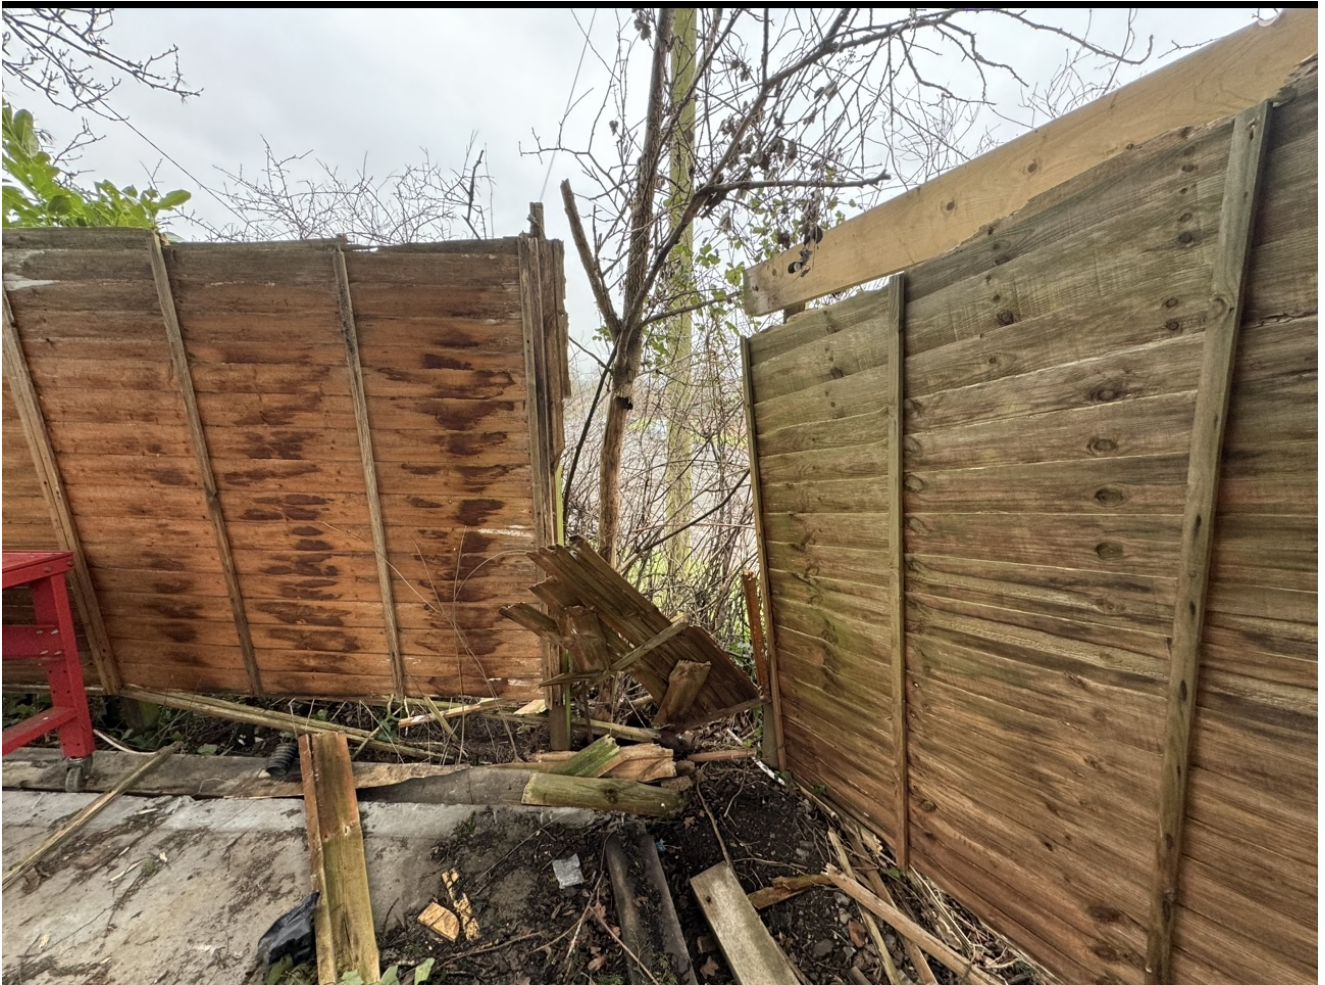
**Image 3**

Former fence collapse - photograph showing the previous boundary in a failed and dangerous condition.

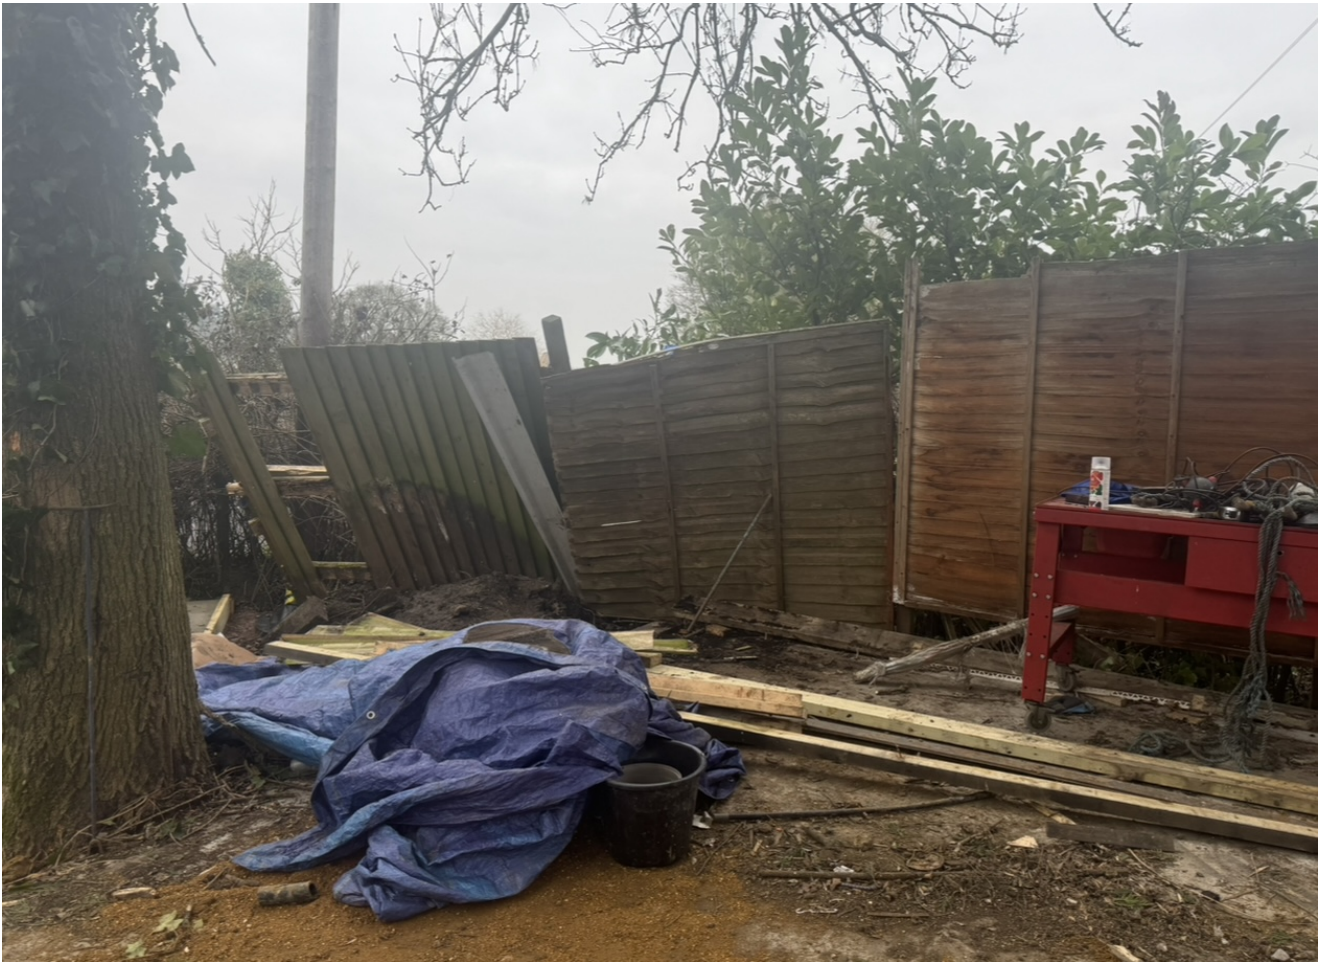
**Image 4**

Former fence collapse - wider view of the previous boundary after collapse.

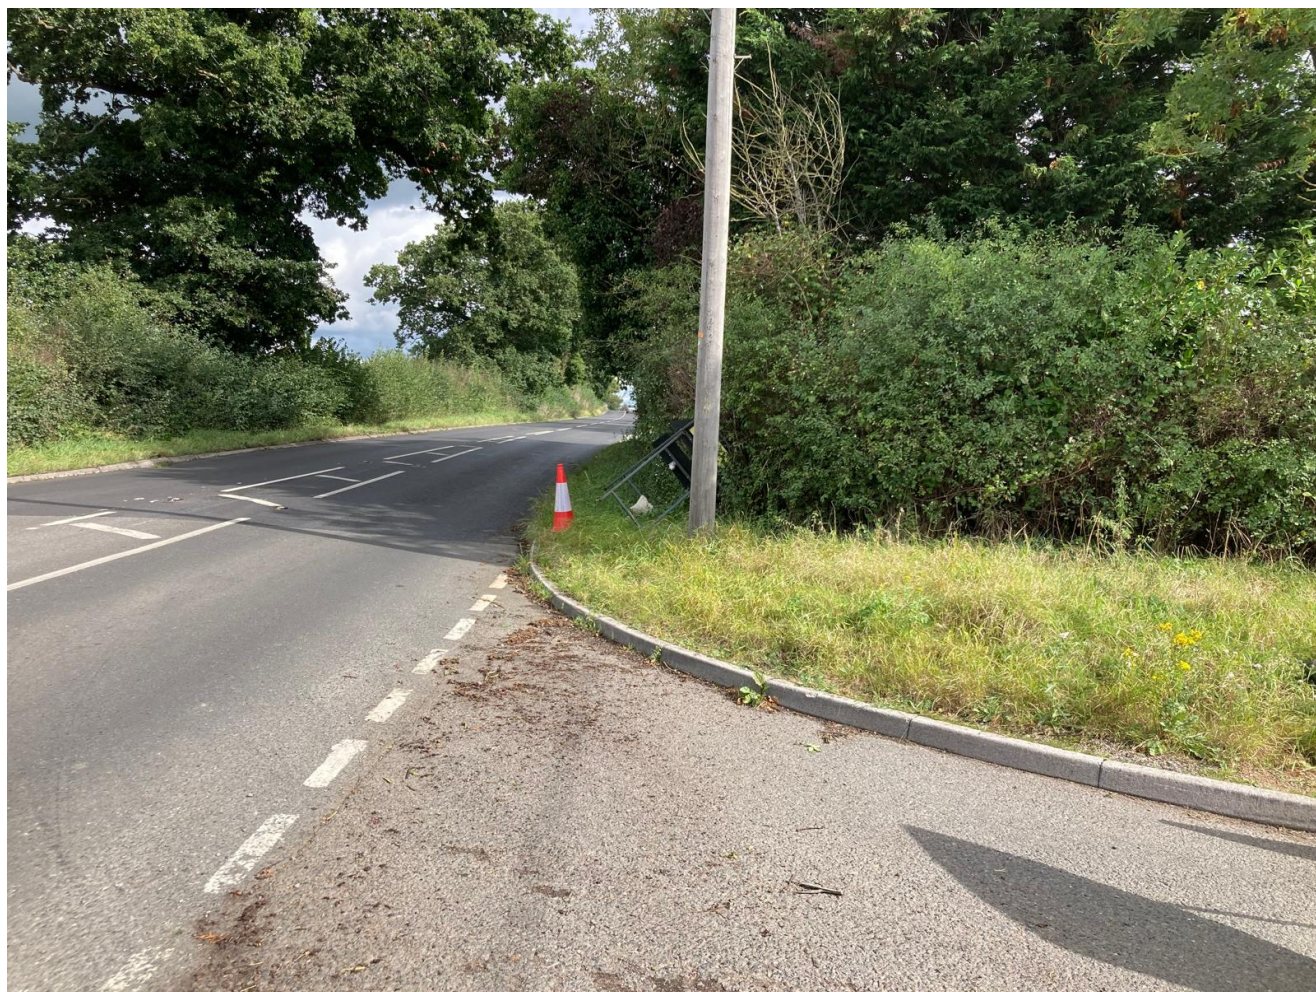
**Image 5**

Former outside boundary visible from the road.

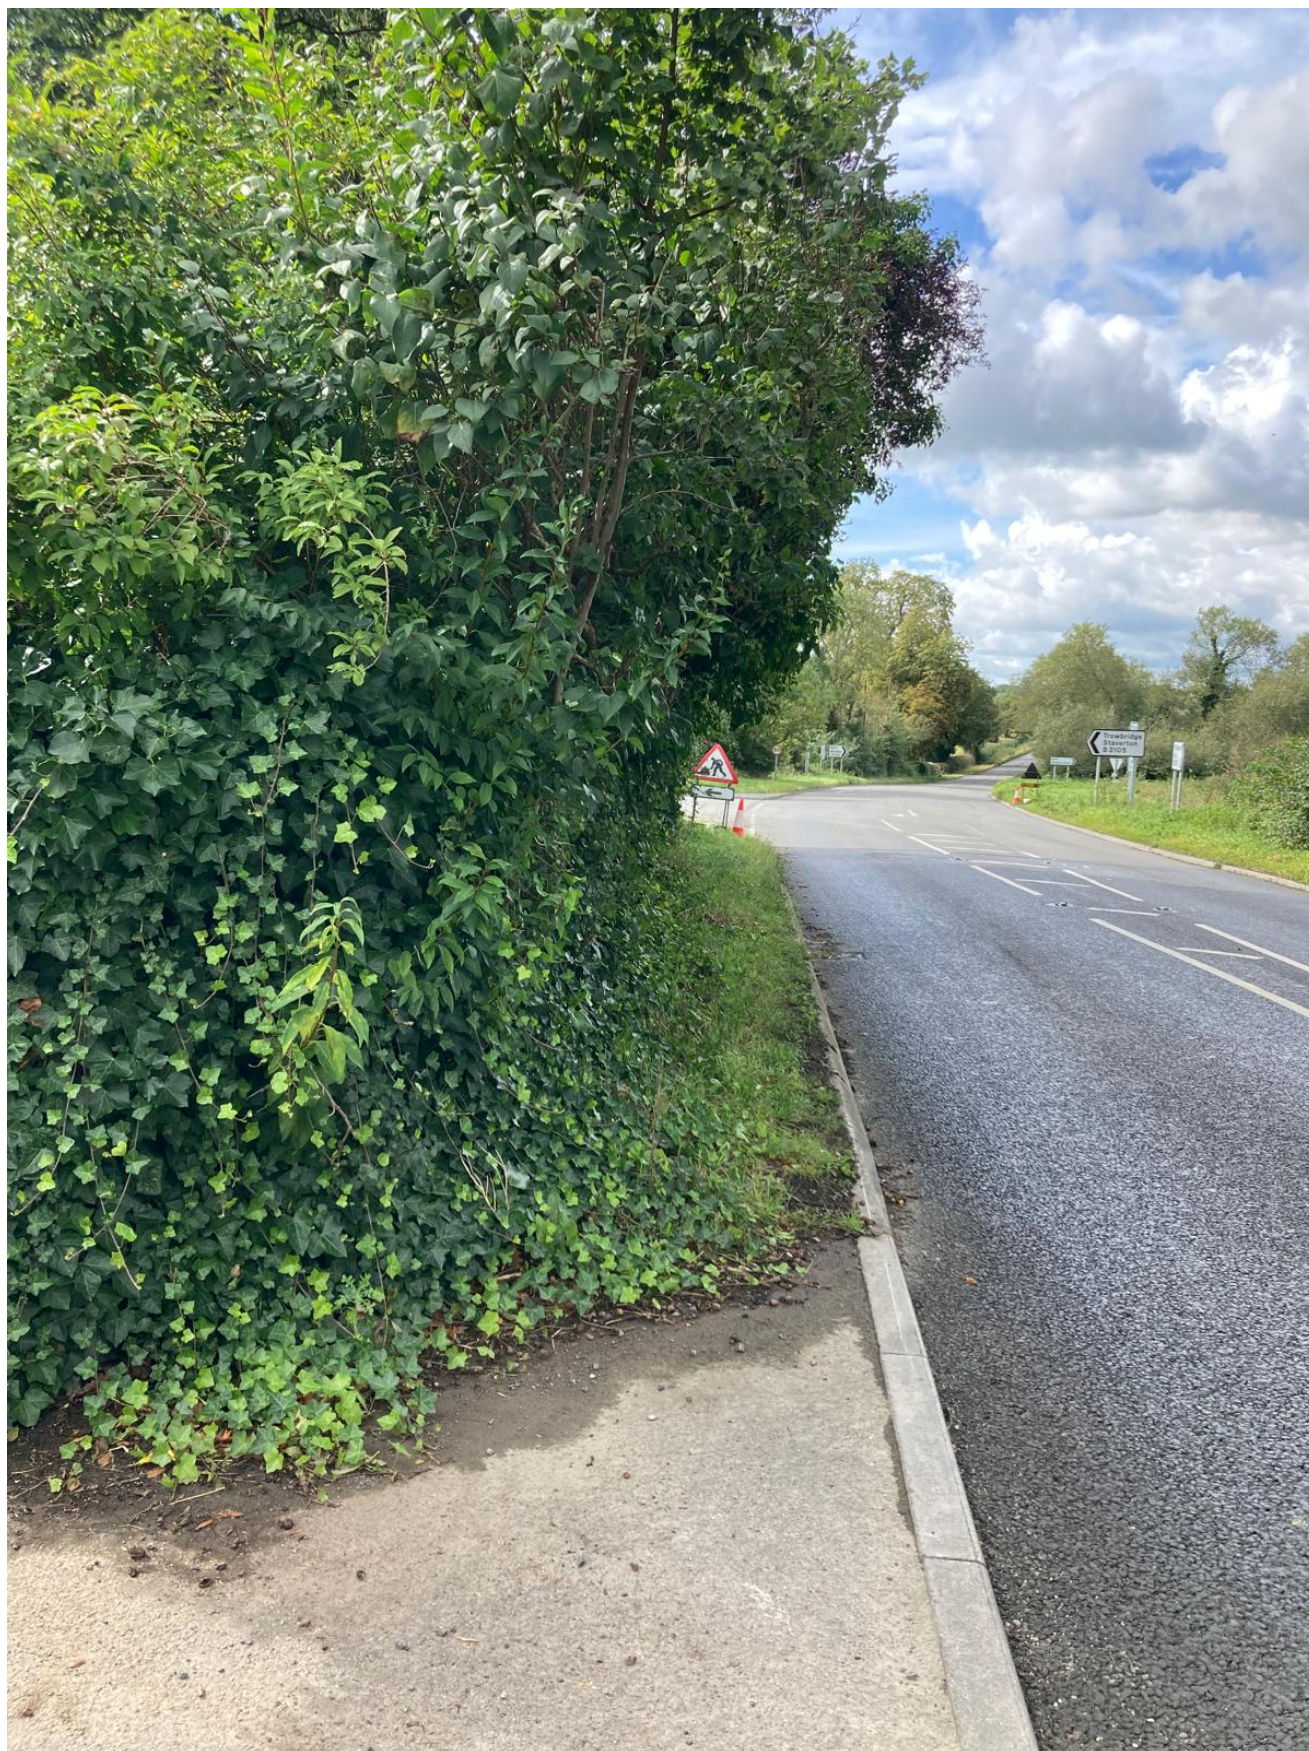
**Image 6**

Former outside boundary visible from the road, overgrown with ivy, thorn bushes and blackthorn.

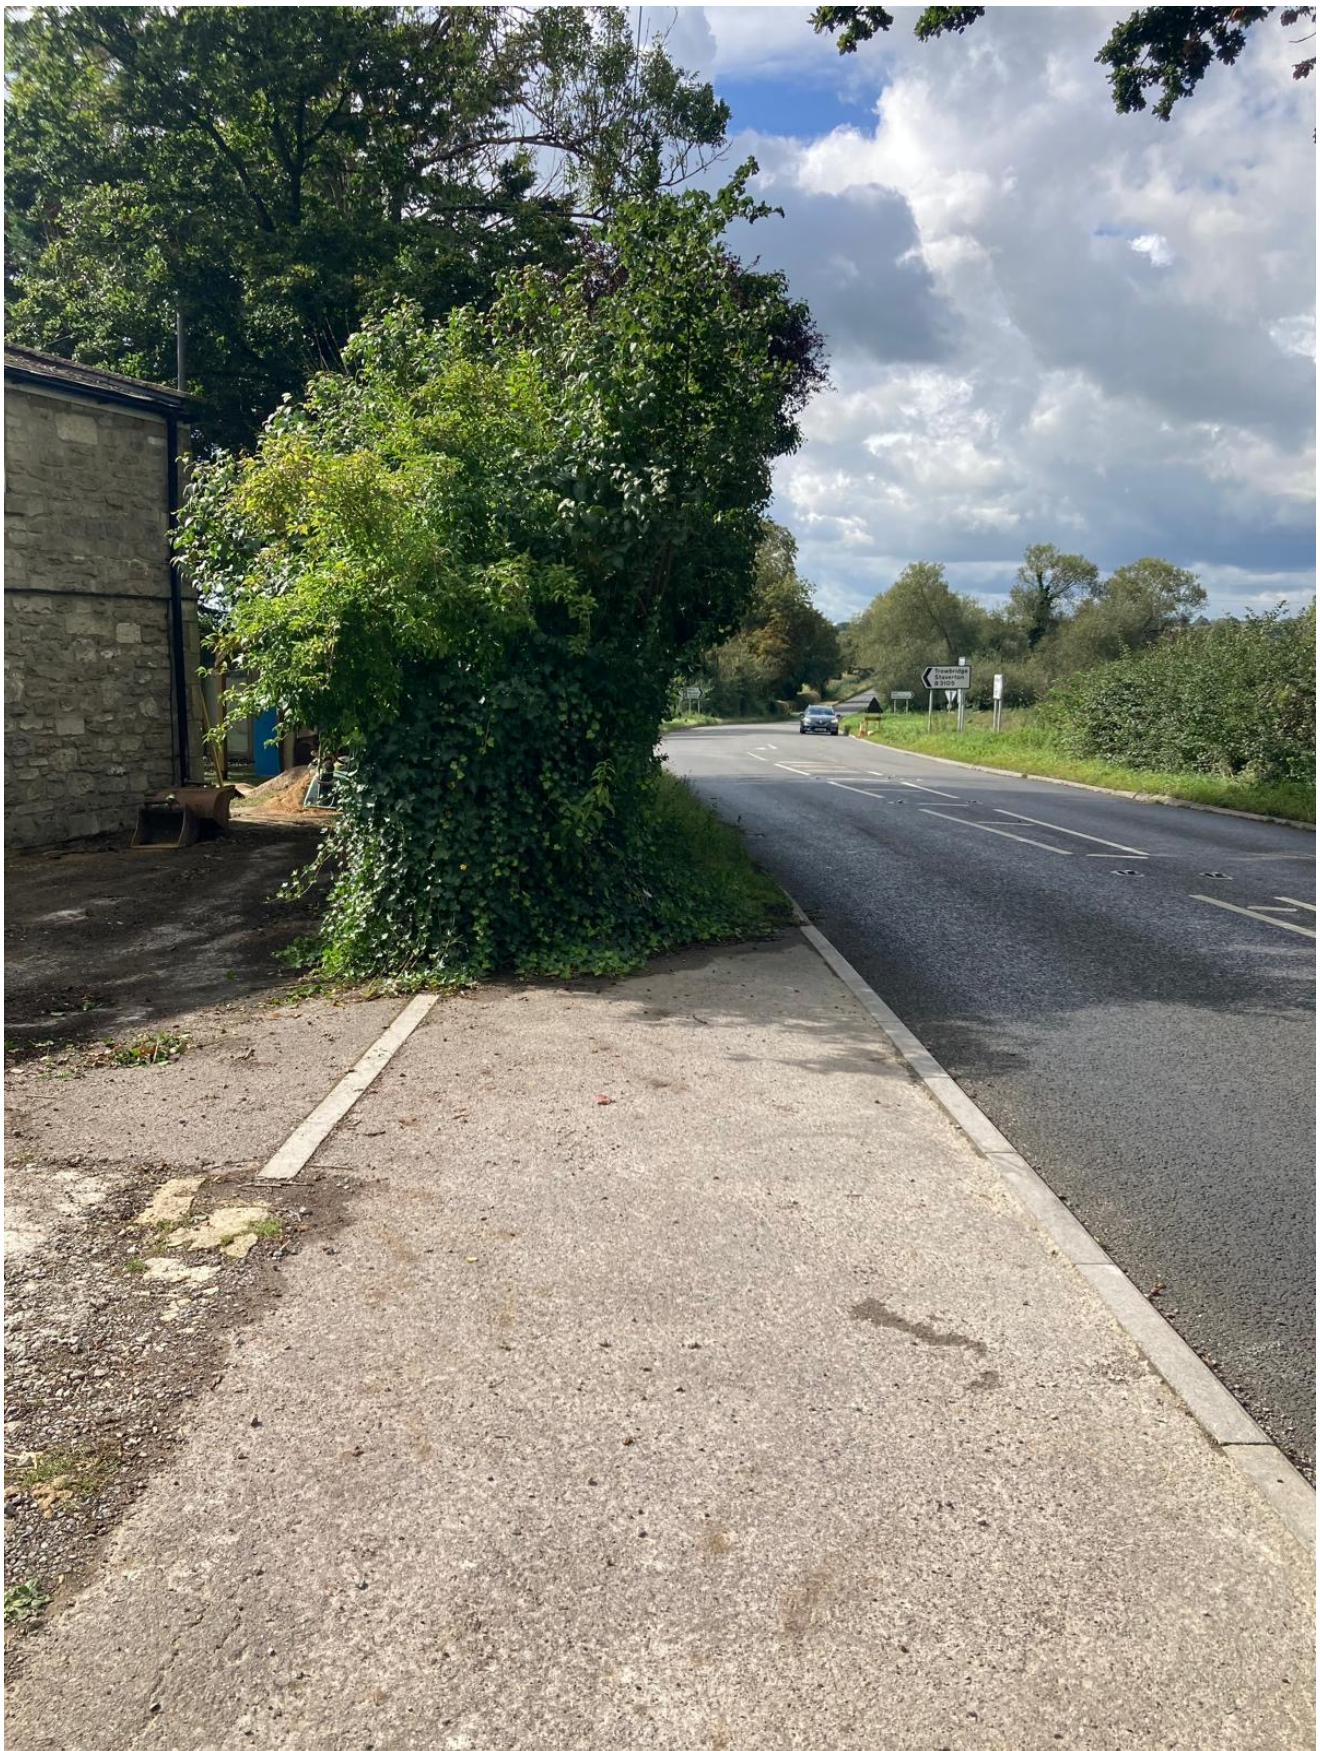
Image 7

Former outside boundary visible from the road and roadside boundary context.

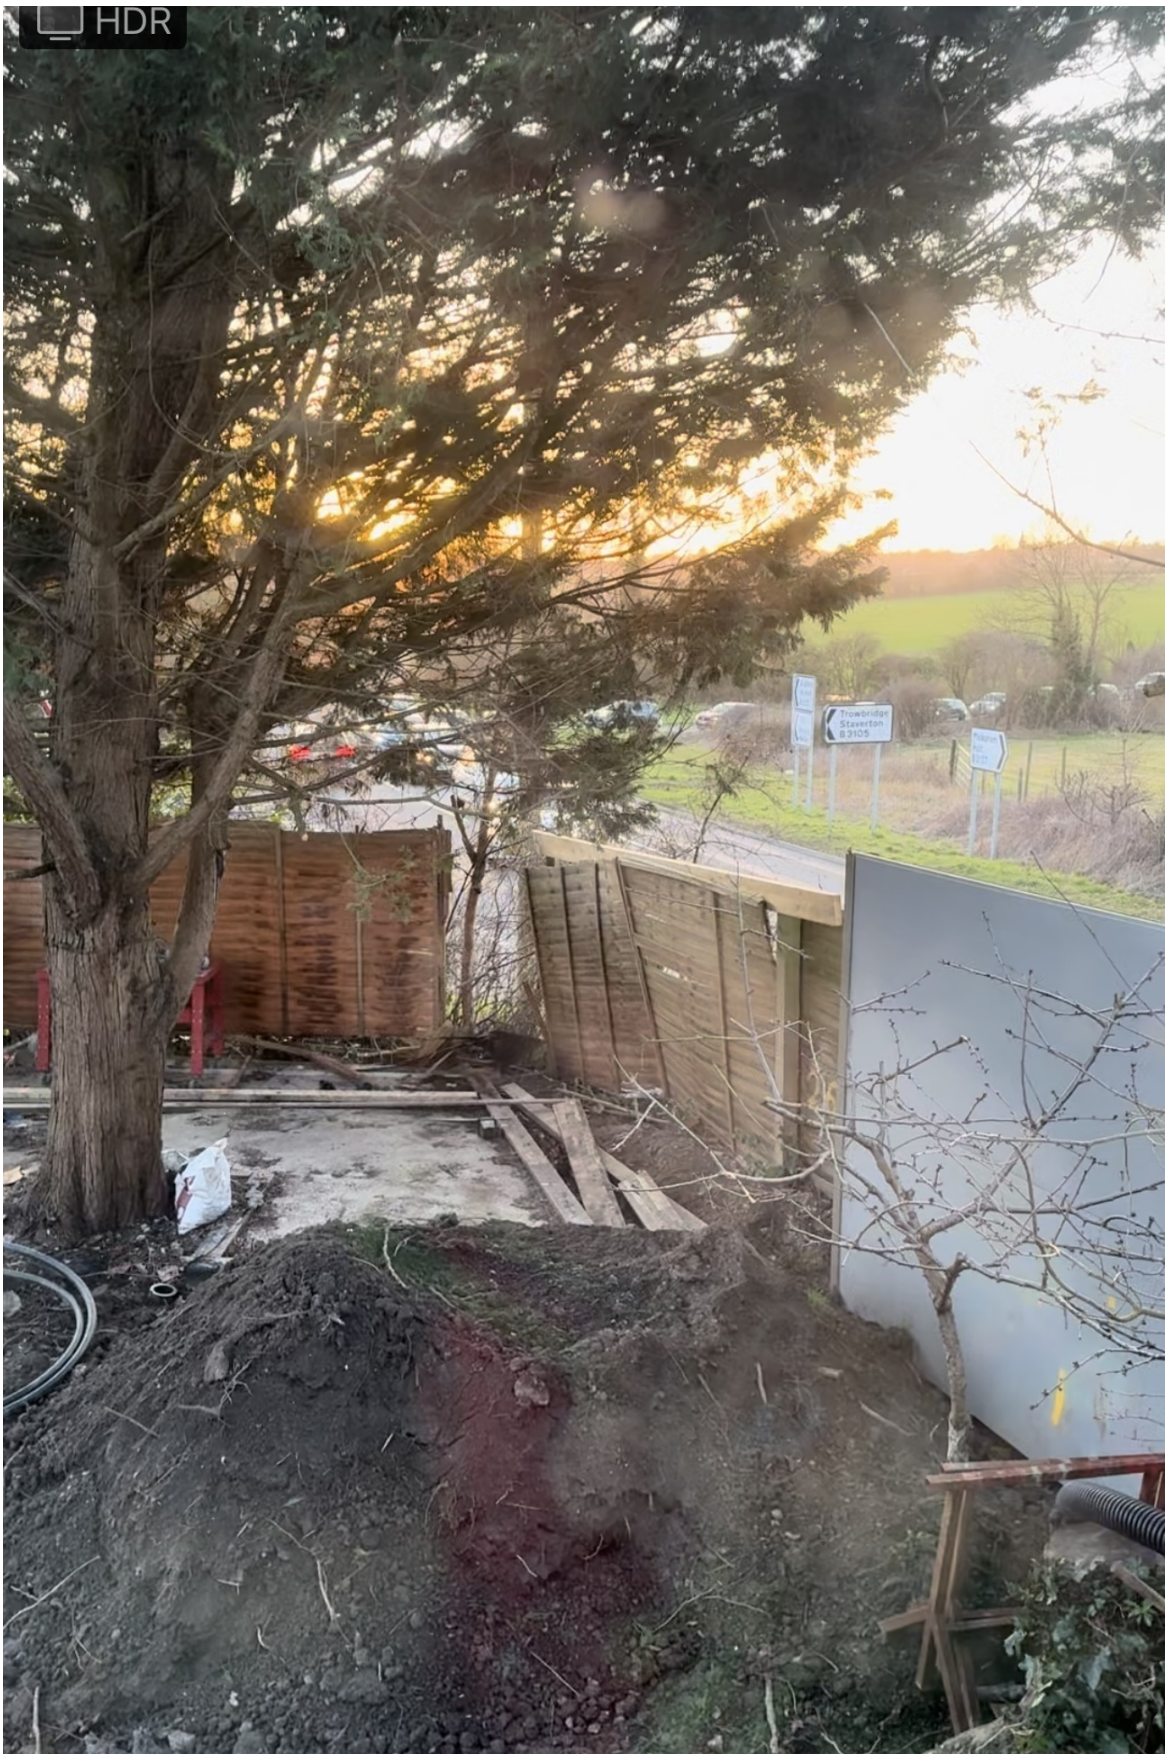
Image 8

Photograph showing the replacement fence being installed alongside the collapsed former timber boundary fence, illustrating the condition of the previous enclosure and the circumstances in which the replacement works were undertaken.
