Ref: PL/2026/00823

**Re: 113 High Street, Burbage, Wilts, SN8 3AA**

Further to your email dated 8<sup>th</sup> June 2026 in respect of the above application, I am writing to provide additional information, intended to address the Conservation Officers comments, specifically relating to the proposed new internal opening between the hallway and shower room.

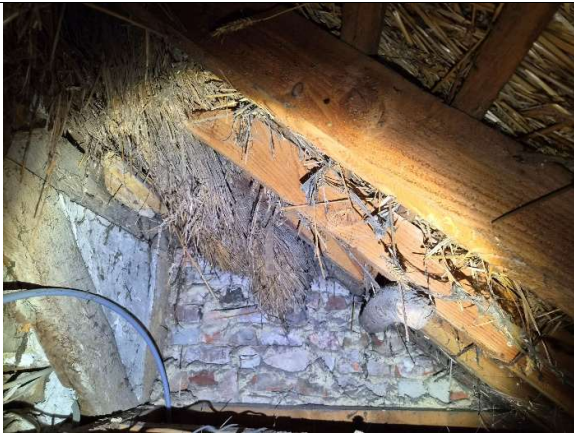
3. With respect to the proposed new internal opening between the hallway and shower room, we can confirm:
  - The wall is of masonry construction, comprising a mixture of brickwork and rubble stone. [\(photo 1\)](#)

1. View of wall as viewed from roof space

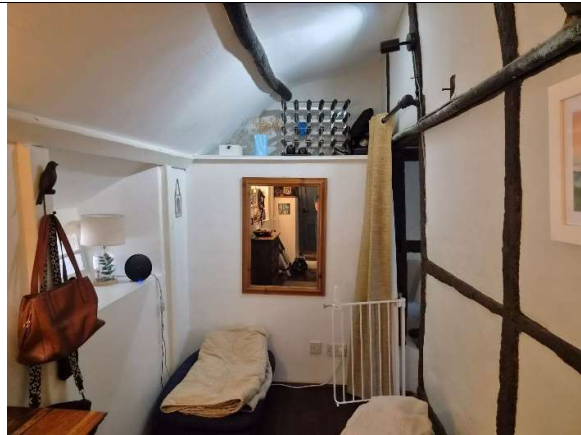
- The left hand (hallway) side of the wall comprises another skin of masonry, though this side of the wall has been altered historically. The upper section of the wall has been reduced in height and is now topped with an MDF shelf. [\(photo 2\)](#)

2. View of wall, as viewed from hall

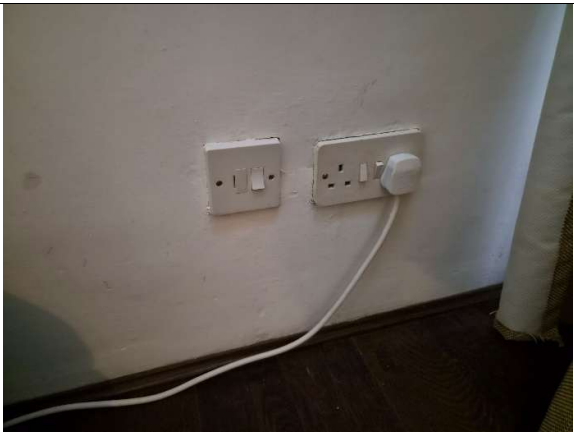
- The masonry on the hallway side is finished with gypsum plaster, which has been painted. A couple of power outlets have been chased into the masonry. The gypsum finish can be seen around the power outlets. [\(\(photo 3\)](#)

3. Modern gypsum plaster finish visible around sockets

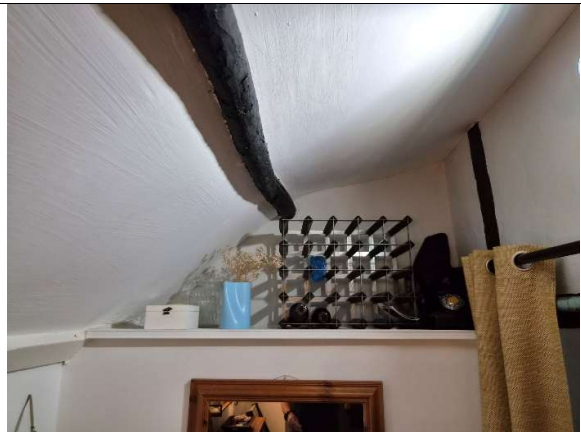
- The wall provides limited support to the roof structure above. A single larch pole purlin bears into the wall, from the hallway side, presumably supporting the roof timbers above. [\(photo 4\)](#)
- Whilst the larch pole can be seen within the roof void above the shower room, it only extends around 500mm into the void. It does not provide support to the roof structure above the shower room [\(Photo 5\)](#)
- The roof structure over the shower room has been replaced. Here the rafters are in modern softwood. [\(photo 5\)](#)
- The shower room ceiling is also a modern addition, with softwood ceiling joists visible [\(Photo 5\)](#)
- The ceilings on both sides of the wall are finished with plasterboard and a gypsum plaster skim
- The ceiling to the shower room side is considerably lower than it is on the hallway side. This will obviously restrict the height of the proposed new door.

4. MDF shelf above wall, where masonry removed. Note purlin

Whilst a new lintel will need to be installed above the head of the opening, this will ensure that the upper level masonry can remain and will preserve support to the larch pole purlin.

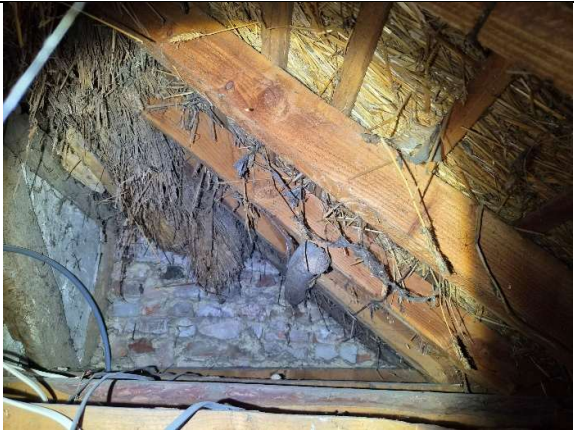
The wall has clearly been the subject of historic alteration. Sections of masonry have previously been removed, with the left-hand side having been reduced in height. Much of the adjacent roof structure has also been replaced.

5. View of modern rafters and ceiling joists above shower room.

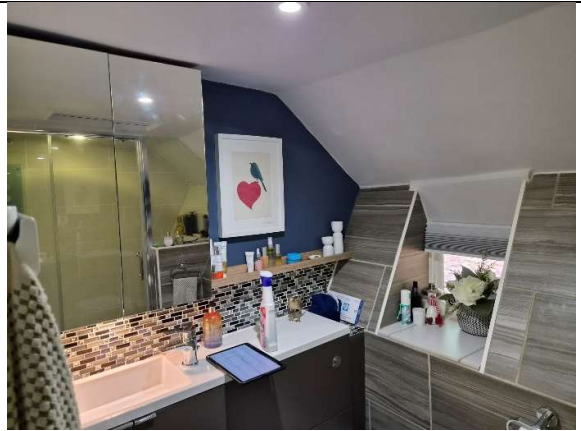
- Only the central part of the wall extends up to the roof line. This part of the wall averages 200mm in overall thickness
  - The right-hand (shower room) side of the wall is lined with softwood framing, finished with plasterboard.

6. View of wall from shower room side
