## Preliminary Ecological Appraisal & Preliminary Roost Assessment

The Kennels, Spye Park, Chippenham, Wiltshire, SN15 2PR SN152PR

The Meadowbrook Trust

This report is prepared to inform a planning application with Wiltshire Council. This proposal can be described as 'The existing kennels building and stables will be sensitively renovated to form two guest houses. The adjacent puppy kennels will be repurposed to accommodate wellness facilities including a steam room, sauna and cold plunge. A landscaped courtyard will be introduced between the three buildings, creating an outdoor space that connects the accommodation and wellness facilities'.

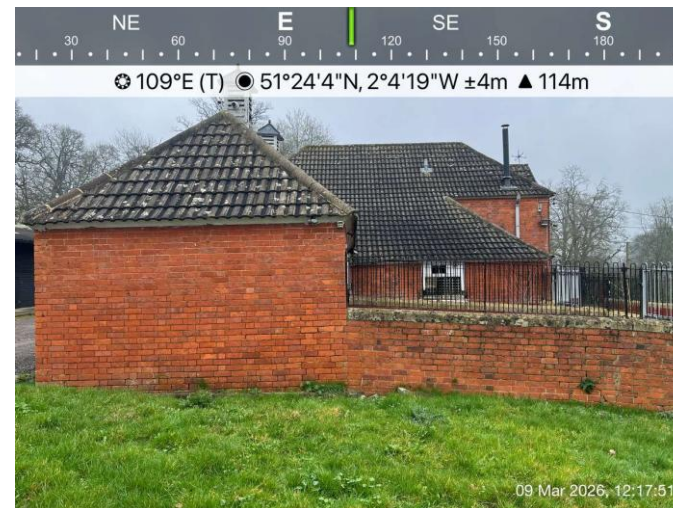
B1 is a two-storey, detached, brick-built building with dog kennels on the ground floor and a flat on the first floor. The building has a hipped roof covered in tiles, and internal voids were recorded. No bat evidence was found during the survey.

In line with Good Practice Guidelines (Collins, J (Ed) 2023), B1 is assessed to have high habitat value for roosting bats due to the building contains multiple lifted tiles, gaps under hanging tiles, and access to the internal voids which contain tears in the loft lining and broken timber boards.

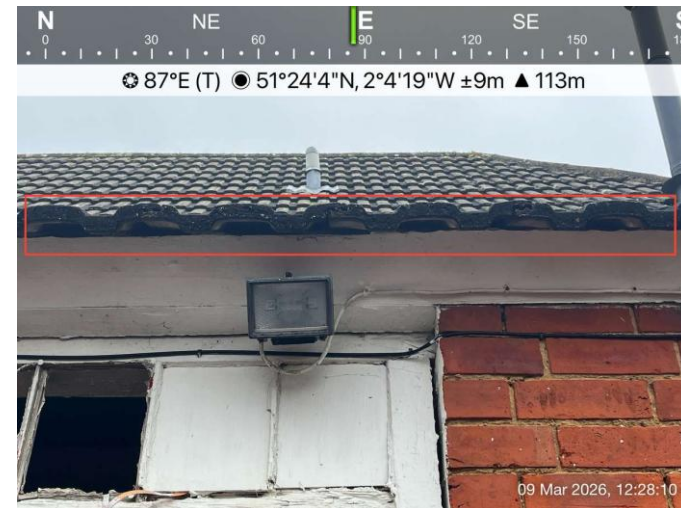
| | | | B1 |
|---|---|---|---|
| Roof | Tiles | The roof is of tiled construction and hipped in structure. The roof condition is average, with multiple lifted tiles noted across the building. Specifically, on the west elevation, lifted interlocking tiles create gaps, and open edge tiles provide access. On the northern elevation, numerous gaps exist under lifted tiles. Four timber cupola structures are present along the ridge line, with lifted LED flashing on the north and south elevations where they meet the roof tiles. These cupolas also provide | |

ventilation with open sides, offering direct internal access to the building. These features may provide roosting opportunities for crevice-dwelling bats.

*Lifted tiles on west elevation of B1*

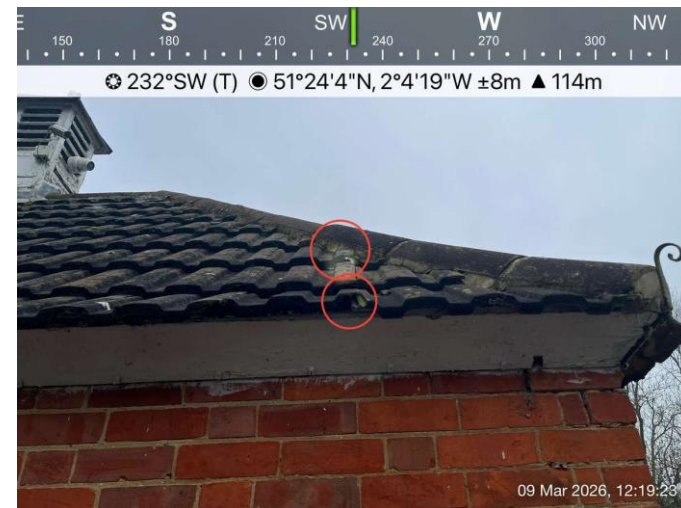
*Gaps under edge tiles on west elevation of B1*

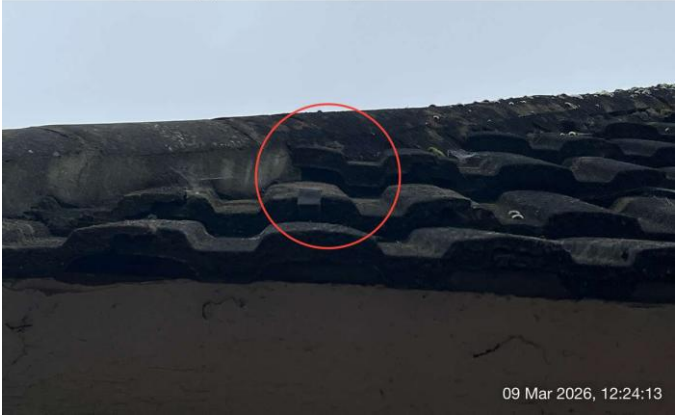
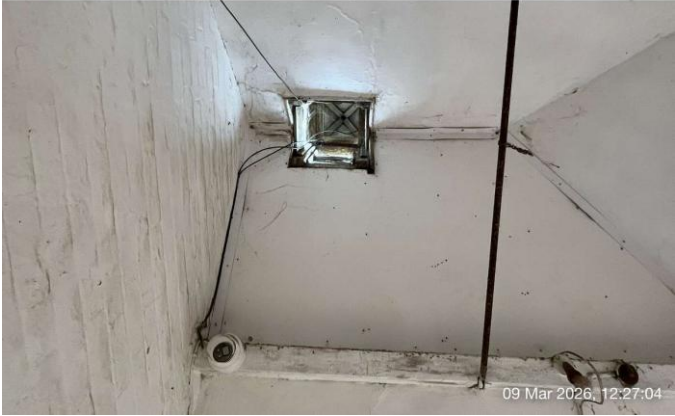
*Lifted tiles on north elevation of B1*

| | | | | <div><div><div><div>SE</div><div>S</div><div>SW</div><div>W</div></div><div><div>120</div><div>150</div><div>180</div><div>210</div><div>240</div><div>270</div><div>300</div></div></div><div><div>204°SW (T)</div><div>51°24'4"N, 2°4'17"W ±10m</div><div>▲ 113m</div></div><div></div><div>09 Mar 2026, 12:24:13</div><div>Gaps under edge tiles on the west elevation of B1</div><div><div><div>SE</div><div>S</div><div>SW</div><div>W</div></div><div><div>150</div><div>180</div><div>210</div><div>240</div><div>270</div><div>300</div></div></div><div><div>217°SW (T)</div><div>51°24'4"N, 2°4'19"W ±14m</div><div>▲ 114m</div></div><div></div><div>09 Mar 2026, 12:27:04</div><div>Internal view of cupola on B1</div></div> |

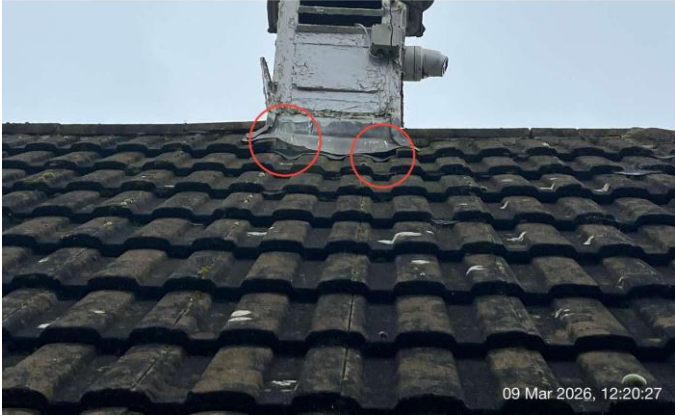
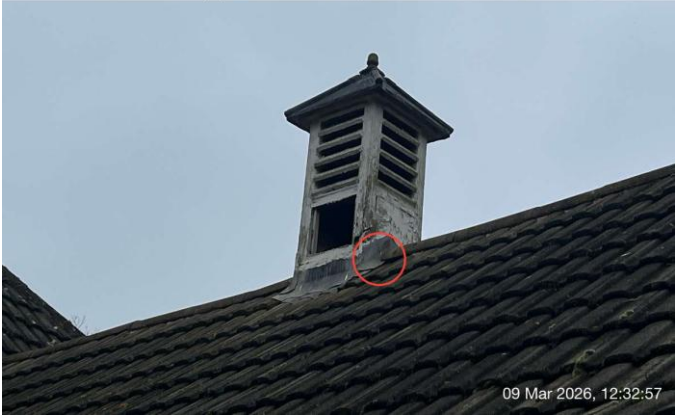
| | | | | <div><div><div><div>SE120150180S210SW240270W</div><div>193°S (T) 51°24'4"N, 2°4'19"W ±3m 112m</div><div></div><div>09 Mar 2026, 12:20:27</div></div><div>Lifted flashing around cupola on north elevation</div><div><div>W240270300330NW330N0NE6</div><div>325°NW (T) 51°24'4"N, 2°4'18"W ±5m 113m</div><div></div><div>09 Mar 2026, 12:32:57</div></div><div>View of cupola from south elevation</div></div></div> | |

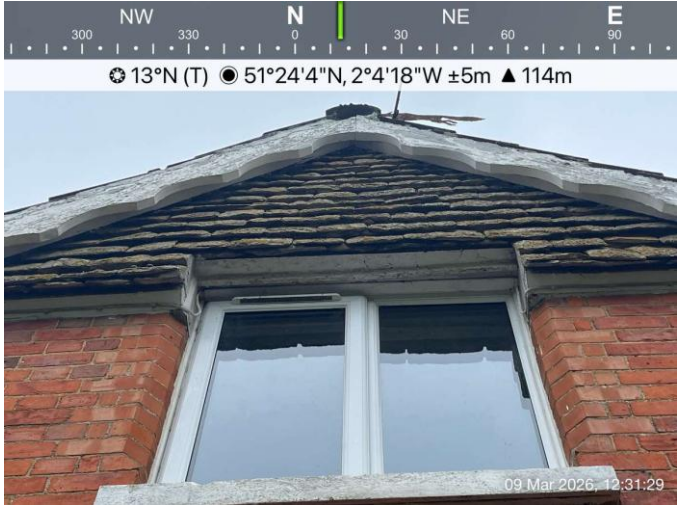
| Walls | Brick-built | <p>The brick-built walls exhibit some cracking and mortar loss, which were inspected and determined to be superficial in nature. On the southern elevation, a section of the building features clay hanging tiles on the first floor, with the majority of these tiles lifted, providing access for crevice-dwelling bats.</p> | <p><i>Handing tiles on the southern elevation of B1</i></p> |

Broken soffit on the west elvation of B1

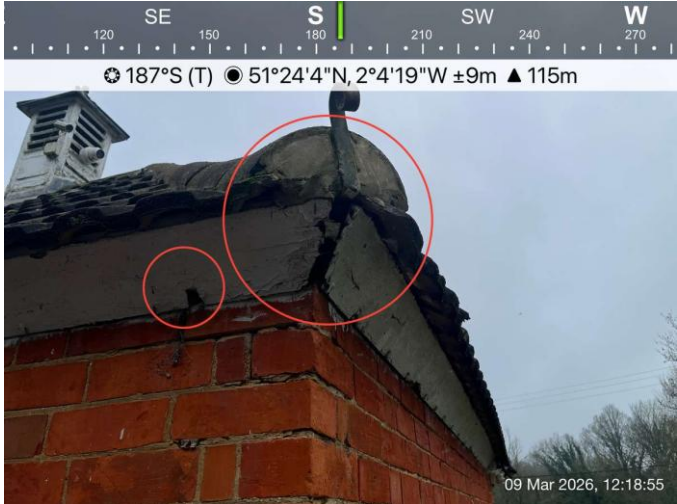
| Eaves | Timber | <p>The eaves and soffits are timber and exhibit frequent defects with multiple gaps present. On the northwest corner, a gap between soffits allows access into the soffit box. On the west elevation, a broken soffit board has created a gap. On the south elevation, decayed soffit boards have created gaps between the soffits and the edge tiles. These features may provide roosting opportunities for crevice-dwelling bats.</p> | <p><i>Gap between soffits on northwest corner.</i></p> |

Decayed soffit on the southern elevation of B1

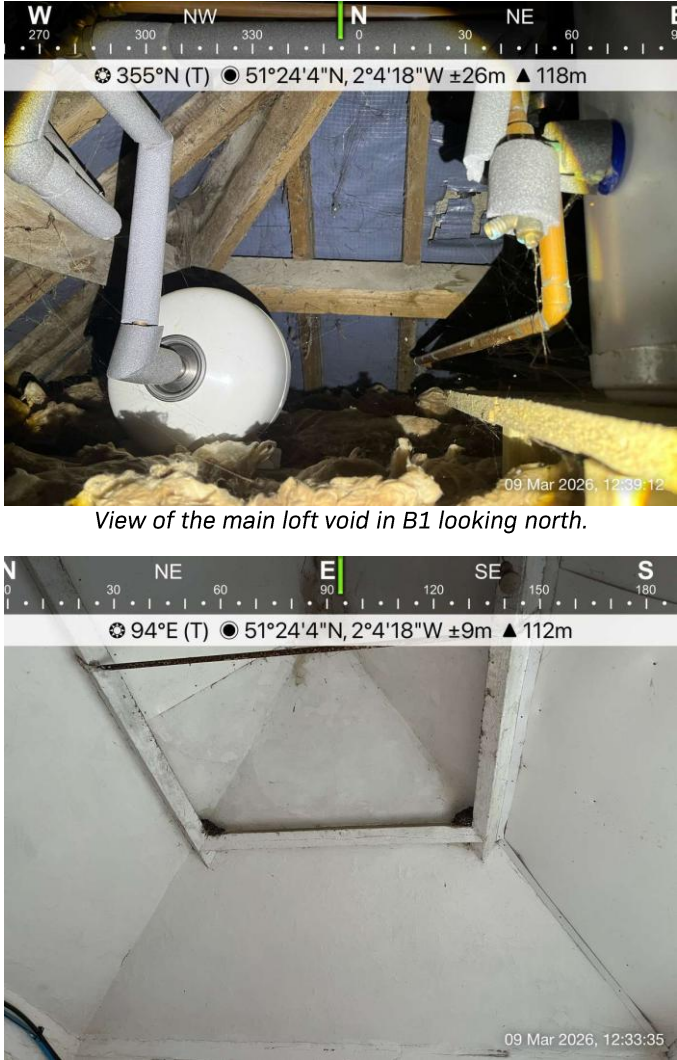
| | Voids | Plastic sheeting + Timber boards | <p>A small loft void, measuring 3m in length, 2.4m in width, and 1.4m in height with an area of approximately 7.2m<sup>2</sup>, was recorded centrally above the first-floor flat. This void is accessible and lined with plastic sheeting. A temperature of 9°C and humidity of 79% were recorded within this void. Three tears were noted in the lining, allowing light ingress and potentially providing roosting opportunities for crevice-dwelling bats. Internally, the building is separated into several kennels with timber board ceilings. Gaps were observed in the timber panels forming the kennel ceilings, which are likely to provide roosting opportunities for crevice-dwelling bats.</p> | <p>The top photograph shows a view of the main loft void in B1 looking north. It features a white spherical object, possibly a light fixture, and wooden beams. The bottom photograph shows bird nests present inside the kennels at B1, with a white wall and a wooden frame visible.</p> | |

| | | | | <div><div></div><p><i>Tears in the loft lining within B1</i></p><div></div><p><i>Light ingress observed in the loft void in B1</i></p></div> | |

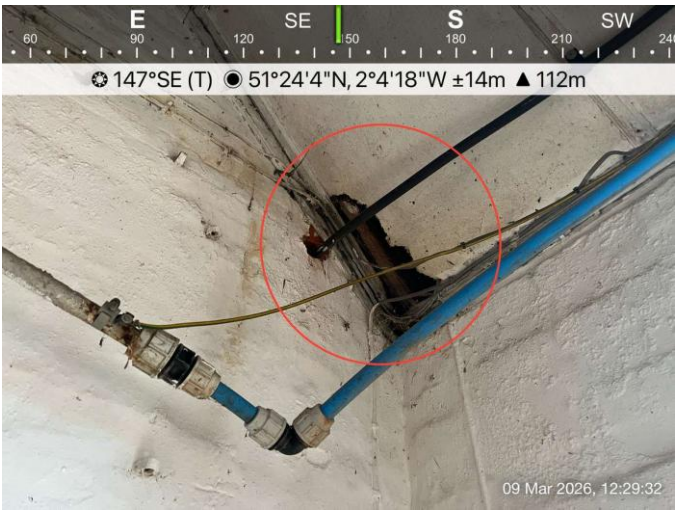
*Gap in ceiling inside the kennels in B1*

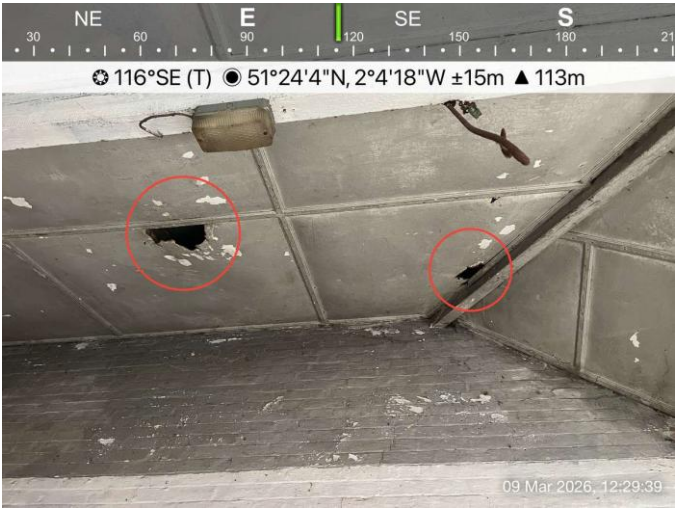
*Gap in ceiling inside the kennels in B1*

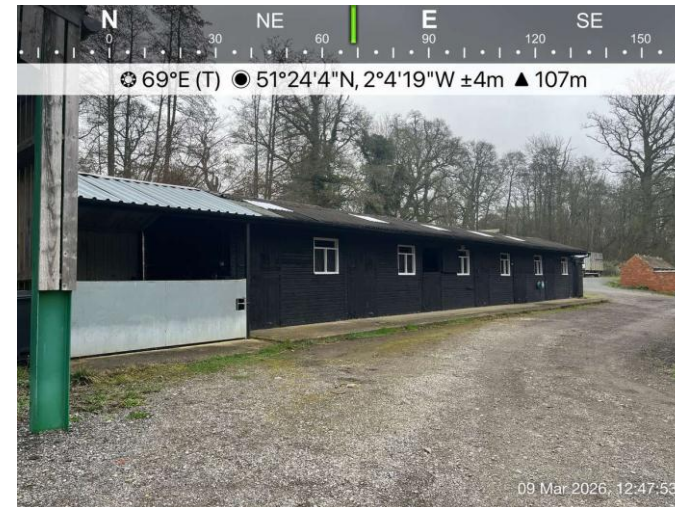
B3 is a single-storey, detached, timber-framed building which has previously been used as horse stables. The main structure has a gabled roof clad in corrugated bitumen felt. To the west elevation of the building, there is a small metal-framed structure with a corrugated metal roof that is utilised for storage. No internal voids were recorded during the survey, and no bat evidence was found within the building. Internally, the building has a timber beam structure.

In line with Good Practice Guidelines (Collins, J (Ed) 2023), B3 is assessed to have low habitat value for roosting bats due to the building containing only a small number of suitable roosting features.

| Feature | Materials | Condition/Suitability | Photographs |
|---|---|---|---|
| Walls | Timber-framed | The walls of the building exhibit open cracks and voids. Specifically, on the northern elevation, a broken timber panel has created a gap, allowing access to the internal space and providing potential roosting opportunities between the external timber structure and internal timber boards. Additionally, several stable doors on the southern elevation are frequently left open, granting access to the interior space. Internally, the building has timber beams which may provide a suitable surface for | |

| | | | cavity-dwelling bats to roost. | <p>Broken timber walls on B3</p> | |

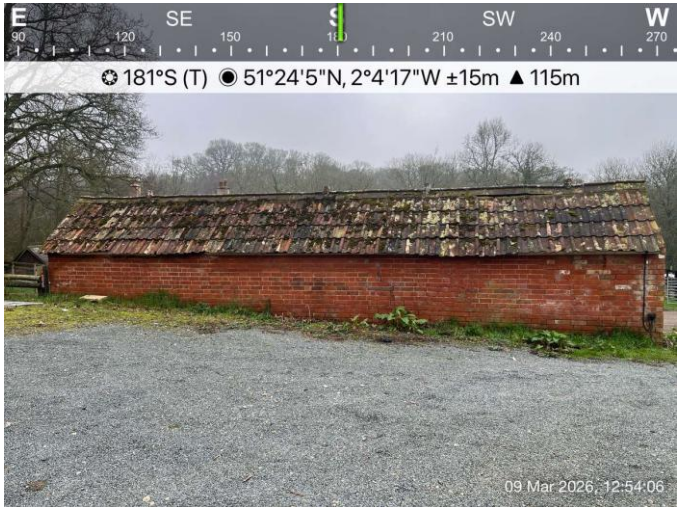
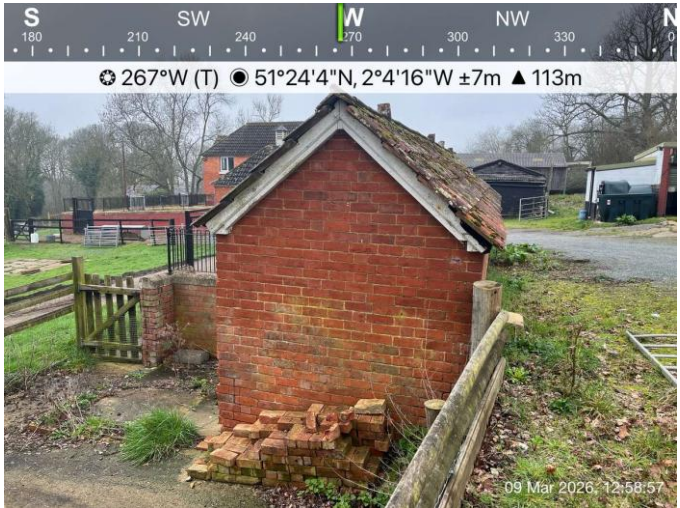
B4 is a single-storey, detached, brick-built kennel building. The structure has a gabled roof covered with clay tiles. The walls are brick-built, and the kennel doors are open, providing internal access on the southern elevation. Frequent defects were noted in the roof, with multiple gaps present. No bat evidence was found during the survey.

In line with Good Practice Guidelines (Collins, J (Ed) 2023), B5 is assessed to have moderate habitat value for roosting bats due to the presence of roosting features, including multiple lifted and broken roof tiles and ridge tiles, as well as direct access into the internal space where suitable features for crevice dwelling bats were observed.

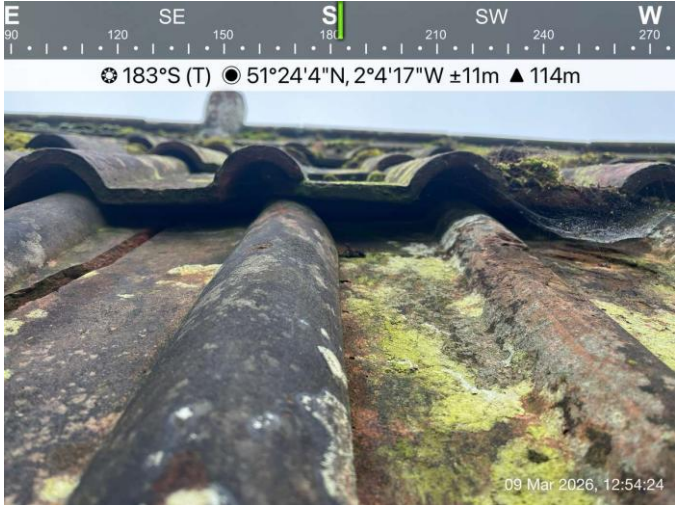
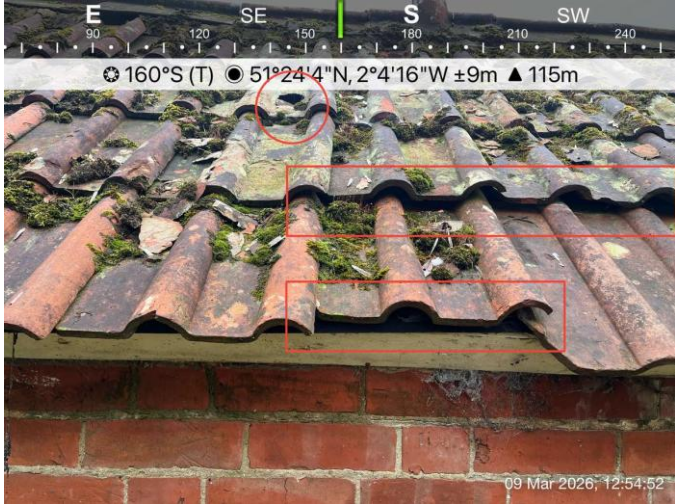
| | Roof | Clay tiles | <p>The roof is of gabled construction and clad with clay tiles. Frequent defects were noted, with multiple gaps present. There are multiple lifted and broken roof tiles on the north and south elevations, which may provide roosting opportunities for crevice-dwelling bats. Multiple lifted ridge tiles were also observed on the north and south elevations. Along the edge of the roof tiles on the east and west elevations, there is missing mortar, which may provide roosting opportunities for crevice-dwelling bats.</p> | <p><i>Lifted roof tiles on the northern elevation.</i></p> <p><i>Lifted and broken tiles north elevation.</i></p> |

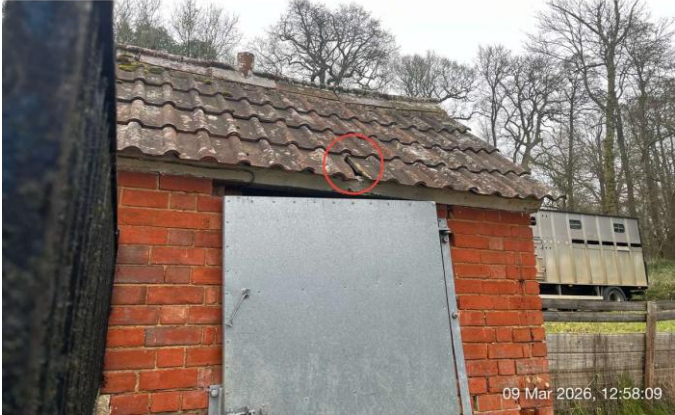
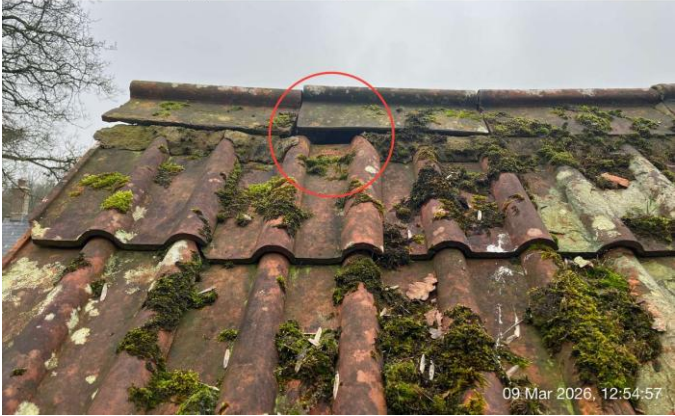
| | | | | <div><div><div><div><div>NW</div><div>N</div><div>NE</div><div>E</div><div>SE</div></div><div><div>330</div><div>0</div><div>30</div><div>60</div><div>90</div><div>120</div></div></div><div><div>48°NE (T)</div><div>51°24'4"N, 2°4'17"W ±11m</div><div>▲ 114m</div></div><div></div><div>09 Mar 2026, 12:58:09</div><div>Broken tile on the southern elevation.</div></div><div><div><div><div>E</div><div>SE</div><div>S</div><div>SW</div></div><div><div>90</div><div>120</div><div>150</div><div>180</div><div>210</div><div>240</div></div></div><div><div>167°S (T)</div><div>51°24'4"N, 2°4'16"W ±8m</div><div>▲ 115m</div></div><div></div><div>09 Mar 2026, 12:54:57</div><div>Gap under ridge tile on the north elevation.</div></div></div> | |

| | | | | <div><div></div><p>Gap under ridge tile on the south elevation.</p><div></div><p>Missing mortar along the edge of the tiles on the west elevation.</p></div> | |

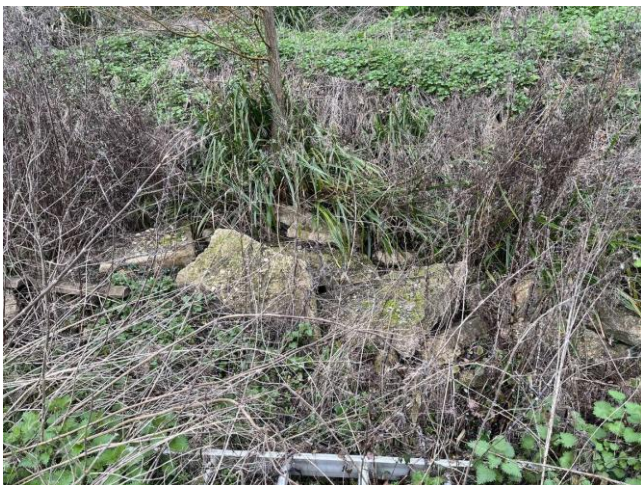
neutral grassland for approximately 71 m. At the time of the survey, the ditch contained approximately 20 cm of standing water. Duckweed covered approximately 10% of the water surface, and the water appeared dark brown in colour, likely due to suspended organic matter. Submerged, emergent and floating vegetation were observed throughout the ditch. A pile of rubble was also observed in the ditch to the northeast of the site.

*Photo 11: Rubble in the northern ditch.*
