## Front – South facing Elevation

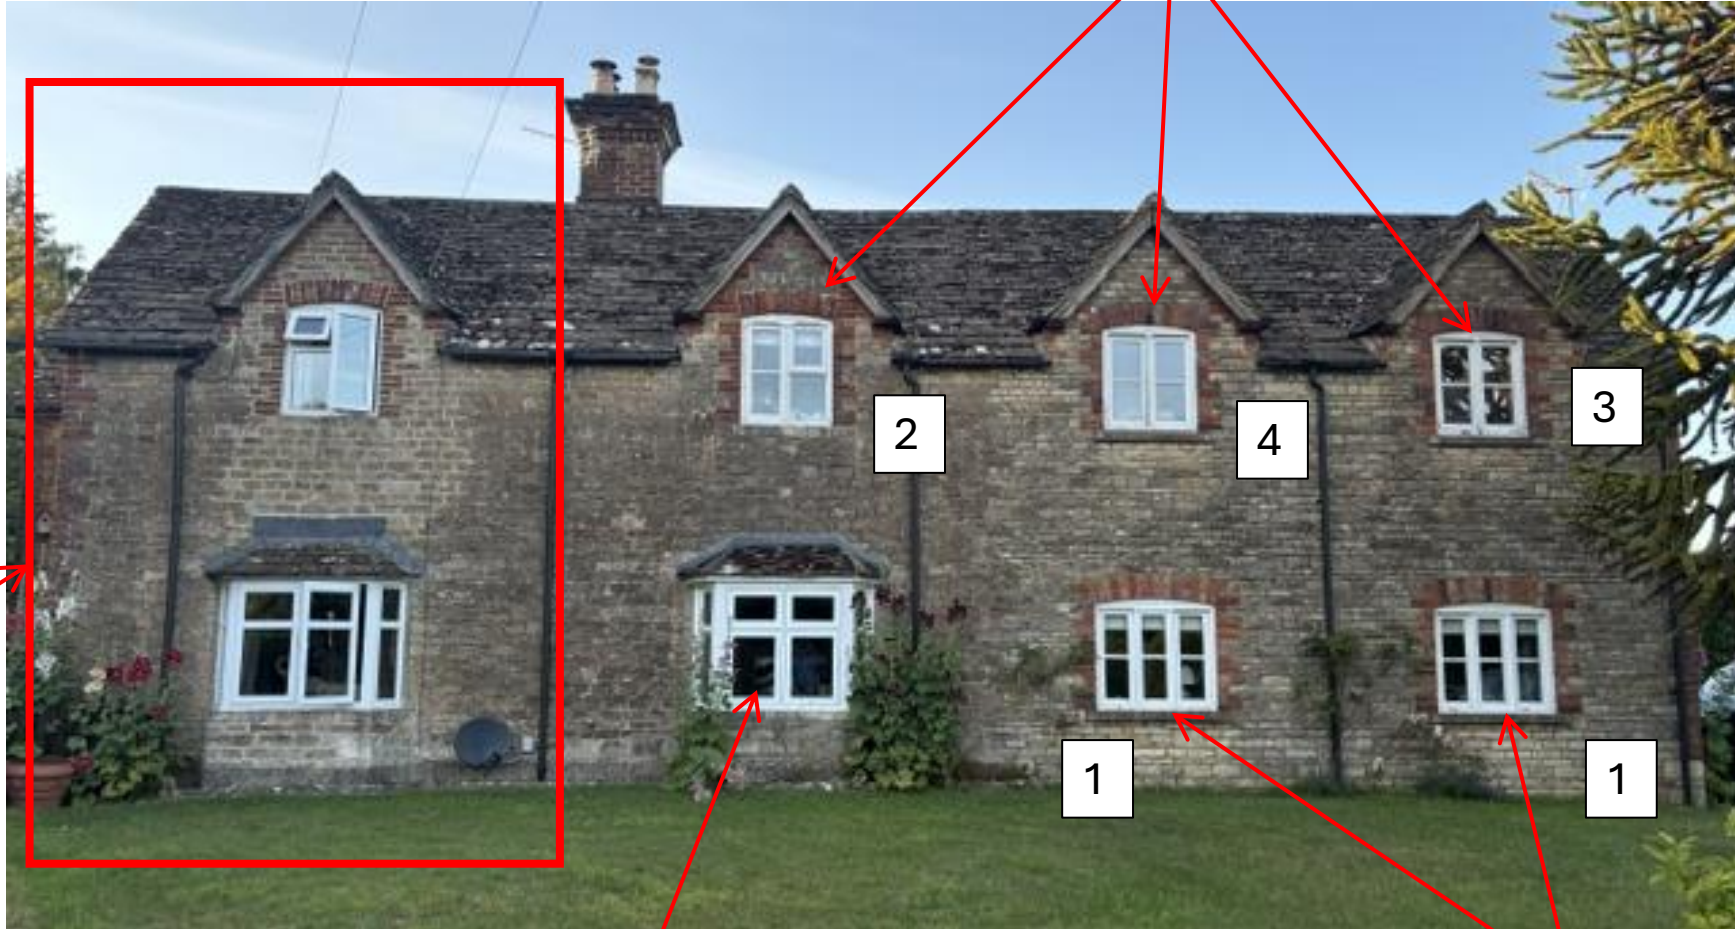
Rotten wooden windows with blown double glazed units will be replaced.

Next door neighbour.  
They have  
Standard  
UPVC  
windows.

Bay window was replaced with flush casement upvc in 2022 as the wooden windows were badly deteriorated and were not secure.

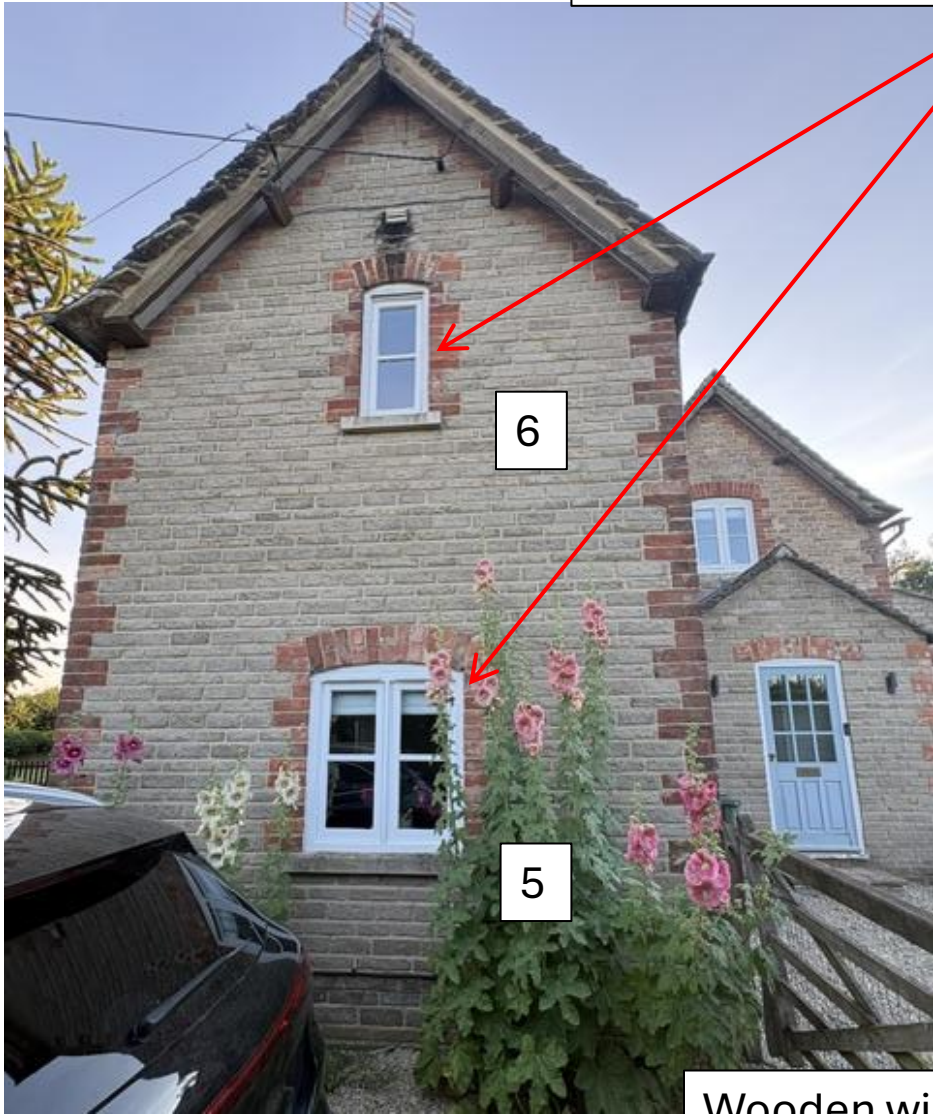
Side – East facing Elevation

Wooden windows will be replaced.

Wooden window will be replaced with French doors as shown in drawings.

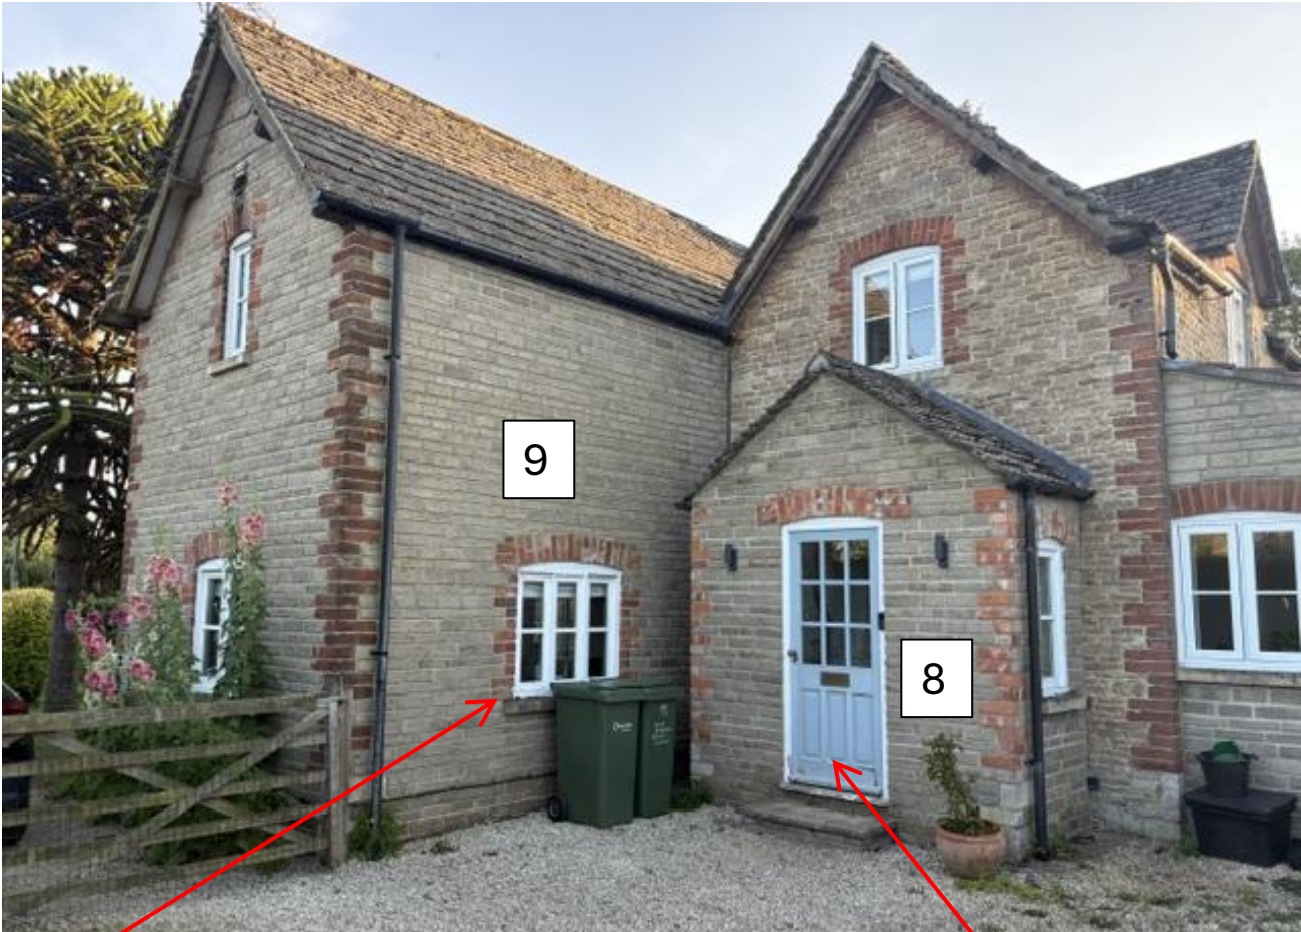
Wooden door will be replaced with composite door as per application.

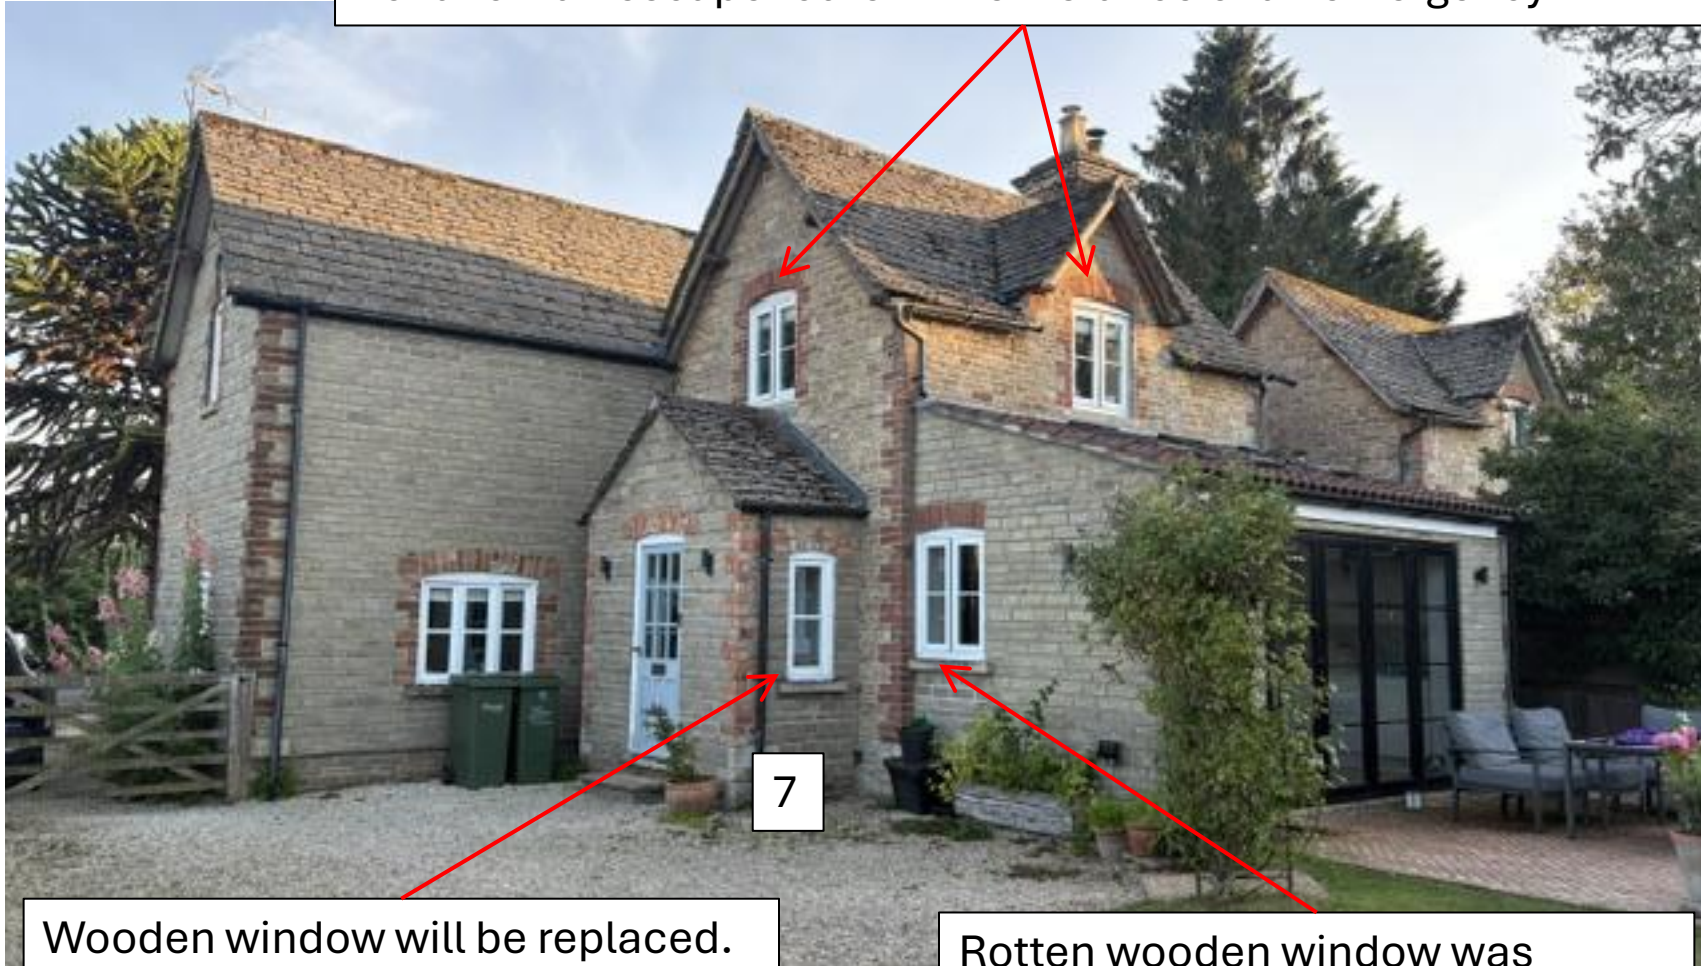
## Rear – North facing Elevation

Rotten single glazed windows were replaced with flush casement upvc windows in 2021. They looked home made. One didn't open at all and the other only had a small opening which would not allow an escape route in the instance of an emergency.

Wooden window will be replaced.

Rotten wooden window was replaced as part of the kitchen refurbishment in 2022. See next page for notes.

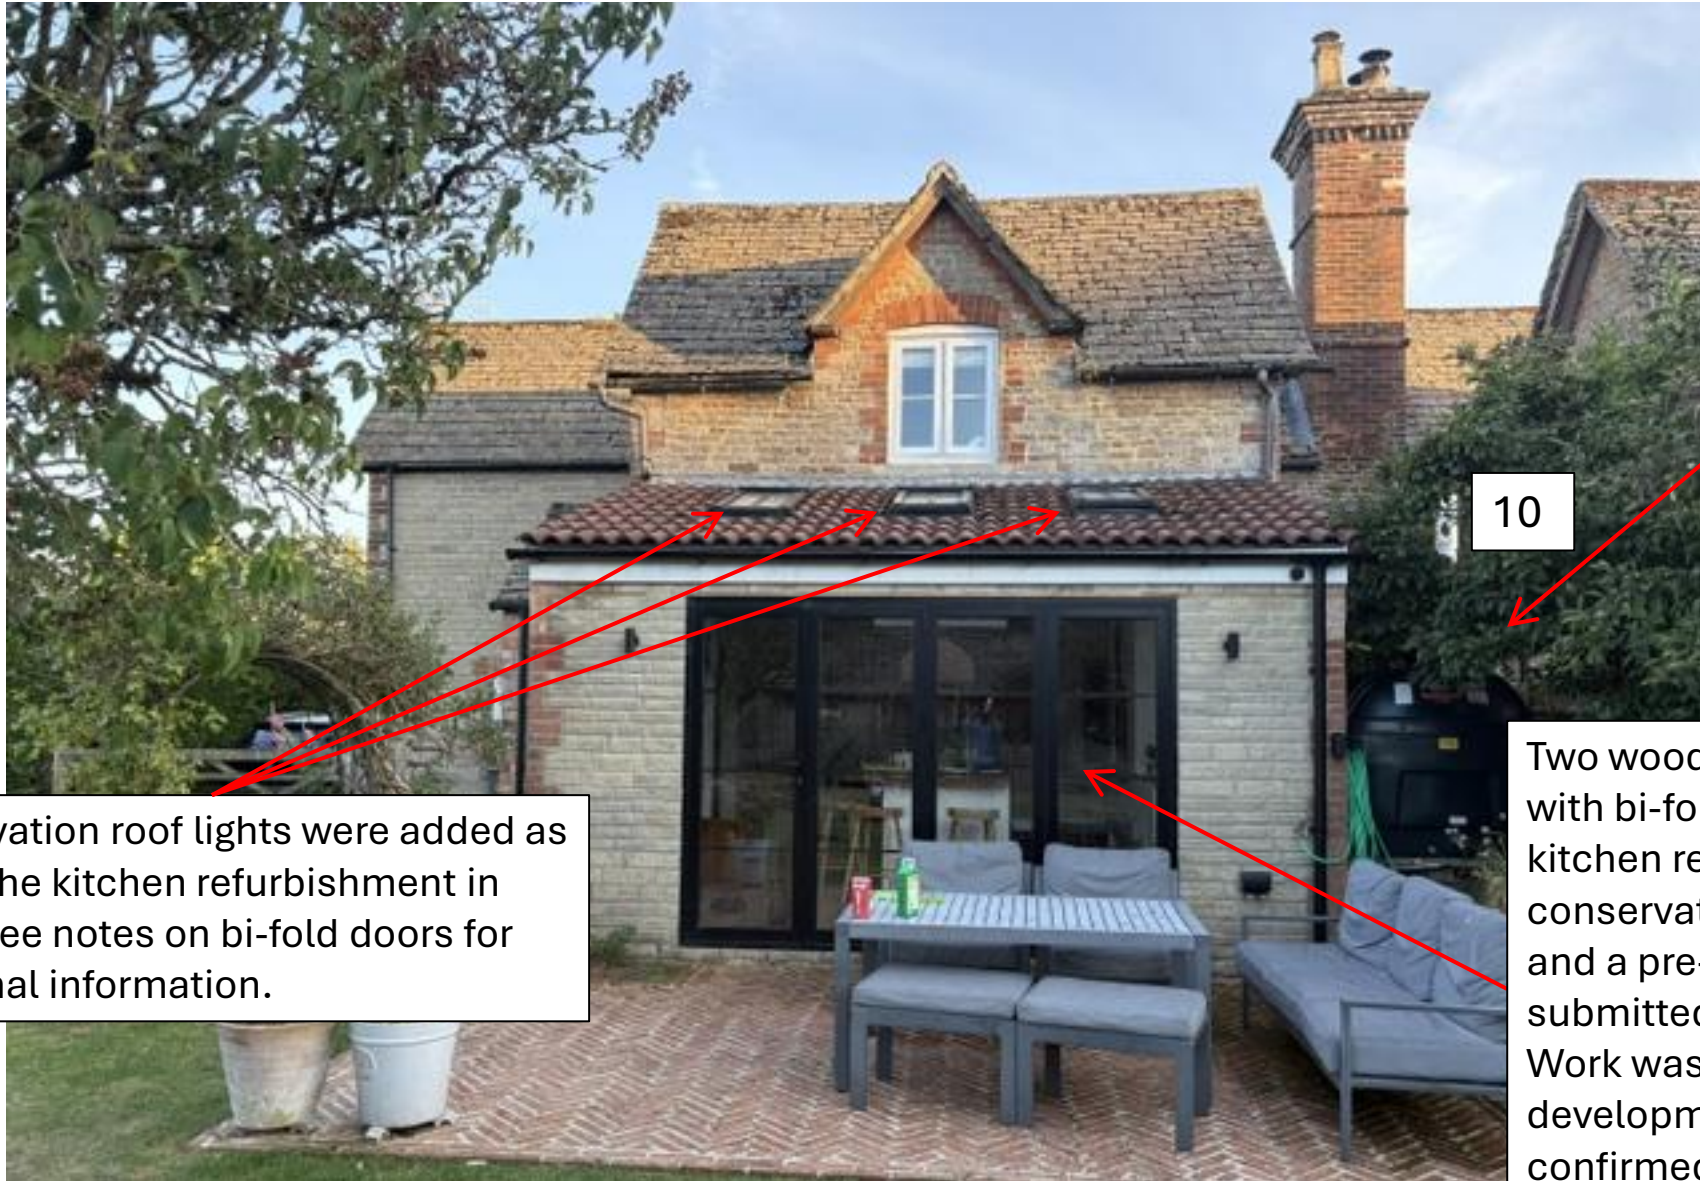
## Rear – North facing Elevation

Conservation roof lights were added as part of the kitchen refurbishment in 2022. See notes on bi-fold doors for additional information.

Rotten wooden toilet window (behind tree) will be replaced.

Two wooden windows were replaced with bi-fold doors as part of the kitchen refurbishment in 2022. The conservation officer was consulted, and a pre-planning check was submitted and response received. Work was carried out under permitted development rights which were confirmed to be intact. Work was signed off through building control.
