## THE ANGEL HOTEL, CHIPPENHAM

### Heritage Justification, Design & Access Statement (L11.01)

July 2026

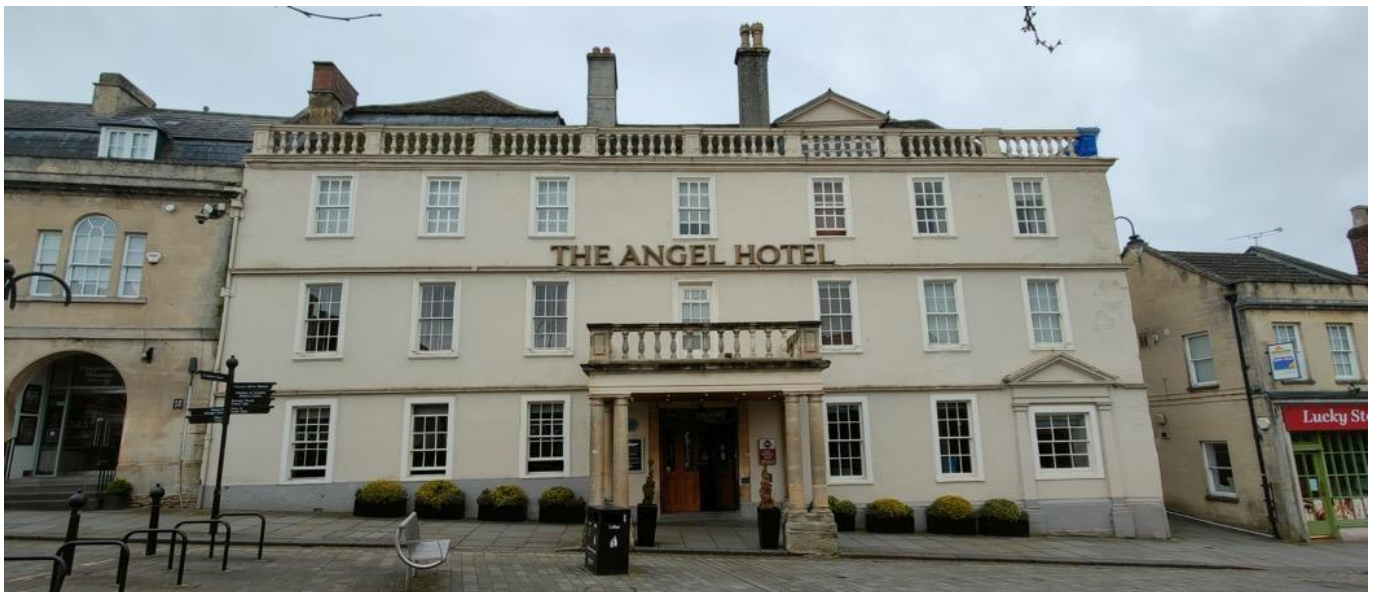
Fig.1: Front elevation with balustrading

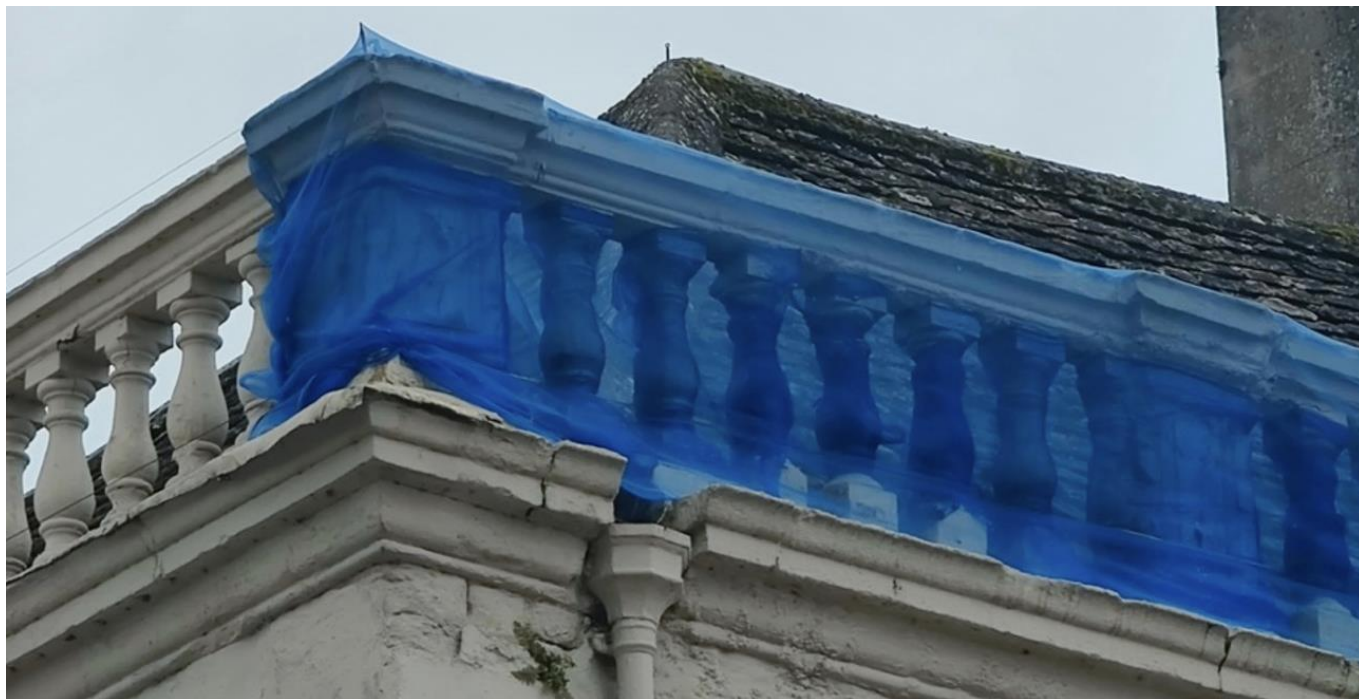
Fig.2: Existing balustrading

The stone balustrade along the east elevation has some evidence of aging but is generally in good condition. It has also undergone previous strengthening work which takes the form of vertical steel supports behind each primary baluster or newel post.

The balustrade on the north elevation is in much worse condition and has not undergone previous strengthening work.
