# **Arboricultural Survey and Impact Assessment**

**Lake 62, Cotswold Water Park, Derryfields, Ashton  
Keynes, Wiltshire**

**March 2026**

**Prepared by:** David Paginton M.Arbor.A

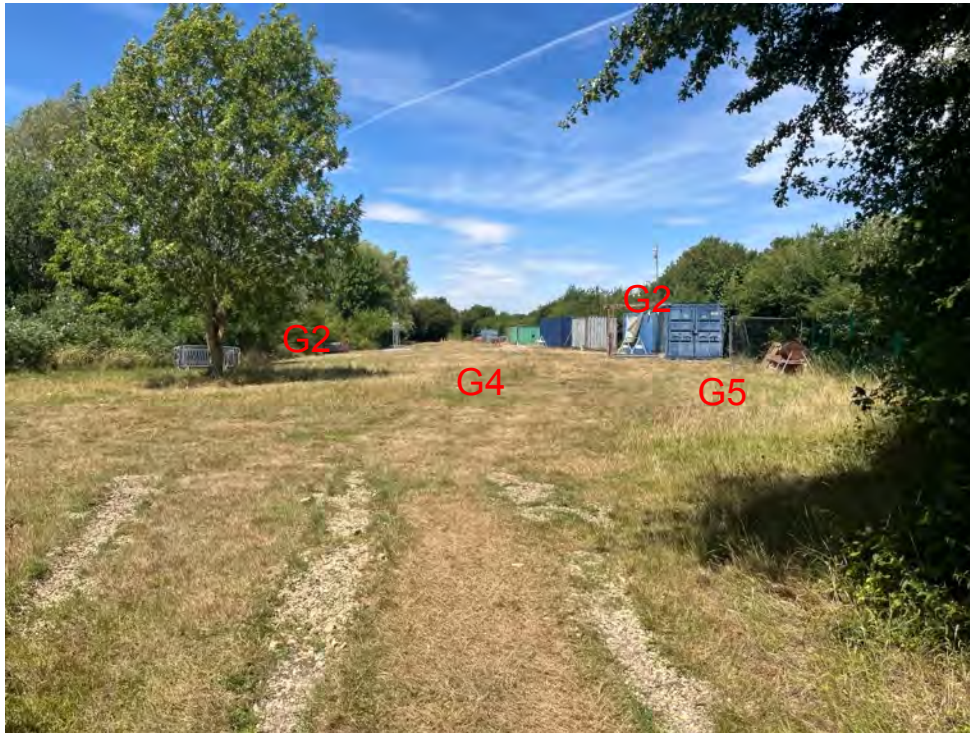
Photo 1: View looking south towards G2, G4 and G5.

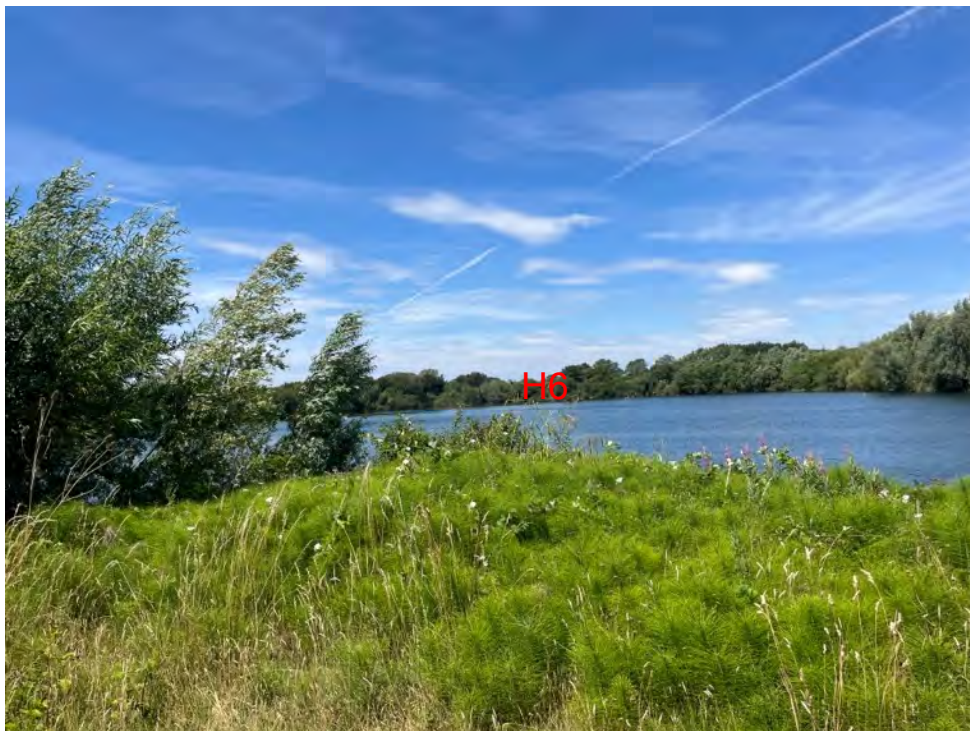
Photo 2: View looking at H6.

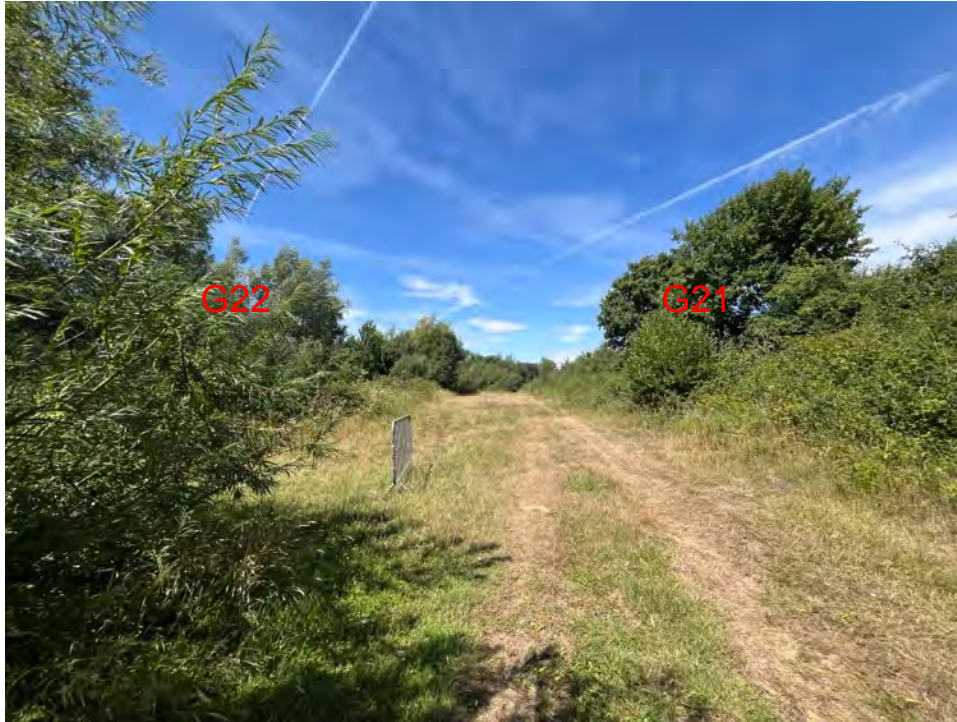
Photo 5: View looking north at at G21/G22.

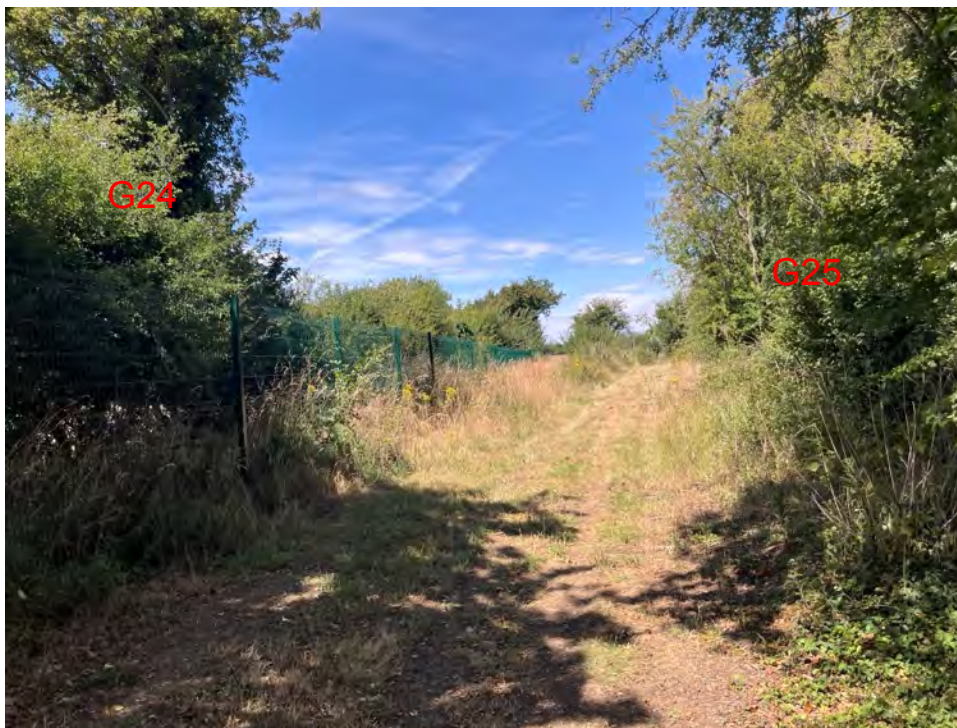
Photo 6: View east along G25.

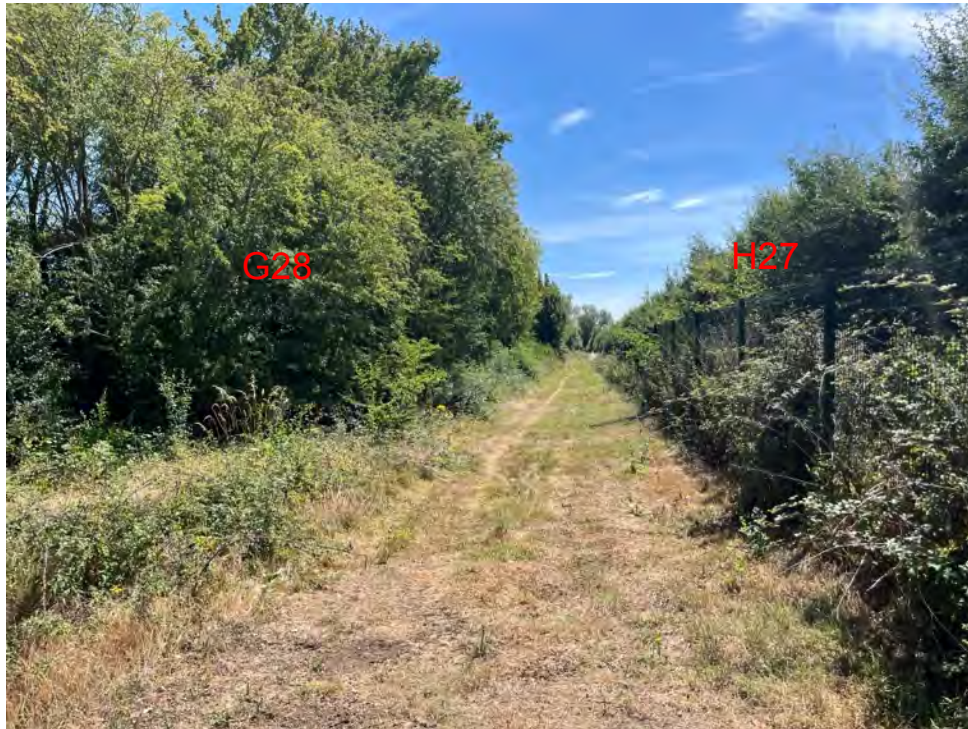
Photo 7: View south along H27.

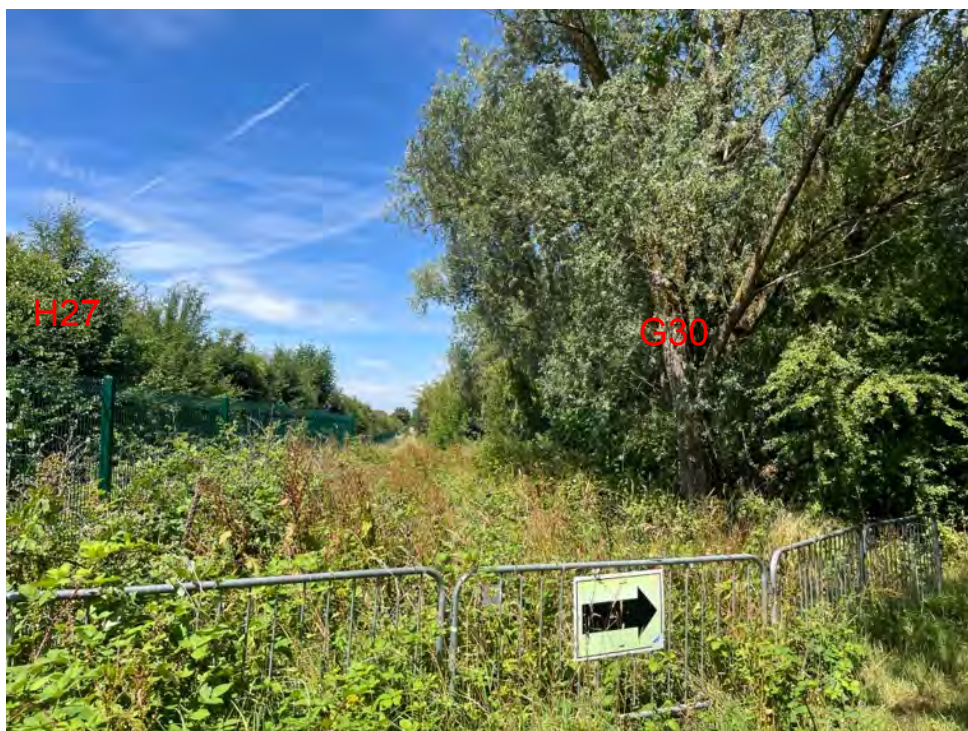
Photo 8: View north along H27.

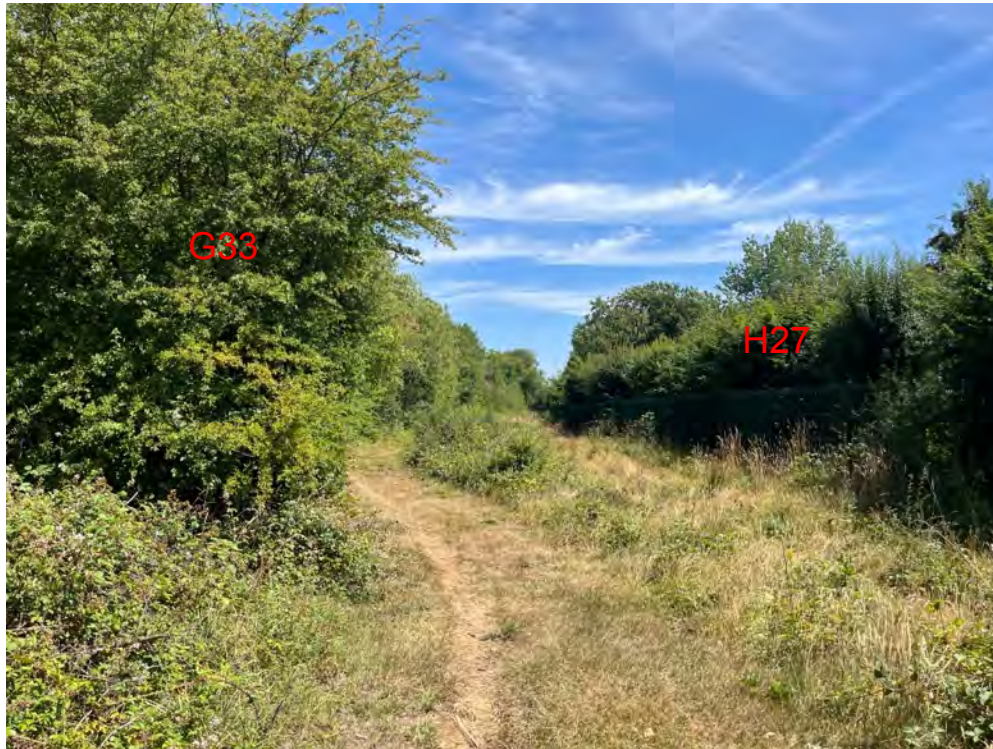
Photo 9: View south at G33.

- G1 (Part) to be removed for a pedestrian access.
- G6, G7 (Part), G9 (Part), G11, G12 (part), T13, G14 (part), G16, G18, G19, G29 (Part), G33 (part) – Removed to facilitate installation of hard surfacing for the new shoreline holiday lodges.
- G35, G31, G34 – removed to allow for a new site access and parking areas.

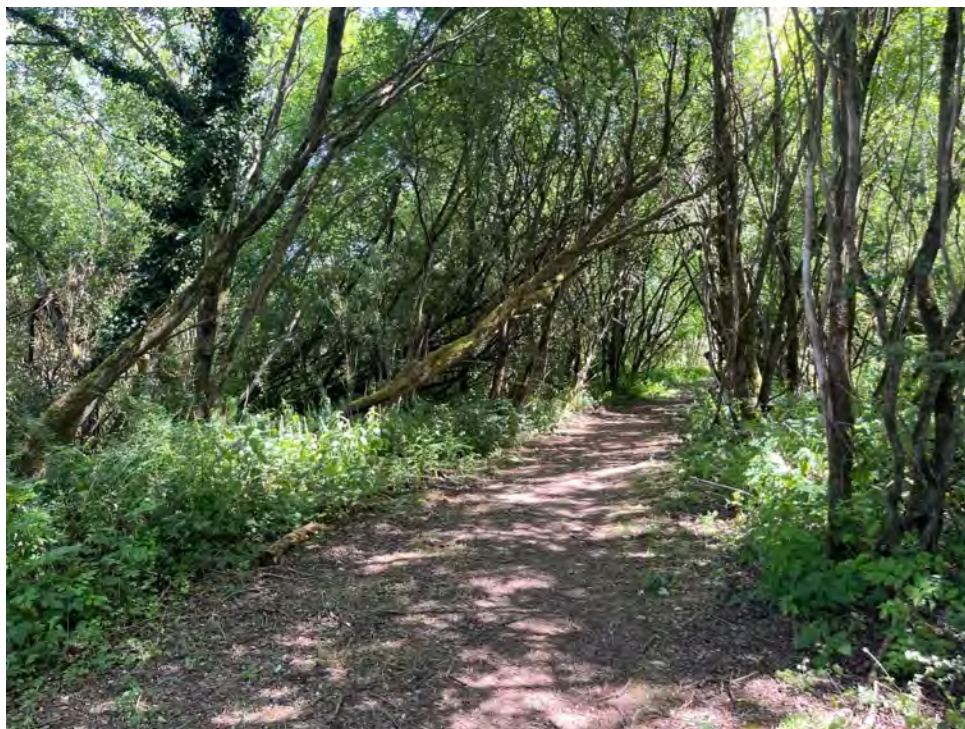
Photo 10: View through G6.

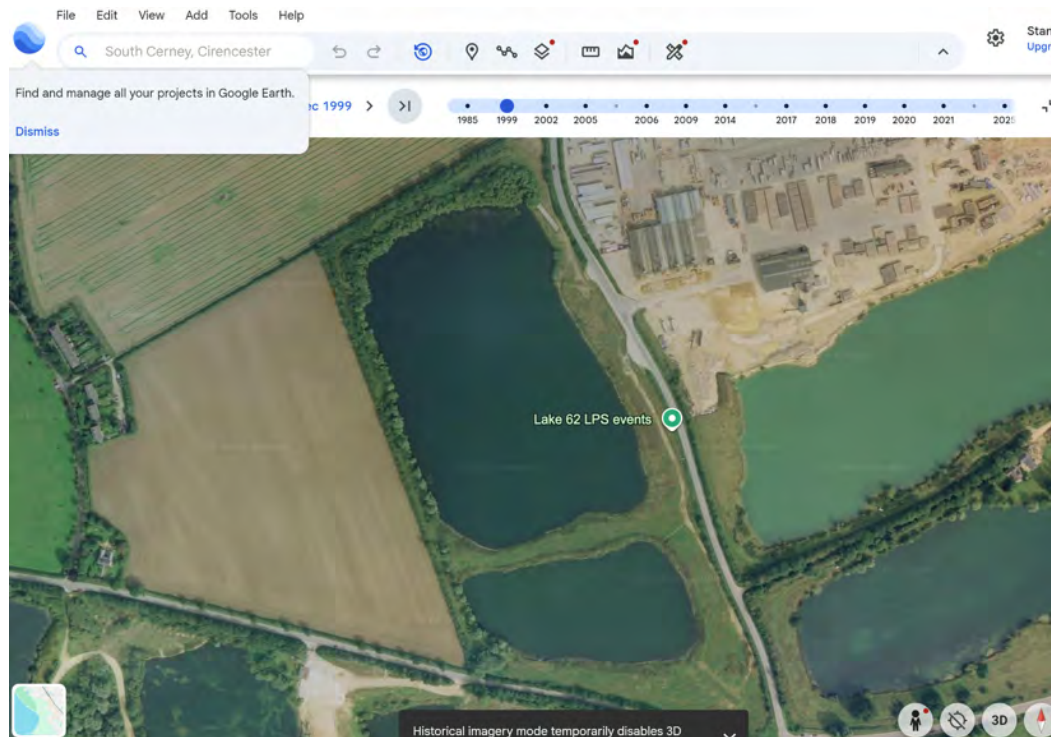
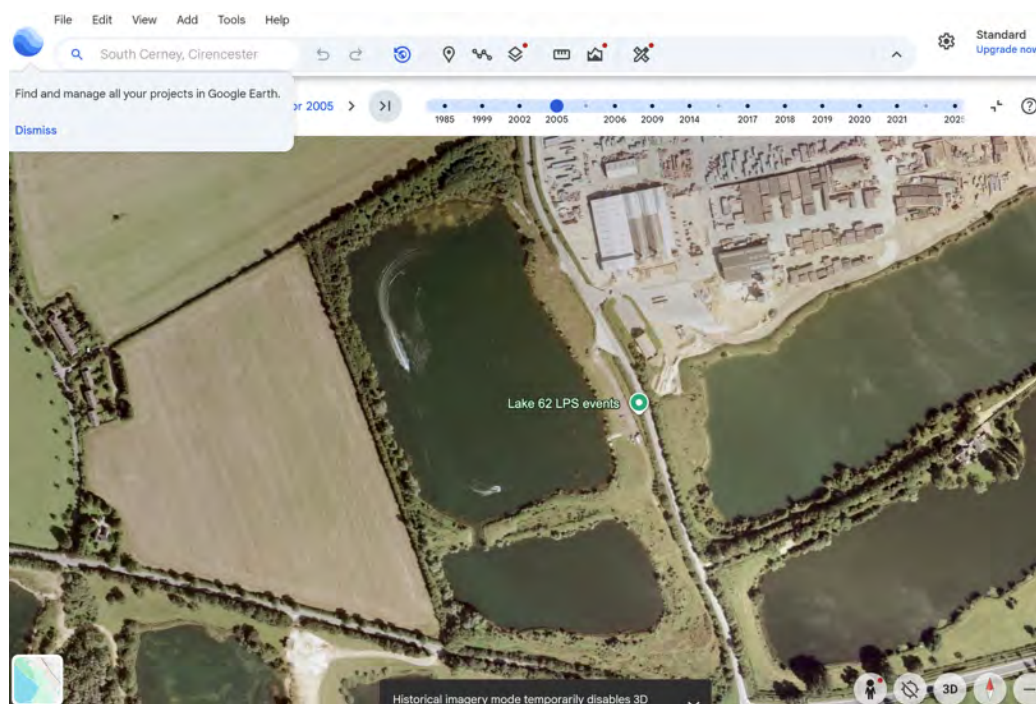
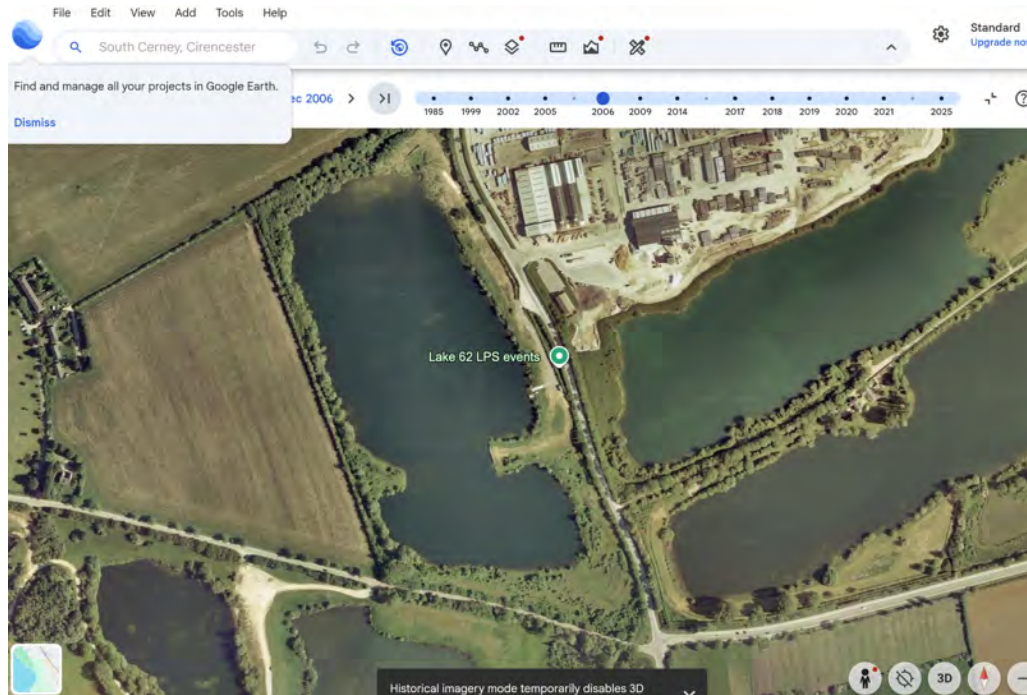
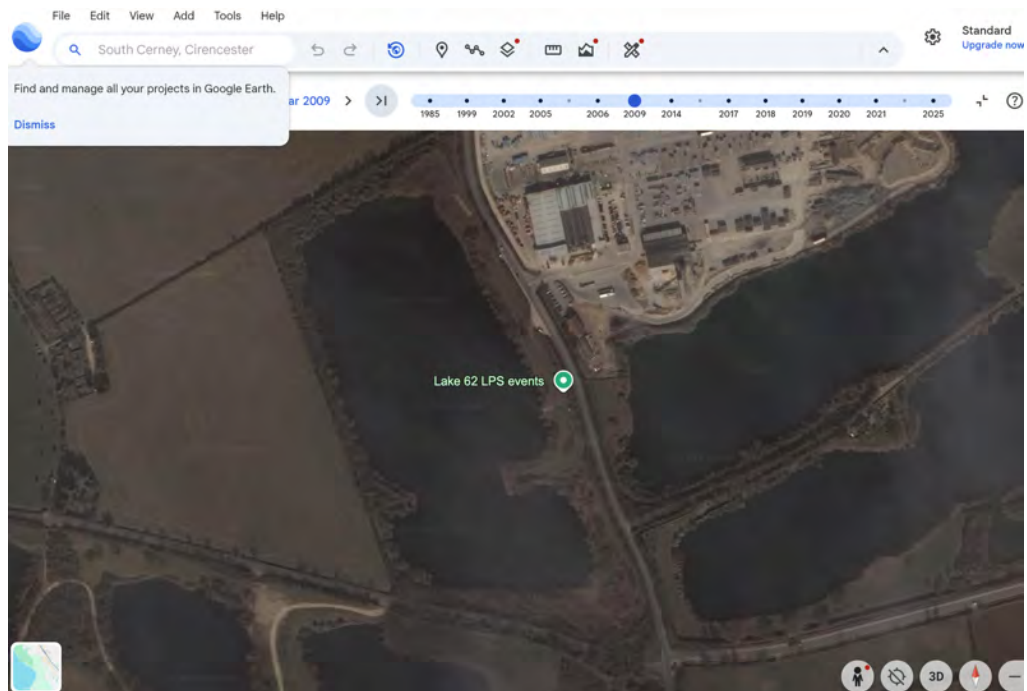
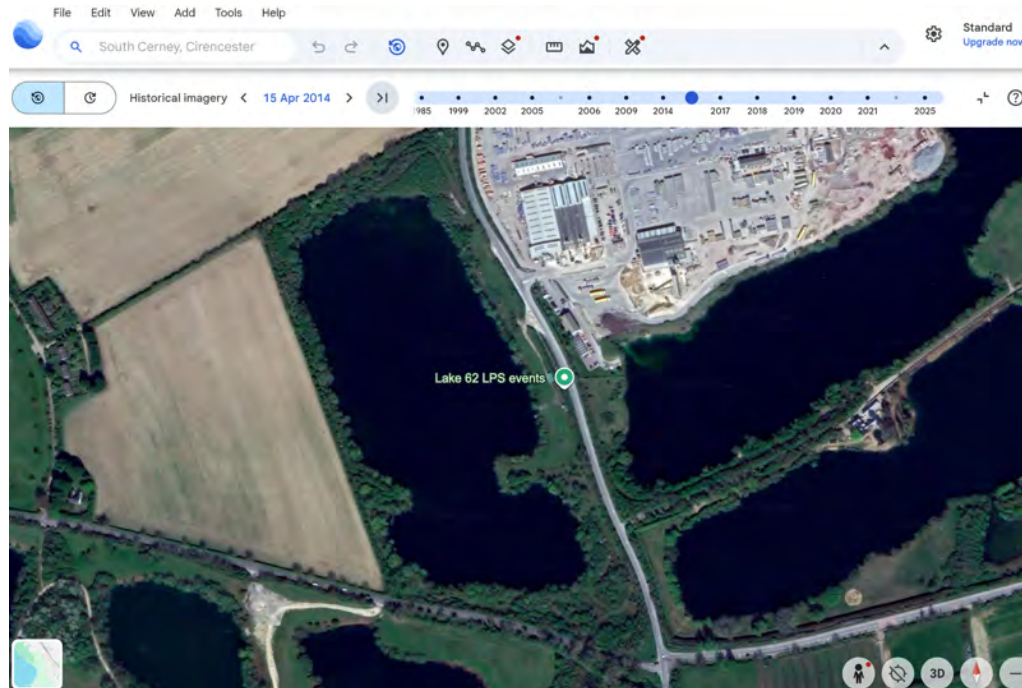
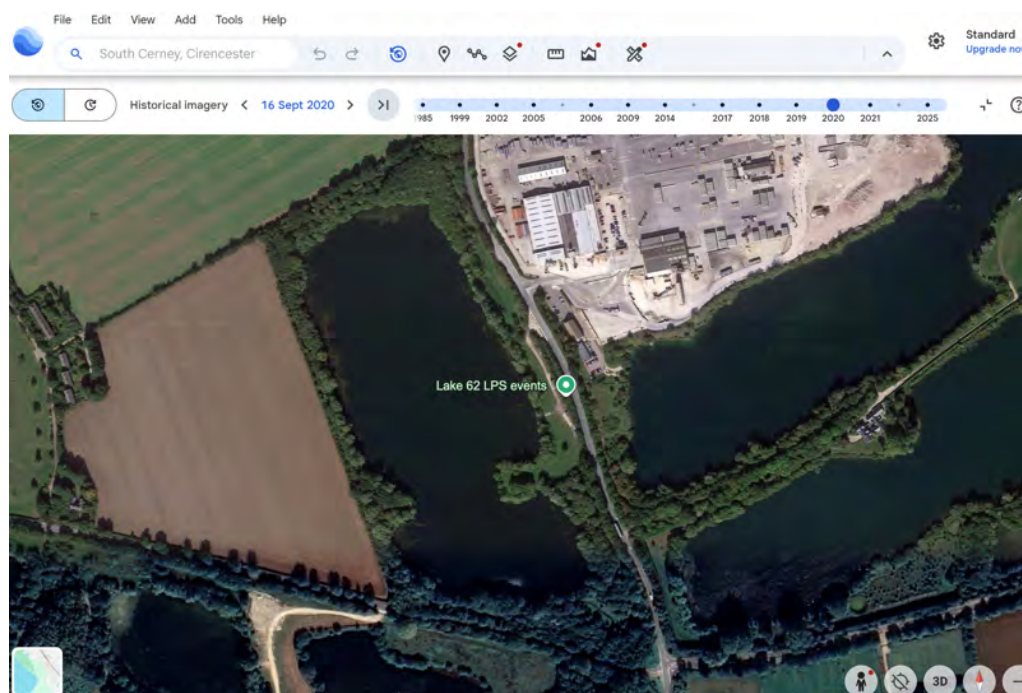
## APPENDIX 7: TIME DEPTH ANALYSIS

- The tree removal would primarily affect trees that are in the region of 24 years of age or less. As shown in Appendix 7 (time depth analysis) Google Earth imagery shows the eastern and southern parts of the site as treeless in 2002. The north and west parts of the site area clearly treed but eastern and southern area open grassland. Trees are shown to have started to grow and colonising the eastern and southern areas post 2005.
