MELKSHAM HOUSE, MELKSHAM,  
WILTSHIRE

Heritage Appraisal 2019 (with addendum for  
minor changes)

A statement to inform potential changes to the  
Grade II listed Melksham House, Melksham,  
Wiltshire

FEBRUARY 2025

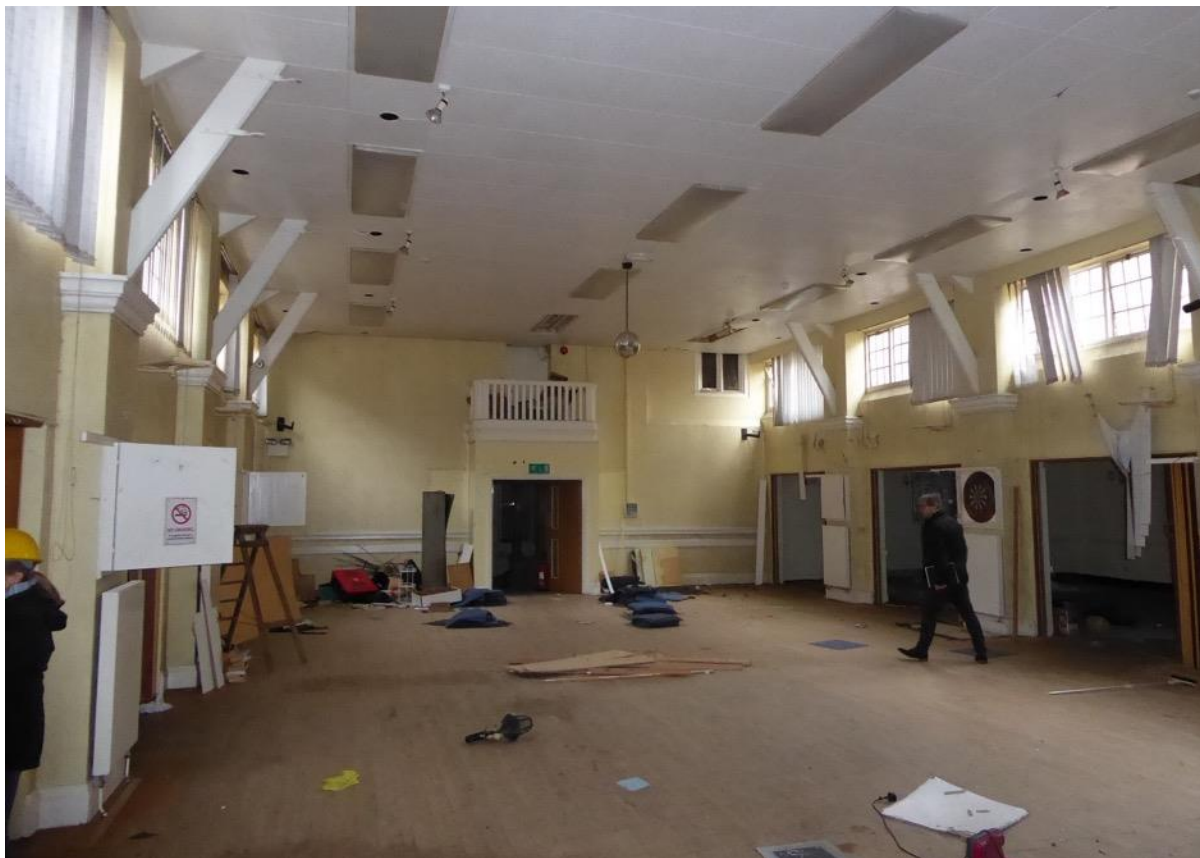
- 5.6 The architectural quality of the 1920s additions is however high and the dance floor and associated side pavilions are well considered spaces with good quality materials and finishes surviving particularly to the floor and the roofs of this part of the building. It is regrettable that the concert/dance hall has lost its stage (thought to have been removed in the late 60s/early 1970s) and the dancefloor itself is in poor condition.

**Figure 13:** Concert hall (looking east)

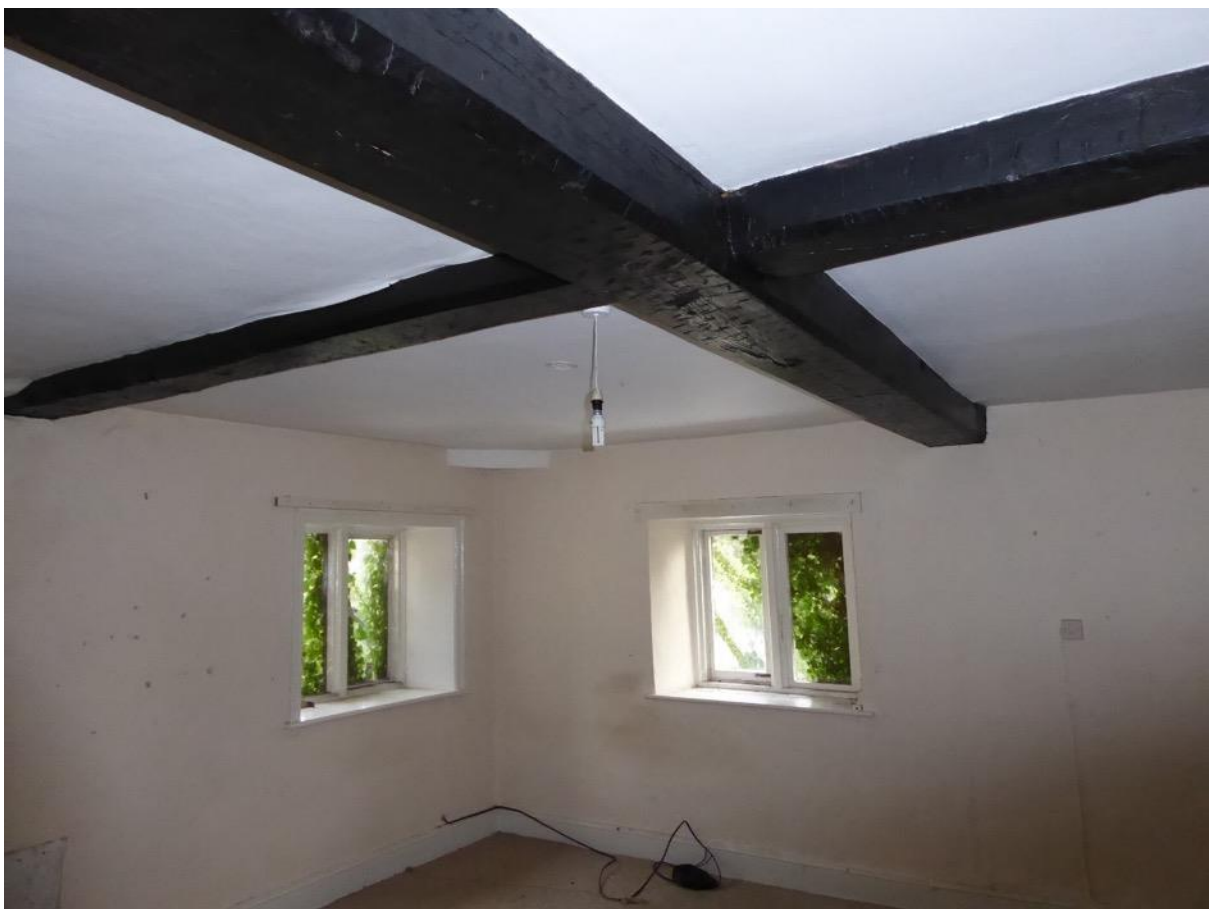
- 4.13 To the first floor of the central section the room above the kitchen (**Figure 20 Appendix E**) has an interrupted spine beam (**Figure 21 Appendix E**) which is charred to the southern end (**Figure 22 Appendix E**) and a chamfered transverse beam into which the spine beam appears to be jointed. These beams appear to be the only surviving pre-fire fabric in the building of which remaining joinery including roof structure appear to have been renewed or replaced in the 19<sup>th</sup> or 20<sup>th</sup> centuries.

**Figure 21:** Ceiling beams to room above kitchen

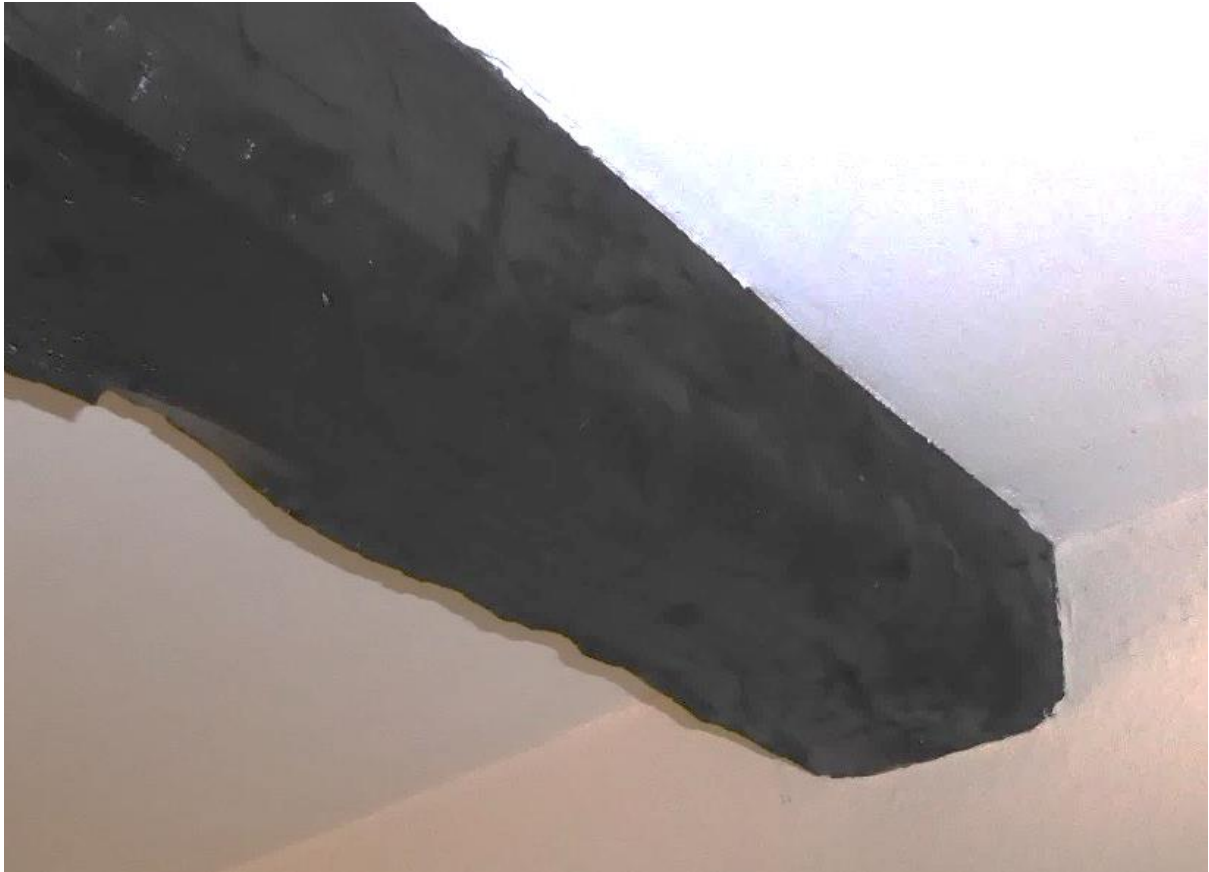
**Figure 22:** Charred southern end to spine beam in room above kitchen

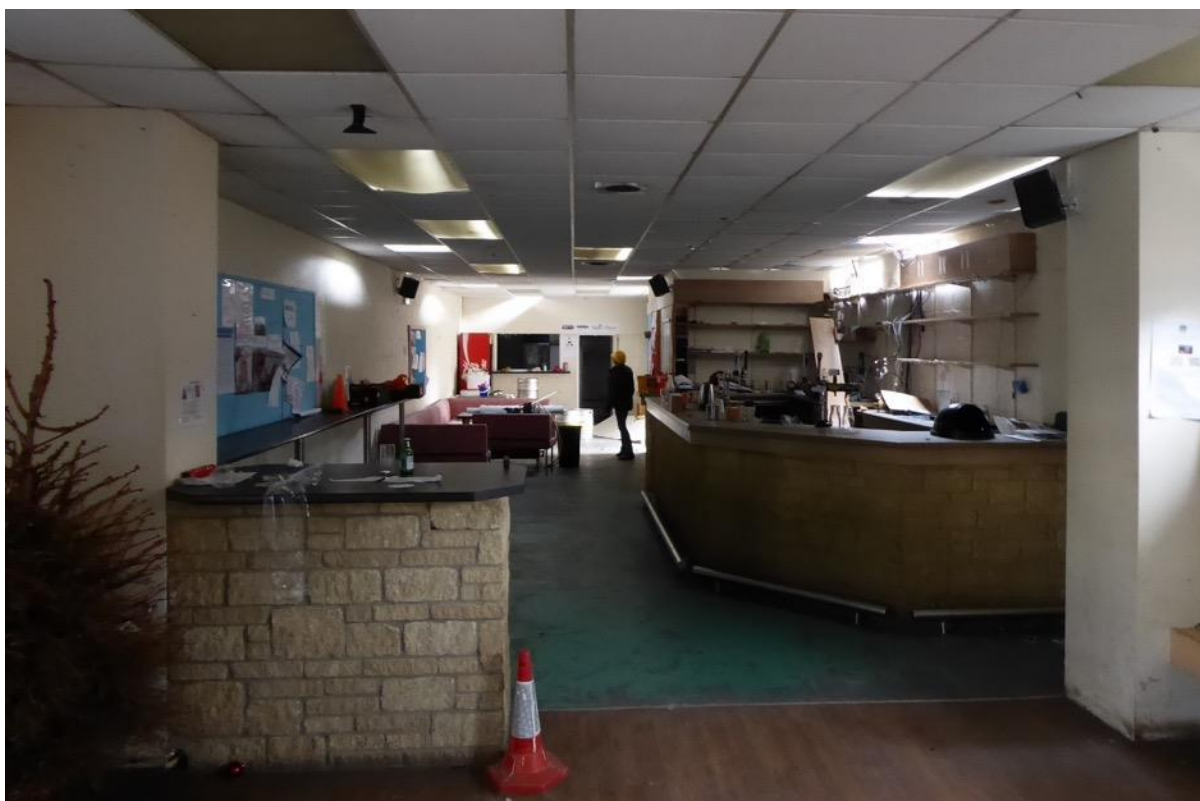
- 4.18 Internally, the space has been lined with modern blockwork (**Figure 35 Appendix E**) up to first floor level and a modern suspended ceiling inserted. The roof has been replaced with modern steel trusses and purlins and a concrete sheet covering with inset glazed panels to the east slope (**Figure 36 Appendix E**).

**Figure 35:** Internal space to bar, former stable

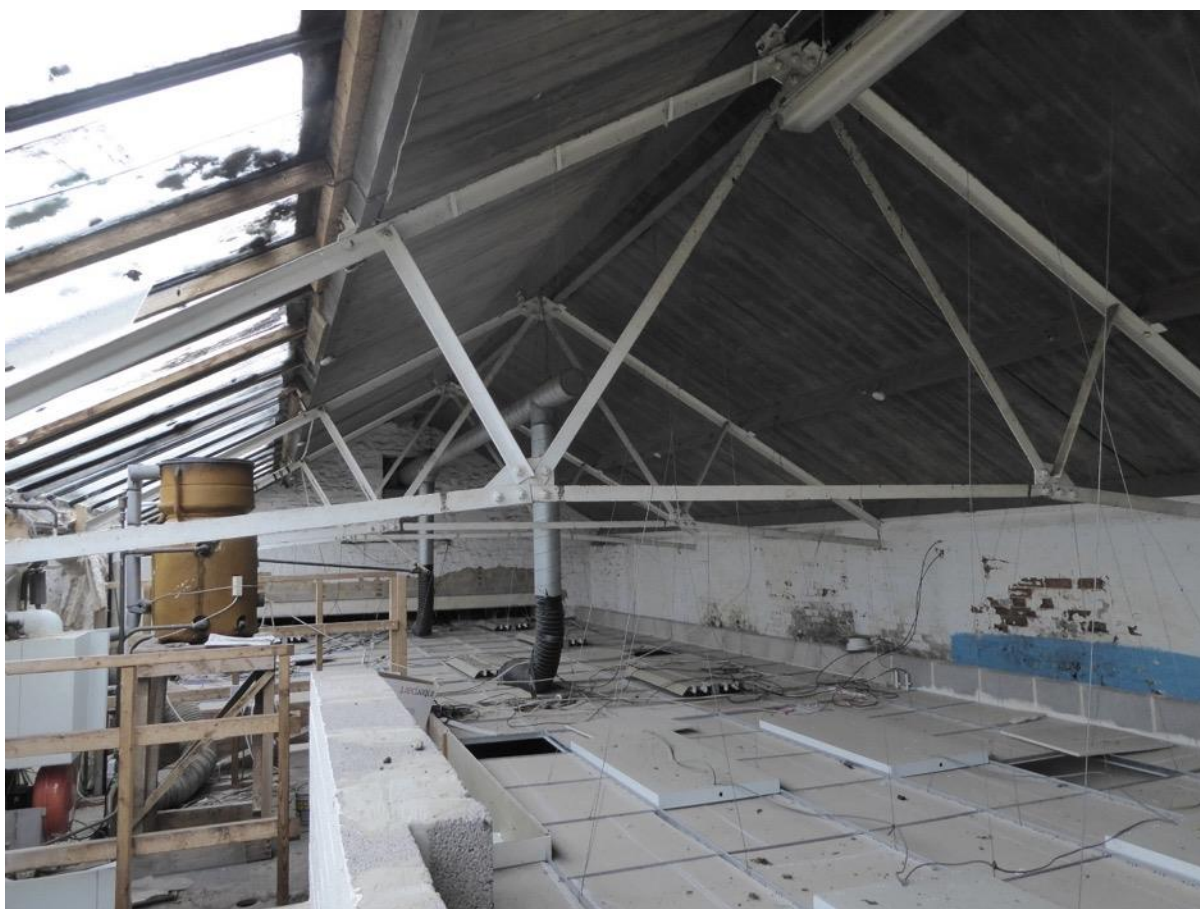
**Figure 36:** Former stable – first floor and roof

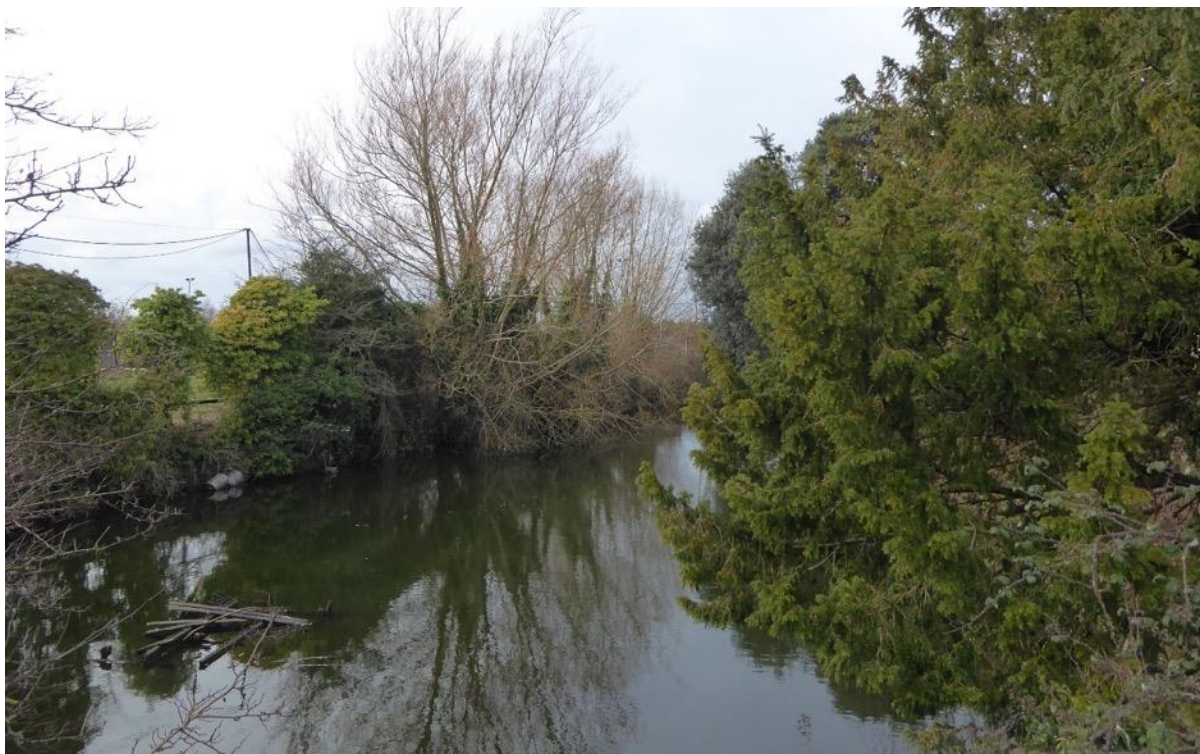
- 7.7 The ornamental pool to the south-west of the house is an unusual survival and in a very poor state of repair. The pool forms an important part of the mid to late 19<sup>th</sup> century remodelling of the grounds and as such has high architectural, historic and aesthetic and possibly communal value (forming part of the sports and social club). Its retention, repair and integration in any future proposals should be carefully considered.

**Figure 41:** Ornamental pond (from east)

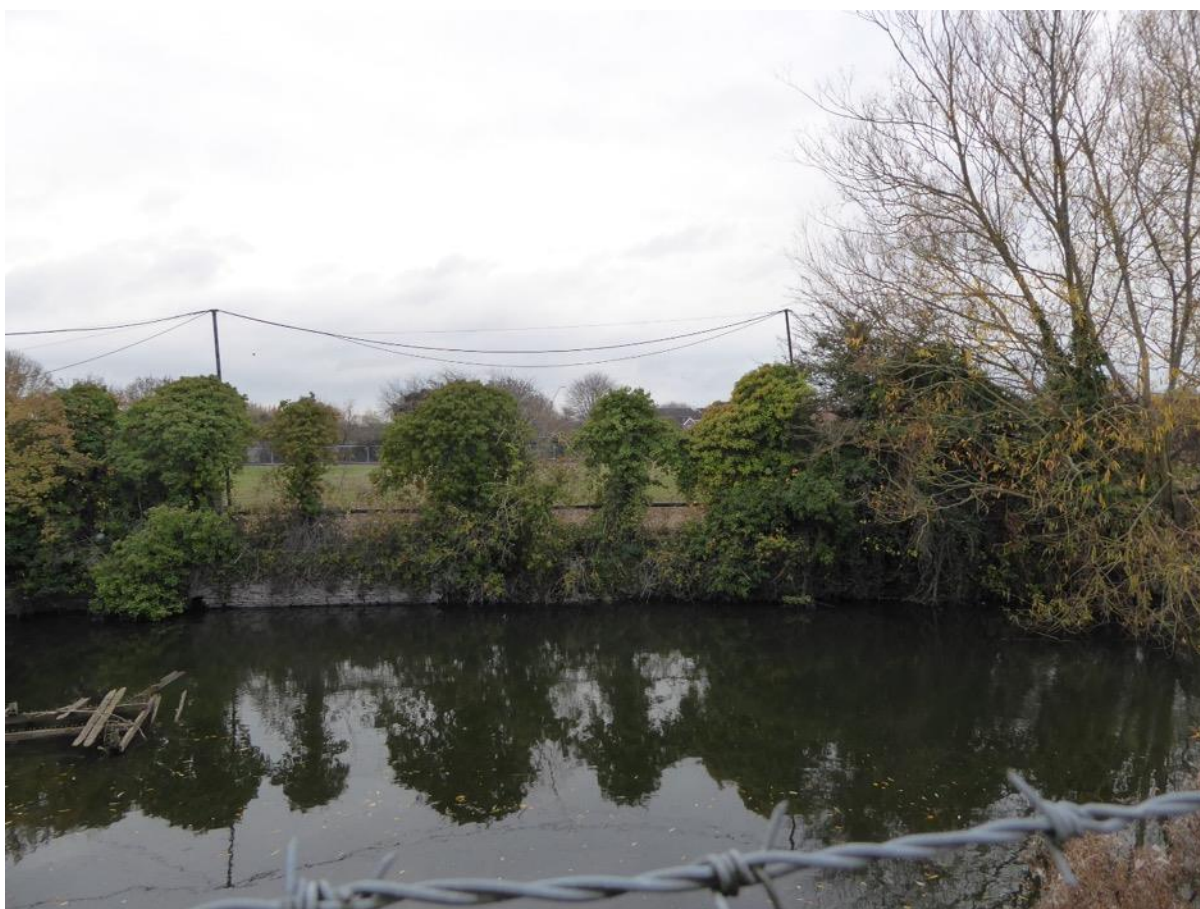
**Figure 42:** Ornamental pond (from north) with rubble stone retaining walls

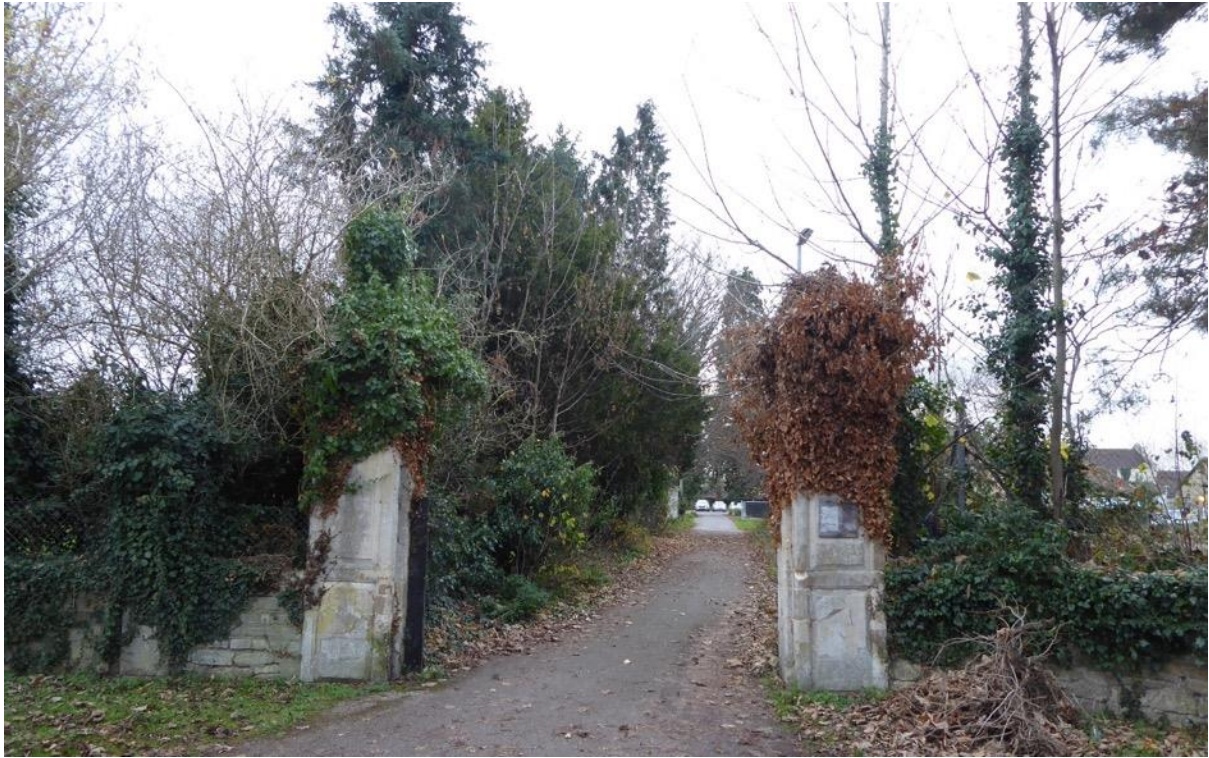
- 5.11 The north entrance to Melksham House from Place Road is in a poor condition as are the boundary walls to its west. These require short to medium term action to ensure their long-term survival.
- 5.12 The ornamental lake is an unusual and interesting survival of the late 19<sup>th</sup> century investment into house and garden. It is in a poor state or repair and has been largely neglected for the last 30 years.

**Figure 43:** North entrance – stone piers (Grade II)

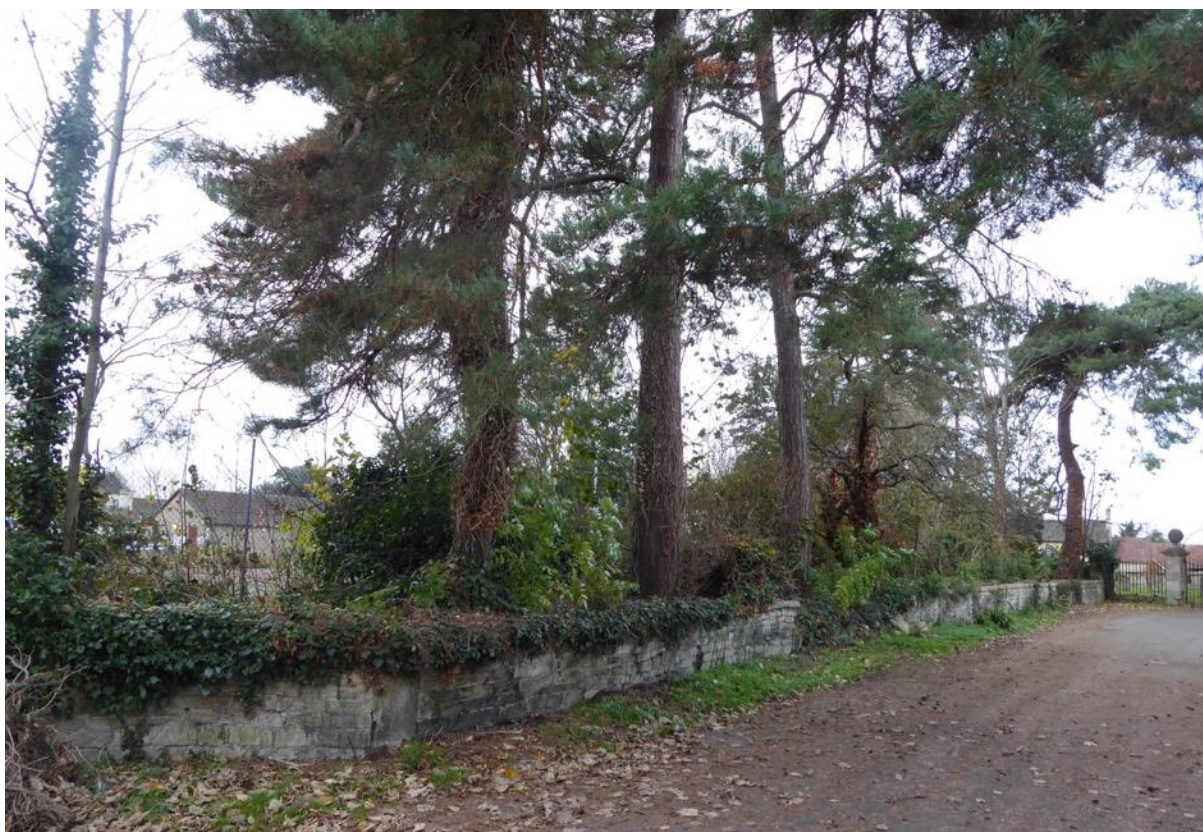
**Figure 45:** North entrance – low wall attached to gate piers to west of piers
