TREE SURVEYING

The Old Smithy  
Holloway  
Malmesbury  
SN16 9HX

Findings of BS5837 Tree Quality Survey

Arboricultural Method Statement

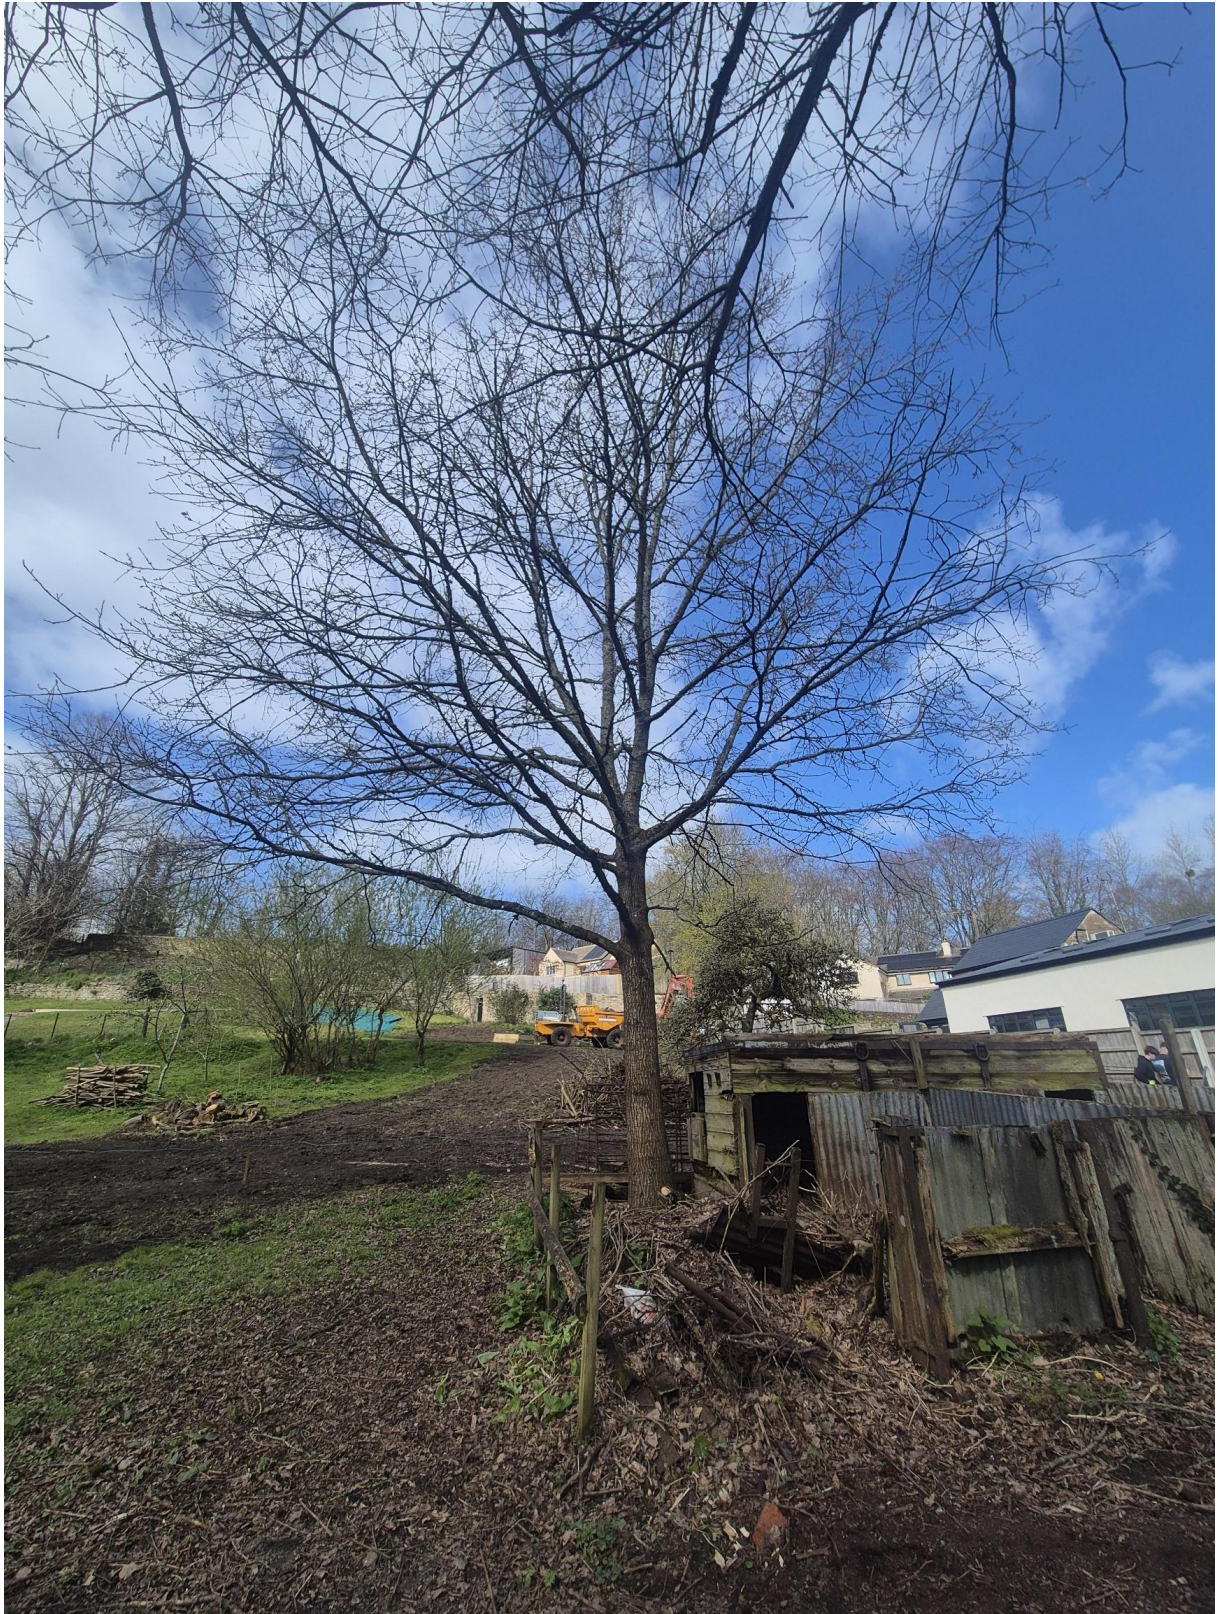
T1

- 2.8. The trees are in good overall condition, with no significant observable defects, other than a normal amount of small diameter dead wood throughout the crown. They are visible from adjacent properties and riverside footway.

| Ref. | Species | Measurements | Survey Notes | Retention Category | RPA | Recommendations | Photo |
|---|---|---|---|---|---|---|---|
| T001 | Pedunculate oak<br>( <i>Quercus robur</i> ) | Height (m): 12<br>Stem Diam(mm): 350<br>Spread (m): 5N, 6E, 5S, 6W<br>Crown Clearance (m): 4<br>Lowest Branch (m): 2.5(S)<br>Life Stage: Semi Mature<br>Rem. Contrib.: 50+ Years | Physiological Cond: Good<br>Structural Cond: Good | B2 | Radius: 4.2m.<br>Area: 55 sq m. | No tree pruning works required.<br>Pre Construction fencing to protect RPA. | |

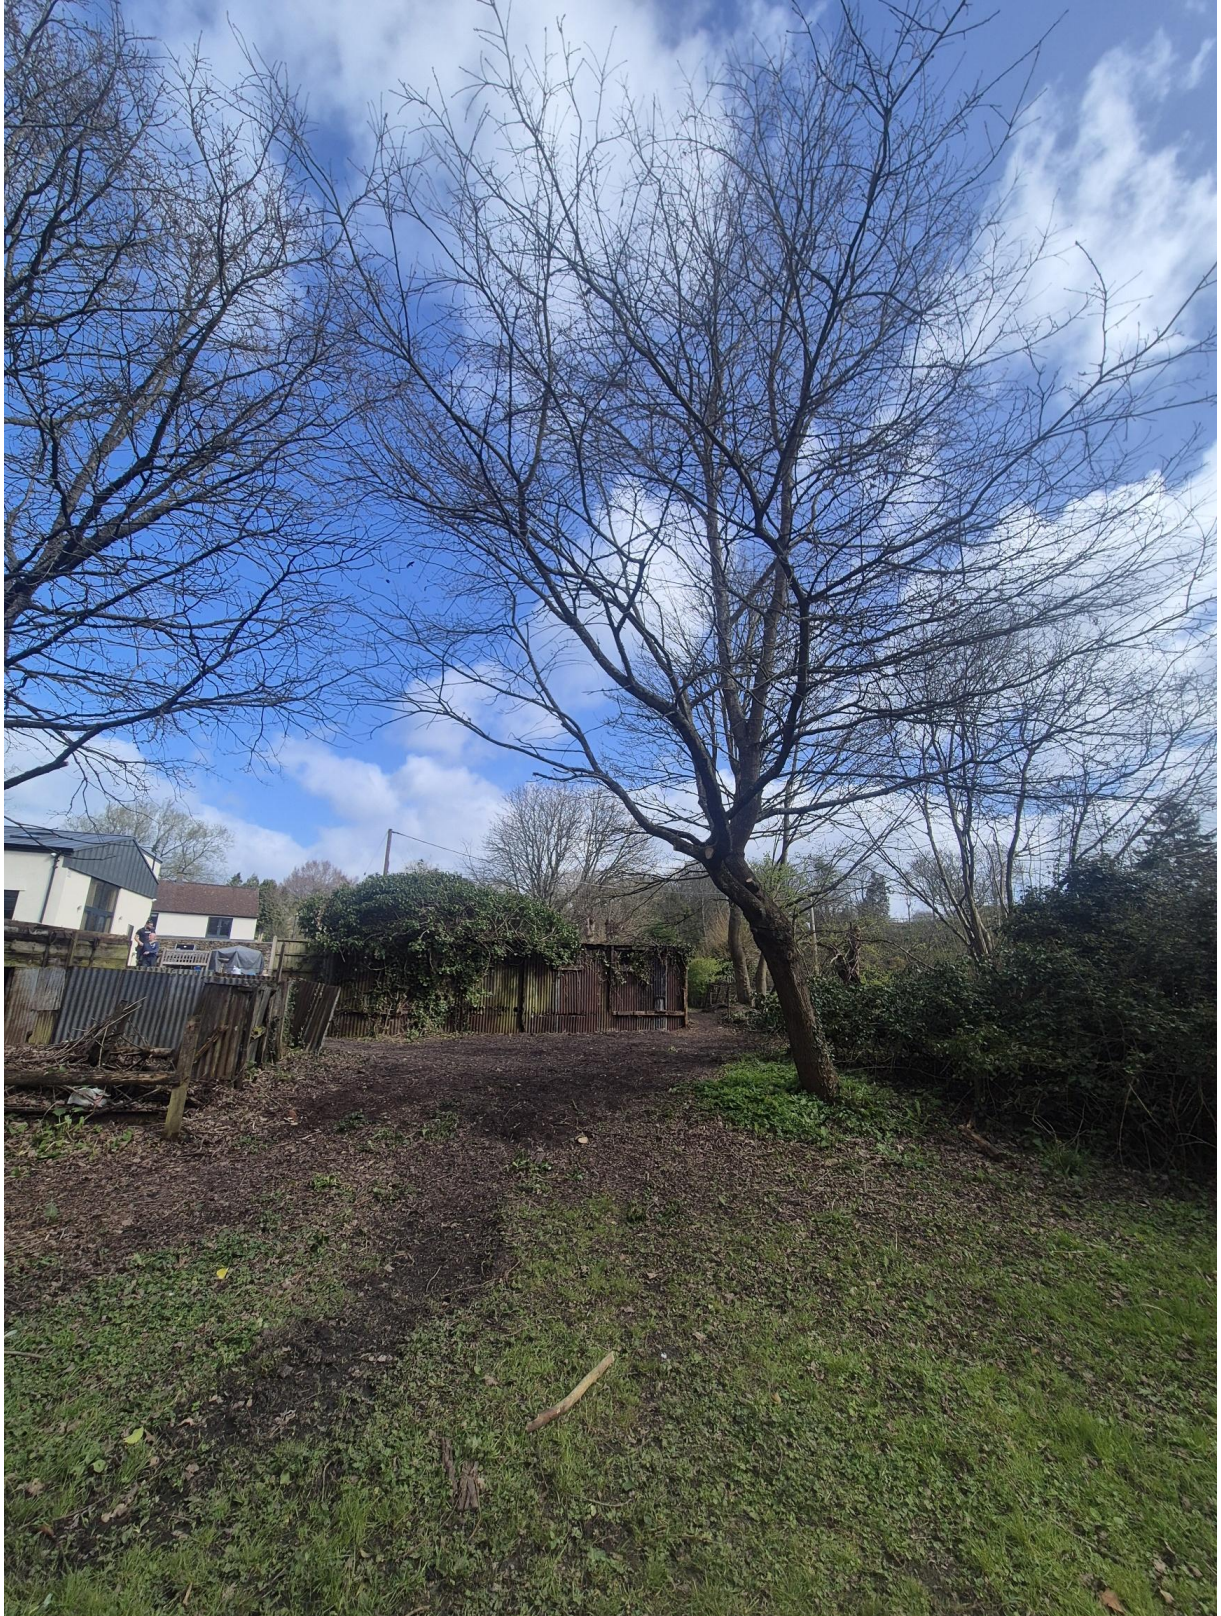
T2

| Ref. | Species | Measurements | Survey Notes | Retention Category | RPA | Recommendations | Photo |
|---|---|---|---|---|---|---|---|
| T002 | Pedunculate oak<br>( <i>Quercus robur</i> ) | Height (m): 12<br>Stem Diam(mm): 390<br>Spread (m): 5N, 6E, 5S, 6W<br>Crown Clearance (m): 4<br>Lowest Branch (m): 2.5(W)<br>Life Stage: Semi Mature<br>Rem. Contrib.: 50+ Years | Physiological Cond: Good<br>Structural Cond: Good<br>Historic root heave, stabilised. | B2 | Radius: 4.7m.<br>Area: 69 sq m. | No tree pruning works required.<br>Pre Construction fencing to protect RPA. | |

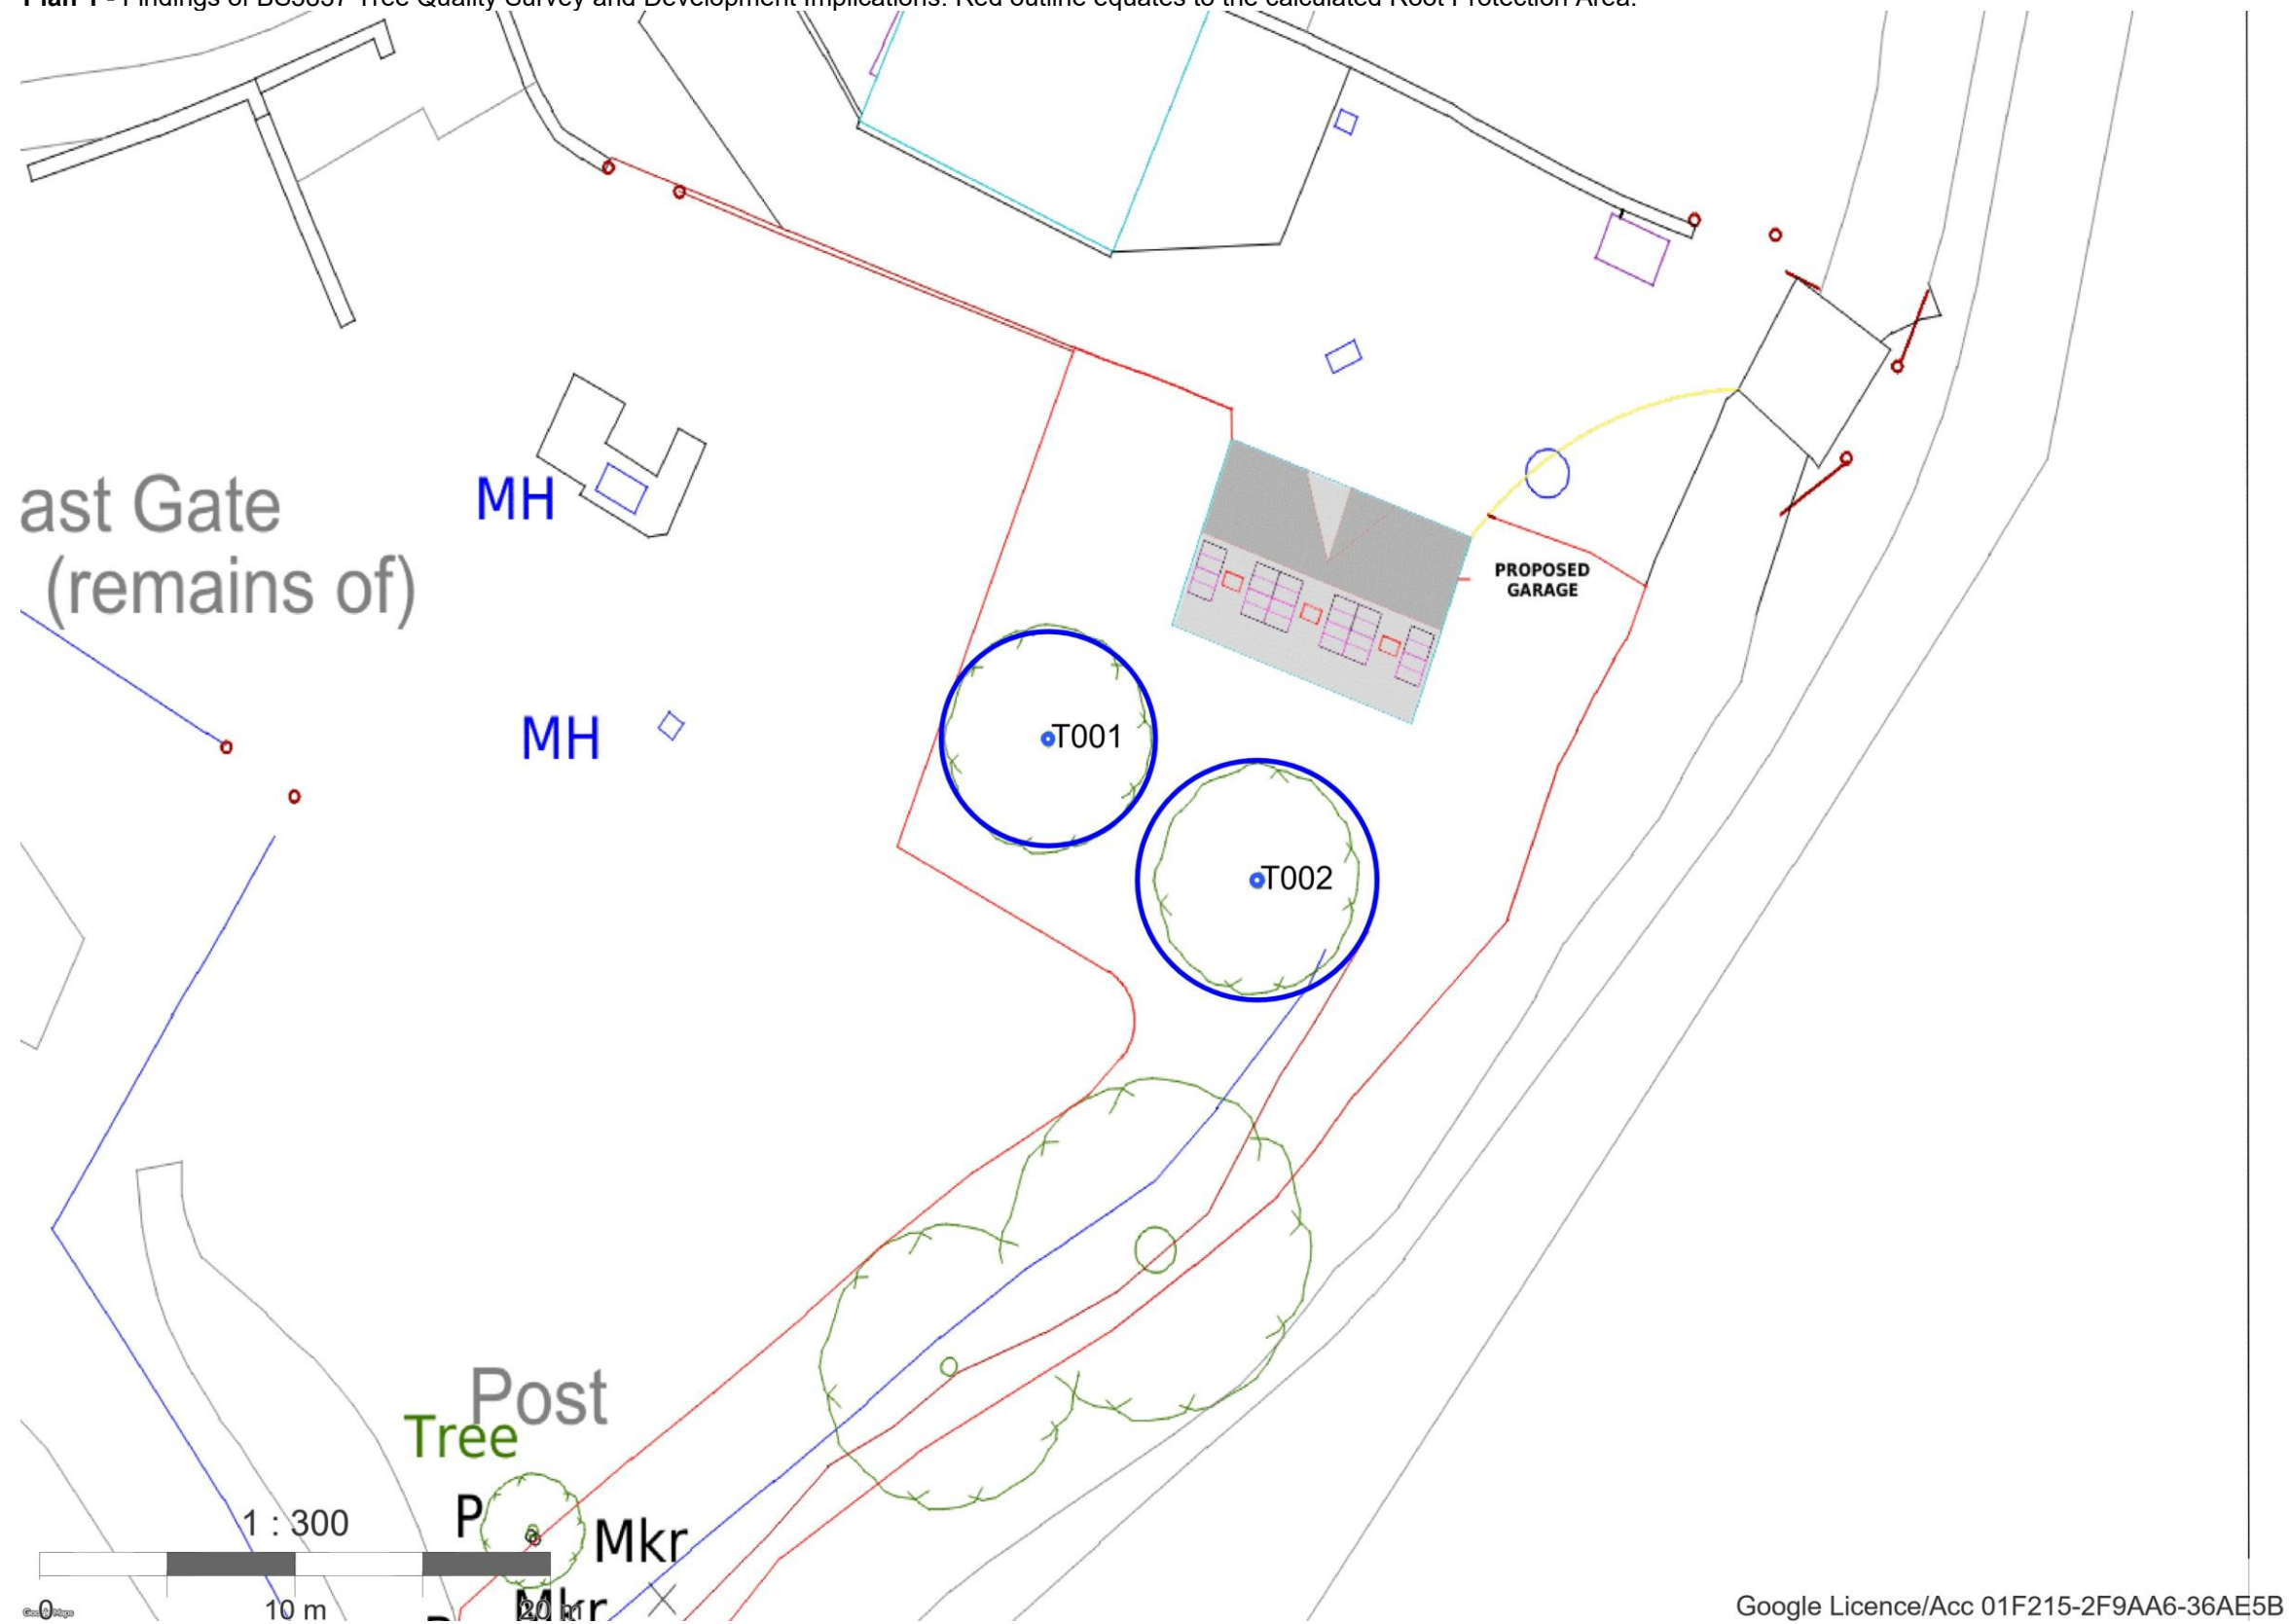
**Plan 1** - Findings of BS5837 Tree Quality Survey and Development Implications. Red outline equates to the calculated Root Protection Area.

- 3.1. The **Findings of Tree Quality Survey** plan located to the rear of this report shows the approximate extent of Root Protection Areas (RPAs). The RPAs have been calculated in accordance with the methodology set out within Appendices C and D of BS5837: 2012, using the stem diameter dimensions obtained during the site visit.
