# Arboricultural Impact Assessment and Method Statement

North Bradley, Trowbridge, Wiltshire

24 June 2026

| Report Reference | 3208-AIAMS-KO |

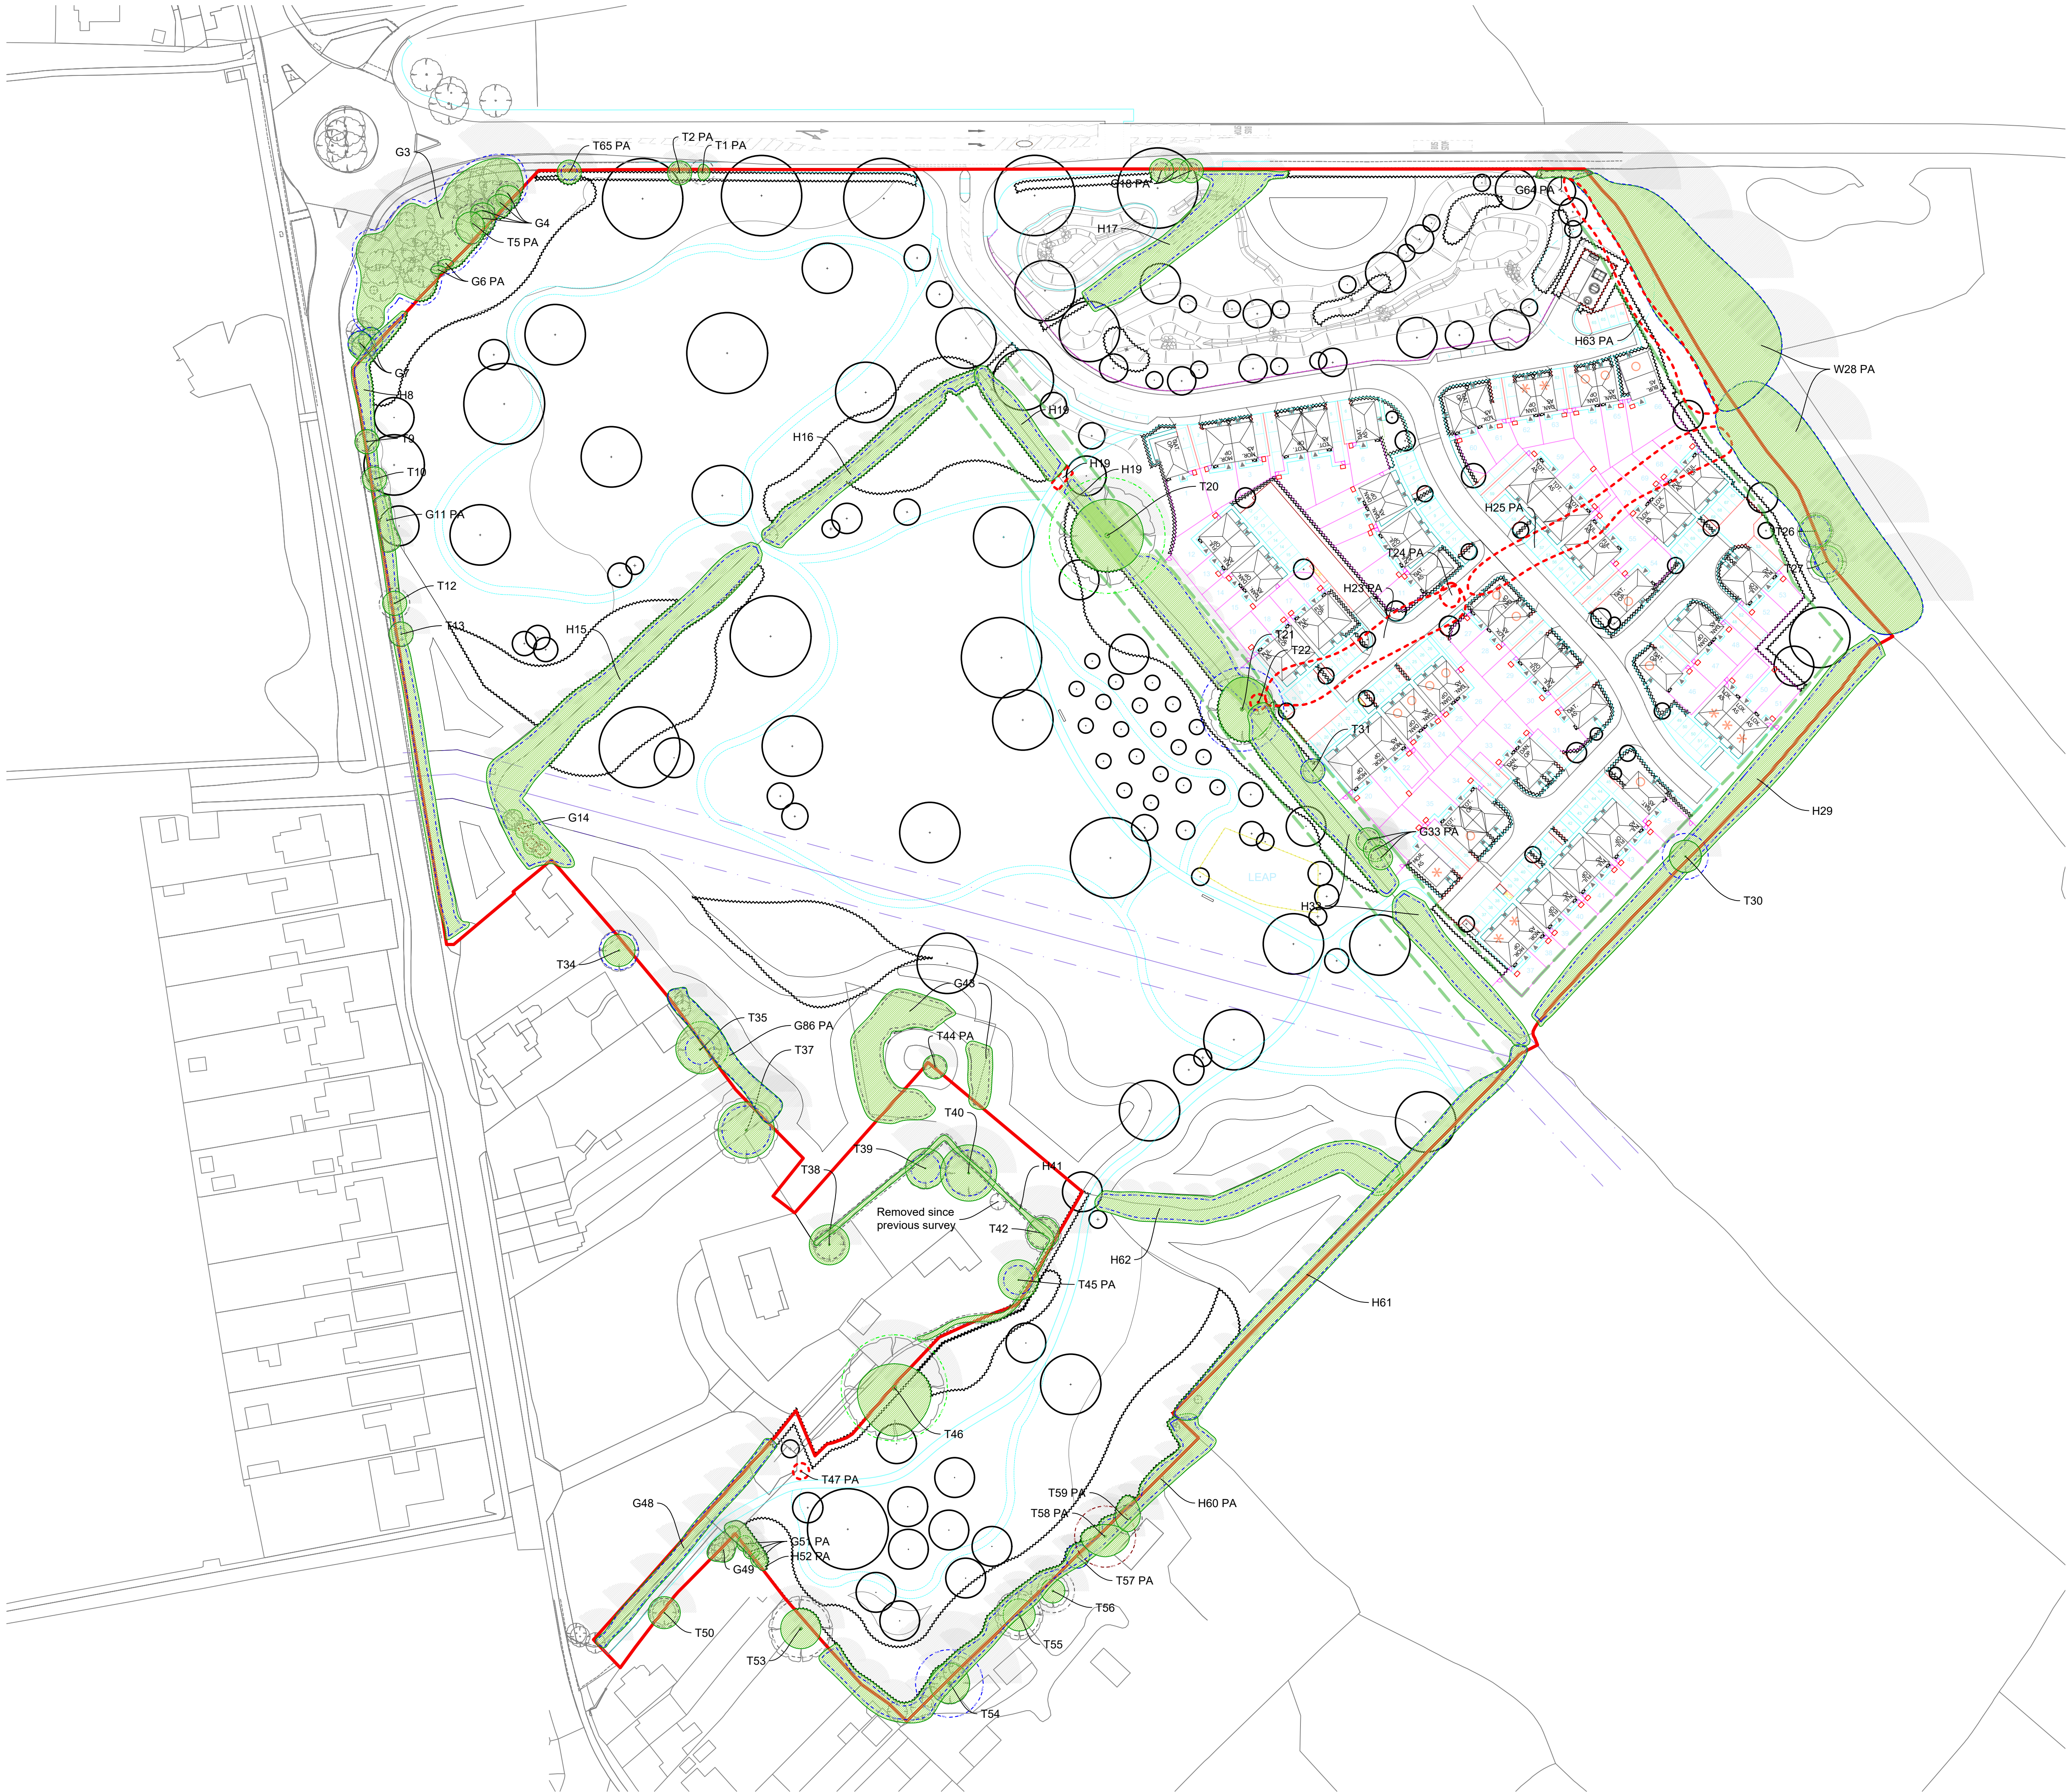
## **Appendix 1 – Tree Retention Plan and Tree Protection Plan**

Those trees that require removal to facilitate the proposed development are shown on the Tree Retention Plan in **Appendix 1** and detailed in **Table 3**.

| Arboricultural Feature | Species | Category | Quantity | Justification |
| H19 | Elm, Hawthorn, Blackthorn | B 2 | One section, approx. 2.2m | To facilitate a new pedestrian access to the Site. |
| T22 | Elm | U | - | To facilitate the building of the new development. |
| H23 | Hawthorn | B 3 | Entire hedge, approx. 55.9m | To facilitate the building of the new development. |
| T24 | Field Maple | B 1 | - | To facilitate the building of the new development. |
| H25 | Hawthorn, Blackthorn | B 3 | Entire hedge, approx. 75.2m | To facilitate the building of the new development. |
| T47 | Ash | C 1 | - | To facilitate a new pedestrian access to the Site. |
| H63 | Blackthorn | C 2 | 67.9m <sup>2</sup> | To facilitate construction of a pump station and new hedge creation. |

| Section | Work Phase | Relevant Arboricultural Feature(s) | Protection Measure/Methodology | Responsibility |
|---|---|---|---|---|
| 2 | Enabling | All retained trees | <p><b>Tree Protection Fencing (TPF)</b></p> <ul style="list-style-type: none"> <li>All TPF should be installed in the locations as shown on the Tree Protection Plan in <b>Appendix 1</b> following completion of the initial tree works prior to the commencement of any groundworks, demolition or construction works on site.</li> <li>The specification for the TPF can be found in <b>Appendix 3</b>.</li> <li>Adequate signage denoting the importance of TPF should be affixed to the fencing. Example signage can be found in <b>Appendix 4</b>.</li> <li>The TPF will denote and form the boundary to the Construction Exclusion Zone (CEZ).</li> <li>Fencing to remain in place for duration of construction.</li> </ul> | Contractor with sign off from project arboriculturist. |
