**PLANNING, HERITAGE, DESIGN AND ACCESS STATEMENT**

**PERIMETER WALL WORKS**

**TO TEDWORTH EQUESTRIAN CENTRE**

**AUGUST 2026 REF: F1883 / DAS**

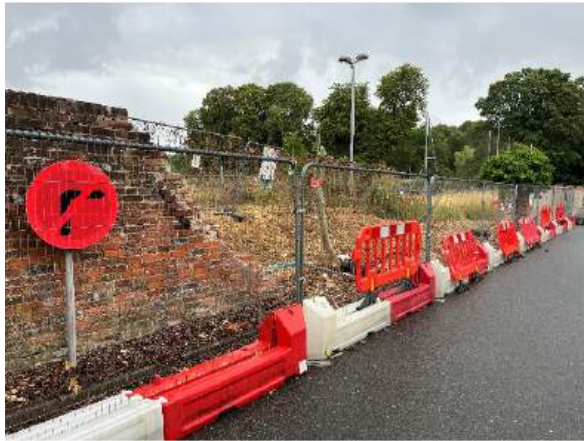
The length of wall adjacent to the Grade II listed gateway, (circa 17m long) has collapsed (Figure 2), whilst the remaining walls show signs of dilapidation and disrepair (Figures 3, 4 and 5). They vary in construction and appearance, and the condition has been assessed by a structural engineer.

Figure 2 – Collapsed Section of Wall E

Wall E – Wall to be reinforced with enlarged buttresses to rear using heritage/ reclaimed bricks. Cement pointing to be replaced with lime mortar. The collapsed section of wall will be rebuilt on a like-for-like basis, with enlarged buttresses.

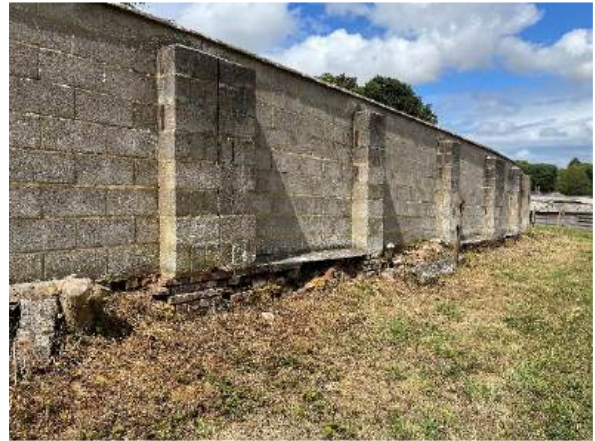
Figure 3 – Undermining of retaining element to Wall B

Wall B – This wall needs to be taken down and rebuilt with new consistent wall approach.

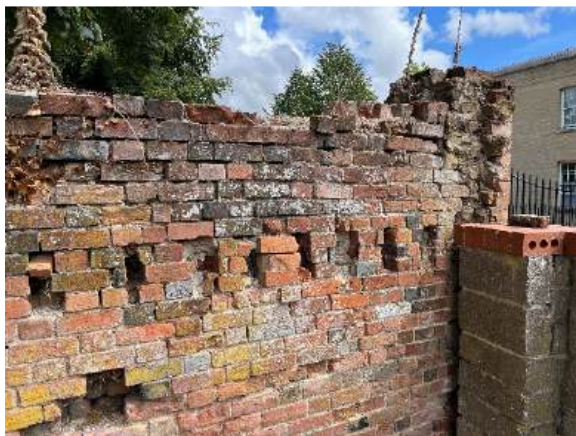
Figure 4 – Deterioration to Wall G

Wall G – Repair/ rebuild top section of wall on a like-for-like basis. Cement mortar to be replaced with lime mortar, and poor-quality blockwork repair to buttress to be replaced with brickwork.

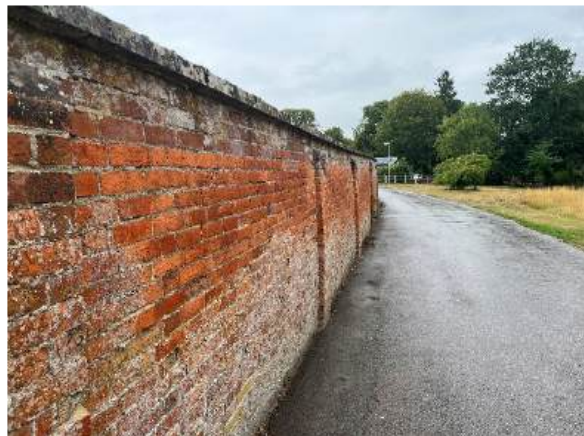
Figure 5 – Leaning to Wall I

Wall I – Wall to be reinforced with enlarged buttresses to rear

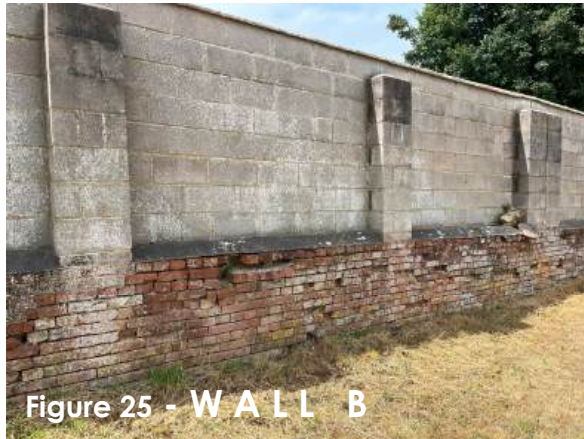
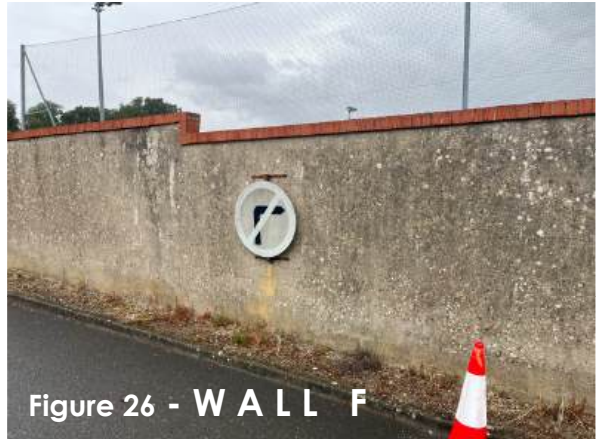
Figure 25 & 26 - Photographs of Wall B (left) and Wall F (right)

The render-faced walls (Walls B & F) (Figure 25 & 26) are in a state of dilapidation and need to be taken down and rebuilt as identified in the accompanying structural report. The retaining section to Wall B is failing, with the render finishes, and coursing cracked and dislodged to both walls B and F. These are considered poor quality walls that detract from the heritage value of the gateway and surrounding heritage assets. Walls B and F require total reconstruction and will comprise a new consistent wall design that better relates to the rest of the perimeter wall, taking cues from the existing structures (particularly Wall A & J), to ensure high quality, historically sensitive alterations to the wall. The proposals aim to retain the existing location of the wall, with minimal change to its overall height.

The design principle of the replacement walls will consist of a series of red brick piers at circa 4m centres with brick walls between. The wall is designed to incorporate features from the existing wall including brick header details to the top of the piers and walls. This will ensure the new construction complements the surrounding historic assets and the character of the existing perimeter wall. The walls will be constructed using a red brick and a cream colour cement mortar, to match the materials of Walls A and J.

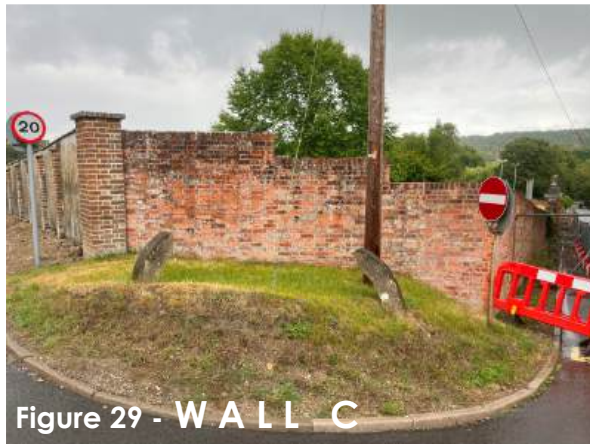
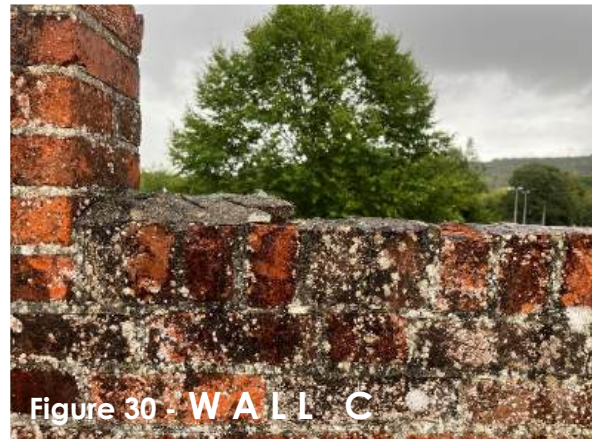
Figures 29 & 30 – Photographs of Wall C

Wall C is in good condition (Figure 29 & 30), with sensitive repairs only including the removal of cement mortar, and small areas of repointing. The scheme prioritises repairs rather than replacement, to preserve historic fabric, with any replacement materials being on a like-for-like basis. This approach will minimise the loss of historic fabric and avoid any detrimental impact.

Wall C – Sensitive Like-for-like repairs only

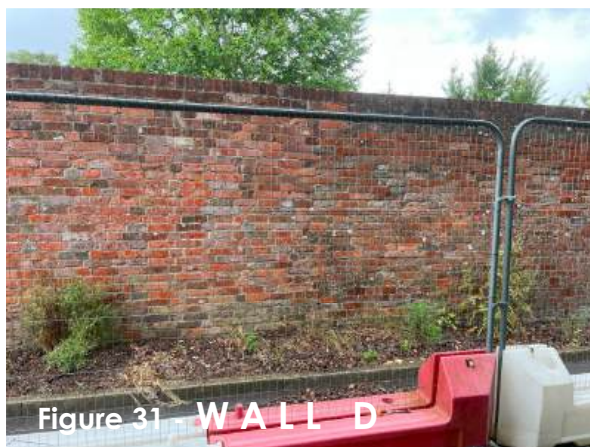
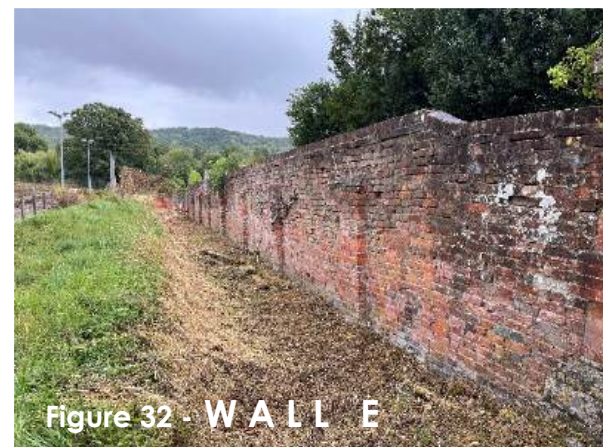
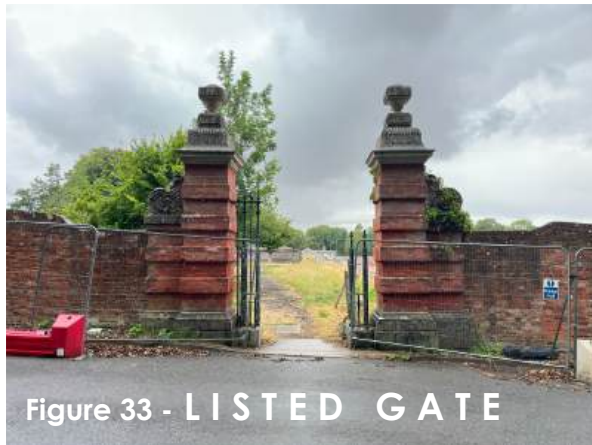
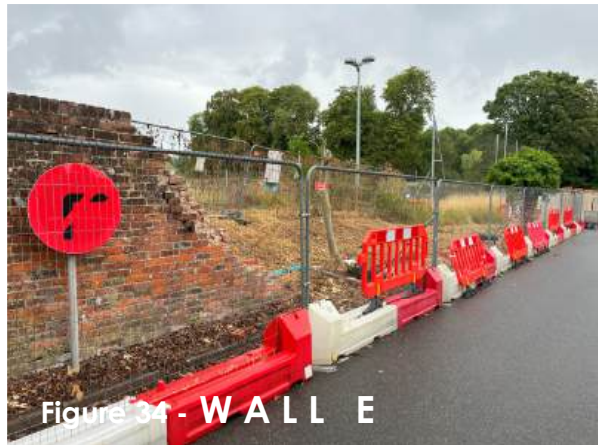
Figure 31, 32, 33 and 34 - Photographs of Wall D (top left), Wall E ( top and bottom right), Listed Gateway (bottom left)

The listed gateway and the attached brick wall (D & E) (Figures 31, 32, 33 and 34) are of historic value in their relation to the gateway. However, they need significant repair work evidenced by the bowing and leaning of Wall D, and partial collapse of Wall E. The wall is to be retained with enlarged buttressing added to the internal face of the wall in accordance with the structural engineers' requirements. This will retain the current appearance to the front of the wall. The new pier extensions will be constructed using new heritage bricks and capped with stretcher plinth bricks. The collapsed section of Wall E is to be rebuilt to match existing with a new foundation and enlarged buttressing. All repointing and construction work will be carried out using lime mortar, and reclaimed brickwork will be used where possible. Where new brickwork is required, these will be handmade heritage bricks to match existing.

Wall D – Wall to be reinforced with enlarged buttresses to rear using heritage/ reclaimed bricks. Cement pointing to be replaced with lime mortar.

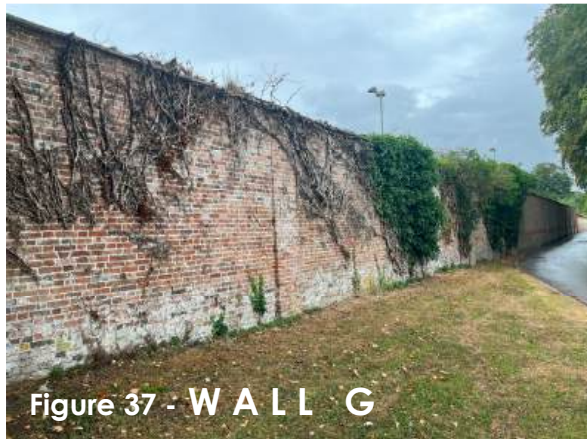
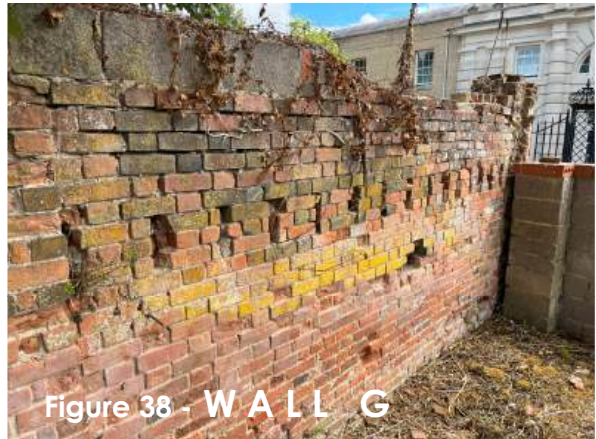
Figure 37 & 38 - Photographs of Wall G

Wall G (Figures 37 & 38) also has historic value, particularly in its proximity to South Tidworth House. This wall requires general repair work to mortar joints throughout, but most significantly the top courses of the wall, immediately adjacent to the 3 mature trees require rebuilding works. This will be repaired on a like-for-like basis using reclaimed and new heritage bricks, with lime mortar. A new stone coping will be installed where it is missing, to match the remainder of Wall G. Any vegetation should be carefully removed to prevent further damage to the masonry. Any previous blockwork remedials to the rear buttress will be carefully replaced with suitable brickwork.

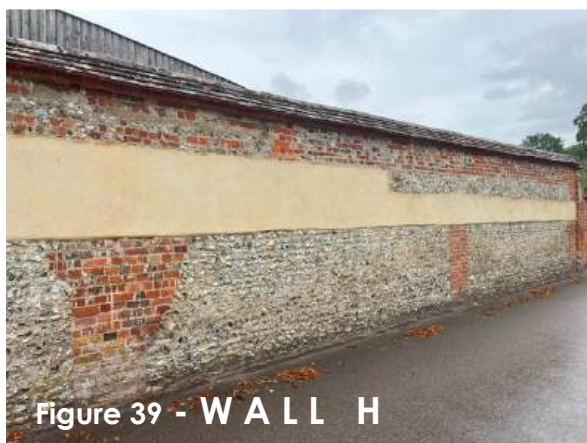
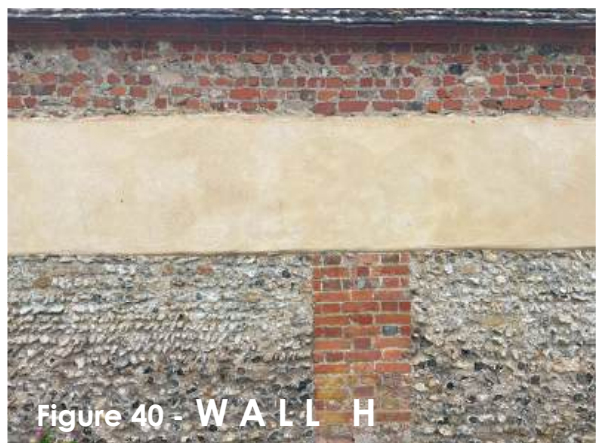
Figure 39 & 40- Photographs of Wall H

Wall H (Figures 39 & 40) is a brick, flint and render wall with historic value due to its use of materials, and its spatial relationship to South Tidworth House. This wall is in good condition with a requirement for minor repairs on a like-for-like basis using lime mortar.

Wall H – Sensitive Like-for-like repairs only. Any cement mortar to be replaced with lime mortar.

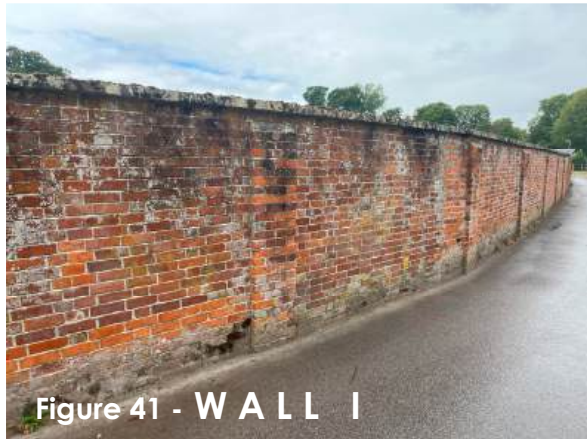
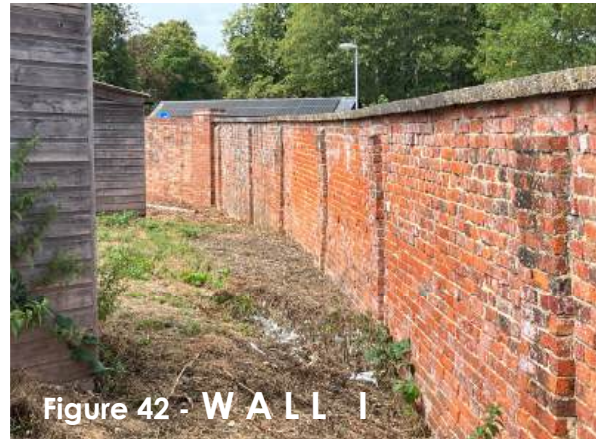
Figure 41 & 42 - Photographs of Wall I

Wall I (Figures 41 & 42) is a brick wall with concrete capping and is considered of some heritage value due to the materials used in its construction. The walls' structure is inadequate with undersized piers and obvious leaning identified in the structural engineers' report. The wall is to be retained with additional buttressing added to the internal face of the wall in accordance with the structural engineers' requirements. This will retain the current appearance to the front of the wall. The new piers extensions will be constructed using new heritage bricks and capped with stretcher plinth bricks. Lime Mortar shall be used for all repair and construction works to Wall I.

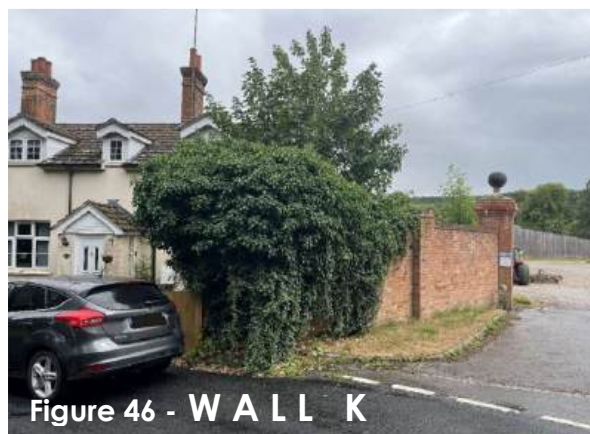
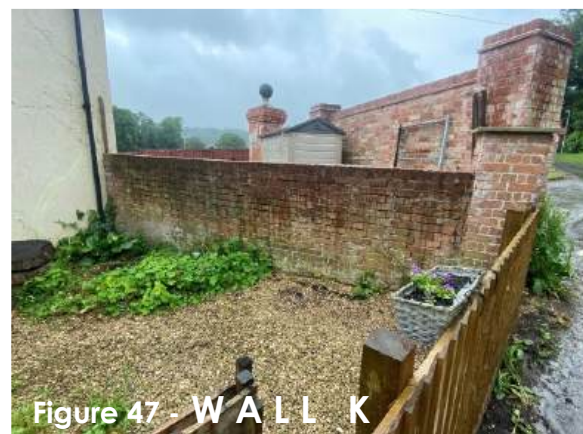
Figure 46 & 47 - Photographs of Wall K

Wall K (Figures 46 & 47) is in poor condition, with general repointing required and a significant crack requiring repair as per the structural engineer's specification.

Wall K – This wall requires minor repair works and repointing.
