# Technical Note

| <b>Project:</b> | Land at Blackmore Farm, Melksham |
| <b>Title:</b> | Update Bat Roost Survey |
| <b>Reference:</b> | 260110_P1476_Bat TN_Final |

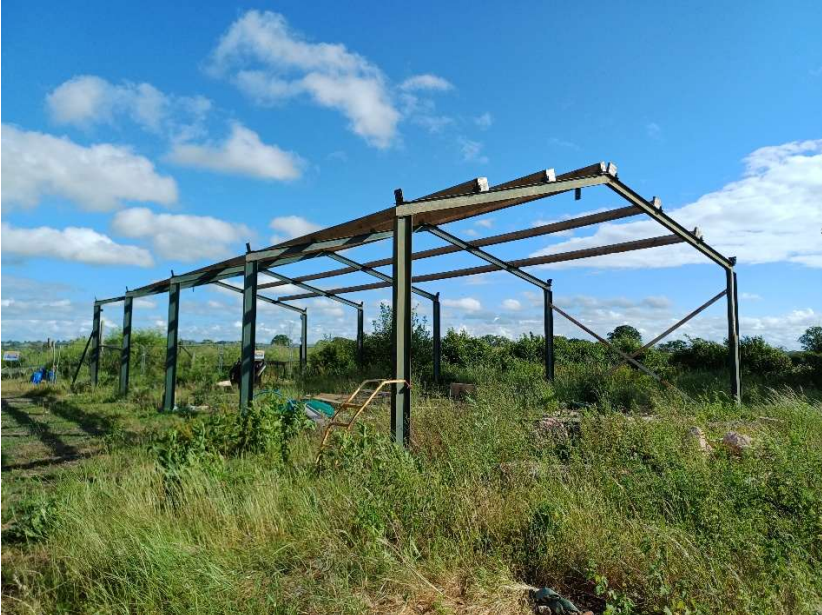
| Building reference | Building description | Roost suitability |
|---|---|---|
| 7 | <p>Steel frame and wood purlin building frame.</p> <p>Photograph 1: View form north of Building 7.</p> | None |

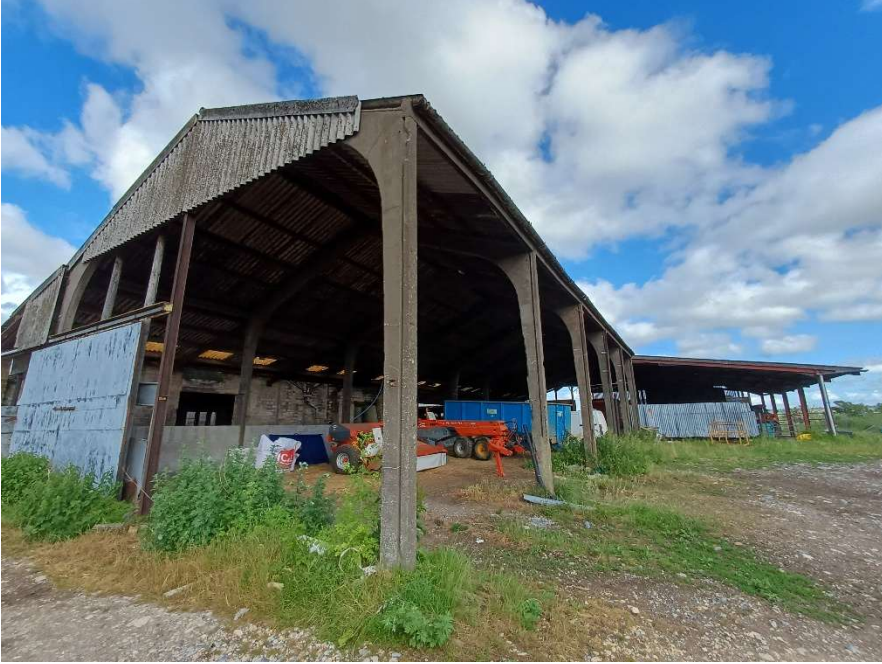
| Building reference | Building description | Roost suitability |
|---|---|---|
| 8 | <p>Agricultural building used for hay and machinery storage. The building was open sided on all elevations, with more agricultural buildings alongside the northeastern elevation. The roof material was corrugated asbestos, the frame was steel and concrete, and there were corrugated metal doors on the northwest and southeast elevations.</p> <p>Photograph 2: Northwestern elevation of Building 8.</p> | Negligible |

| Building reference | Building description | Roost suitability |
|---|---|---|
| | <p data-bbox="352 1003 783 1032">Photograph 3: Interior of Building 8.</p> <p data-bbox="352 1736 970 1765">Photograph 4: Southeastern elevation of Building 8.</p> | |

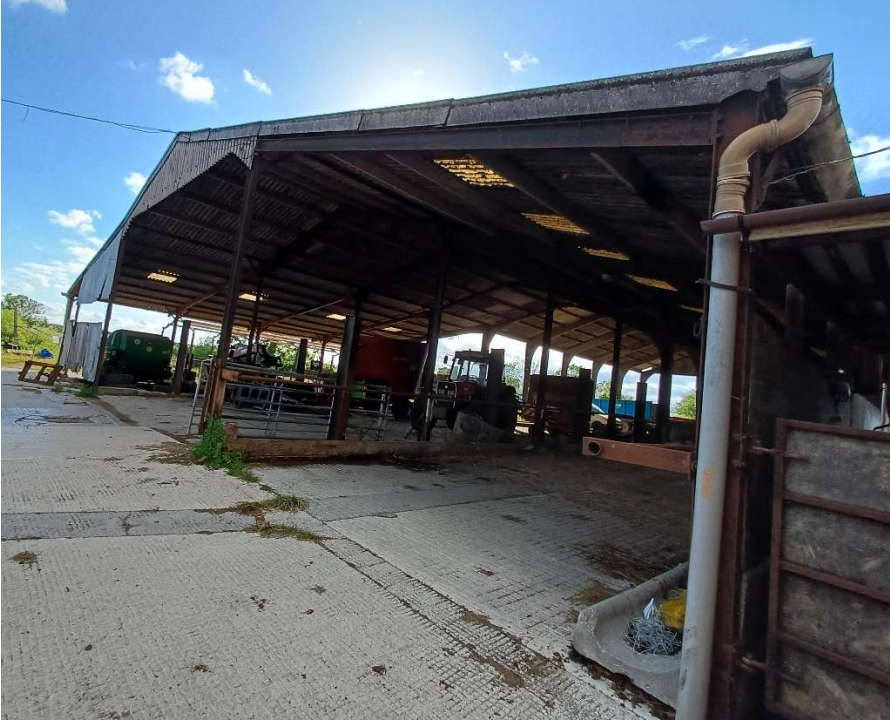
| Building reference | Building description | Roost suitability |
|---|---|---|
| 9 | <p>Agricultural building used as cattle shed. The building was open-sided on northeastern elevation. The roof material was corrugated asbestos. The frame was steel and concrete, and there were corrugated metal doors on the northwest and southeast elevations.</p> <p>Limited potential for roosting bats was noted under the fascia boards on the northeastern gable (southern section); refer to Photograph 9.</p> <p>Photograph 5: Southwestern elevation of Building 9.</p> | Low |

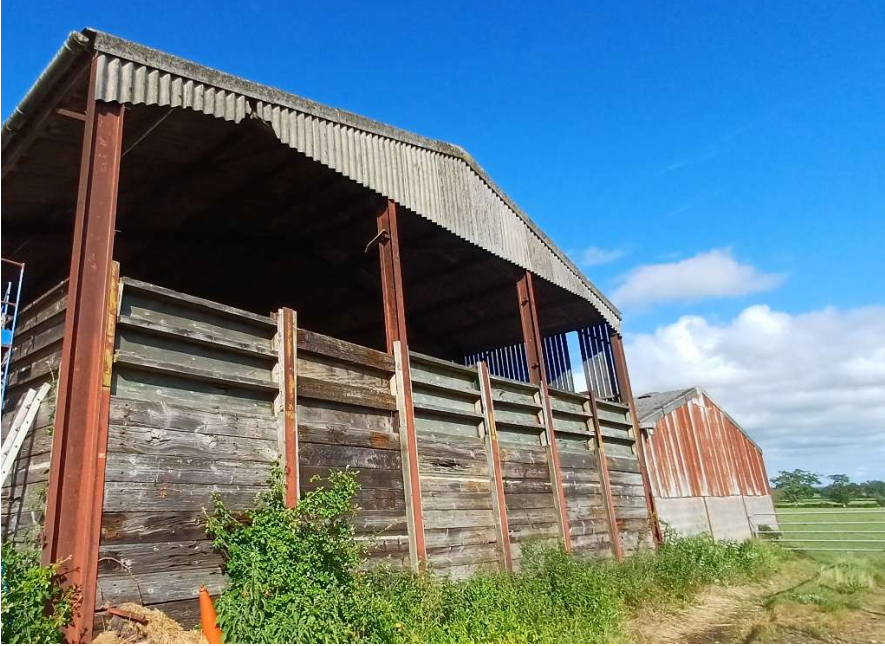
| Building reference | Building description | Roost suitability |
|---|---|---|
| | <p data-bbox="352 981 979 1016">Photograph 6: Northwestern elevation of Building 9.</p> <p data-bbox="352 1715 1198 1751">Photograph 7: Northeastern elevation of Building 9 (northern section).</p> | |

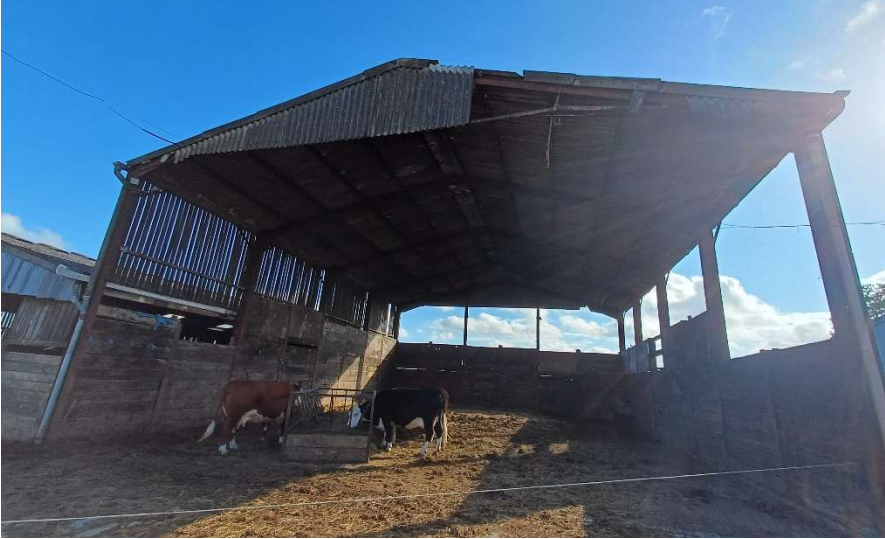
| Building reference | Building description | Roost suitability |
|---|---|---|
| | <p data-bbox="352 880 1198 909">Photograph 8: Northeastern elevation of Building 9 (southern section).</p> <p data-bbox="352 1559 1134 1588">Photograph 9: Internal view of the southern section of Building 9.</p> | |

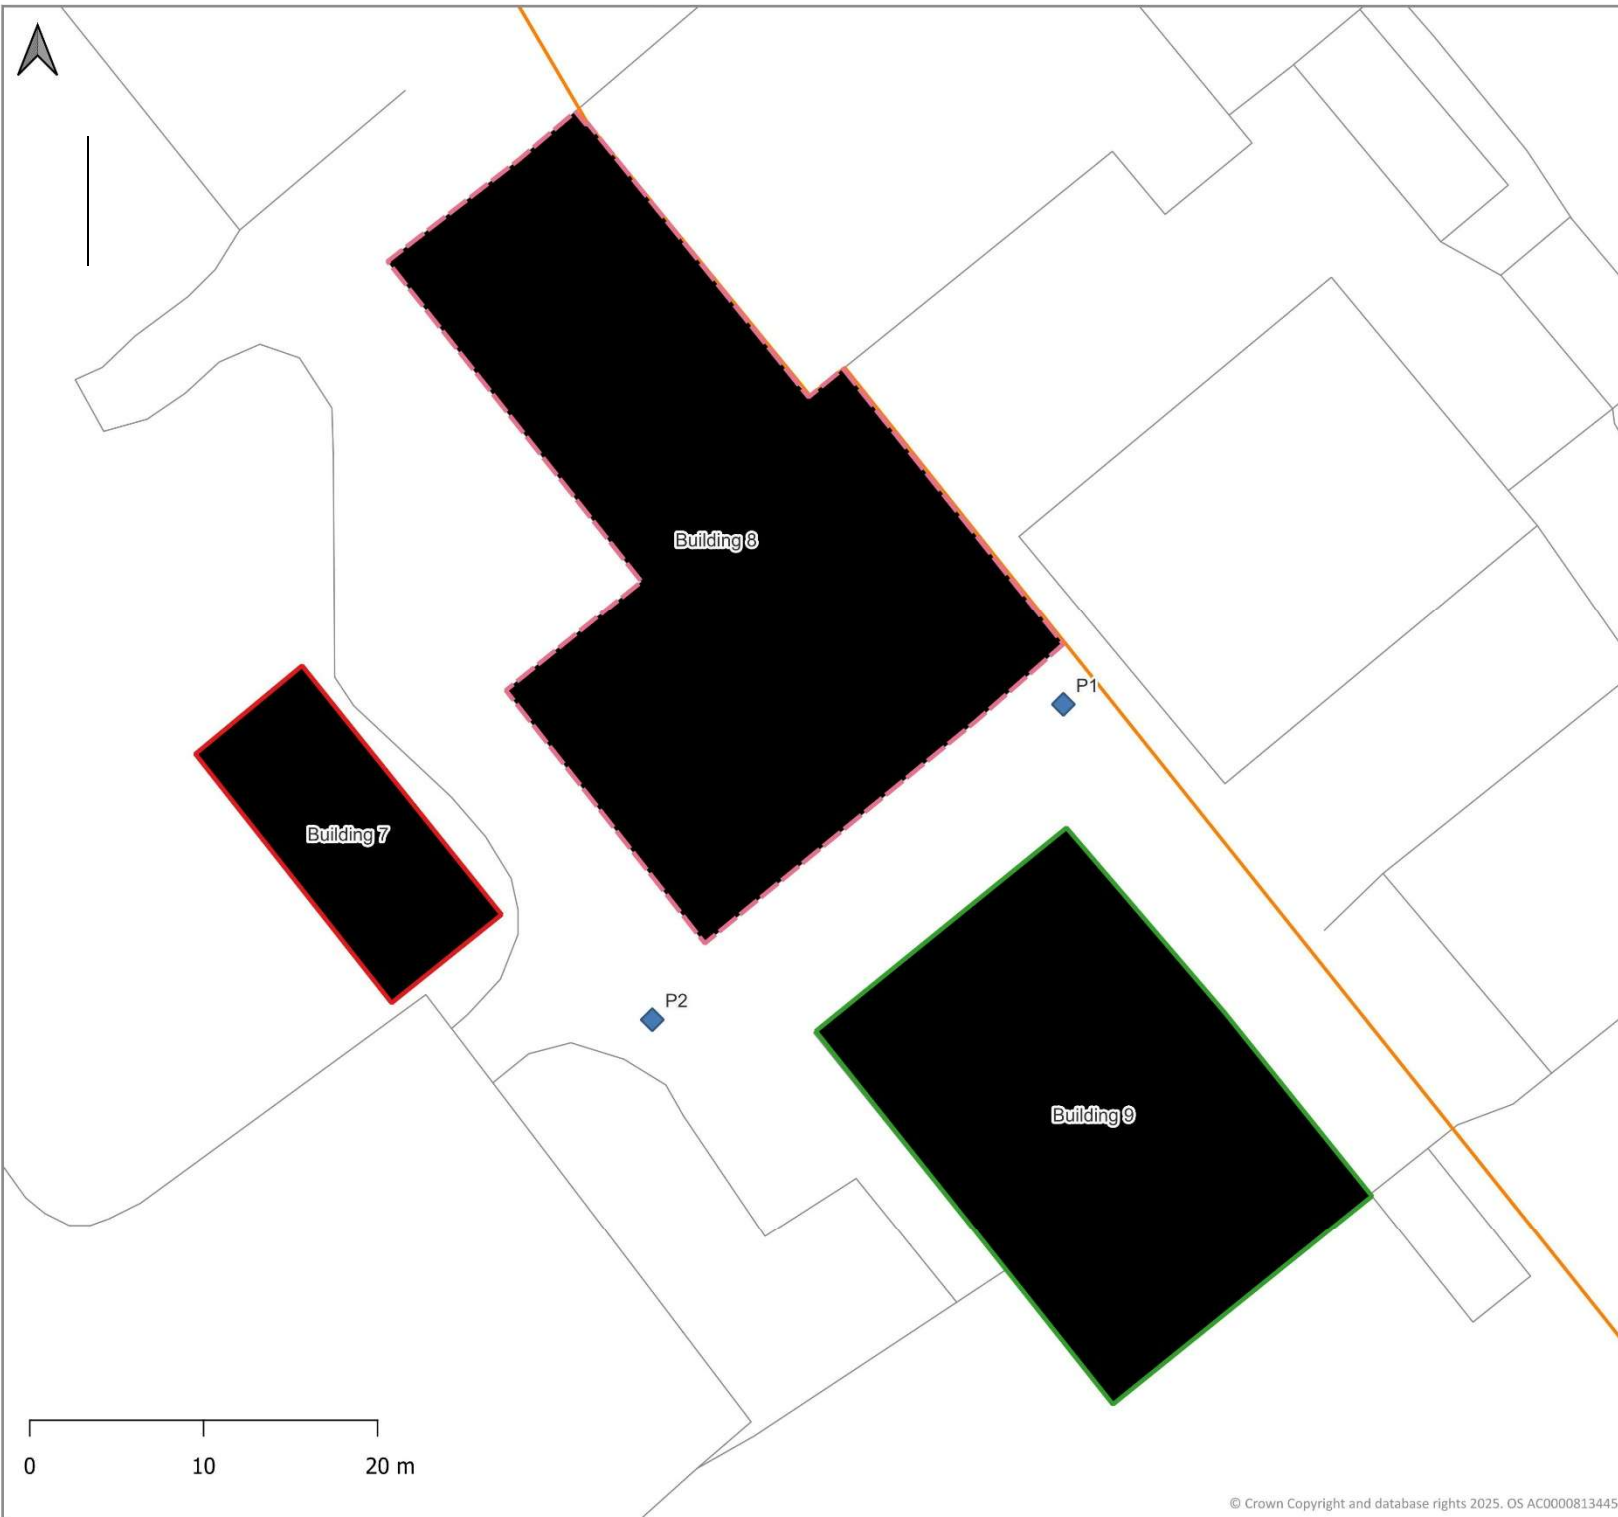
## **Figure 1: Bat Roost Survey Plan**

- 2.2.1. One building was considered to have Low bat roost potential (see Section 3 below). In accordance with BCT guidelines, a dusk emergence survey was carried out on 2 June 2026.
- 2.2.2. Surveyors were positioned around the building to adequately cover all potential bat access points identified during the building inspection; refer to Figure 1. The emergence survey started 15 minutes before sunset and continued for up to 90 minutes after sunset. Anabat Scout bat detectors were used; bat registrations were recorded for later analysis using ‘Analook Insight’ software. One surveyor (P1; refer to Figure 1) was stationed with a thermal camera, which was positioned to record the bat potential bat access points on the northeastern gable; refer to Table 3.1.
