# Design and Heritage Statement

Replacement of front door, frame and canopy — 18 Kingsbury Street, Marlborough

18 Kingsbury Street, Marlborough, Wiltshire, SN8 1JA

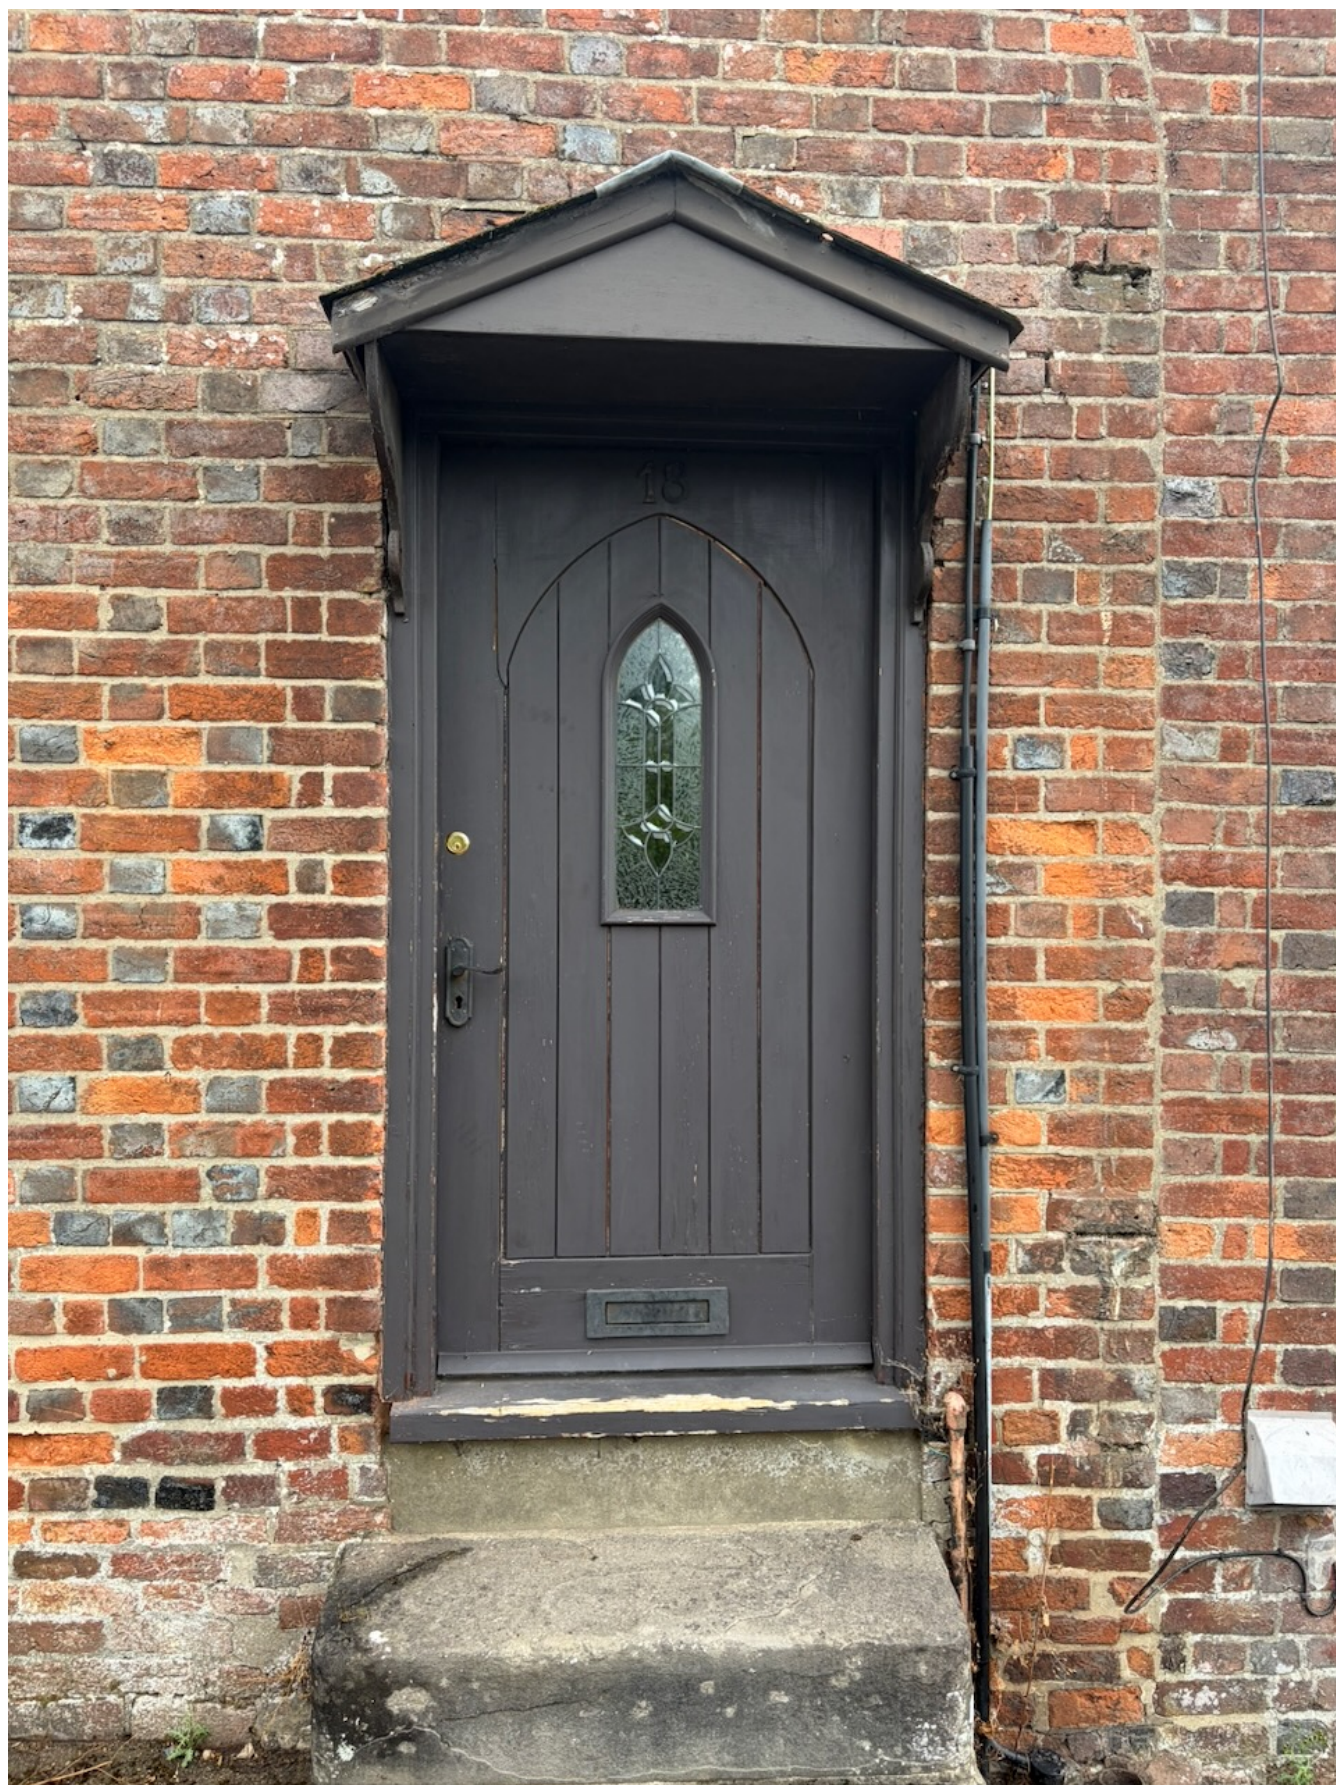
Photograph 2: Current door

The works are needed because the door is failing structurally. The joiner reports that it is rotting, warped and falling apart, that past repairs and a large amount of filler have been concealed under thick paint, and that it is coming apart at the joints because the tenons are failing, so it is not repairable. Two contractors have confirmed the condition.

| Feature | Proposed work | Impact (harmful, neutral, beneficial) |
|---|---|---|
| Front door | Replace with a purpose-made door in sapele hardwood, painted to match; traditional mortice and tenon joints, wedged; tongued, grooved and V-jointed boards with chamfer detail both sides as existing; gothic shape to the head of the boards and gothic vision panel, all to match existing; painted to match the existing colour | Neutral |

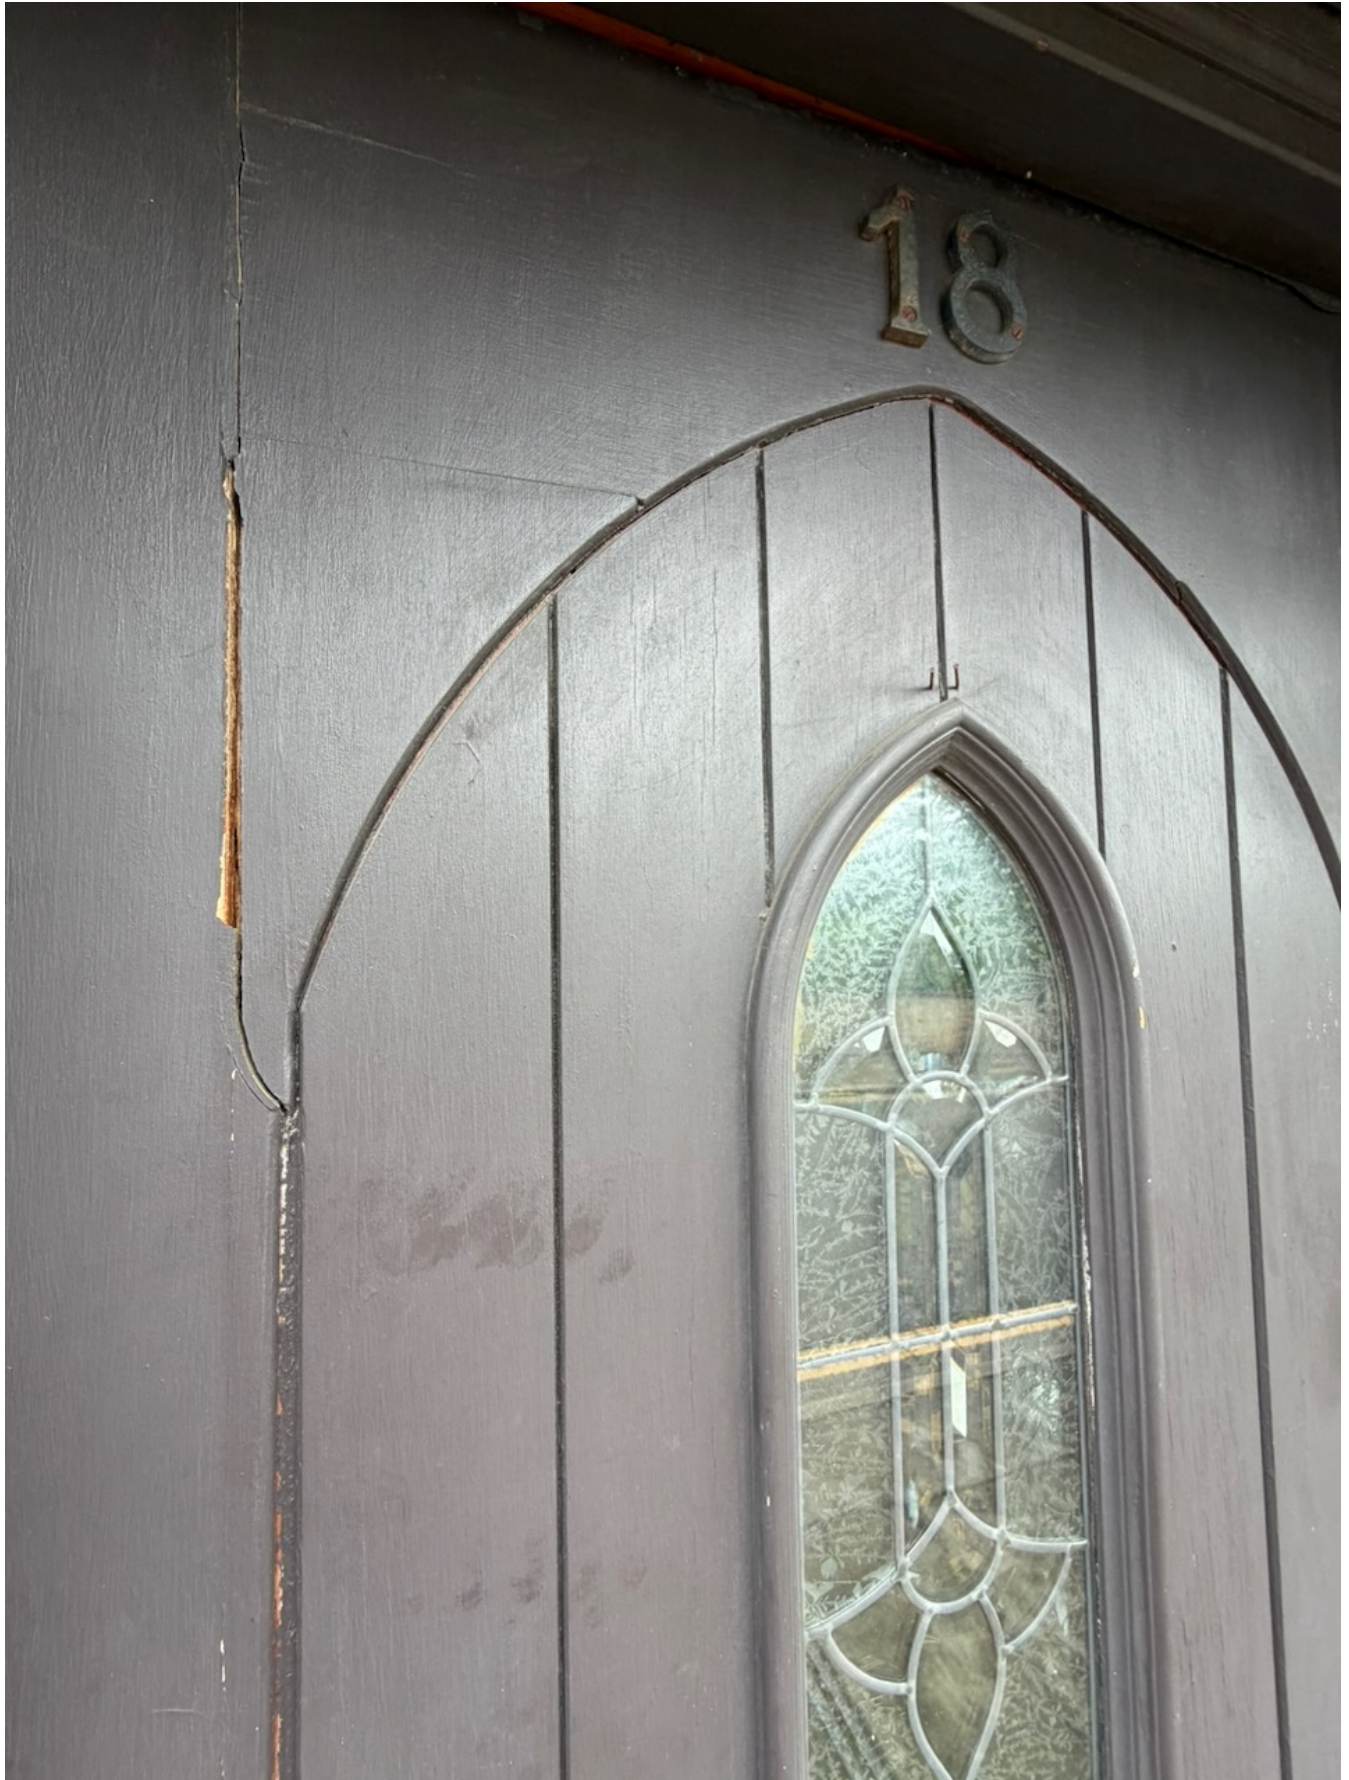
Photograph 3: Deterioration of current door

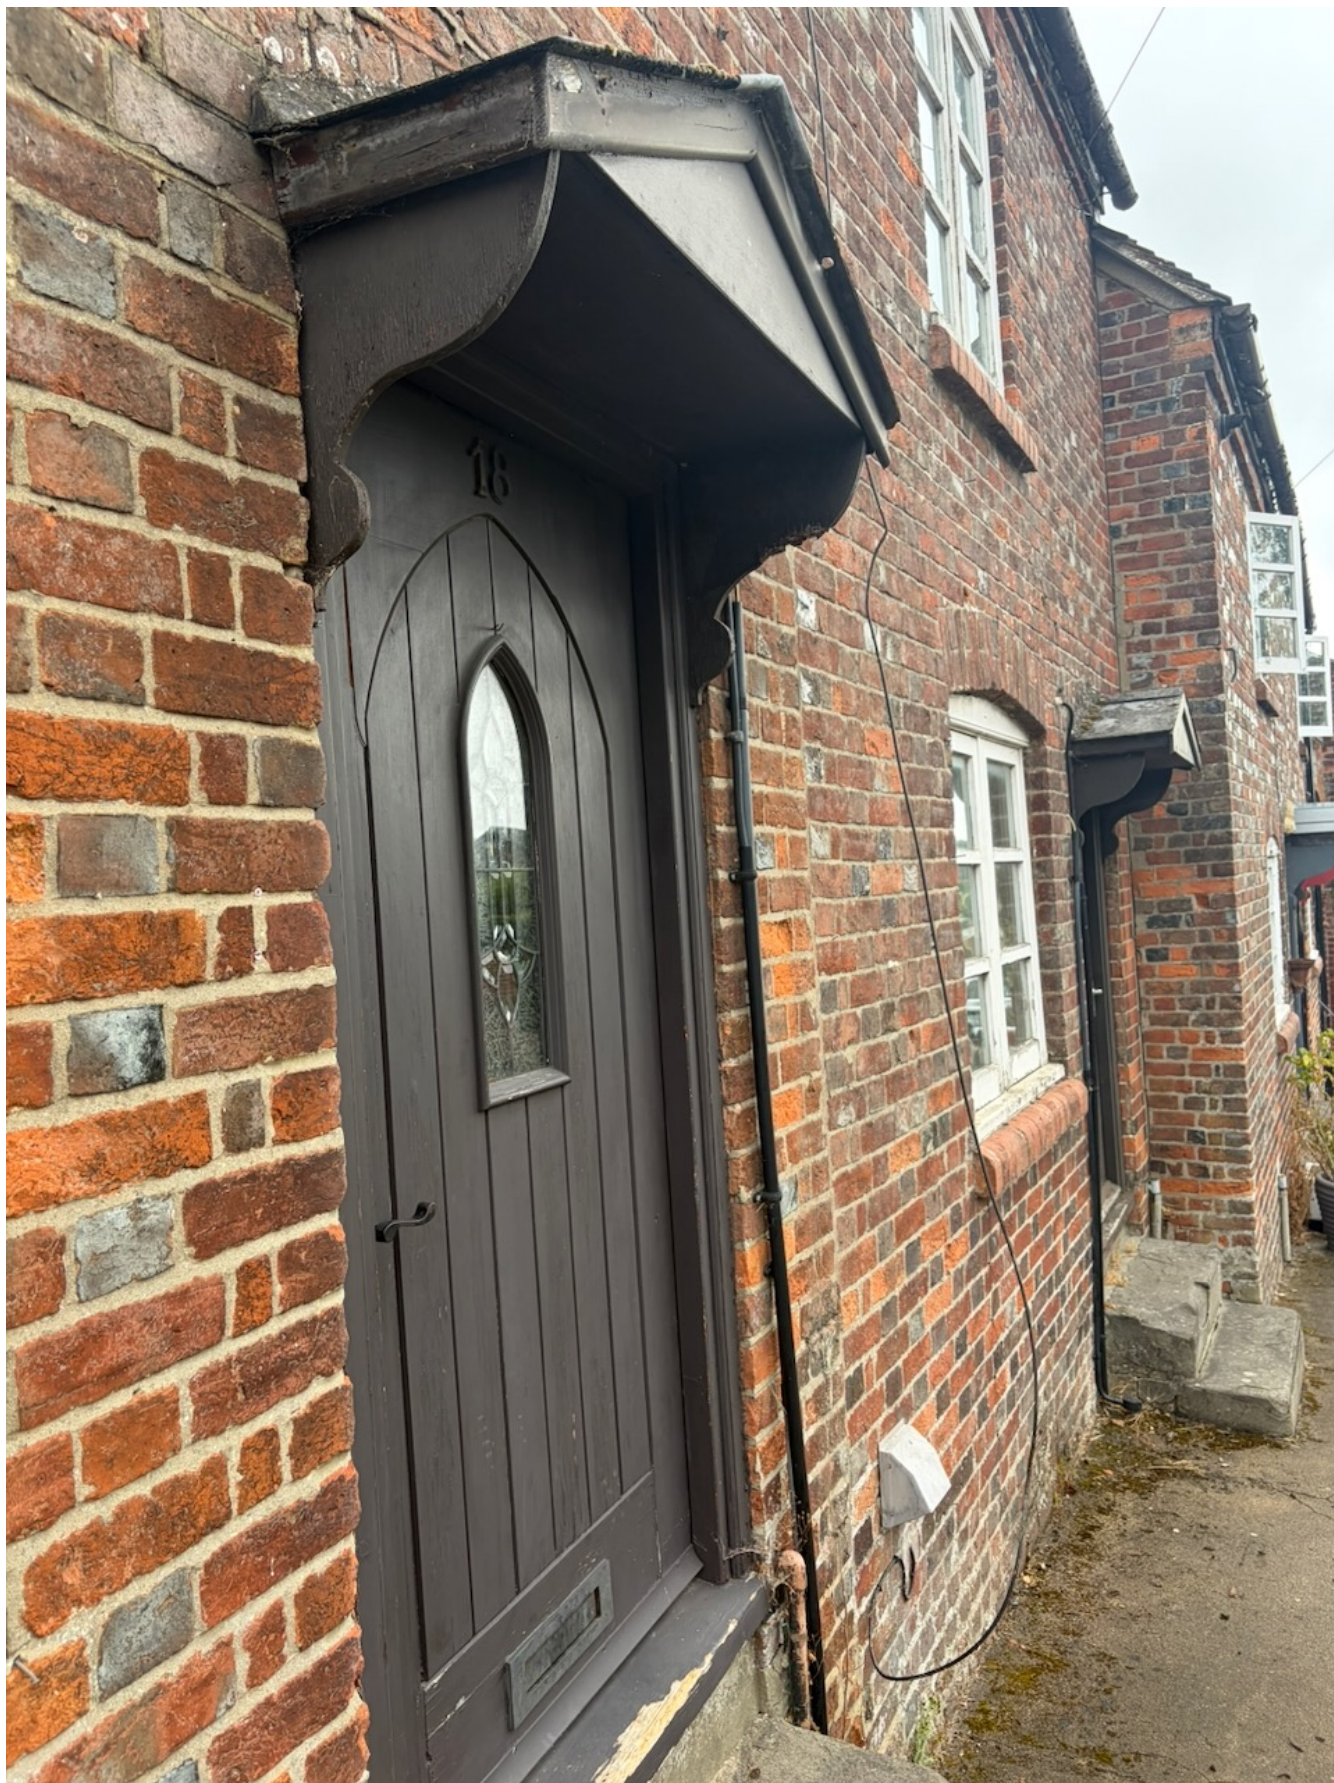
Photograph 4: Current canopy

| Feature | Degree of significance |
|---|---|
| Existing canopy (fabric) — plywood construction, C20 replacement of the historic hood design — and the boarded internal face of the door | Neutral |

| Feature | Proposed work | Impact (harmful, neutral, beneficial) |
|---|---|---|
| Canopy | Replace with a replica using exterior plywood sections to match existing, replicating the bargeboards, fascia and scroll-cut “gallows” brackets; existing roof slates reused | Neutral |

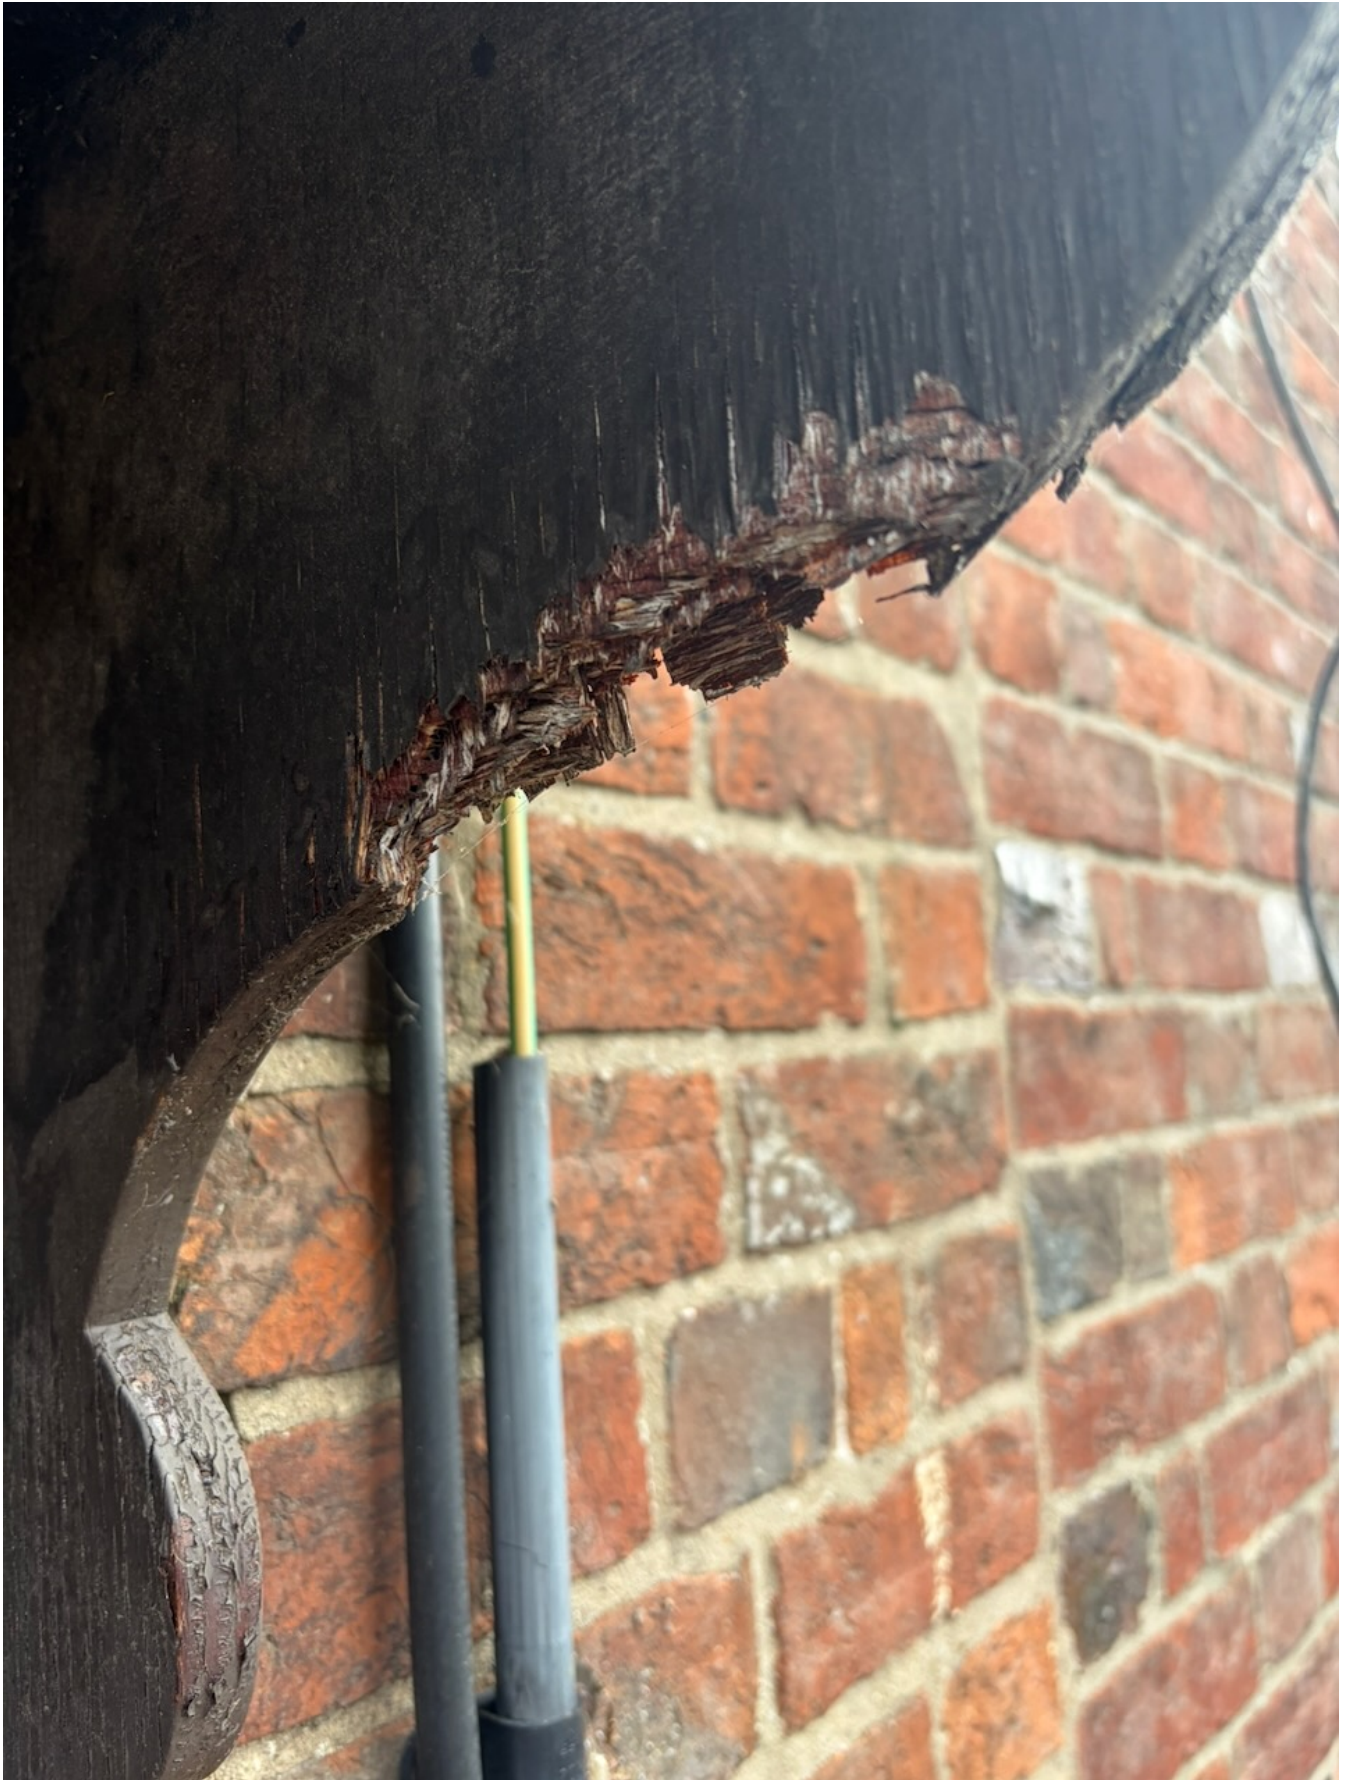
Photograph 5: Deterioration of canopy
