# HERITAGE STATEMENT

Repair and Rebuilding of Curtilage Boundary Wall and Gated Entrance  
*Hatch Farmhouse, East Hatch, West Tisbury, Wiltshire, SP3 6PH*

**Site address:** Hatch Farmhouse, East Hatch, West Tisbury, Wiltshire, SP3 6PH

**Listed building:** Hatch Farmhouse — Grade II, List Entry 1318817, listed 6 July 1987

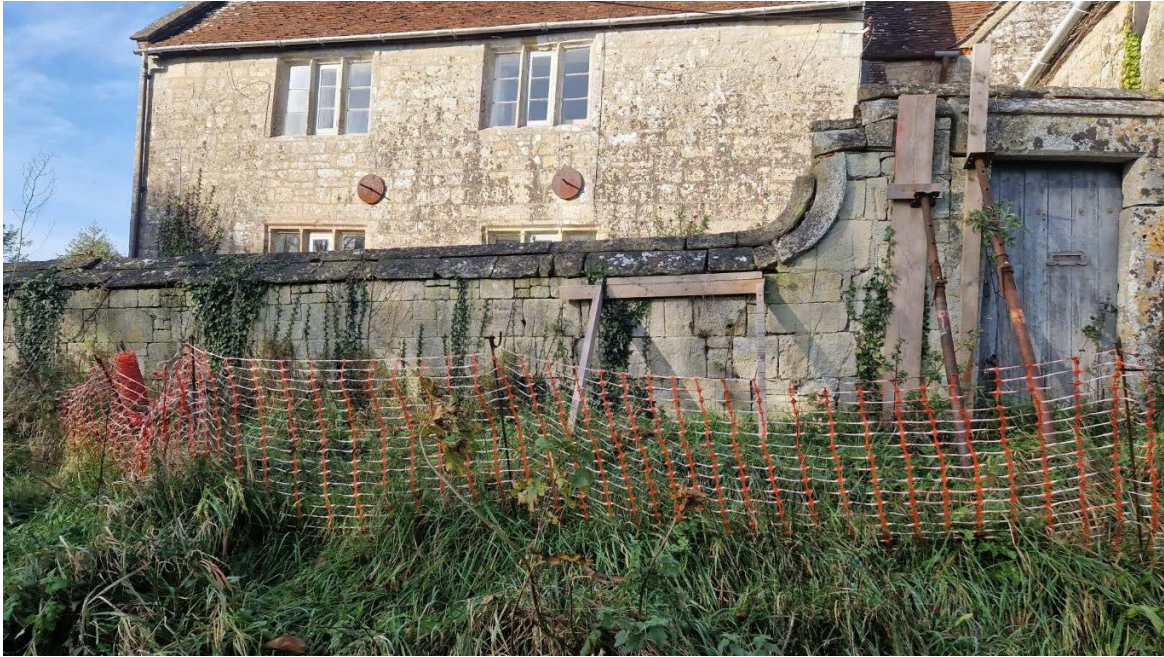
The affected structure is a stone boundary wall standing approximately four feet (1.2m) high along most of its length, built of coursed rubble limestone with a flat stone coping, running along the side of the main house and continuing as the property boundary toward open farmland beyond (see Appendix A, Photo 1). The stone is of local origin, consistent in character with the Tisbury and Chilmark limestone historically quarried within a few miles of the site and used widely in the area's vernacular buildings, including, it is reasonable to assume, the farmhouse itself. A subsidiary gated opening forms part of the same run, providing rear access to the property rather than serving as the main entrance to the house. It is marked by a shaped stone pier with a moulded, ramped and rolled coping, echoing a matching scrolled detail where the wall meets the house itself. A boarded timber gate is set within the pier opening (Photos 5 and 6).

*Photo 1: General view of the boundary wall and subsidiary rear gated access from the roadside, showing its relationship to the farmhouse and the temporary propping currently in place.*

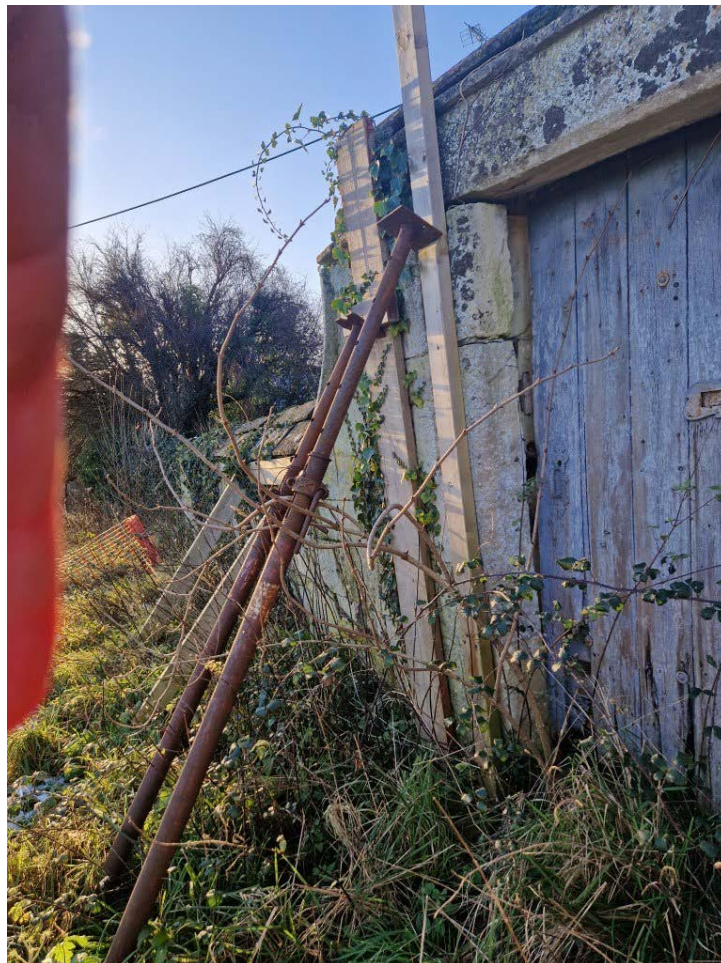
As an interim safety measure, timber and steel raking shores have already been installed against the leaning gate pier and adjoining wall (Photo 2), pending permanent repair. This temporary propping does not address the underlying cause, which is the subsided ground beneath the foundation, and is not a long-term solution. Left as it stands, the wall and gate surround are likely to fail, at which point the stone would need to be cleared away rather than carefully conserved.

*Photo 2: Detail of the temporary timber and steel raking shores installed against the gate pier and adjoining wall as an interim safety measure.*

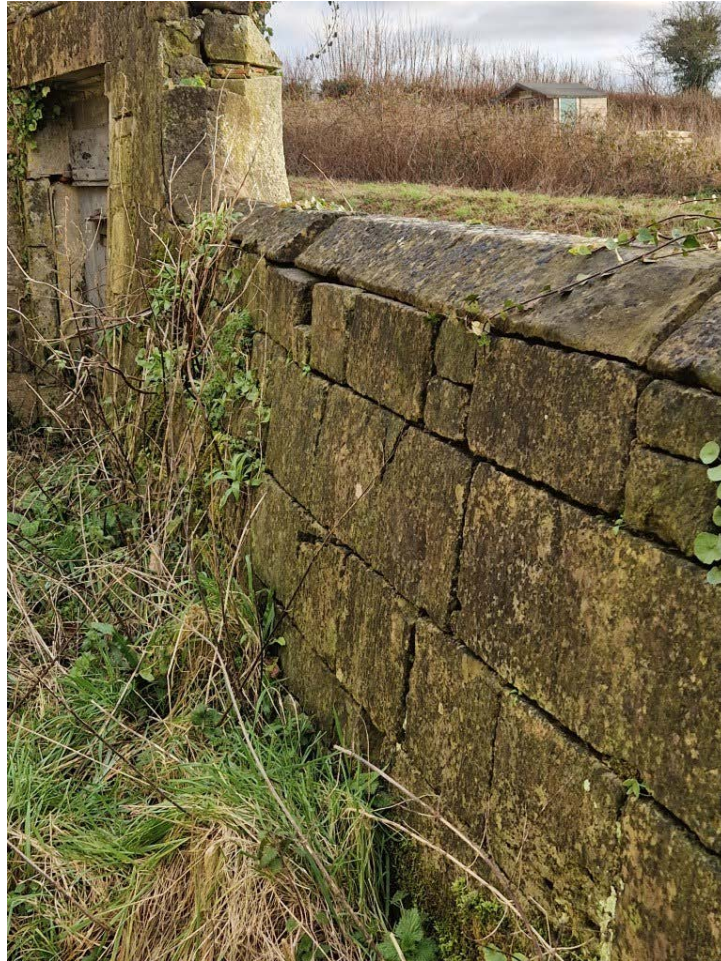
The ground beneath the wall is suffering from subsidence, and inspection of the wall confirms clear physical evidence of this movement. A diagonal crack runs through several courses of stonework partway along the affected run, consistent with differential settlement beneath the wall's foundation (Appendix A, Photo 3). At the gated entrance, the stone coping has cracked and separated, with sections of the pier visibly displaced from their original position (Photo 4). Ivy and other self-seeded growth have colonised parts of the wall; root action of this kind is a further, compounding cause of loosening in traditionally bedded walling of this type.

*Photo 3: Displacement and leaning of the coursed stonework, consistent with ground movement beneath the wall's foundation.*

- Careful, hand dismantling of the affected wall and gate surround, recording and setting aside each stone for reuse.
- Excavation and preparation of a new foundation beneath the affected run, designed to address the ground subsidence and provide a stable base.
- Rebuilding of the wall and gate surround using the same stone, recovered and reused, laid to match the existing coursing, bond, height and profile exactly, including reinstatement of the moulded, ramped coping in its existing form.
- Reinstatement of the gated entrance in its present form and position, using the existing gate and ironmongery where sound, or a matching replacement where an element cannot be reused.

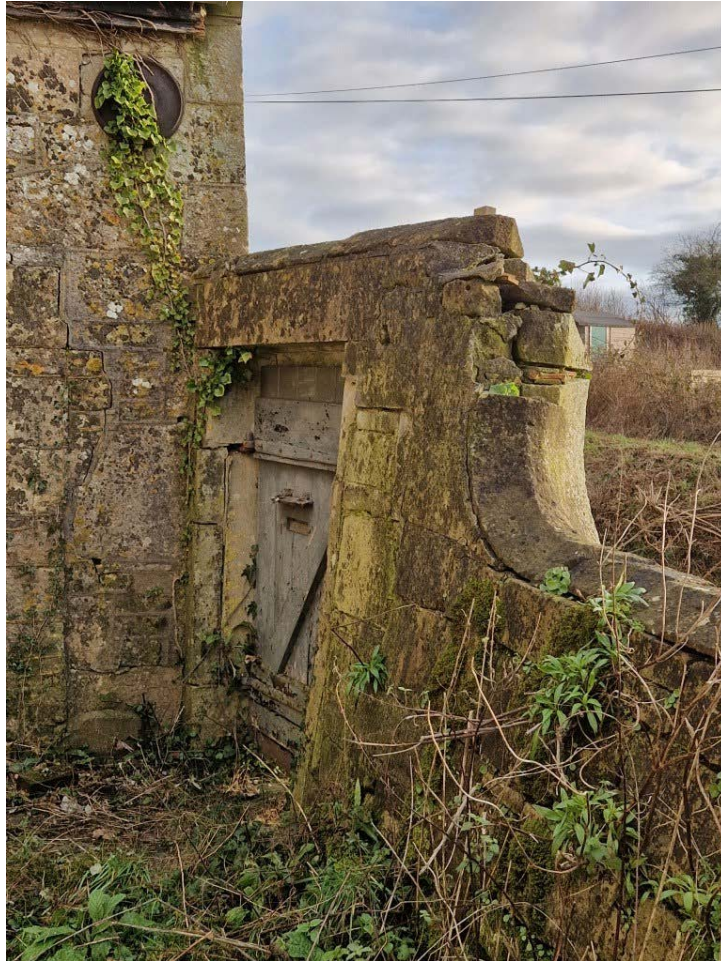
*Photo 4: Cracking and displacement of the stone coping at the gated entrance pier, showing the extent of movement.*

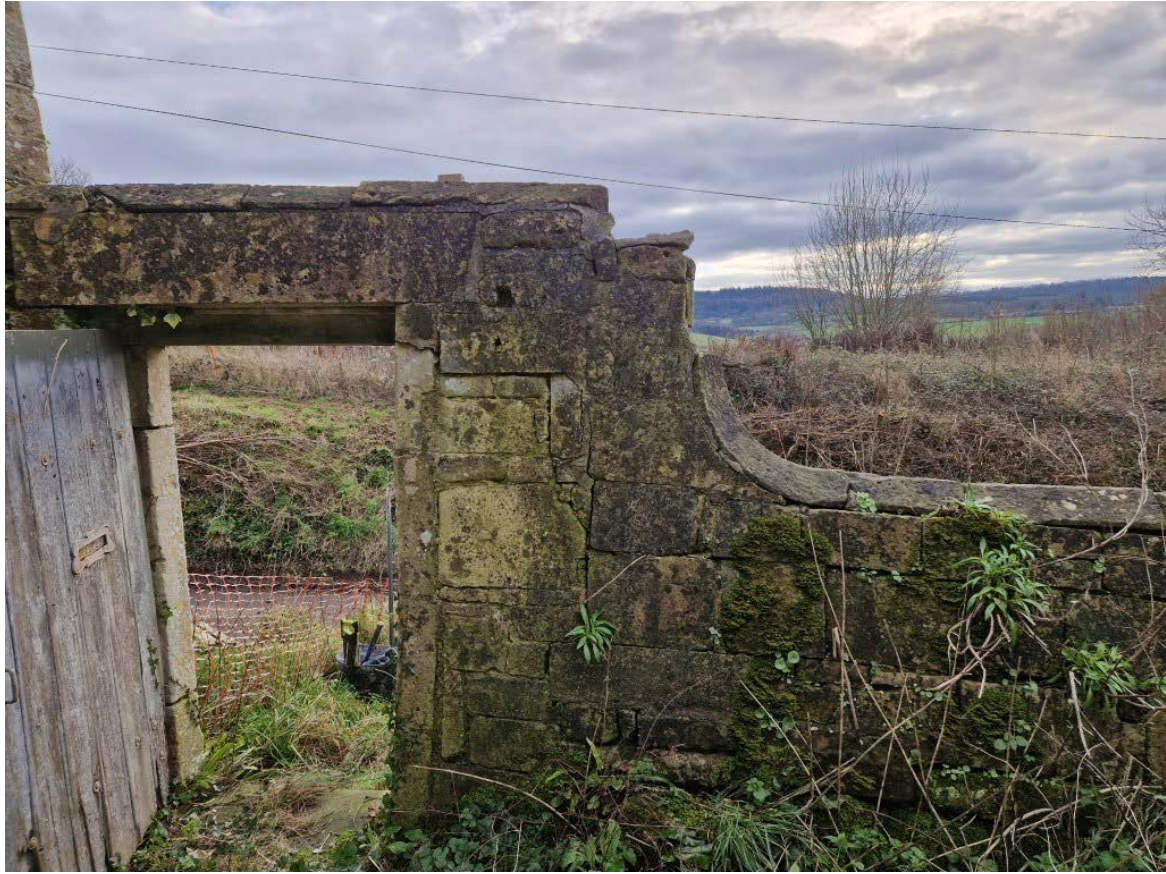
*Photo 5: The subsidiary rear gated access and its moulded, ramped stone coping, with the boundary wall continuing beyond.*
