## DESIGN, ACCESS AND HERITAGE STATEMENT

IVY HOUSE, PRIORY STREET, CORSHAM, WILTSHIRE, SN13 0AR

*August 2026*

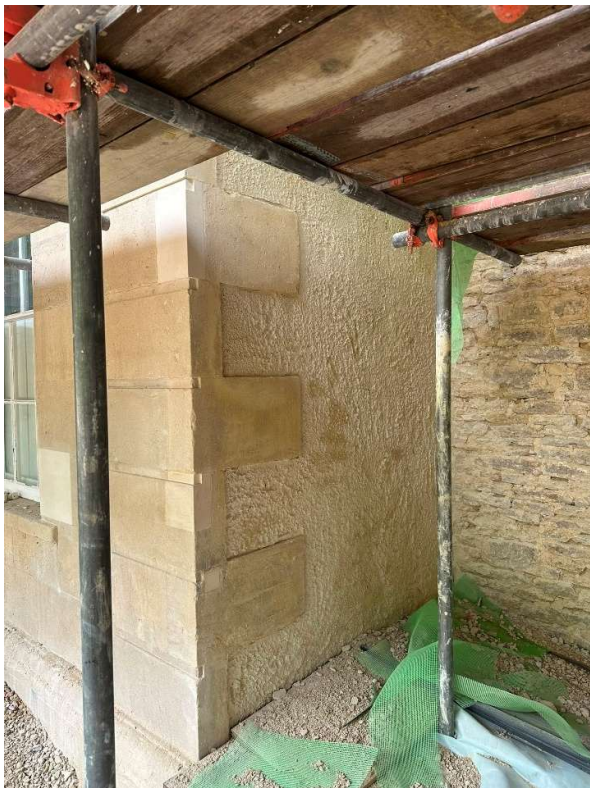
The quoin detailing on the corner of the entrance façade will remain exposed. This matches the rendering detail on the west façade, currently being implemented. See photo below.

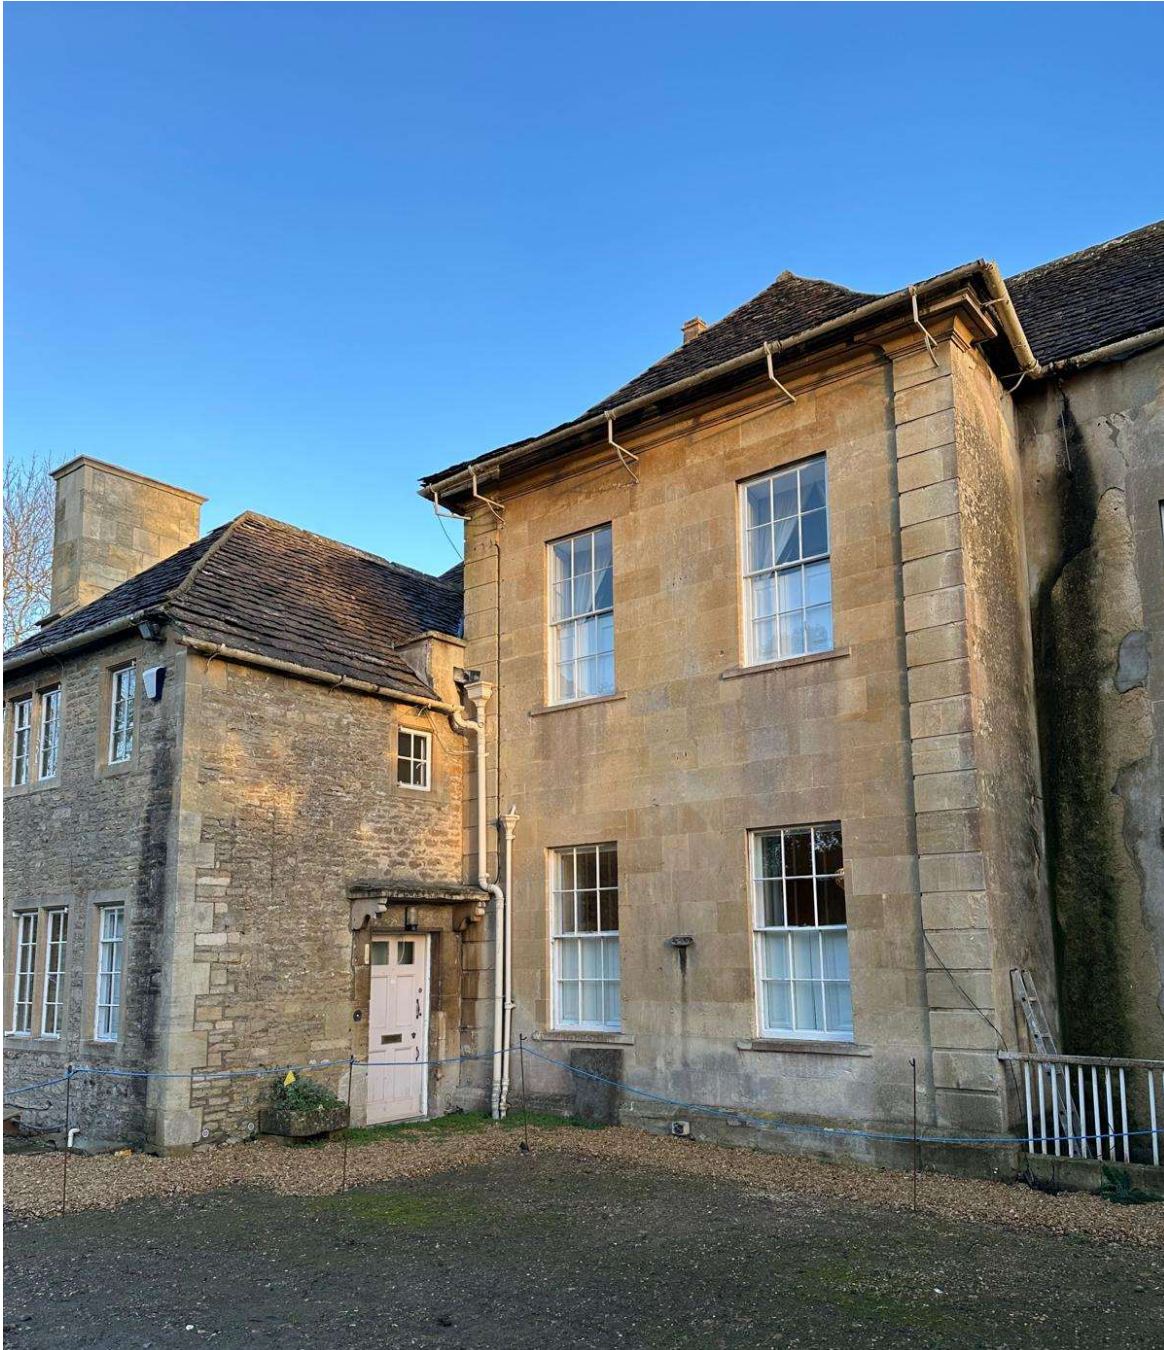
Fig 1 Rubble façade to be lime rendered, adjacent ashlar dressed façade on the right.

It is proposed to render the elevation in a breathable natural hydraulic lime render, struck with fine lines at regular intervals to imitate ashlar block coursing consistent with the coursing pattern of the principal elevations.

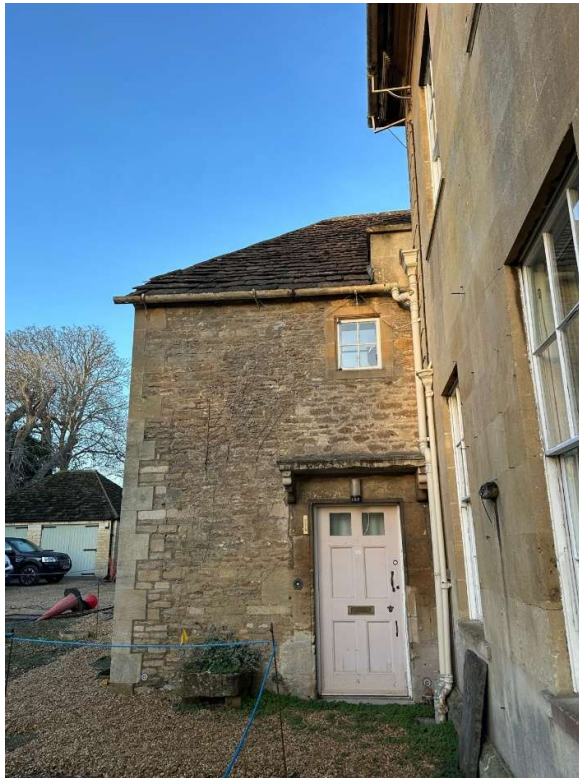
Fig 2: New entrance façade  
In state of disrepair

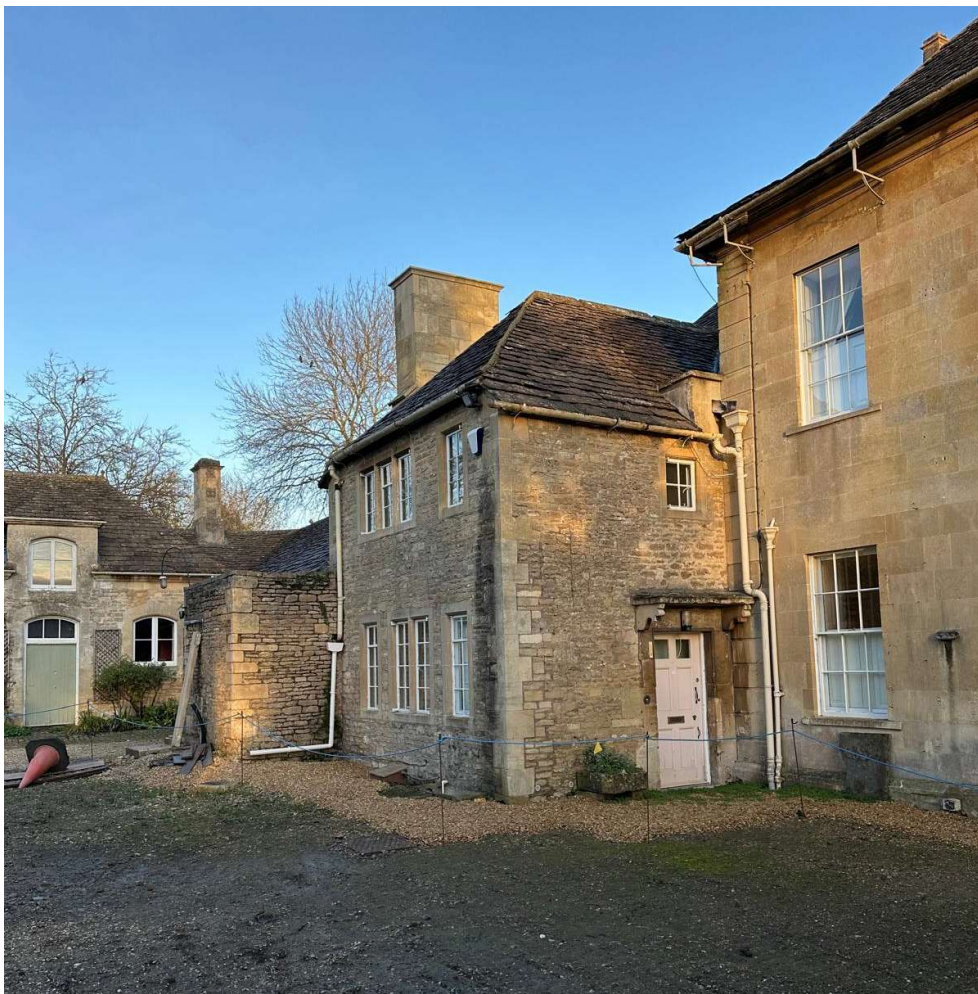
Fig 3: New entrance façade with  
single storey wood store  
beyond

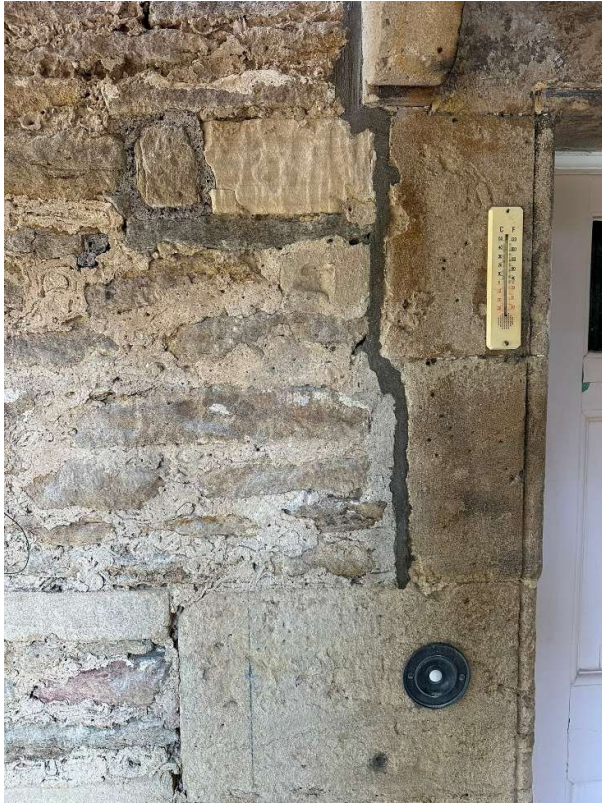
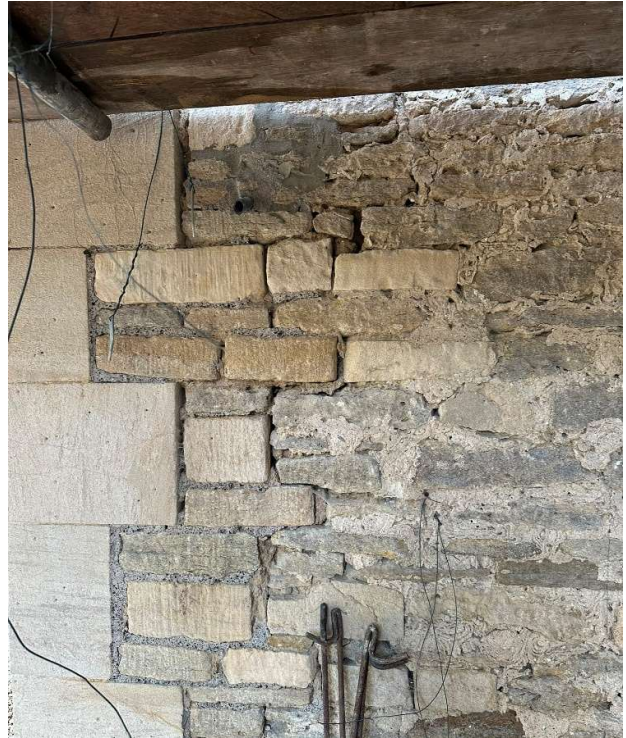
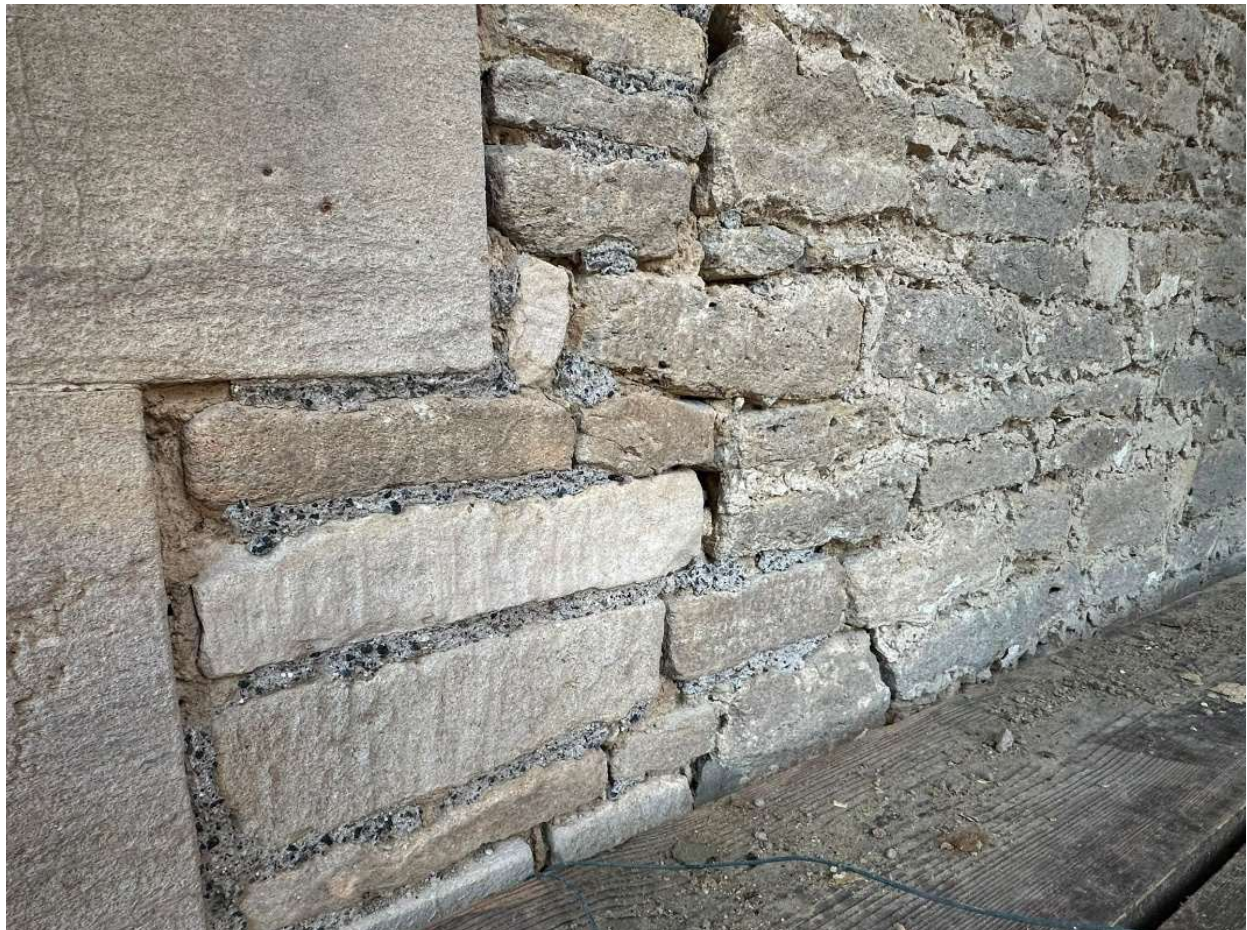
The existing rubble stonework is in poor repair, with visible crumbling mortar, evidence of open joints and loss of historic pointing. The treatment of this façade needs to be addressed to prevent inevitable moisture ingress. Please see Appendix 2 for photographic evidence.

Fig 4: Group of Photos: Rubble stone with open mortar joints and cement repairs

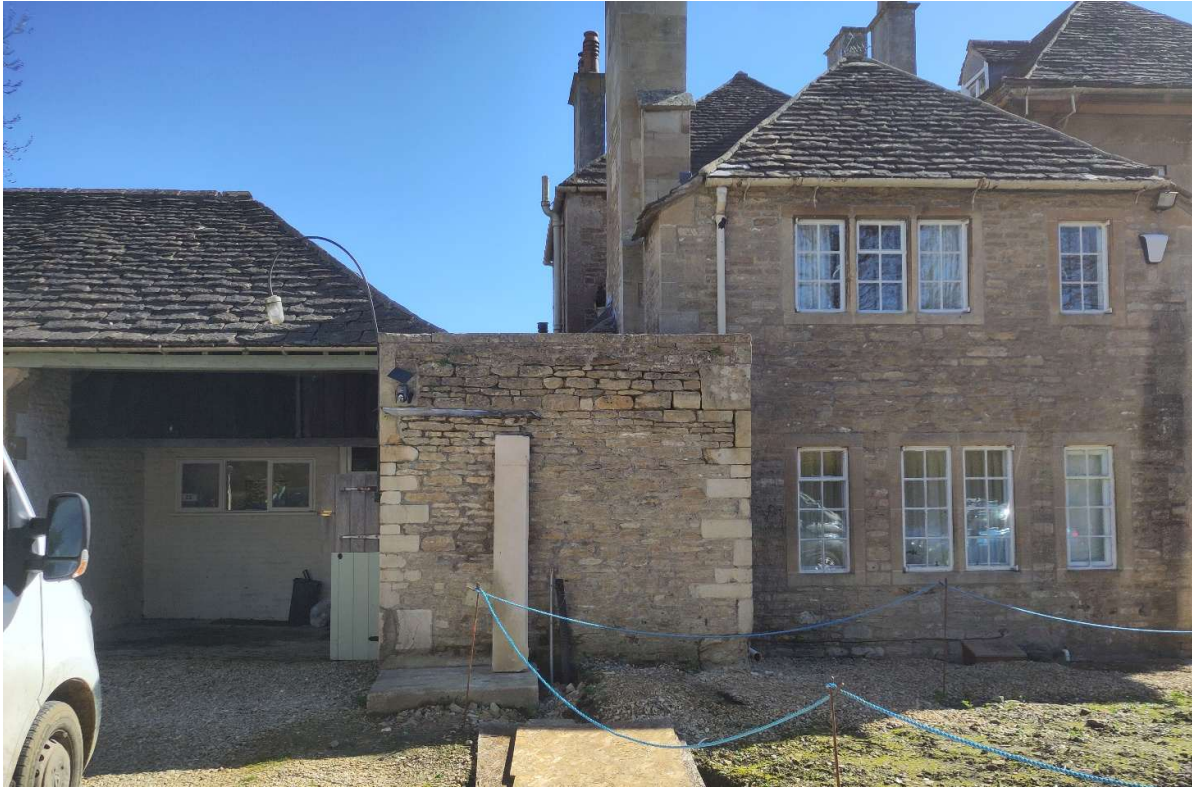
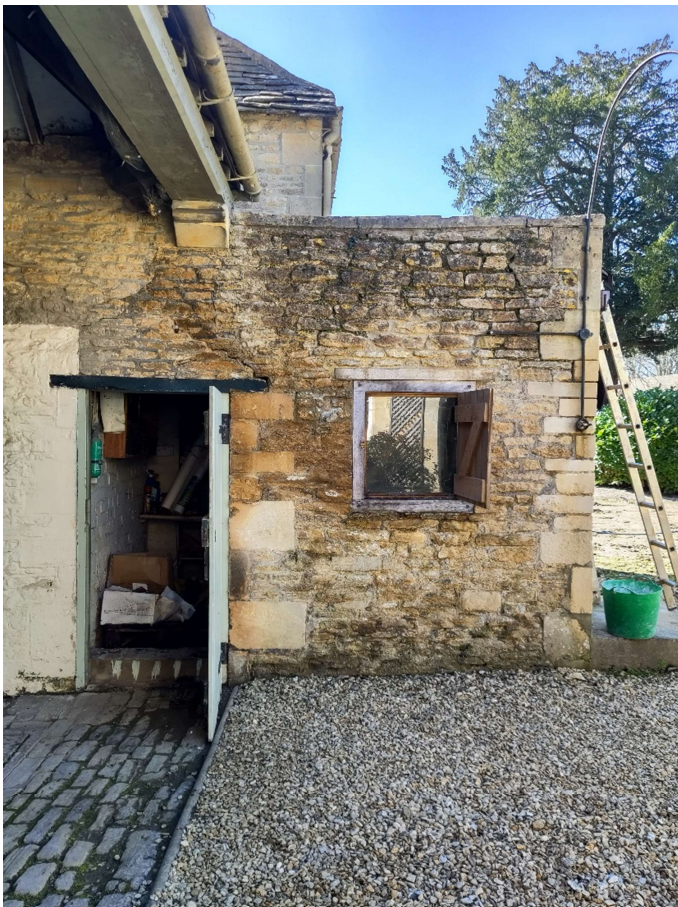
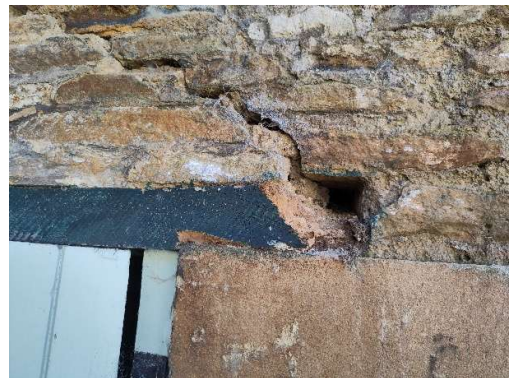
Fig 5: (top) wood store west façade  
Fig 6: (above) rotten wood lintel  
Fig 7: (left) wood store north facade

- Replacement external door and window: the existing door and window and rotten lintels are to be replaced on a like-for-like basis, matching the design, proportions, materials and finish of the existing openings, necessitated by their current disrepair. The only exception to this is the removal of the rusted timber stable shutter and the addition of traditional glazing bars to the window.

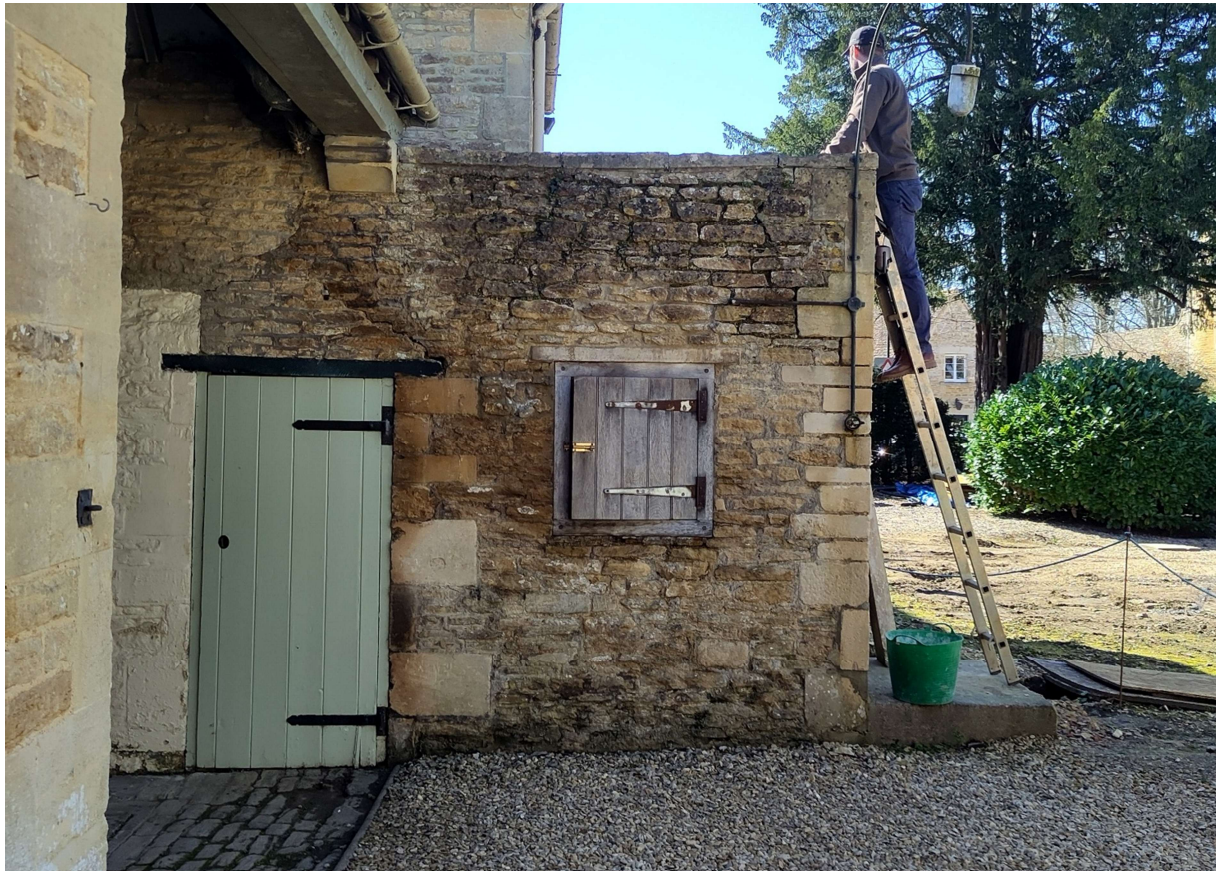
Fig 8: Wood store with shutter over window

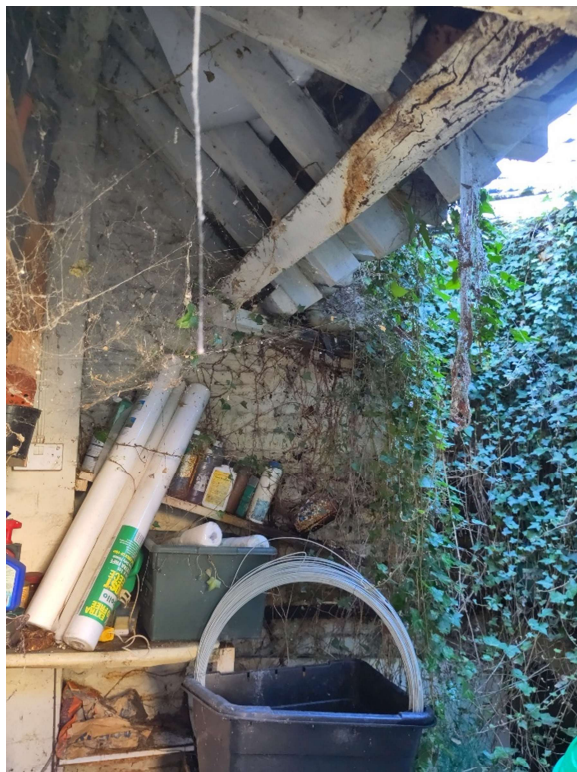
Fig 9: Internal wood store – rotten rafters and vegetation

- **Replacement of rotten rafters:** The existing roof rafters have been affected by rot and will be replaced with new timber D30 Grade oak beams, sized by the structural engineer.

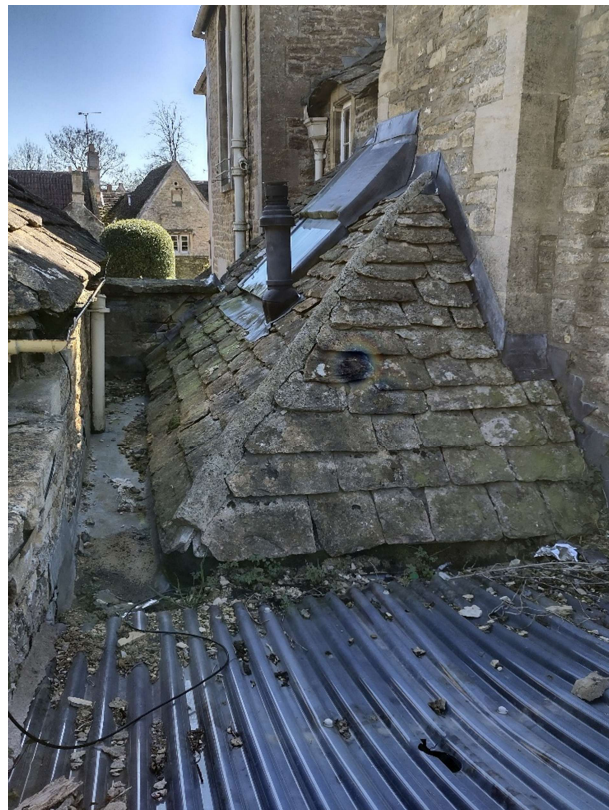
Fig 10: Wood store roof and polycarbonate sheeting

- New lead roof covering to replace the existing polycarbonate sheeting: this removes a modern, incongruous and structurally failing covering and replaces it with a traditional lead roof appropriate to the significance of the site and consistent with the character of roofing found elsewhere within the historic curtilage.

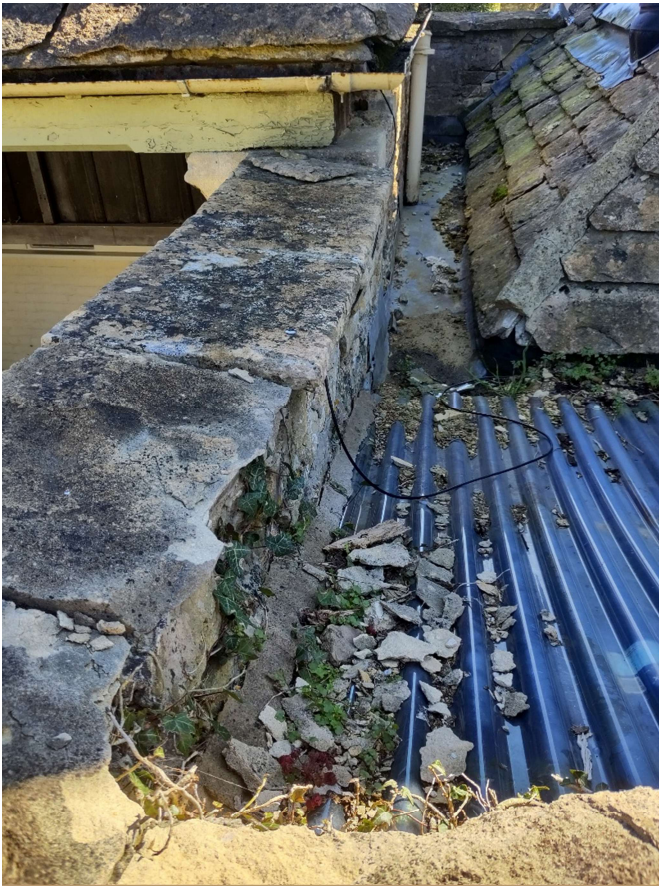
Fig 10: Weathered stone parapet to be replaced

- New stone parapet: detailed to match the existing bay window on the west elevation of the original house. This replaces the existing stone parapet which is currently weathering into disrepair.

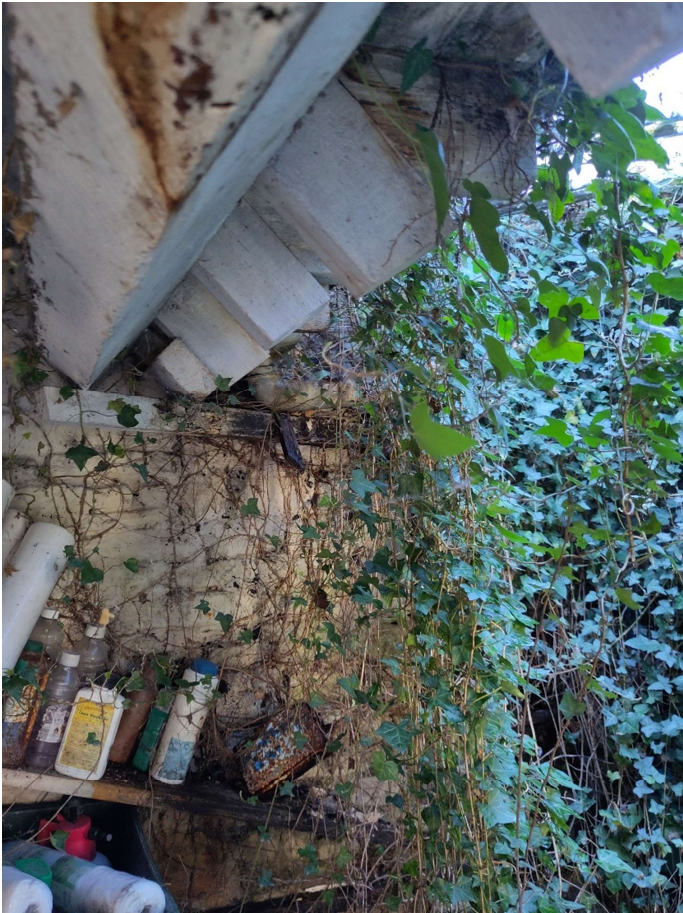
Fig 11: Dilapidated wood store interior
