# MURHILL HOUSE

## PLANNING, DESIGN & HERITAGE STATEMENT

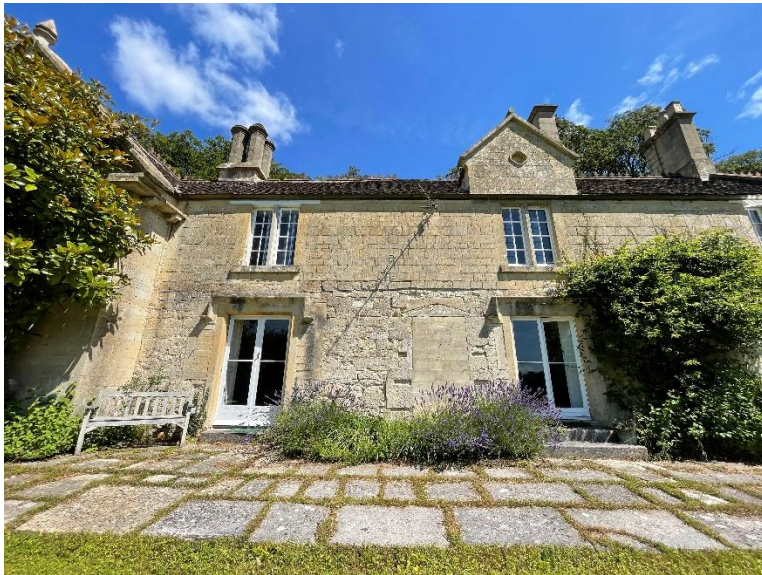
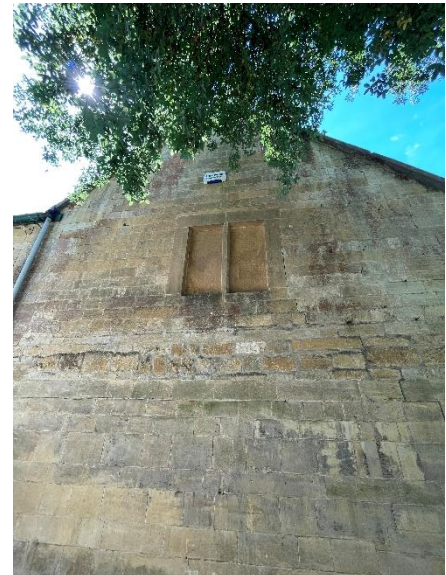
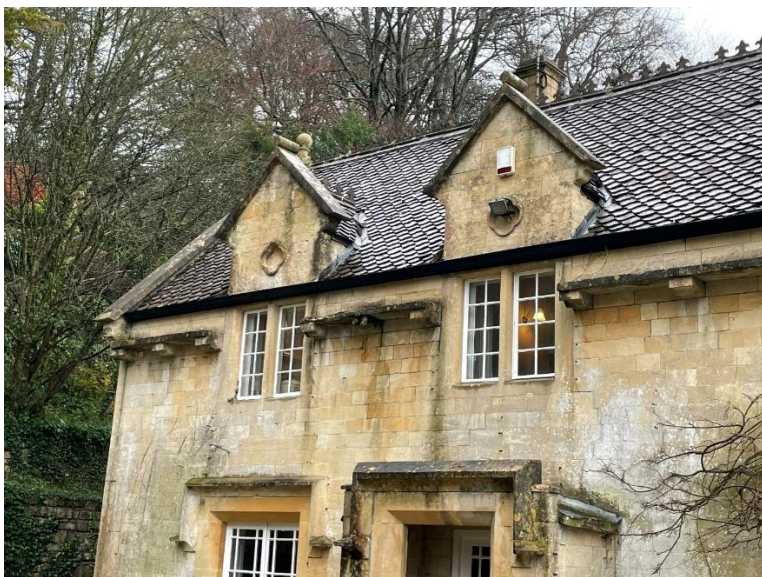
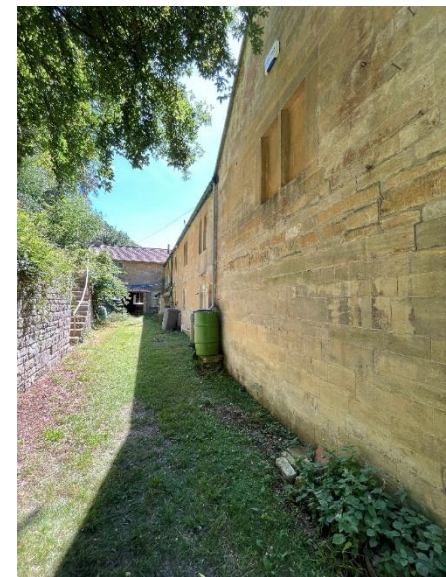
Today Murhill House is a semi-detached property set over ground and 1<sup>st</sup> floor levels, with a small cellar to the north west corner and an attic above the northern half of the roof. It is of traditional construction with solid walls made from the local limestone. There is some deterioration of the stonework and pointing, particularly to the west and south elevations.

Figures 13, 14, 15 and 16 – Examples of deterioration of stonework to south, north and west elevations. An historic doorway to the west elevation was infilled as part of the 19<sup>th</sup> century improvements and there appears to be a blocked up window to the north elevation.

1. A complete overhaul of the roof, including timber repairs, a new waterproofing breather membrane, battens, natural handmade clay tiles, leadwork, stonework repairs, roof lights, rainwater goods etc.
2. Replacement of the existing external doors to Room 3 (Kitchen) and Room 4 (Dining Room) with new slimline double glazed timber framed units.
3. Opening of the historic window to the north side of the house (Bedroom 5) and installation of new slimline double glazed, timber-framed casement windows.
4. Refurbishment, timber repairs and decorations to all other windows and doors.
5. Stonework and general pointing repairs.
6. Enlargement of the patio to the south side of the house and replacement of existing concrete slabs with new natural stone paving.
7. Associated alterations to the foul and rainwater drainage systems.

Stone and mortar repairs will use local Bath limestone and a natural hydraulic lime mortar mix (NHL 2-3.5), with sharp pointed sand. Existing historic internal walls will be repaired using traditional lime plaster.

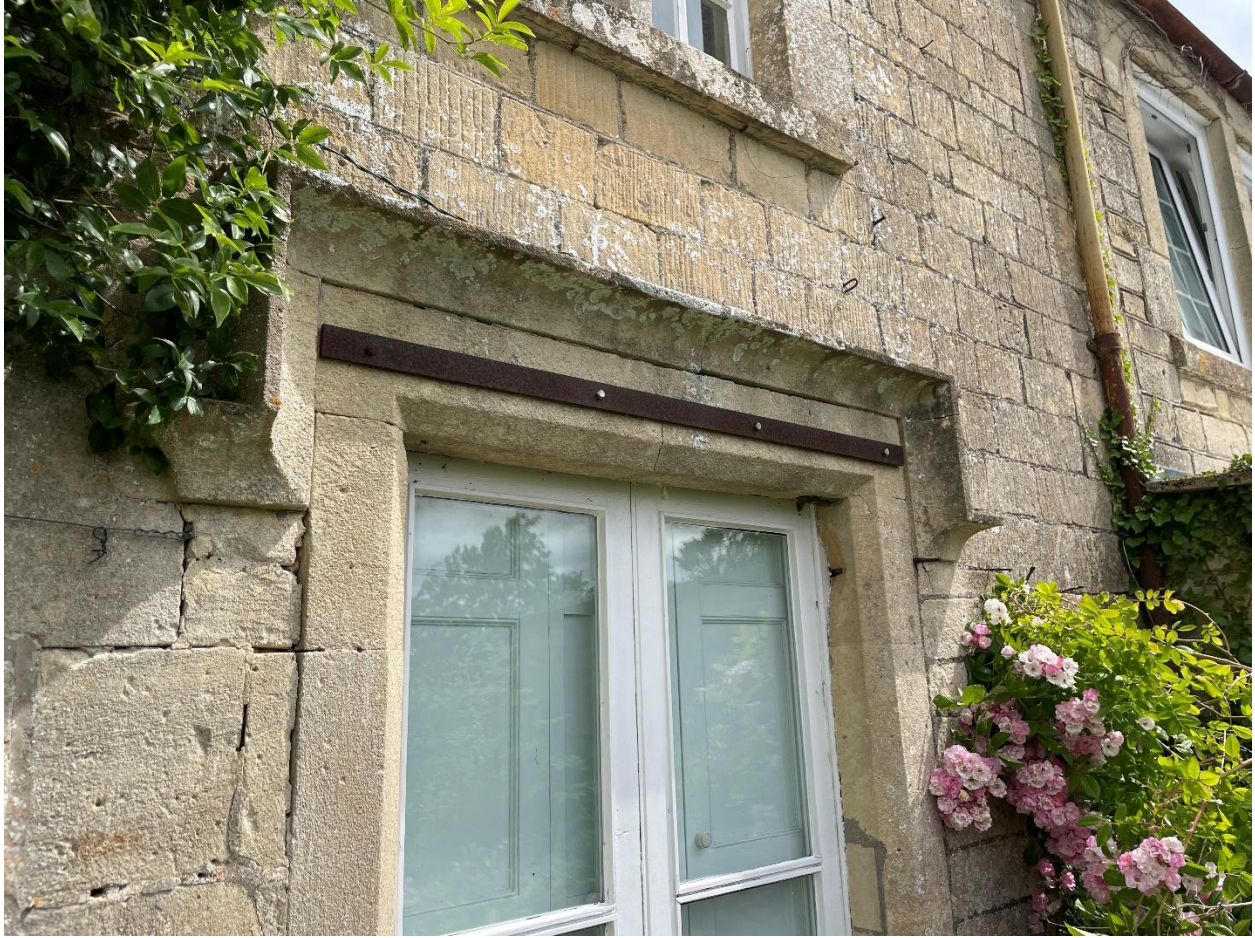
Figure 17 - A metal strap has been added as a structural repair to the lintel on the south elevation.

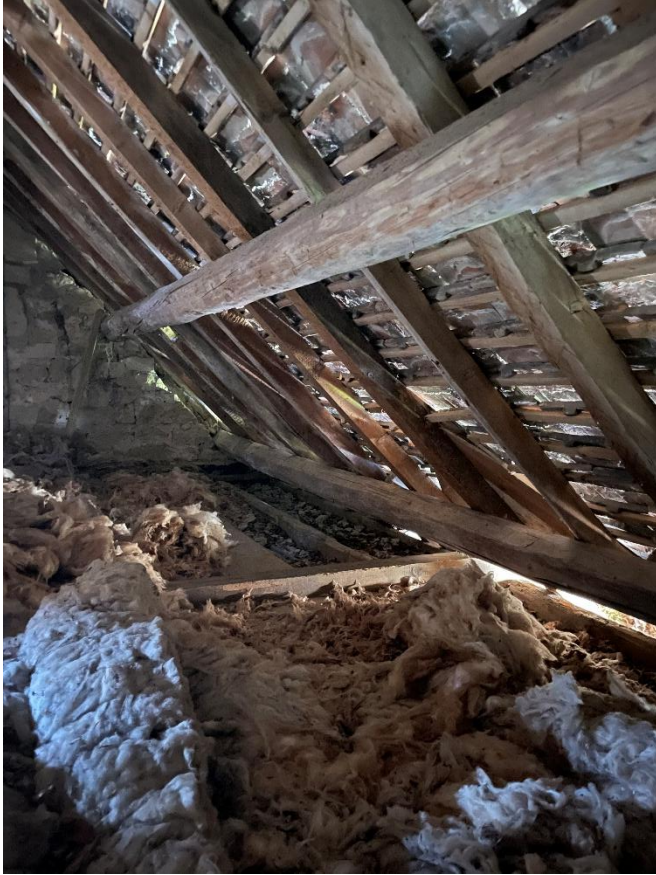
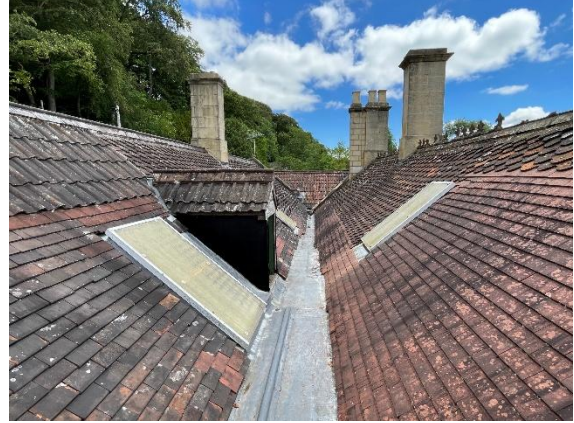
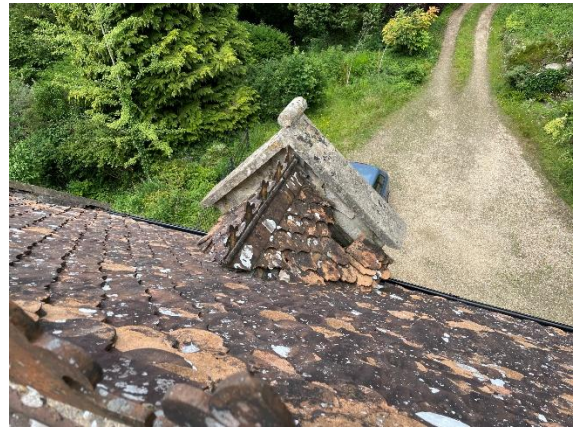
The pitched roof is covered with natural clay tiles (a mixture of plain tiles, club tiles and double romans with partial Fleur de Lys ridges), and a central lead-lined valley gutter. Various modern roof lights have been added to the northern section of the roof. Rainwater goods consist of a mixture of cast iron and uPVC replacements. The southern and western sections of the roof have been partially insulated. The roof is in a poor condition with numerous areas requiring immediate attention, including tiles, flashings, timberwork and stonework.

Figures 18, 19 and 20 – The roof is generally in a very poor condition with no roofing felt, poor levels of insulation, numerous slipped or missing tiles and defects to stonework, leadwork etc.

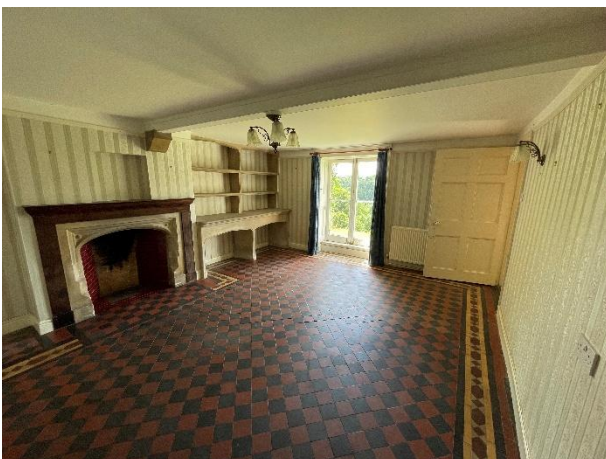
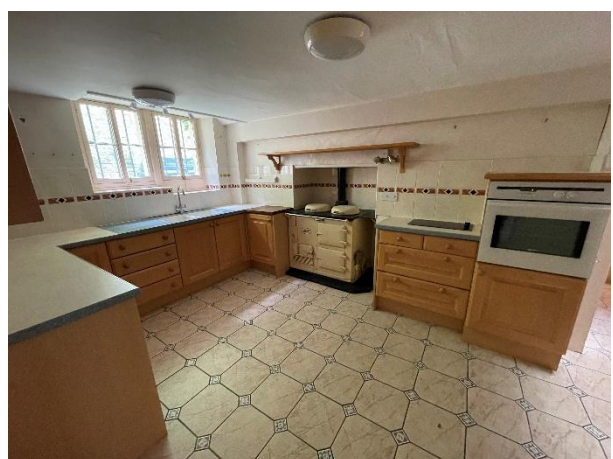
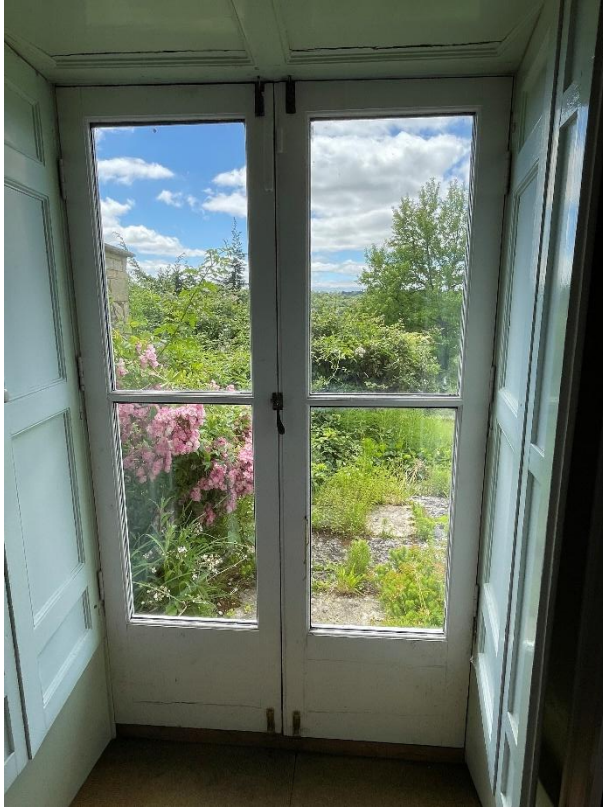
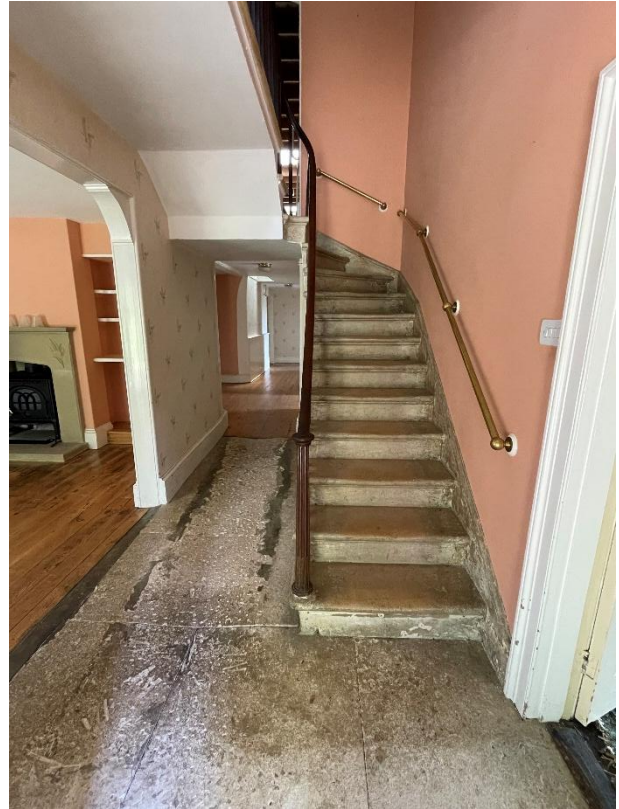
The windows and doors are primarily single glazed, timber-framed units with poor quality secondary glazing fitted internally. Some have also been replaced with new double glazed units.

Figures 21, 22, 23 and 24 – The house retains a number of historical features but has been modernised and altered significantly in places, including windows and doors, some of which have been replaced by double glazed units.

Where windows and doors are to be replaced these have been designed to reflect the existing joinery details, but incorporate slimline double glazing to improve thermal performance in accordance with Part L of the Building Regulations.

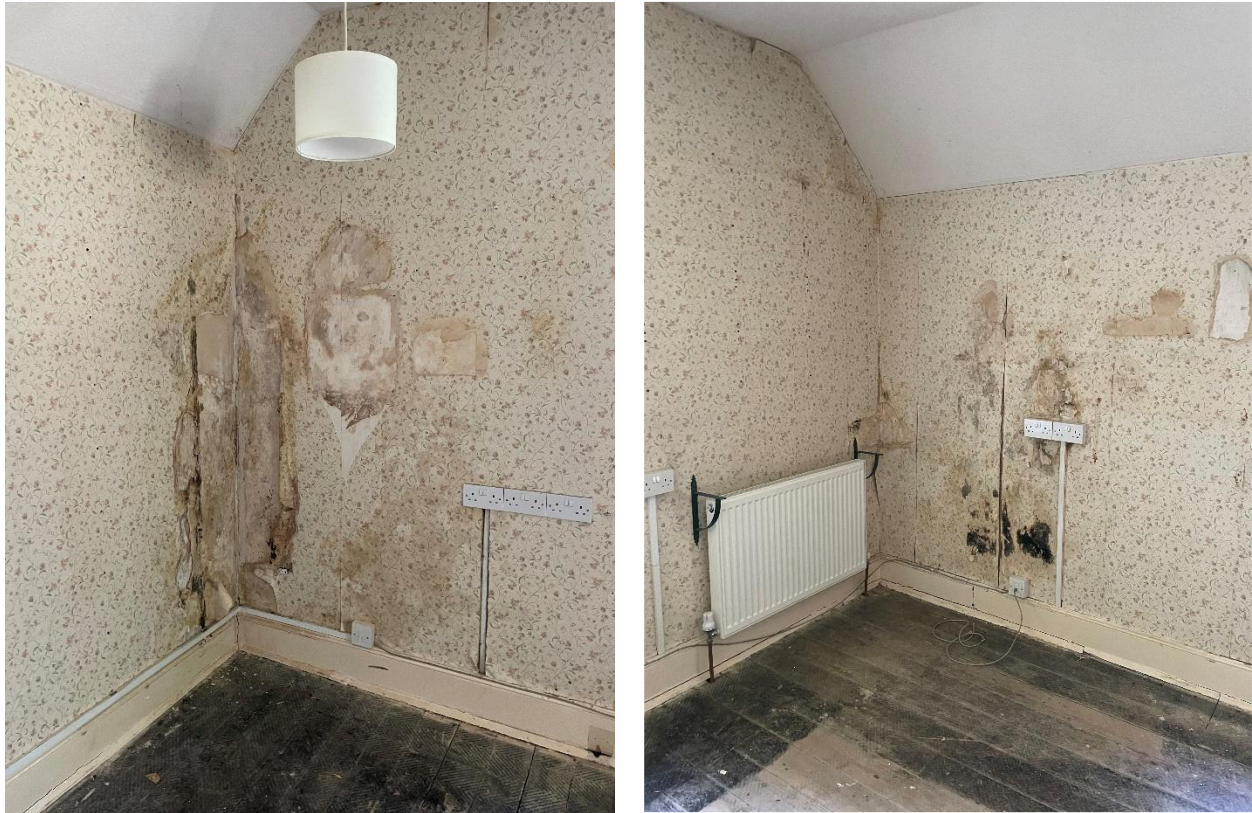
There is evidence of serious water ingress, particularly to the south and west facing rooms, which is thought to be largely related to the poor condition of the roof/parapet walls above. This has led to notable deterioration of the internal plasterwork and finishes. Polystyrene insulation has been added

in places, such as the west facing wall in Room 2, presumably in an attempt to either improve the thermal performance of the property and/or deal with the damp.

Figures 25 and 26 – There is serious water ingress at 1<sup>st</sup> floor level in Bedroom 1 primarily due to the poor condition of the roof.

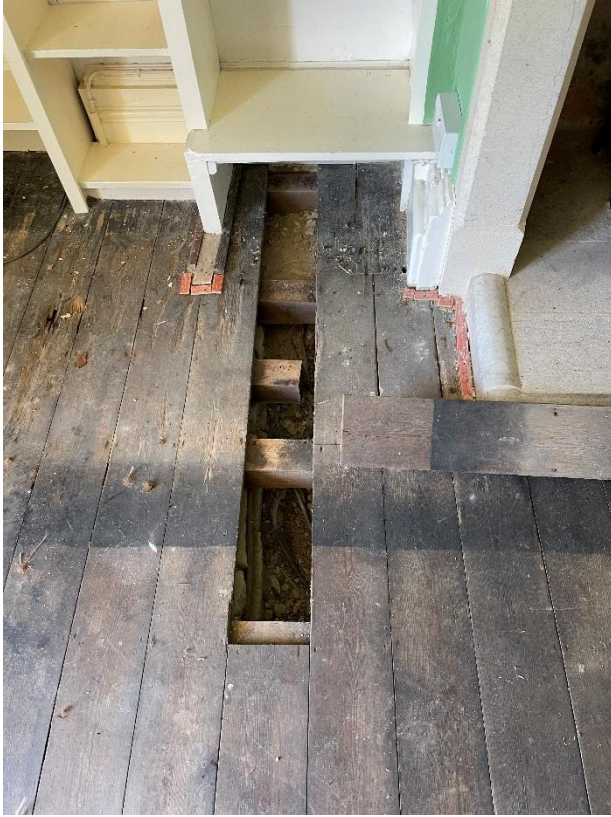
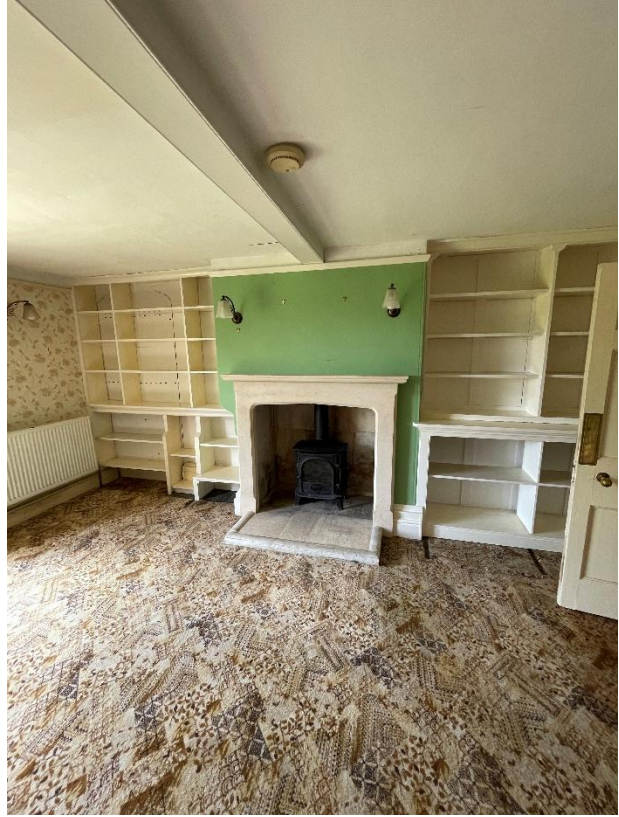
Figures 27 and 28 – pine floorboards have been lifted to show floor construction. Some fire places such as Room 3 (proposed kitchen) have been previously altered.

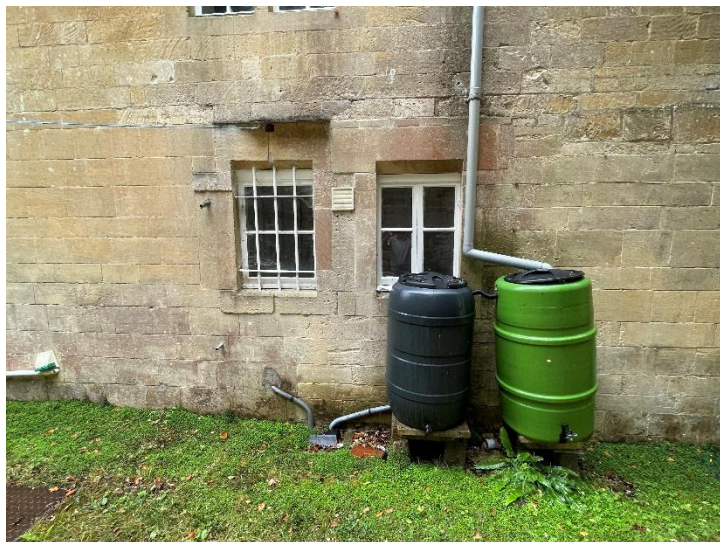
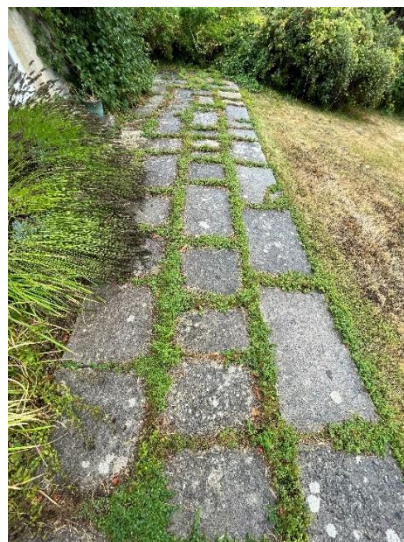
Figures 44 and 45 – Water butts to the northern elevation and concrete paving stones to the south elevation laid in 1938.

The only alterations proposed to the gardens involve a slight enlargement of the terrace to the south side of the house and replacement of the existing concrete slabs with new natural stone paving. By repairing the building and replacing inappropriate materials, the proposals will improve the aesthetic value and significance of the house and in so doing enhance the setting and character of the Cotswold National Landscape.

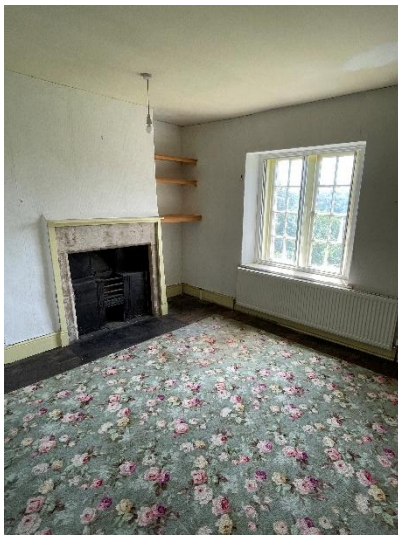
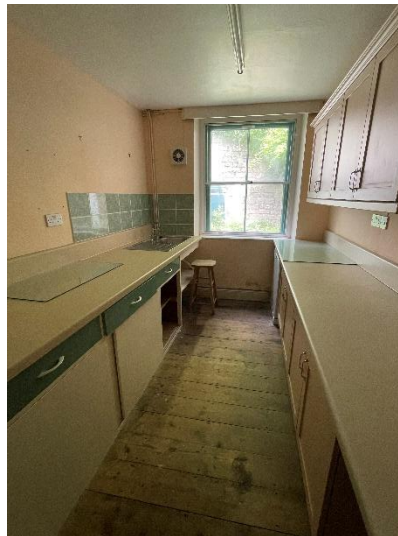
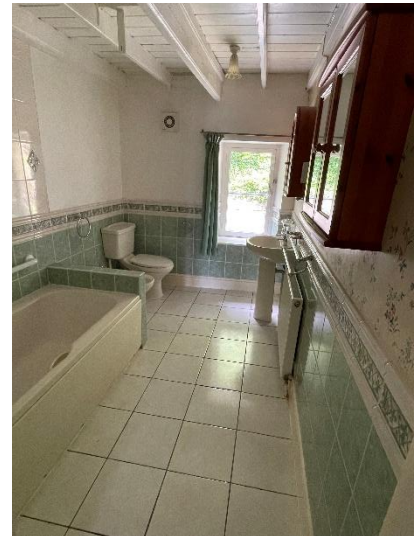
Figures 46, 47 and 48 – Although the house retains some historic features it has been unsympathetically modernized in places.

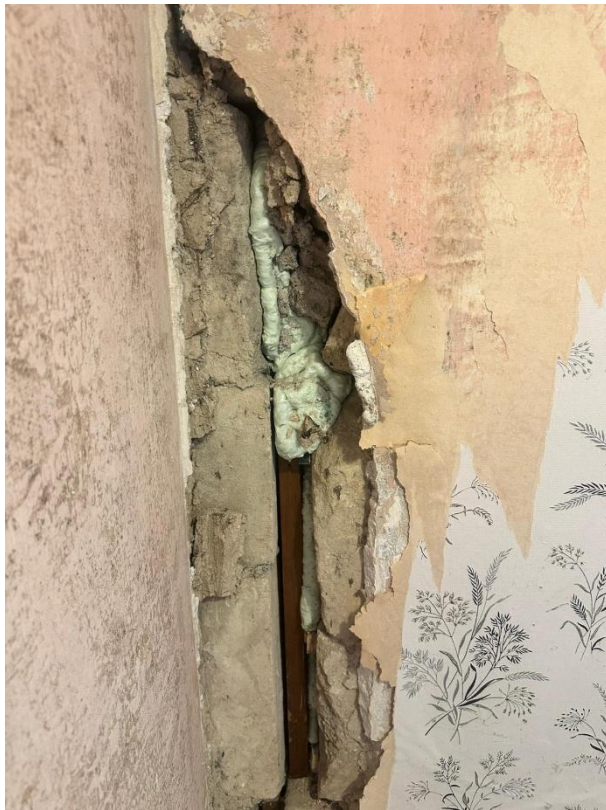
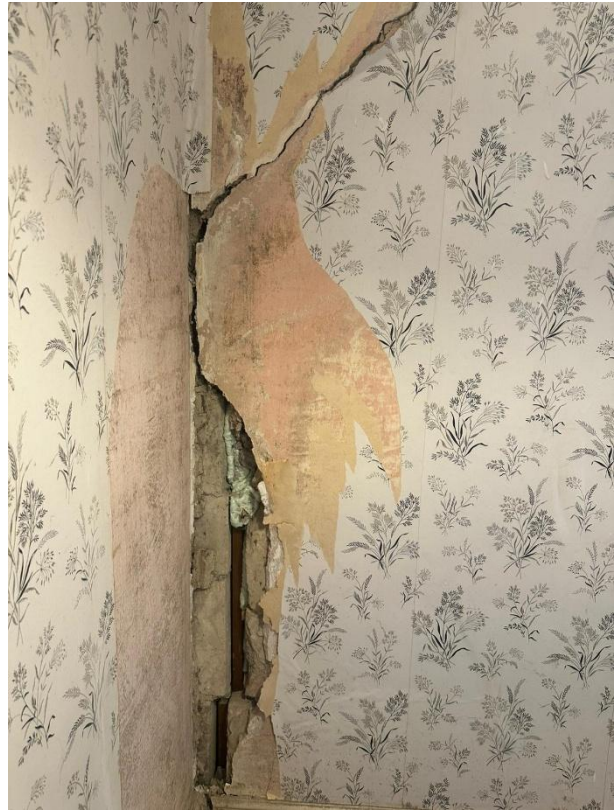
Figures 49 and 50 – The wall between Rooms 3 and 4 is in very poor condition and will require significant repairs.
