# PHOTOGRAPHIC RECORD - BEFORE, DURING AND AS CONSTRUCTED

90 Stratford Road, Salisbury, SP1 3JS

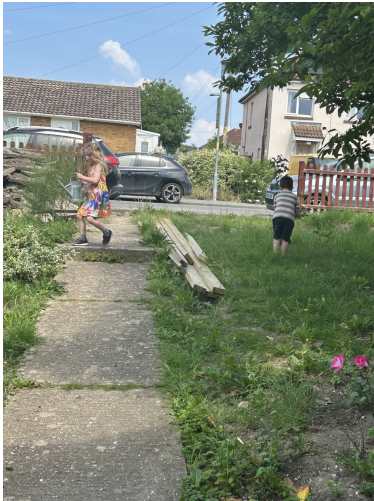
BEFORE - front garden prior to the works, showing lawn/soft landscaping and the existing concrete pedestrian path.

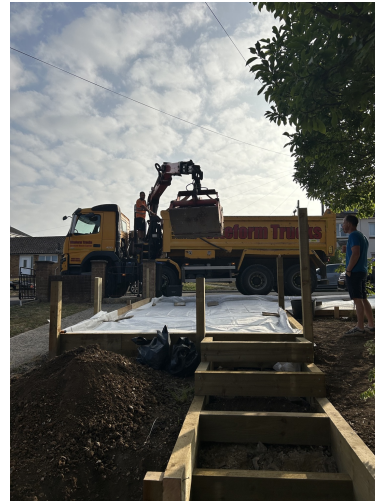
DURING WORKS - geotextile membrane, hardstanding formation, timber retaining work, fence posts and central steps/path.

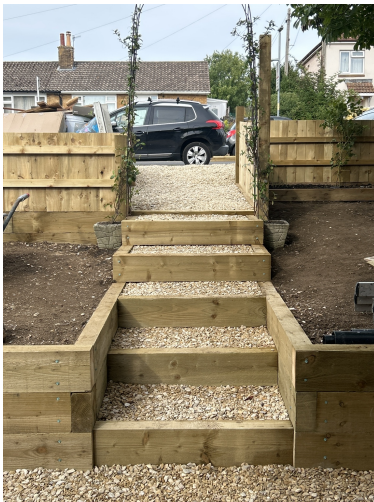
AS CONSTRUCTED - central stone steps/path and the pedestrian opening through the transverse timber fence.

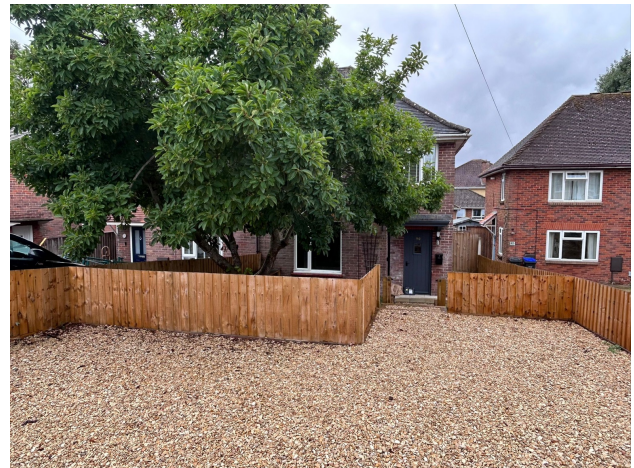
AS CONSTRUCTED - wide view from the hardstanding showing the transverse fencing, pedestrian opening and retained magnolia.

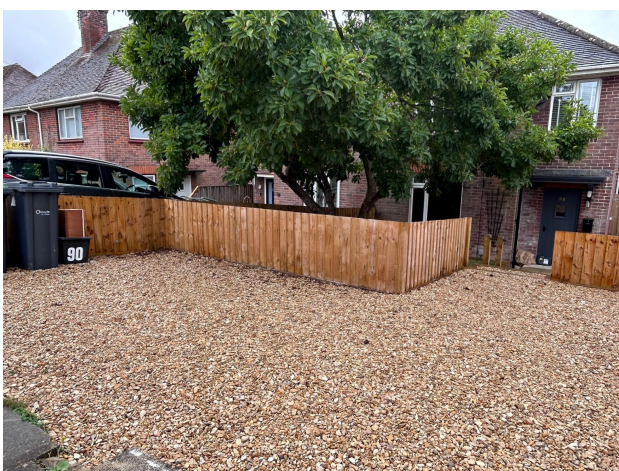
AS CONSTRUCTED - hardstanding/parking area and 900 mm timber fencing.

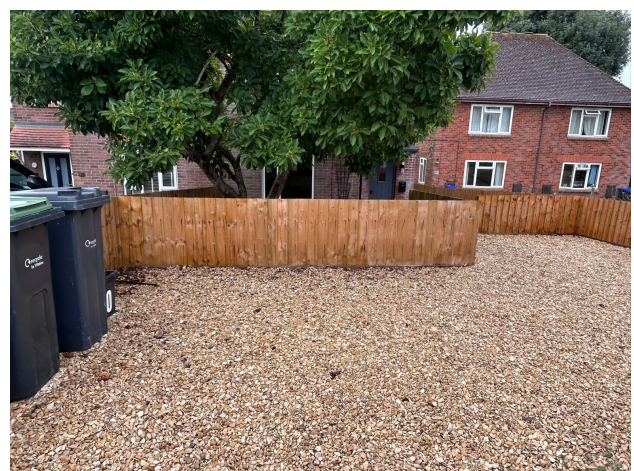
AS CONSTRUCTED - additional view of the permeable Cotswold buff stone hardstanding and timber fencing.
