# **Red House Barn**

## **Bat Report**

September 2026

**Red House Barn**  
**Ecology 9207**  
**Version 02**

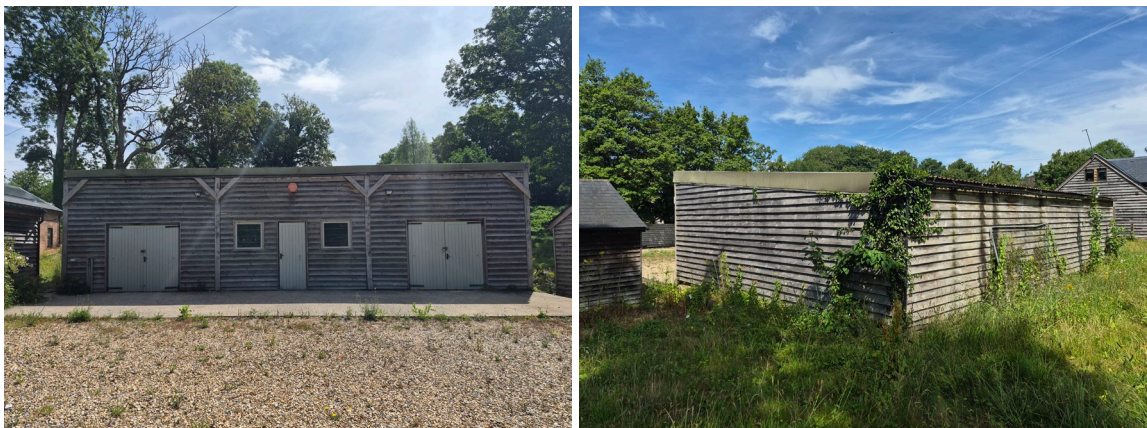
- 4.3 Building 1 is a single storey building with wood clad walls and a low angle pitched roof lined with corrugated metal panels. The building is split into three separate rooms, all accessed via doors on the western elevation as well as two central windows. There are no soffit boxes or fascia boards present, uPVC guttering is present on the eastern elevation (**Figure 4 and 5**).
- 4.4 The building appears to be quite new and is in good condition. The wood cladding on the exterior is well sealed, the doors and windows are tightly sealed and there are no crevices around the edge of the roof. Gaps are present directly underneath the corrugated metal sheeting on the eastern elevation (**Figure 5**).

**Figure 4 and 5:** Western and southeastern elevations of B1.

- 4.6 The building was assessed as having **negligible** potential to support roosting bats due to a lack of internal and external features, no void space available, and as no insulation is present and the building has a metal roof it is likely that the building suffers from severe temperature fluctuations throughout the day. Gaps are present underneath the corrugated metal roof, however the gaps underneath will suffer from severe temperature fluctuations and are considered to be unsuitable for bats.

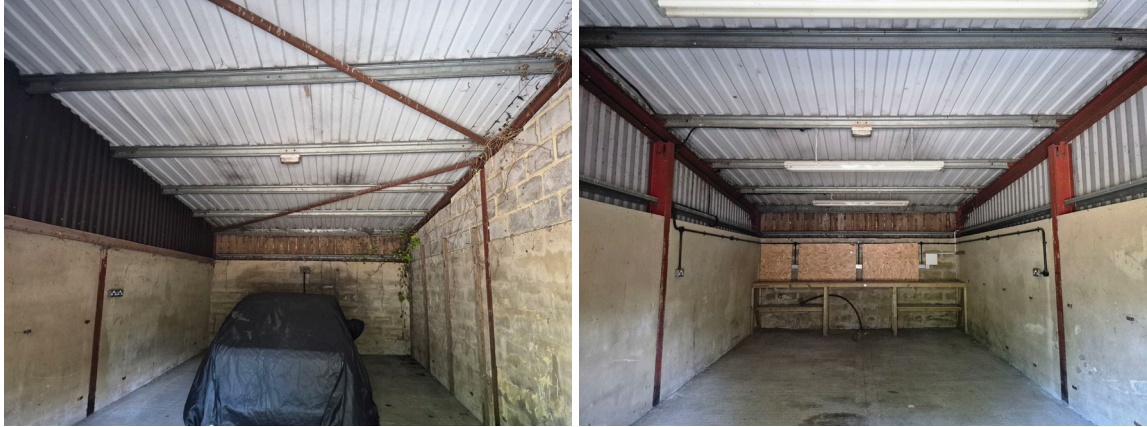
- 4.5 The building internals comprise bare breeze block walls as well as wooden boarding. The ceiling has no insulation and no voids are present. All the internal framing is comprised of metal. One of the rooms contains a vehicle, whilst one contains building materials and tools, and the third room is empty (**Figure 6, 7 and 8**).

**Figure 6 and 7:** Southern and central rooms within B1.

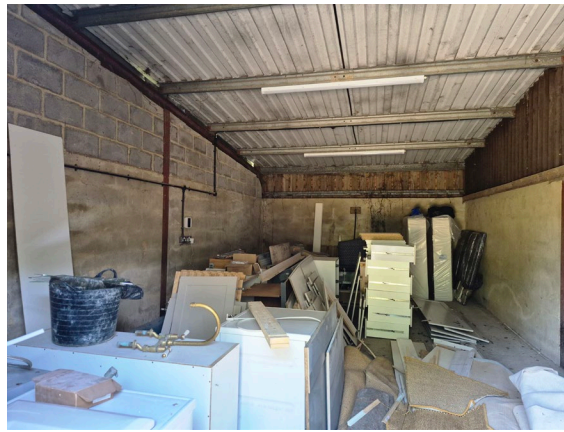
**Figure 8:** Northern room within B1.

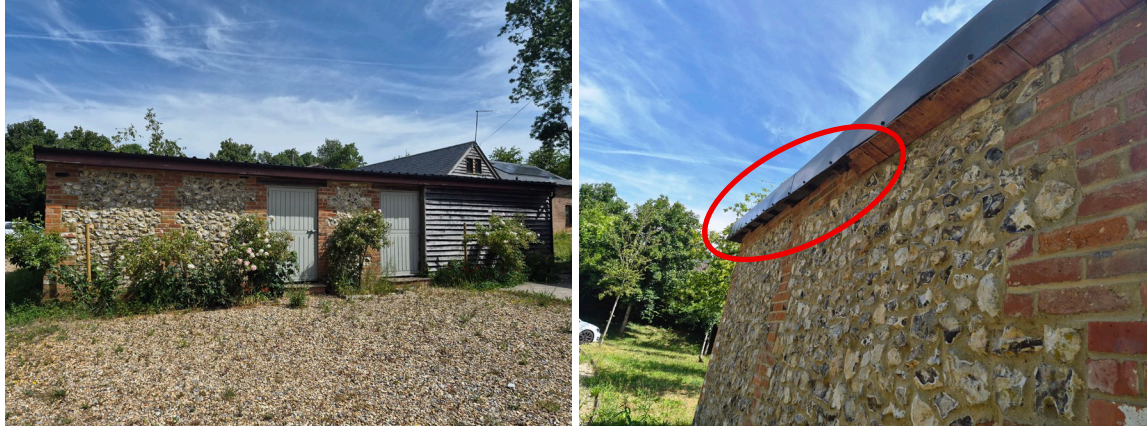
- 4.7 Building 2 is a red brick and stone walled single storey stable building with two separate stables (**Figure 9**). The building has a low angle pitched roof of corrugated metal sheeting, and has a wooden soffit on the western, southern and eastern elevations, and uPVC guttering on the southern elevation (**Figure 10**). A section of the wall on the southern elevation is lined with wood cladding but the remainder of the walls are comprised of red brick and stone.
- 4.8 The building is largely in good condition with no external features seen except for damage to the soffit box on the western elevation, where a section of the soffit has been damaged to the point that there is access into the soffit box (**Figure 10**).

**Figure 9 and 10:** Southern and western elevations of B2 showing damaged soffit.

- 4.10 Building 2 has been assessed as having **low** potential to support roosting bats due to the presence of the damage to the soffit box as well as the complexity of the internals of the building providing potential crevices roosts throughout the building interior. The building will require a single emergence survey in order to determine whether bats are roosting within the building.

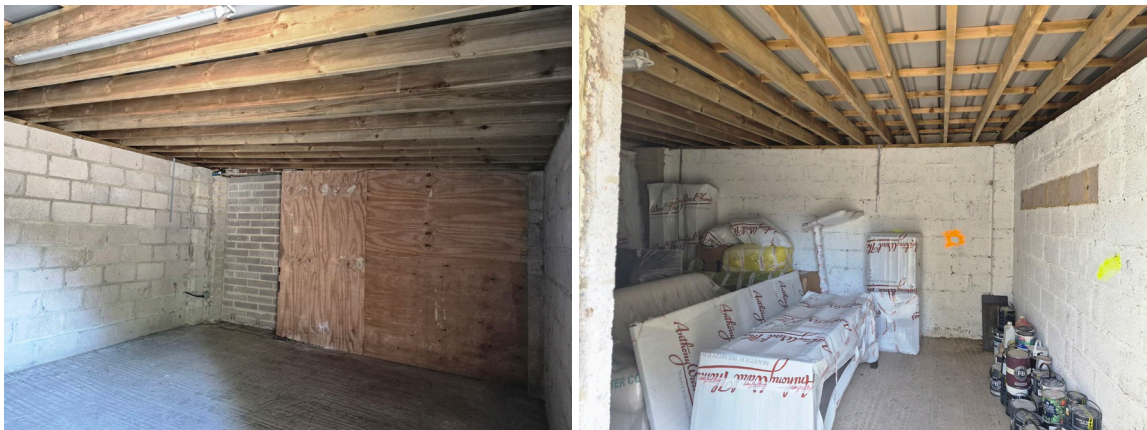
- 4.9 Internally Building 2 is comprised of bare breeze block walls and wooden joists. Gaps run along the length of the breezeblock walls providing crevices throughout the building, as well as providing access from one room to the other. The eastern room is empty whilst the western room contains building materials. There is no insulation present and no roof voids, with the underside of the corrugated metal roof visible in between the wooden joists (**Figure 11 and 12**).

**Figure 11 and 12:** Eastern and western rooms within B2.

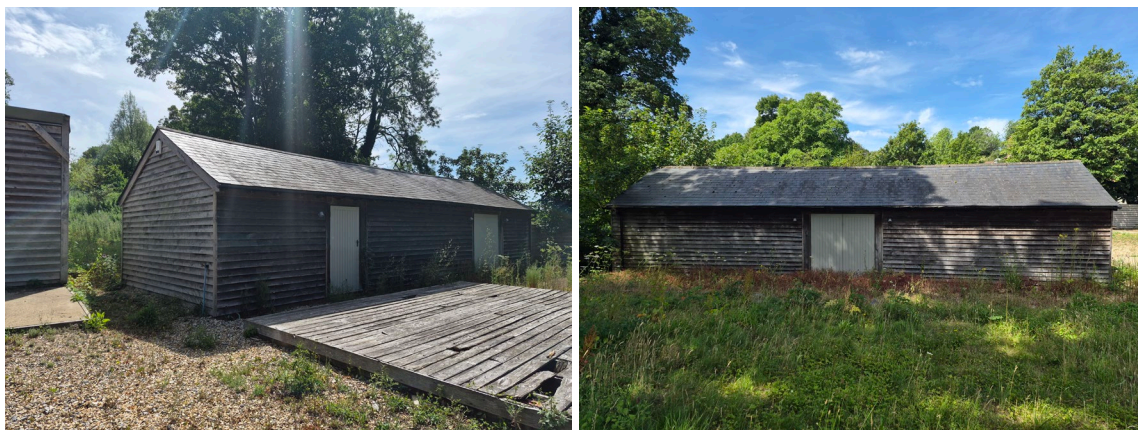
- 4.11 Building 3 is a long single storey barn comprising a pitched roof with grey slate tiles and wood clad walls on all elevations. The building is new and is in good condition with the roof tiles and wooden cladding all well sealed, with no missing tiles or warped cladding present (**Figure 13 and 14**).

**Figure 13 and 14:** Northwestern and eastern elevations of B3.

- 4.13 The building has been assessed as having no potential to support roosting bats as there are no external or internal features, no access points, and the building contains no void space.

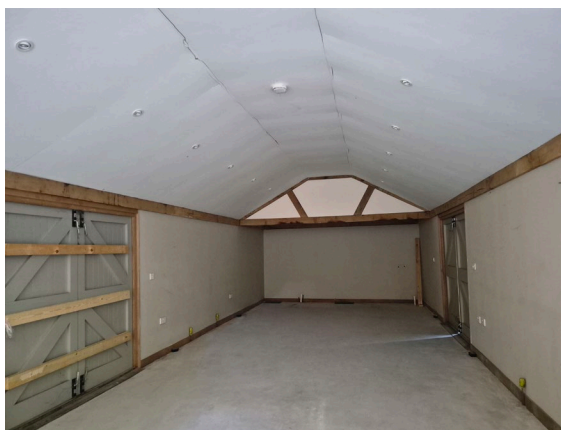
- 4.12 Internally the building comprises a single room, with bare walls and a plastered ceiling. There is no roof void present, and no internal features, or furniture present within (**Figure 15**).

**Figure 15:** Internal views within the eastern section of the building.
