## 534 - 137 High St Marlborough

## Heritage Statement

15 April 2025

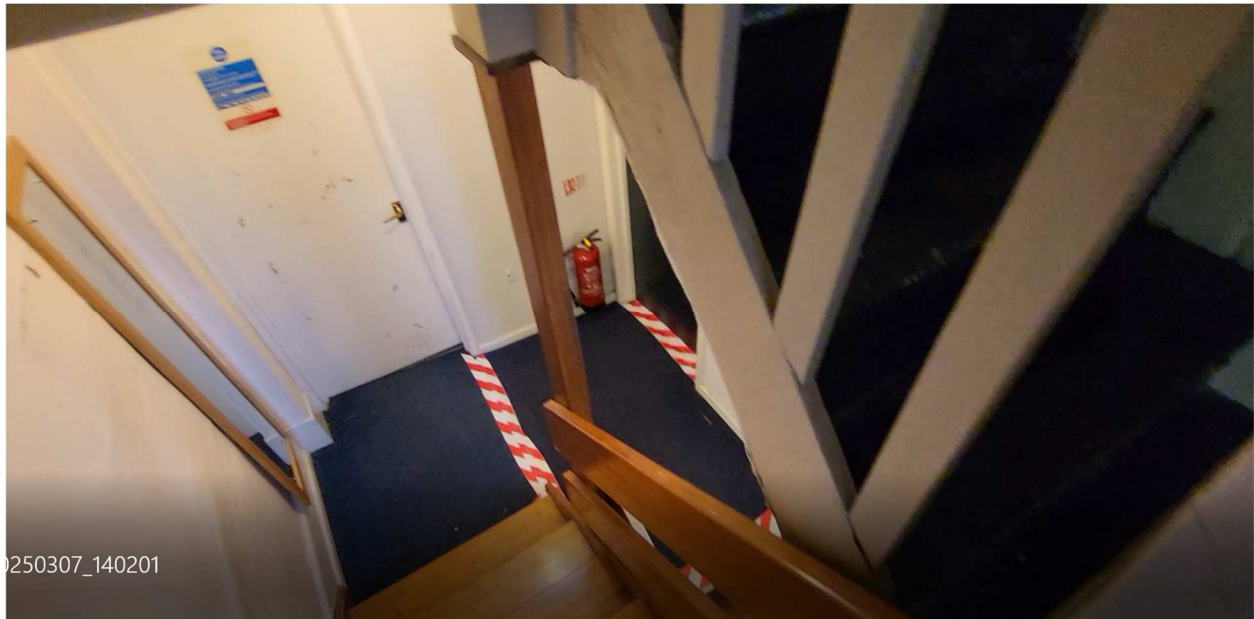
The modern stairs continue up to the third floor, half landing, as shown in the image overleaf. At the landing it dovetails into the historic fabric. To summarise most of the staircases are not original.

*Third floor the only remaining part of the original staircase left RHS.*

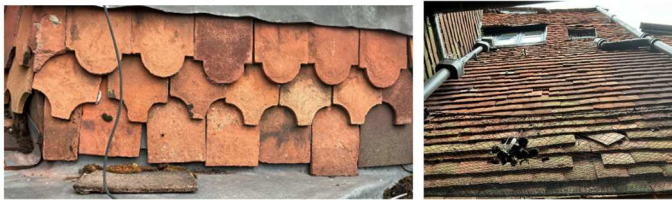
*Lose weathered tiles*

- Renewal of “Club and Fishtail” and plain vertical hanging tiles, along with supporting battens etc., using matching materials. See image below.

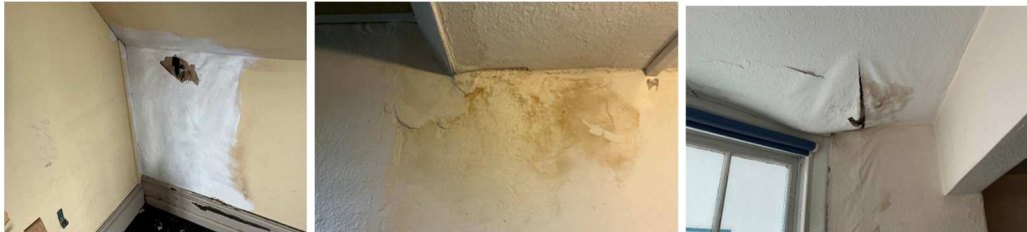
*Roof leaks*

- Repairs to roof leaks and making good internal water damaged surfaces.

The removal of standing water in the basement will help preserve the historic fabric. Replacing the leaking roof of the front bay window with a traditional lead covering will help restore the building to its original construction. The replacement vertical tiles will match the original in both material and appearance, and other works to address water ingress will further preserve the historic fabric of the building.

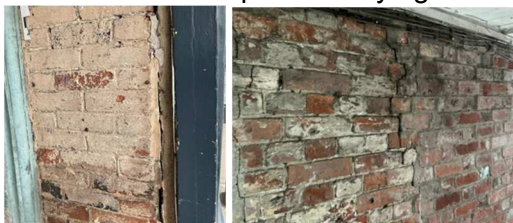
*Minor work to wall on Chandler Yard – helifix repair*

- Minor structural repair of bellying and cracked walls

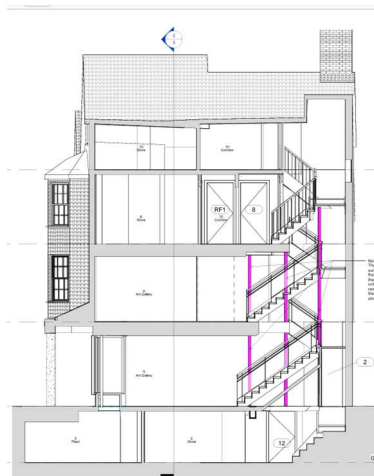
Wiltshire Fire Brigade has reported that the building is unsafe. The key issue is the open staircase, which allows fire and smoke to travel unimpeded vertically between the floors (see image below). From the image, it is clear that there is no containment for the staircase. In the event of a fire, the chances of escape from the upper floor will be extremely limited. There is only one practical solution to this problem: to encase the staircase in a protected vertical shaft.

*Existing arrangement staircase*

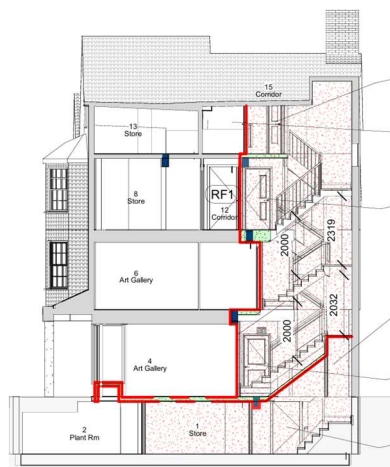
*Proposed arrangement*

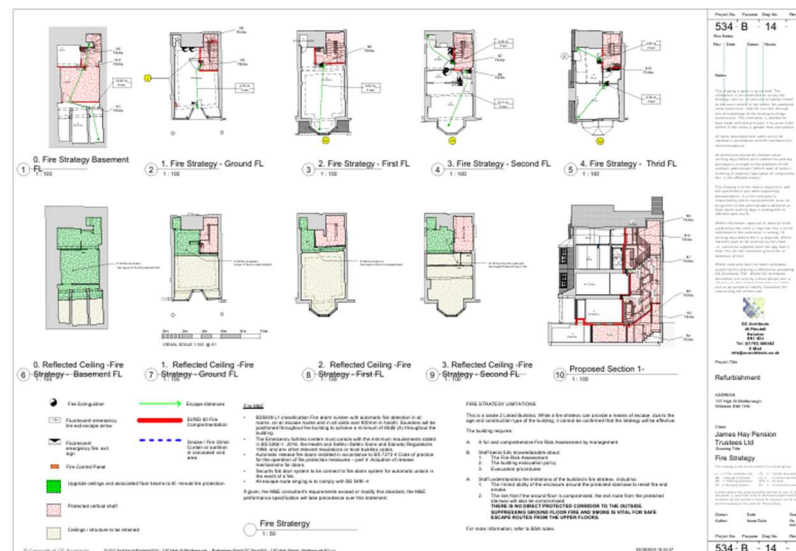
The Fire Engineer has confirmed that this is the only acceptable solution. From the Fire Strategy Drawing 534/B/14 (see image below) only the modern ground and first floor staircases need to be replaced with winder stairs.

To create a protected shaft the red-shaded area in the image, the following work will be required:

- New fire compartment partitions and associated doors will be required on the ground, first, and third floors and walls on the second floor may need upgrading.
- The existing modern doors, which also forms part of the protected vertical shaft, will either receive a 30-minute intumescent paint coating or be replaced with a fire doorset.
- The vertical shaft fire walls do not align. To make the shaft vertically contiguous, the ceilings will also require upgrading to a 60-minute fire rating. The scope of this work is defined by the green-shaded area in the image.
- To create a safe exit route from the shaft to the building's exit point, the existing modern basement plasterboard ceiling will also need to be replaced with 60minute fire rated surface.
