## Wiltshire Council Planning Consultation Response

**Application No:** PL/2026/01029  
**Retrospective Application for replacement/ modified/new/windows and doors, internal works to include new partitions, staircase, recovering of roof surfaces and associated works**  
**Penleigh Farm, Fairwood Road, Dilton Marsh, Westbury, BA13 4EB**

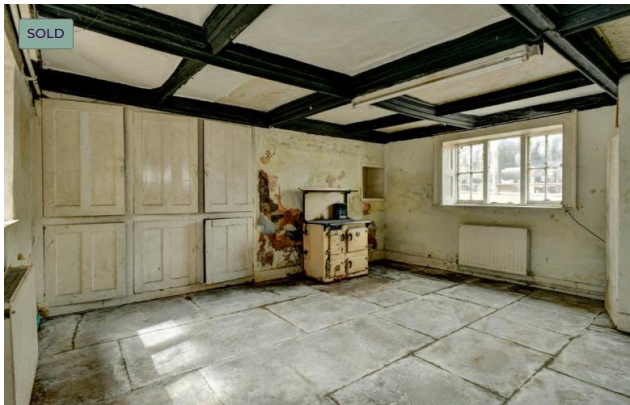
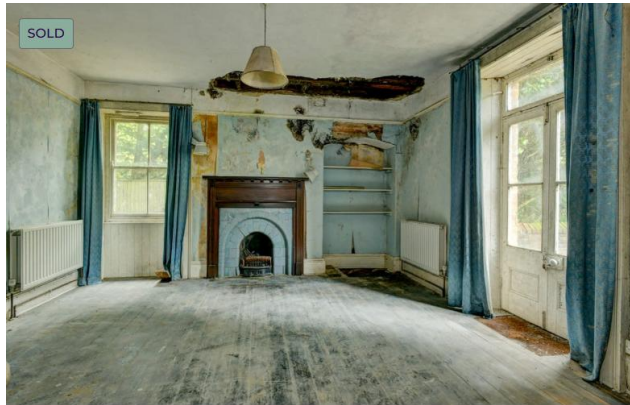
It is understood that the property had been vacant for a number of years, and has been subject to arson attacks. The sales details provide some images on the condition of the property. This shows that there was issues of rot, presumable from water ingress and poor maintenance. As part of the application, a Photographic Survey was provided. This shows that some fire surrounds were removed, some glass in the windows is smashed, or boarded, that there are localised areas of damage through arson and that some

stripping out has occurred. However, there remains some architraves, skirting boards, plaster (and wall paper) on walls and plaster finish to the ceilings, and complete floors and some fire surrounds. It is acknowledged that the building was not habitable at the time of purchase, and that works were required to bring the building back to a habitable condition.

Both taken from the Carter Jonas website - [Farm for sale in Penleigh, Fairwood Road, BA13 : Bath : BTR230014](#)

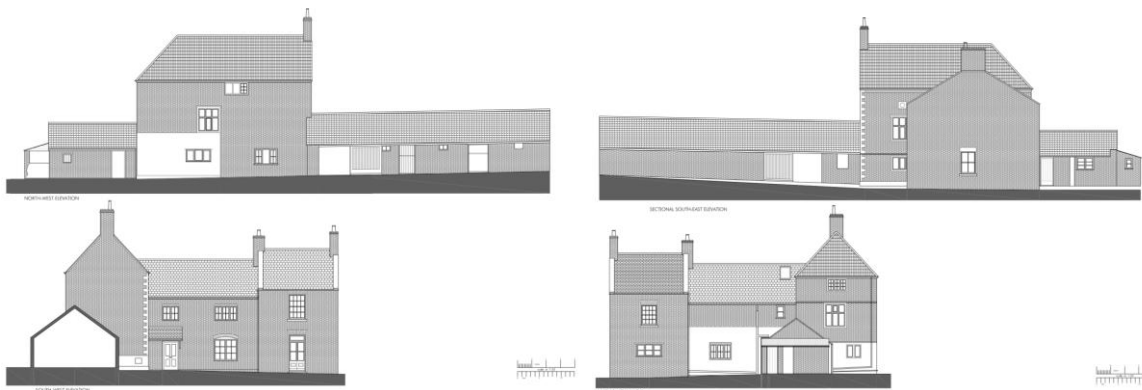
Previous 'existing' elevations.

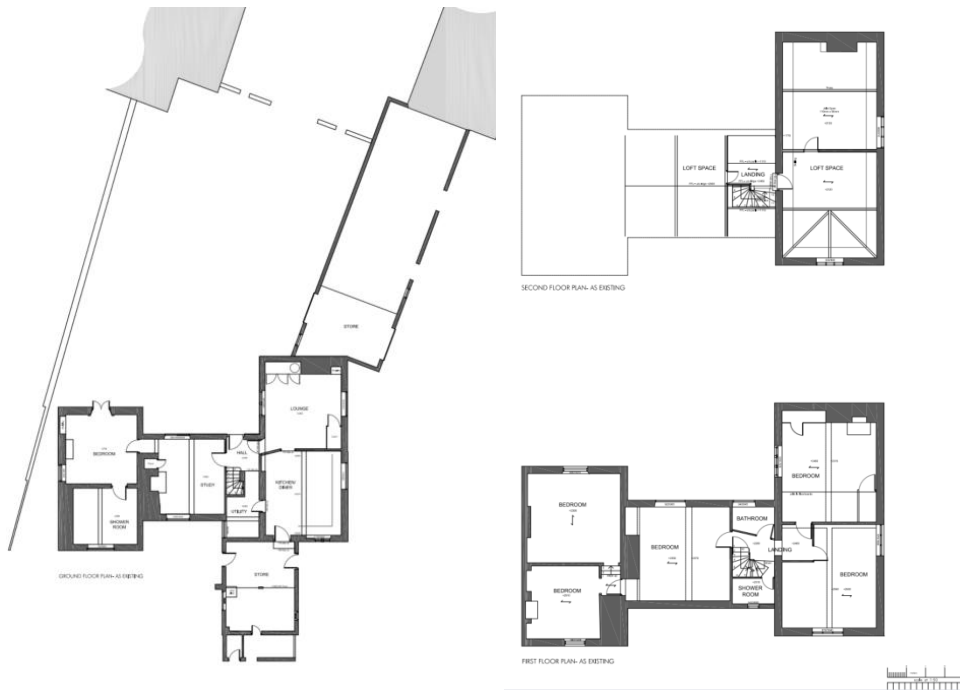
The 'existing' floor plans.

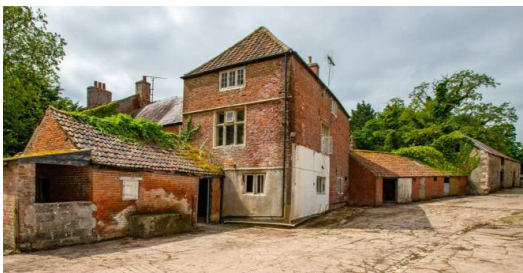
The replacement of the roof covering should respond to the existing roof covering, and samples should have been provided. As shown on the estate agents' photo (below), there is a mix of roof covering, including Bridgewater tile. It is understood that works have only been undertaken to part of the roof (slate) and therefore it is presumed that not other works to the tiled roof covering has been undertaken. There is a concern that if the building is in as poor a condition as stated, then the building is not watertight, and therefore temporary works (such as scaffold 'top hat', or similar) should be installed to protect the building.

*Estate Agent (Carter Jonas) image of the property on the sales details.*
