# **Arboricultural Impact Assessment**

## **Colerne Industrial Park, Bath Road**

**Report Reference Number: 260901-1.1a-CIP-AIA-HB**

**Report Title:** Arboricultural Impact Assessment

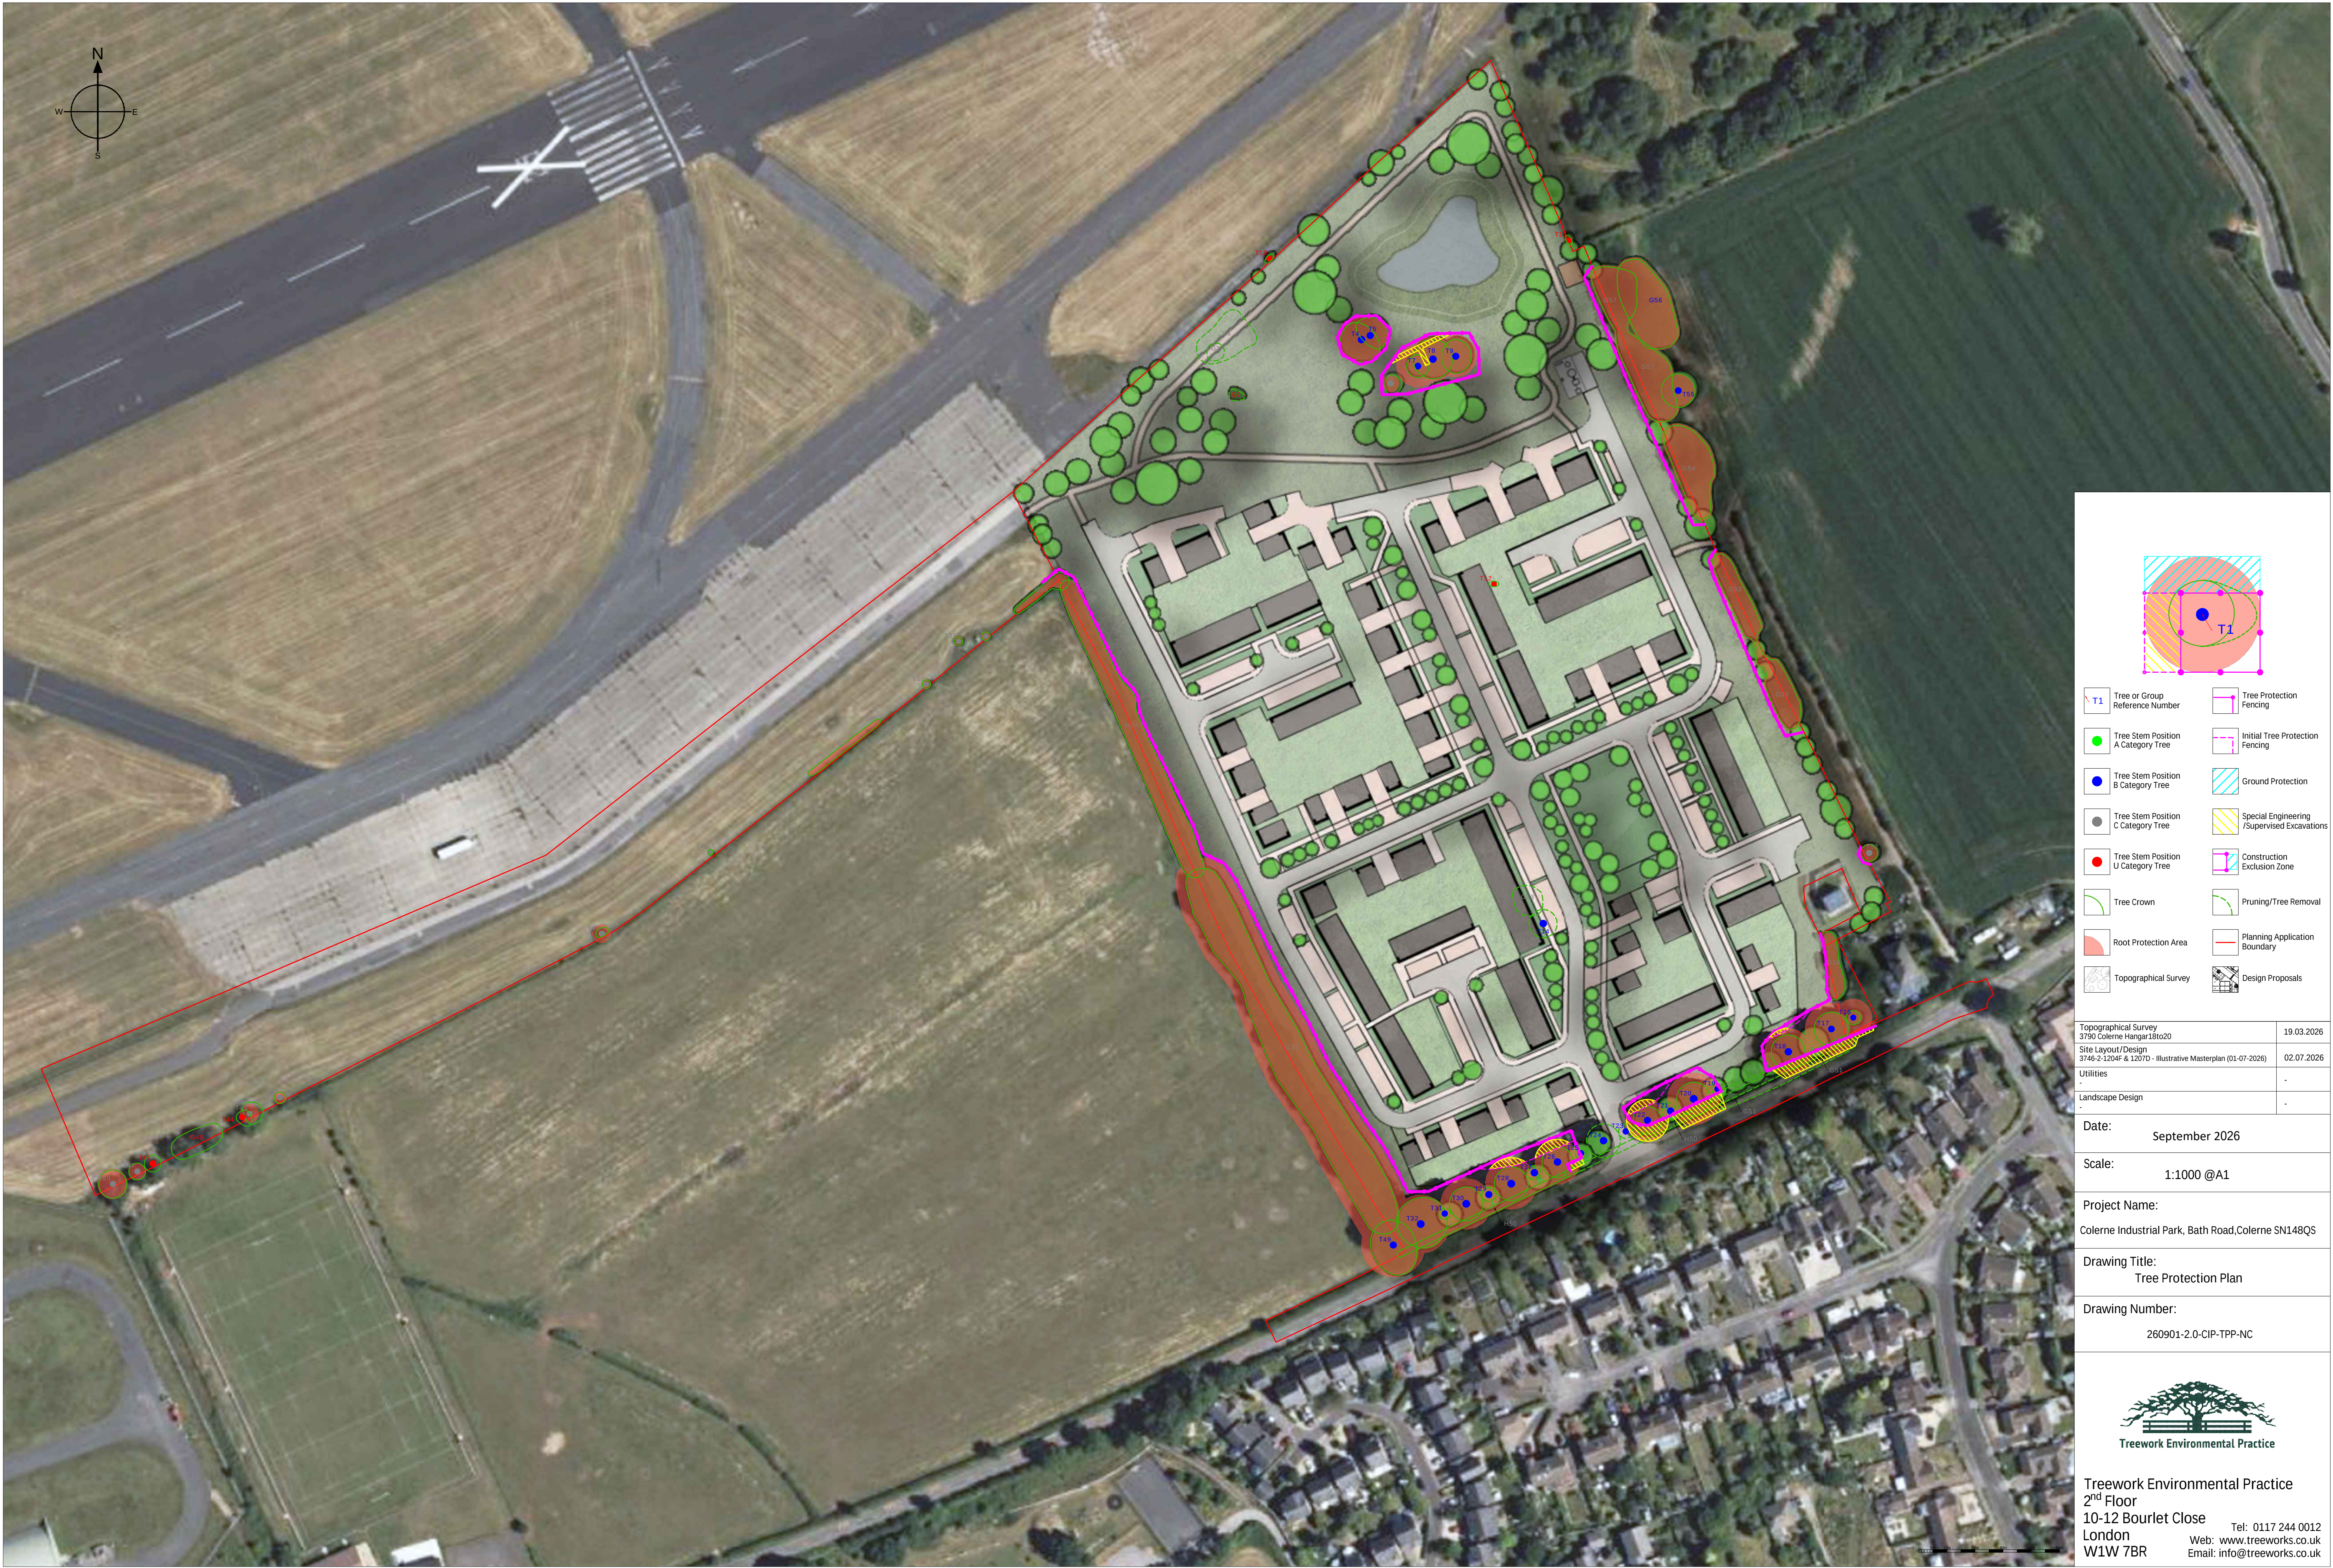
### **Tree Protection Plan**

- 4.1.4 Adjacent to T18, T22, T26 and T28 an Initial Tree Protection Fence is shown in Appendix A. As part of the RPA has an existing hard surface this can be used for access during site clearance. Once the existing hard surface has been removed the tree protection fence must then be realigned to ensure the full RPA on the north of the trees is fully protected during construction.

- 4.2.2 The removal of existing hard surfacing, within the RPA of retained trees (T7, T8, T18, T22, T26 and T28), could result in direct and indirect damage to roots if not carried out carefully. Providing these areas are removed in accordance with a detailed Arboricultural Method Statement and supervised by the project arboriculturist, damage to roots and tree health can be kept to acceptable levels. Ways of working to minimise harm would include position and types of plant and machinery used, depth of excavation, type of infill material and site supervision.

- 4.2.3 The proposed new footway and road widening within the RPA of retained trees (T17, T18, T20, T22 and T26) could result in direct and indirect damage to roots and affect tree health if not carried out carefully.

- 4.2.5 Principles that the detailed design should follow are to avoid excavation, have a permeable and porous structure that allows gaseous exchange, and where possible have a permeable wearing course to allow gaseous exchange and water percolation to underlying roots. Provided a form of no-dig construction can be achieved, probably using a cellular confinement system, and is installed in accordance with a detailed Arboricultural Method Statement, damage to roots and tree health could be kept to acceptable levels.
