## Phase I Geo-Environmental Desk Study Report

COLERNE INDUSTRIAL PARK,

Report Ref: B5482/25/DTS

February 2026

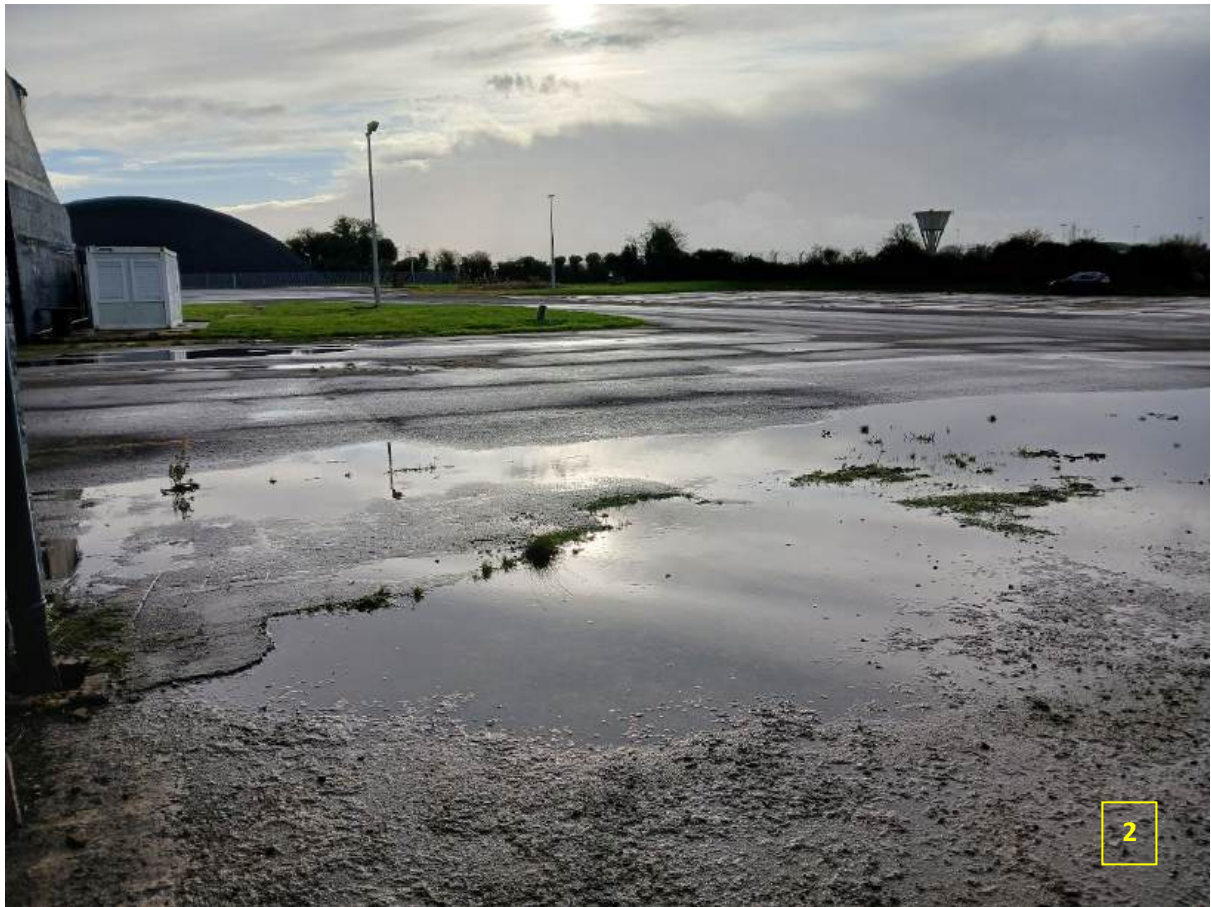
Area in front of hangar 18 with indications of surface water flooding (facing southwest)

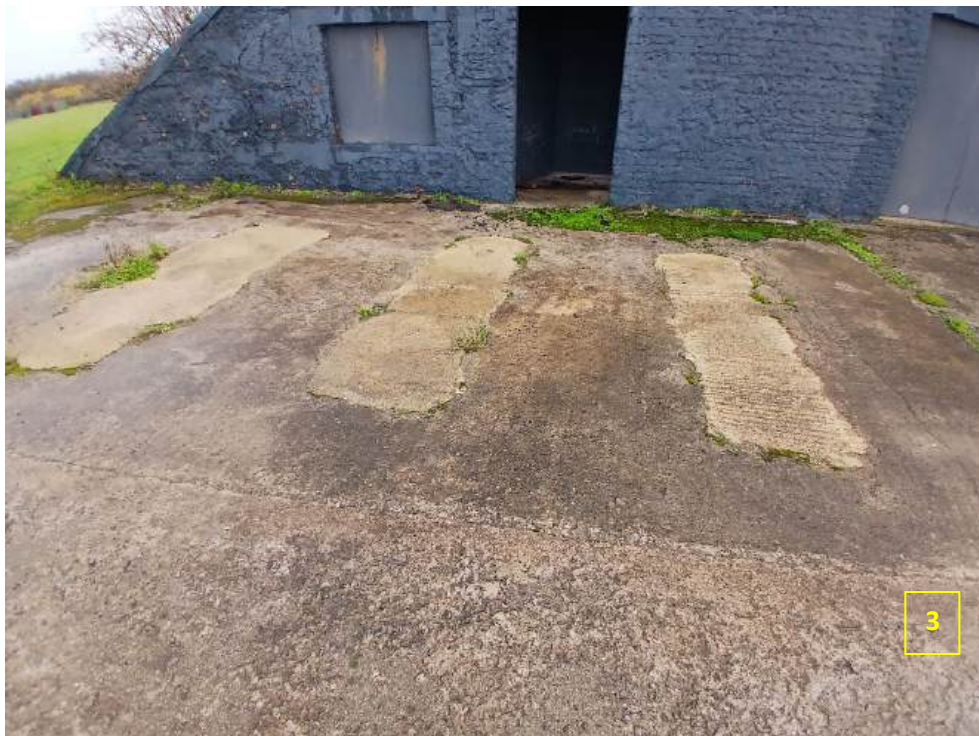
Scarring in concrete in front of hangar 18 (facing east)

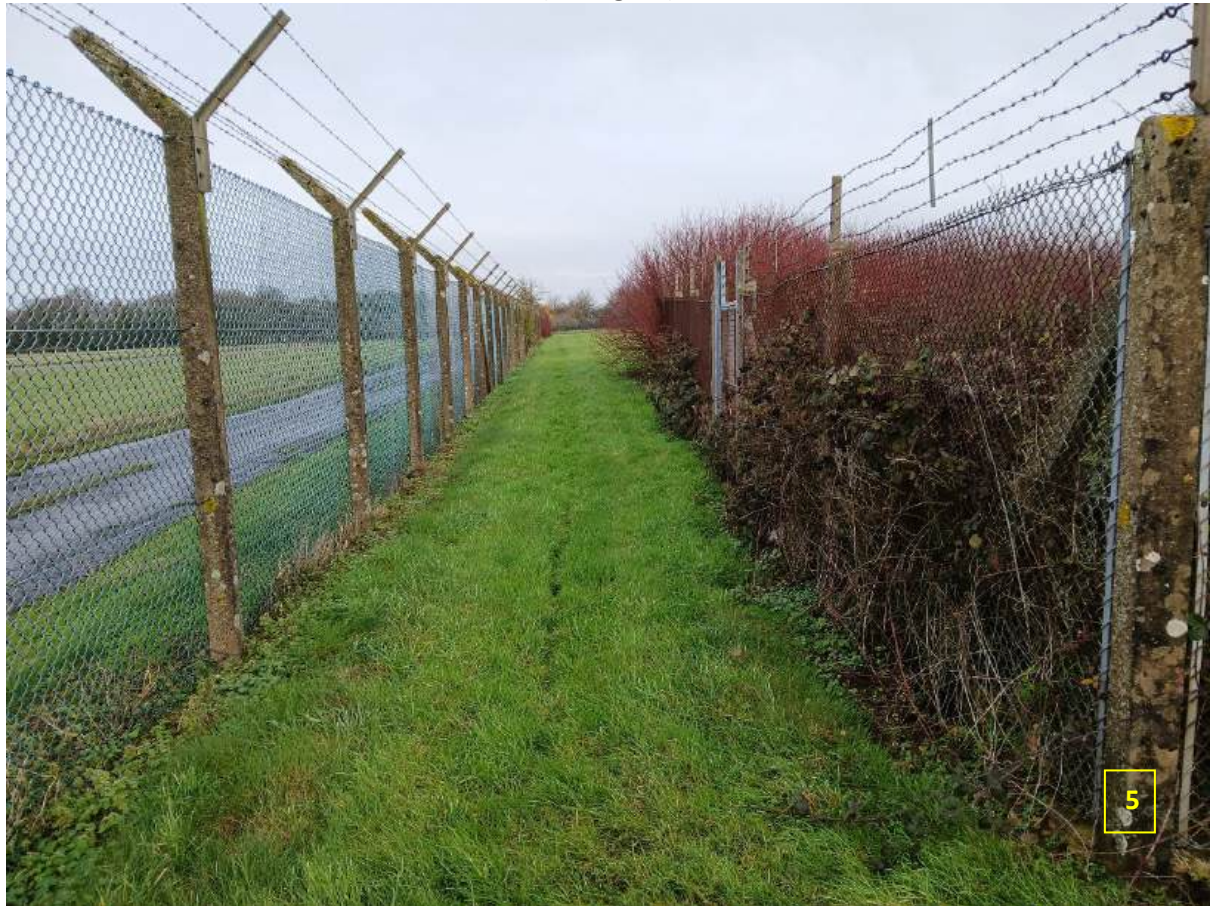
**Border fence to airfield (left) and fenced off depression to possible former sewage tank (right)  
(Facing NE)**

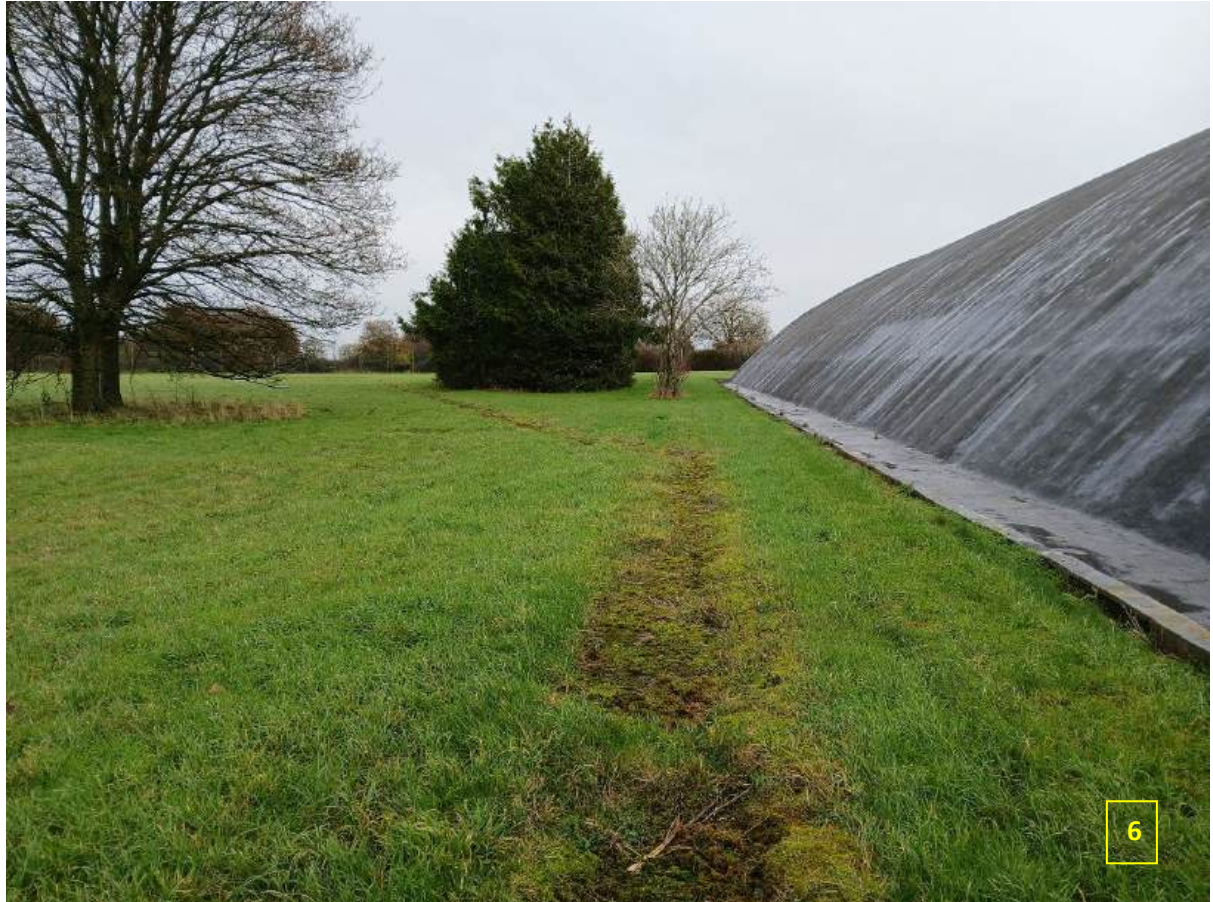
**Overgrown concrete path alongside hangar 18 (Facing E)**

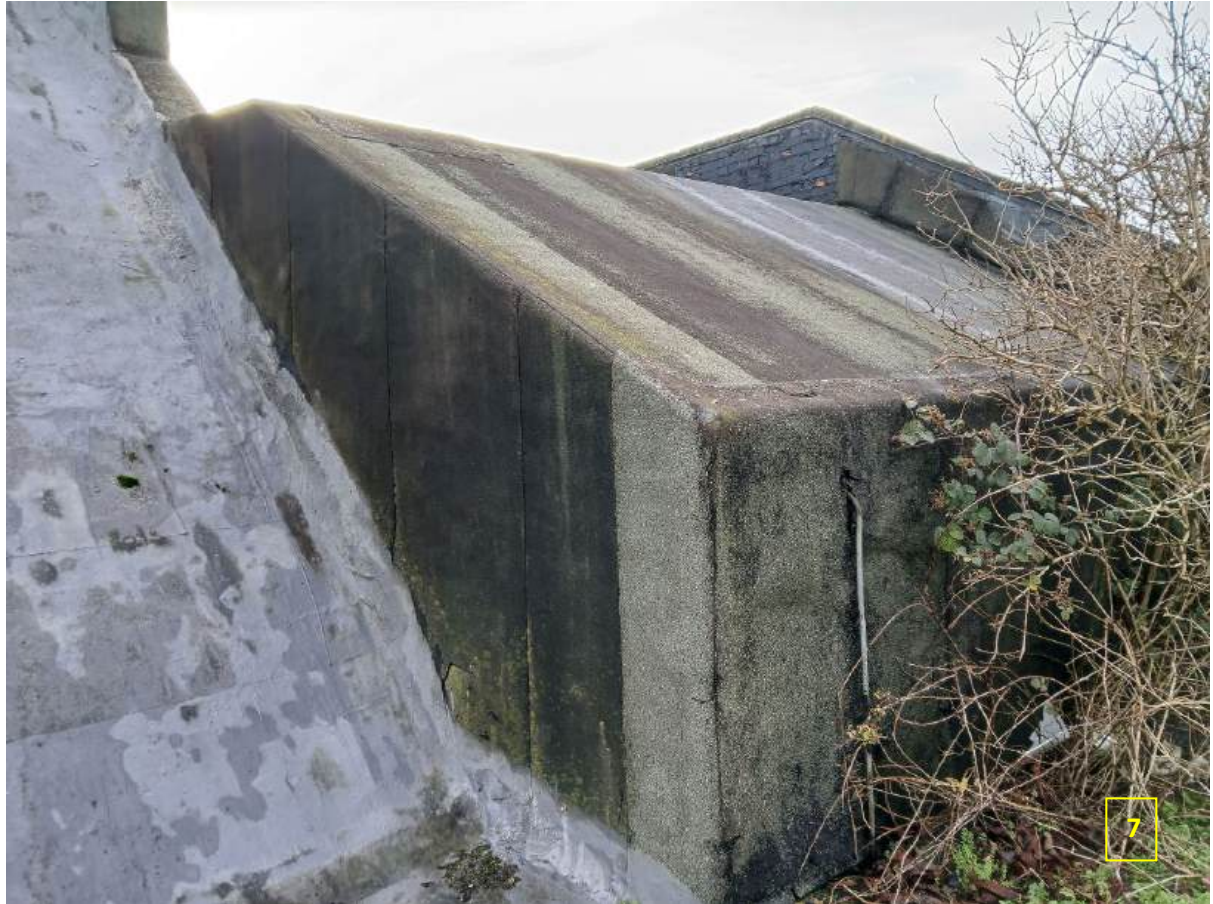
Side building at front of hangar 18 covered with mineral roofing felt (possible bituminous?) (Facing NW)

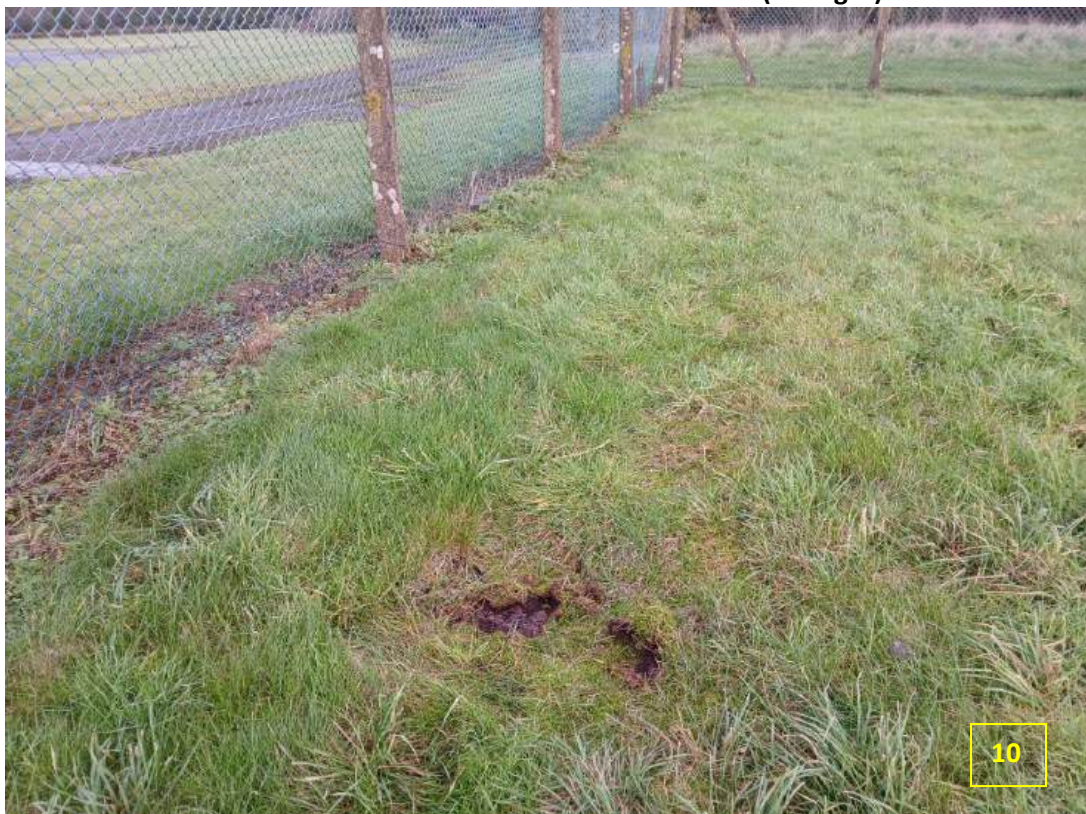
**Concrete obstruction at airfield border fence (Facing N)**

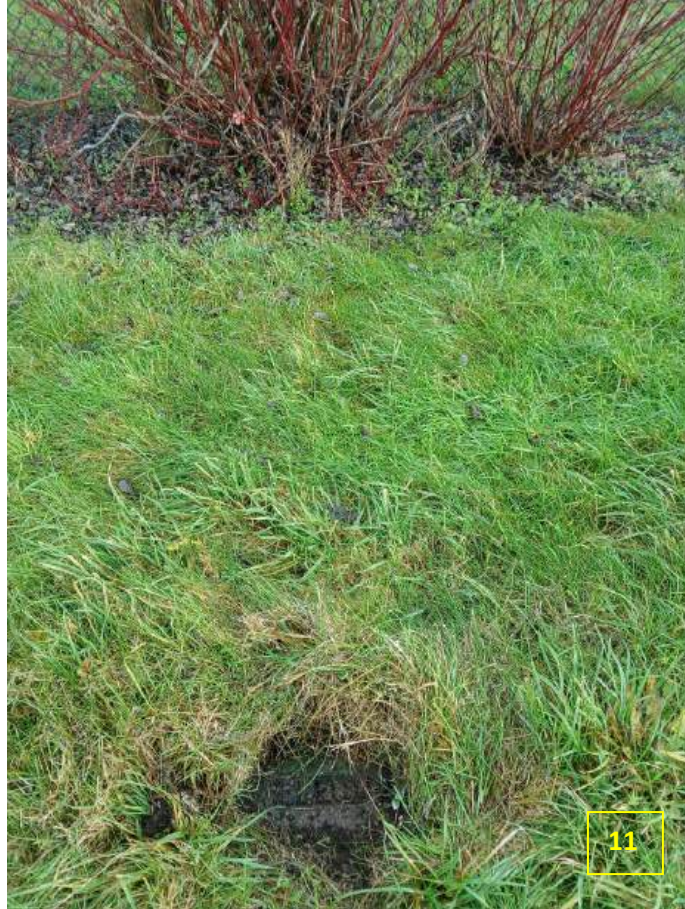
Overgrown electric warning brick parallel to fence line (Facing E)

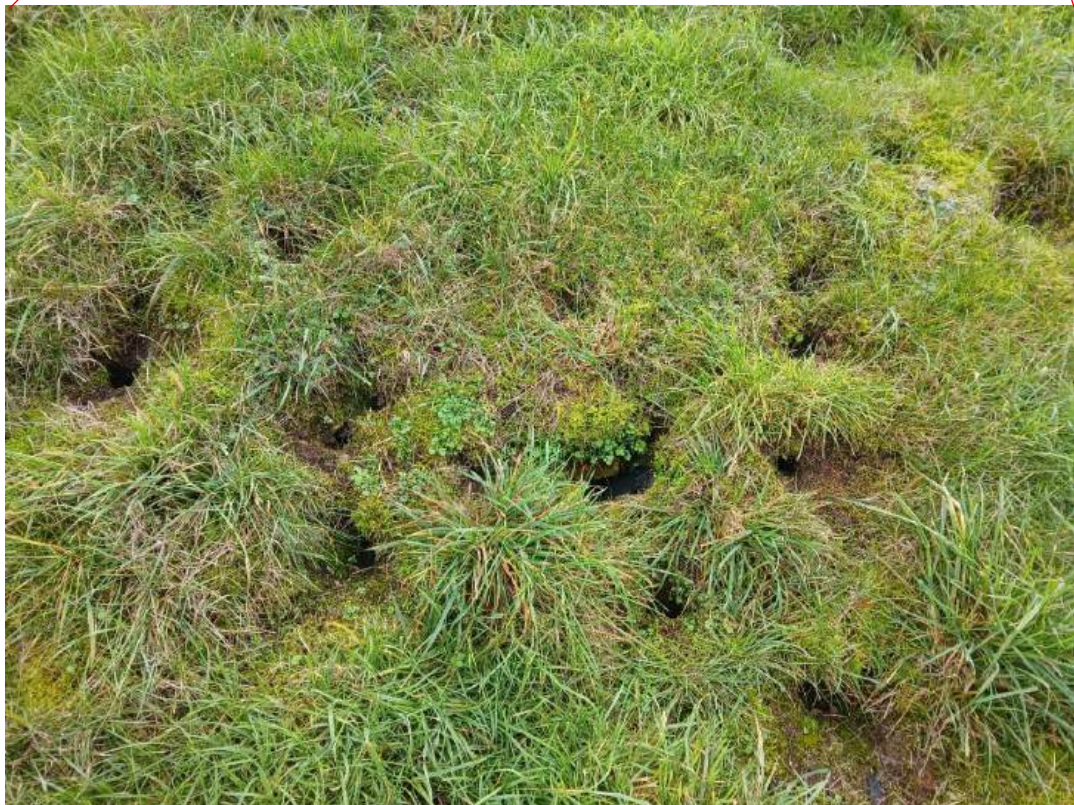
**Several random holes in embankment**

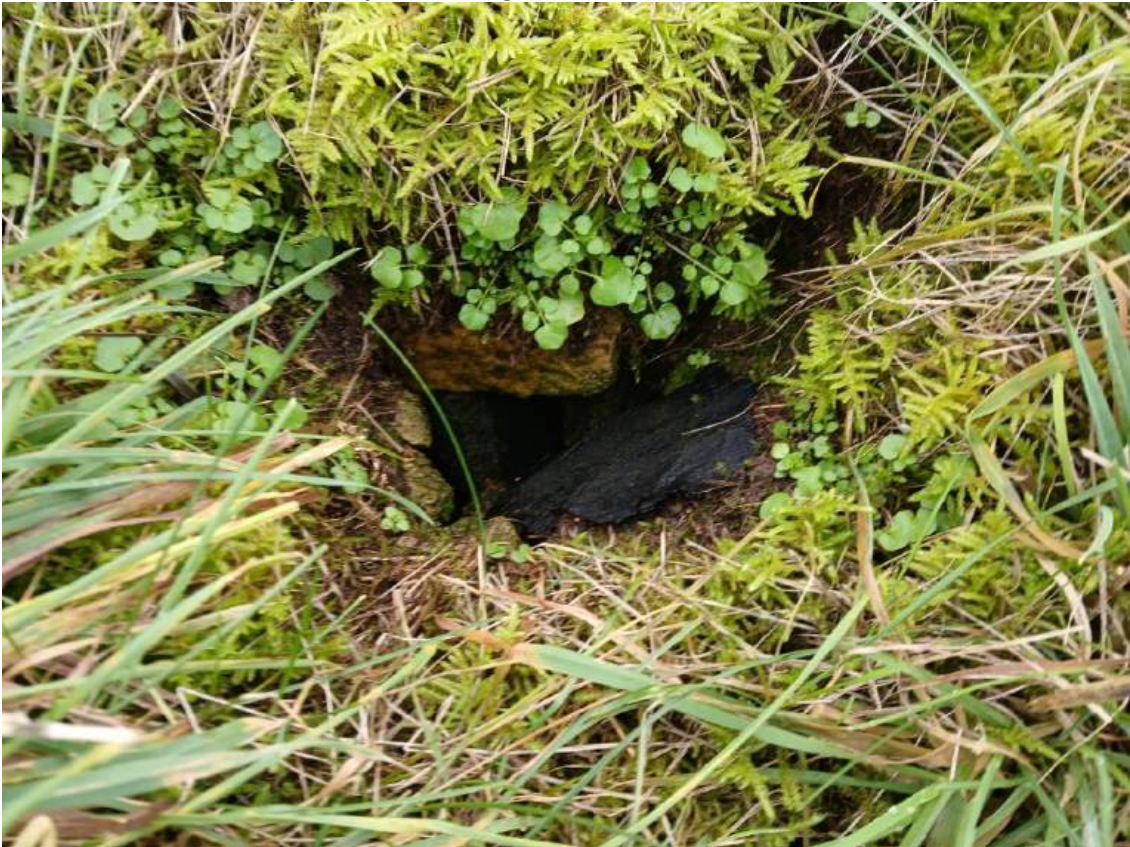
| | <p><i>Several manhole covers on site are in fair to poor condition and might suddenly collapse when stepped on (only applicable for covers within grassed area).</i></p> <p><i>Parallel to the southern side of hangar 18 is a possible buried concrete feature of unknown purpose which shows signs of possible collapse at 1 location (several small holes in the grass).</i></p> |

**Possible locally collapsed underground structure. Black membrane pieces.**

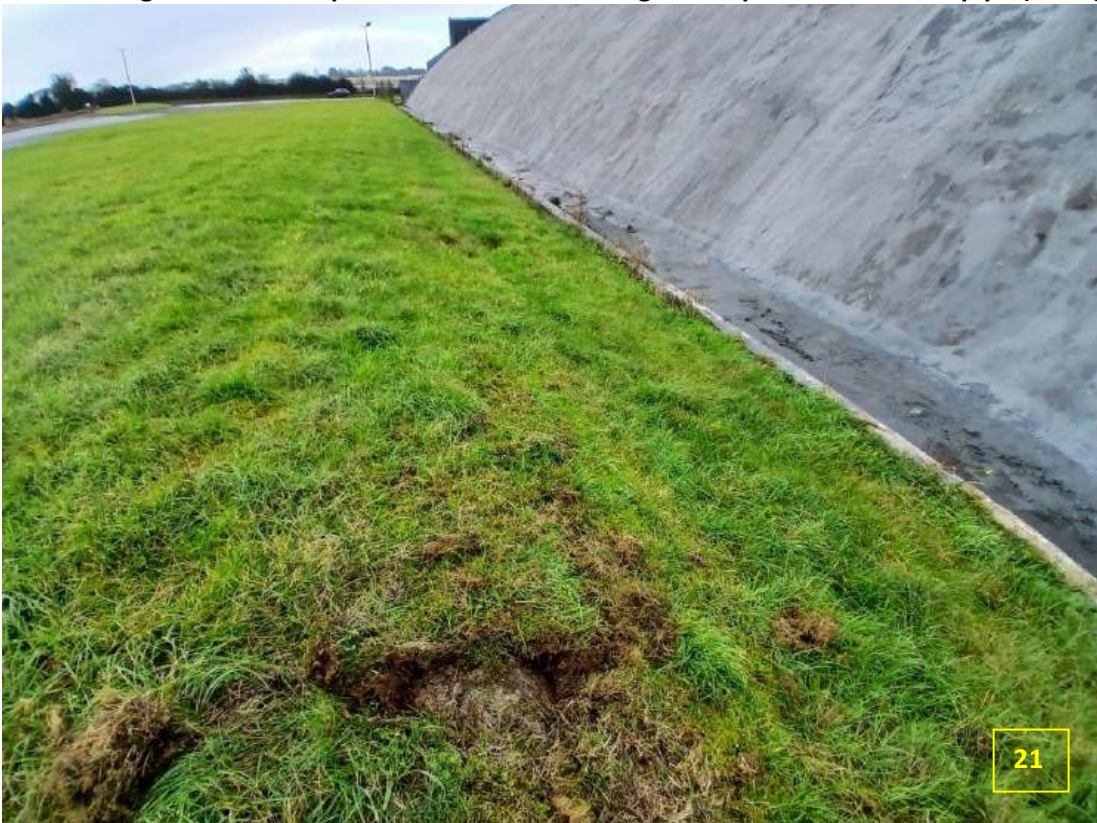
**Rounded underground feature parallell south side of hangar 18 – possible concrete pipe (Facing W)**

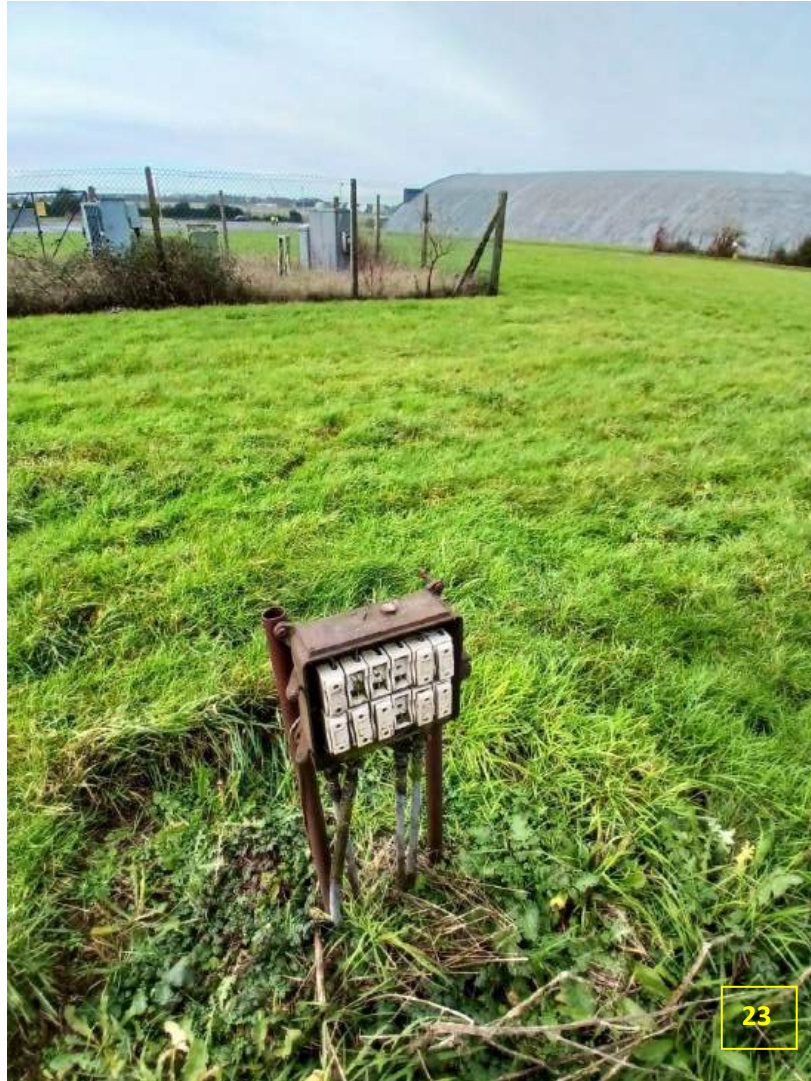
Assumed disused electric fuse board (Facing SW)

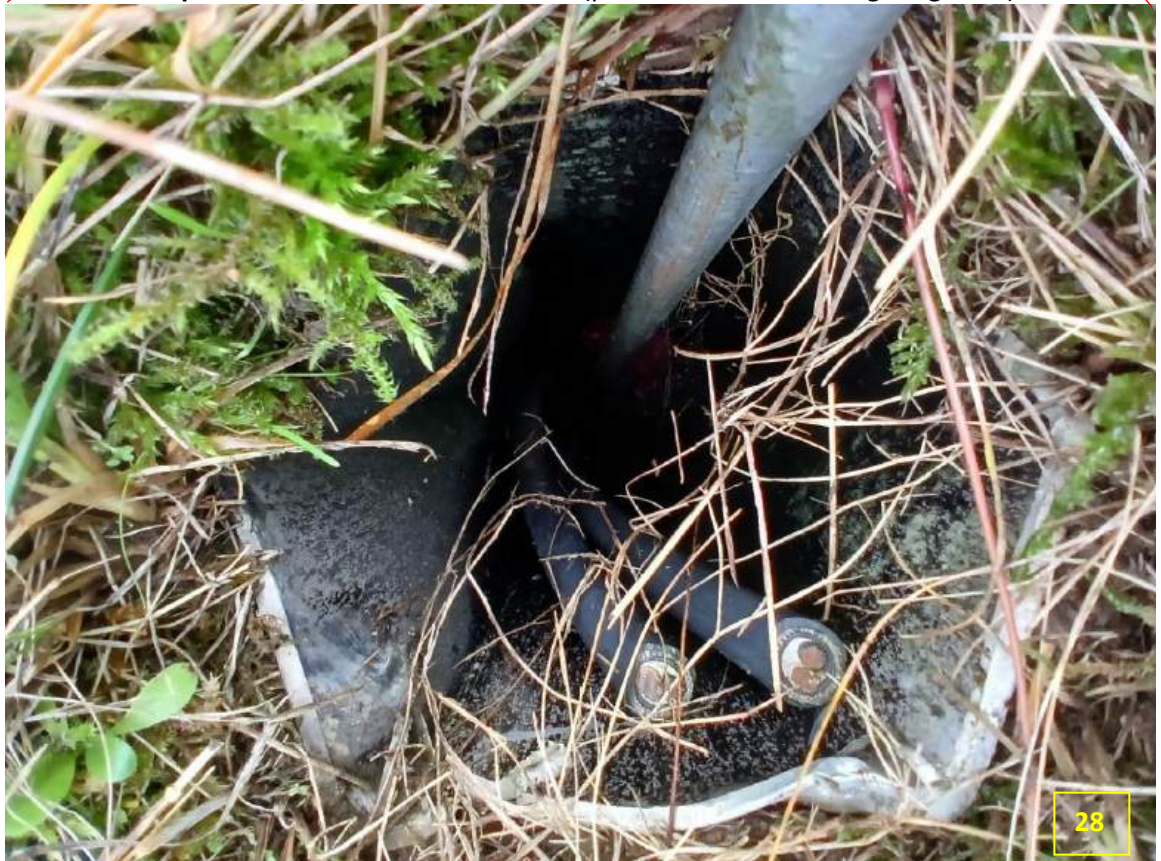
| <p>Are there any other hazardous features of the structures on site?</p> <p>For example, collapsing buildings, broken glass, unprotected parapets or other falling hazards, trip hazards, bare cables.</p> | <p><i>Overgrown slightly raised derelict foundations in grassed area of in front of hangar 20.</i></p> <p><i>Multiple covers in unsafe condition which are mainly covered by additional protection (wooden pallets).</i></p> <p><i>1 cut off electric cable protruding out of the ground (marked with a metal pole) near the electric offsite substation east of hangar 19.</i></p> |

**Unprotected, cut-off electric cables (possible former flood lighting mast)**

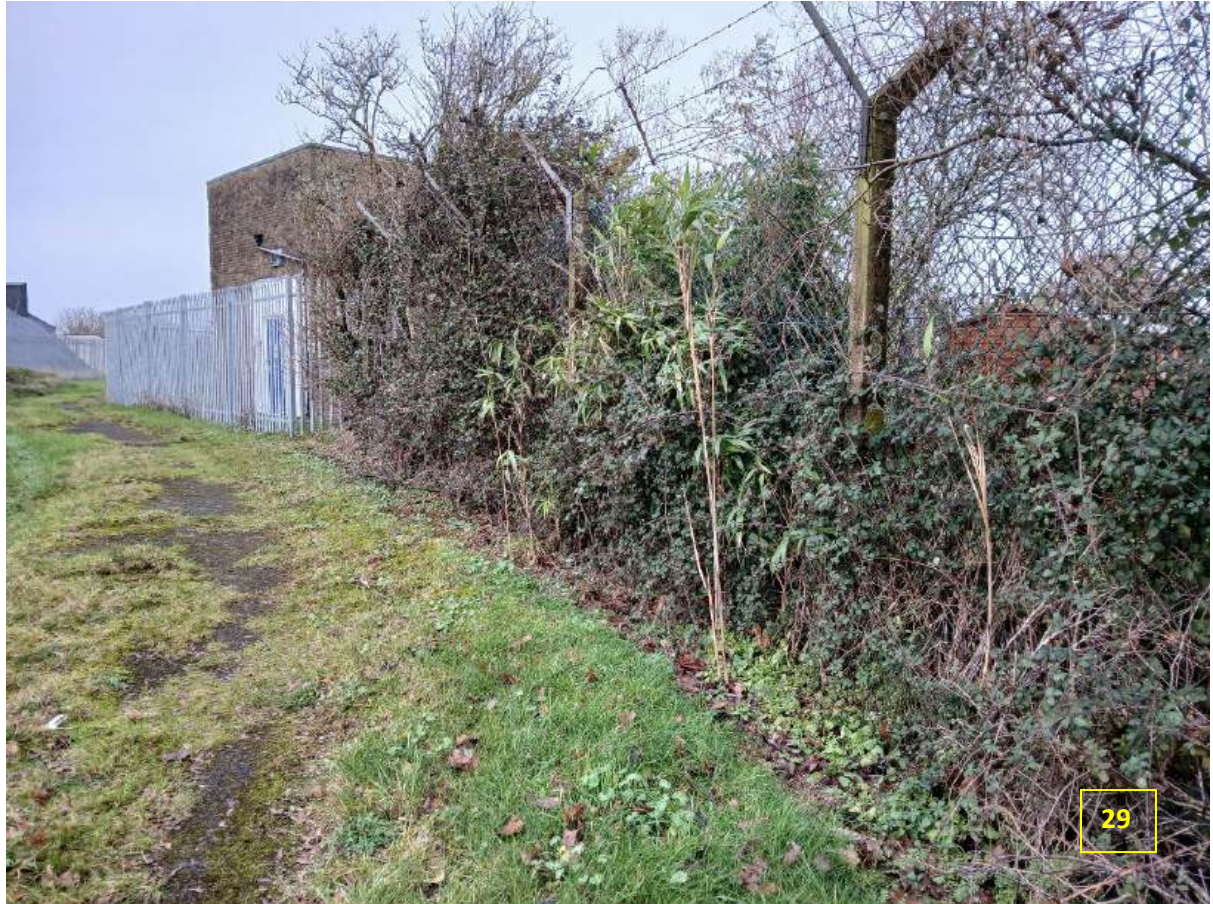
| Are there any noxious weeds on site?<br><br>Specifically Japanese knotweed, giant hogweed, Himalayan balsam.<br><br><b>Note: Giant hogweed is hazardous if skin contact occurs.</b> | <i>Not officially a noxious weed but at the southeast perimeter fence the adjoining residential property has bamboo which has spread through the fence onto site.</i> |

**Bamboo plants grown through site boundary fence from residential building (Facing N)**

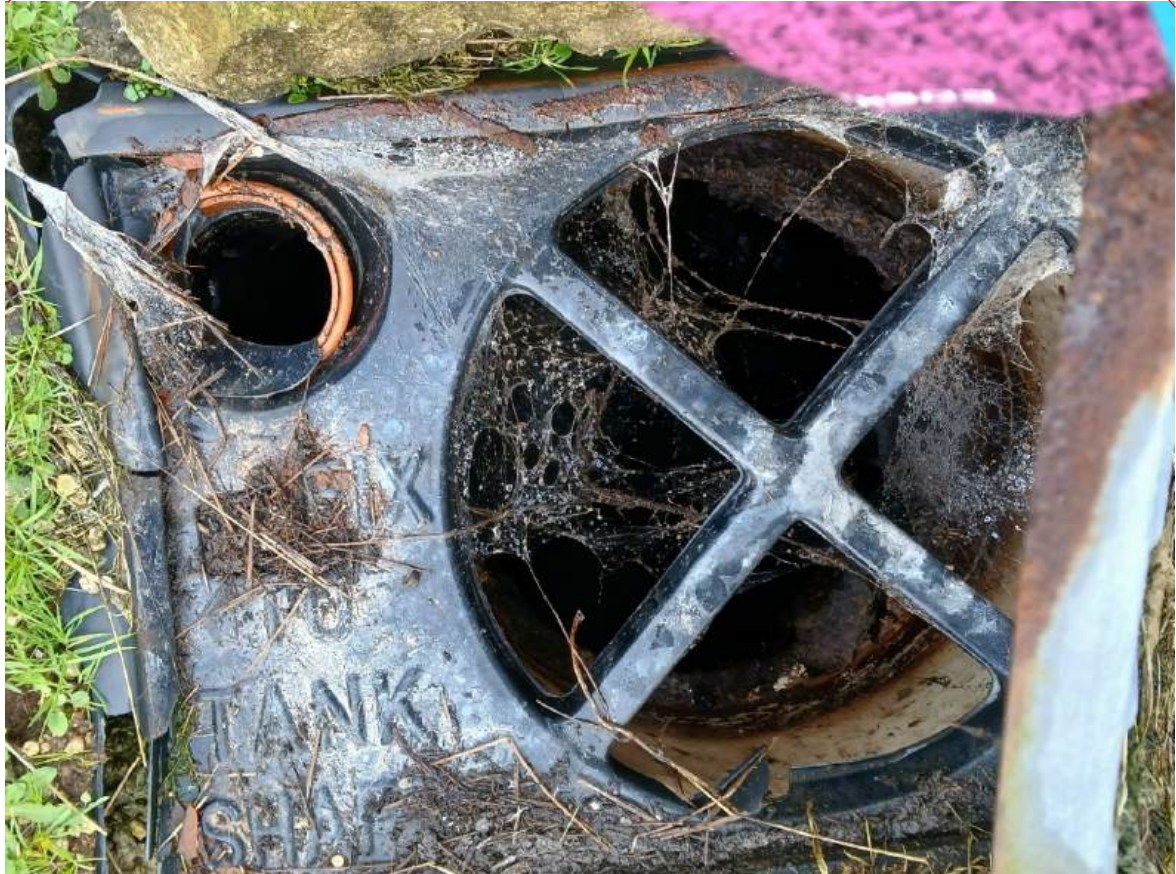
| Are there any chambers or underground services with covers missing or damaged that might constitute a hazard. | <i>Yes, damage and rusted. But marked with stone, euro pallet etc.</i> |

Septic tank (filled) (cover damaged)

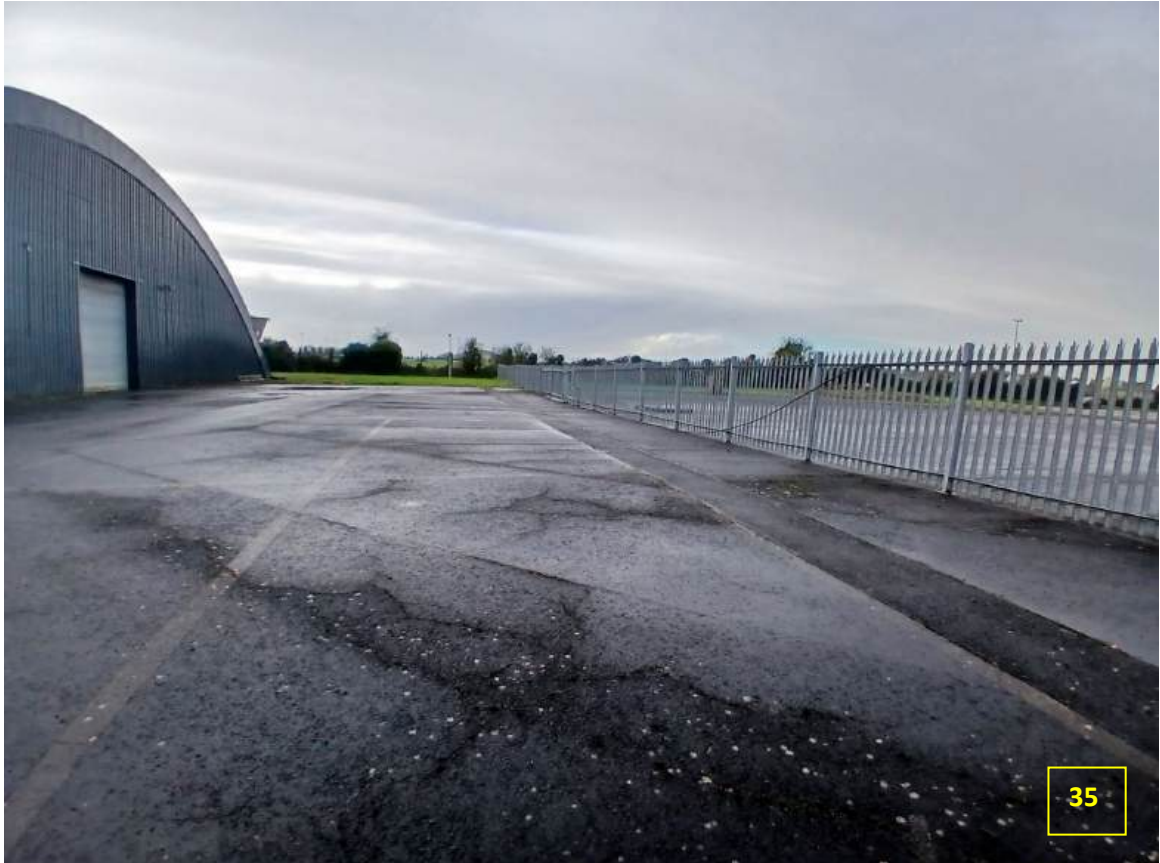
Multiple hardground scarring at front of hangar 20 (Facing W)
