# Arboricultural Impact Assessment & Tree Protection Plan

## For trees on land at Chaldicotts Barns in Semley

**Report Reference:** NB-2026-067-AIA-RevC

**Report Date:** 22<sup>nd</sup> September 2026

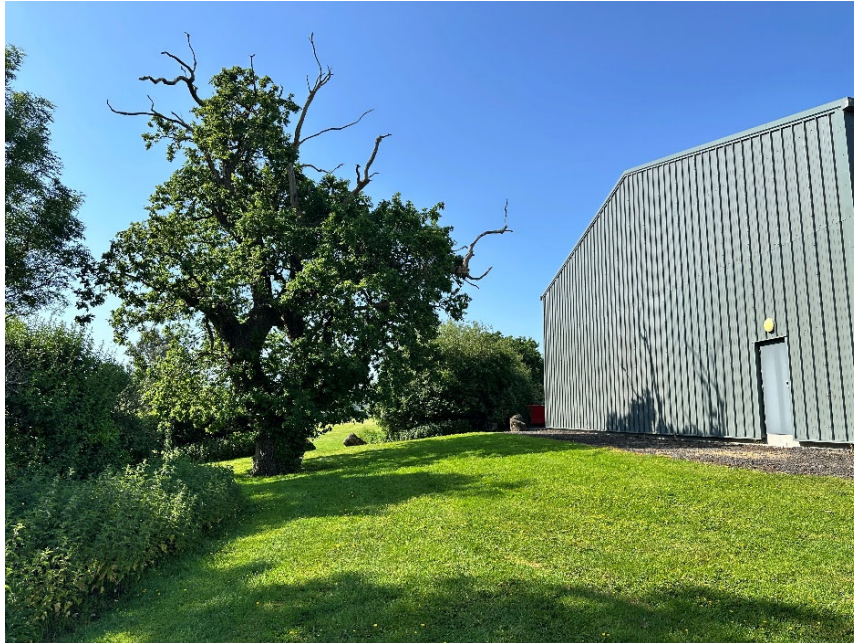
Figure 2: A veteran oak to the south-east of the site (T1).

| Tree Number | Tree Species | Height (m) | Number of Stems | Stem Ø (cm) | N - Radius (m) | S - Radius (m) | E - Radius (m) | W - Radius (m) | 1st Branch (m) | Age Class | Overall Health | ULE (Years) | Tree Structural Condition & Site Notes | Recommended Management | Category |
|---|---|---|---|---|---|---|---|---|---|---|---|---|---|---|---|
| T1 | English oak | 16 | 1 | 121 | 5 | 6.5 | 4 | 5.5 | 3 | V | G | 40+ | Scars and small cavities on scaffold limbs. Stag headed upper canopy from a naturally retrenching crown. This tree has classic veteran tree features.<br>The levels have once been increased on the western side. | No action required at present. | A3 |

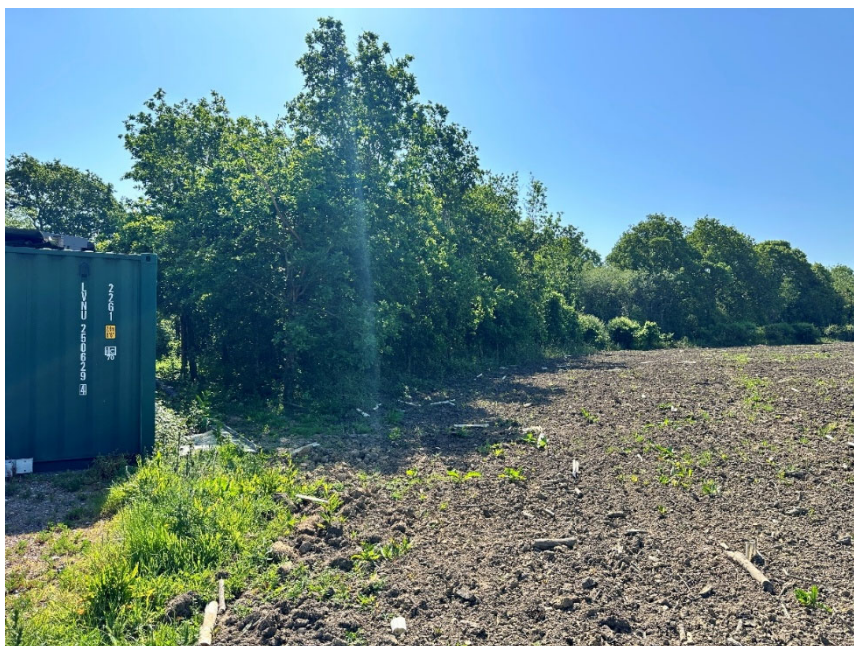
Figure 3: A small broadleaf copse to the north-east of the site (G3).

| Group Number | Tree Species | Number in Group | Height (m) | Number of stems | Stem Ø (mm) | N - Radius (m) | S - Radius (m) | E - Radius (m) | 1st Branch | Age Class | Overall Health | ULE (Years) | Tree Structural Condition & Site Notes | Recommended Management | Category |
|---|---|---|---|---|---|---|---|---|---|---|---|---|---|---|---|
| G3 | Oak and hazel | 30 | 12 | 1 | 150 | 2.5 | 2.5 | 2.5 | 2 | EM | G | 10+ | A small dense copse in the corner of the site. The eastern side has been flailed away from the track. | No action required at present. | C2 |

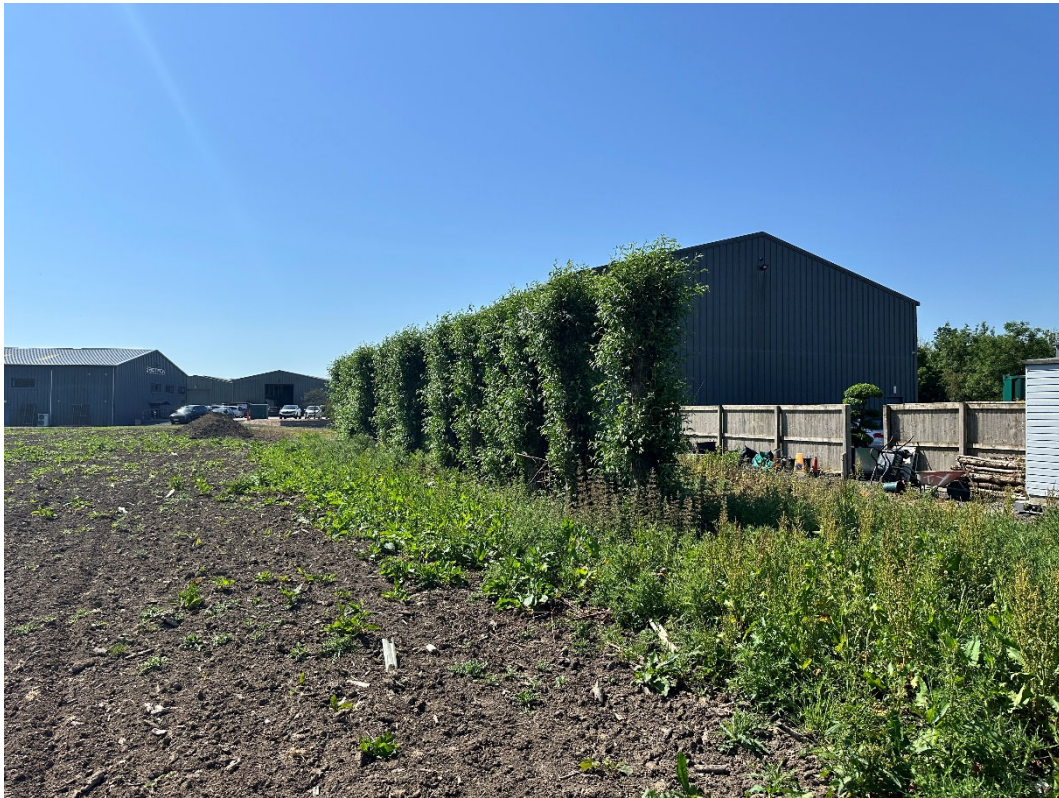
A new tarmac surface is proposed in an area near a group of pollarded willows (G7). Considering the existing site topography, it is likely that the trees will currently be rooting in soil beneath the area to be surfaced. Considering this a low-impact method of installation will be required in these locations; this must be built in accordance with guidance provided in Arboricultural Practice Note 12<sup>7</sup>.

**Figure 4:** *A group of pollarded willows on the western site boundary (G7).*

| Group Number | Tree Species | Number in Group | Height (m) | Number of stems | Stem Ø (mm) | N - Radius (m) | S - Radius (m) | E - Radius (m) | 1st Branch | Age Class | Overall Health | ULE (Years) | Tree Structural Condition & Site Notes | Recommended Management | Category |
|---|---|---|---|---|---|---|---|---|---|---|---|---|---|---|---|
| G7 | Cricket bat willow | 12 | 4 | 1 | 265 | 0.5 | 0.5 | 0.5 | 1 | EM | G | 20+ | A linear group of pollarded willows. | No action required at present. | B2 |

To protect the roots and soil near the adjacent trees, it is proposed that a cellular confinement system will be laid on the soil surface in the area identified on the tree protection plan (TPP-1 RevB) and the surface will be topped with a permeable wearing course. Essentially the proposed methodology will not allow any digging or compaction of the soil near the trees, and the existing soil levels will not be lowered in the root protection areas of the adjacent trees. In advance of laying this surface, the ground preparation works will be carried out under arboricultural supervision and cellular confinement systems will be installed in accordance with the accompanying arboricultural method statement.

The new hard surface has been specifically designed to be at least 600mm from the base of each tree to facilitate future growth. Given these trees have a vigorous nature and the space beneath the proposed surface has once been disturbed, provided the surface is laid in accordance with an approved arboricultural method statement, I expect the adjacent trees to easily tolerate this impact without any noticeable effect on their long-term health.
