**Bishopstrow House Hotel  
and Spa  
Boreham Road  
Warminster  
Wiltshire**

*Built Heritage Assessment*

BBHC Project: 1891  
BBHC Report: 18066

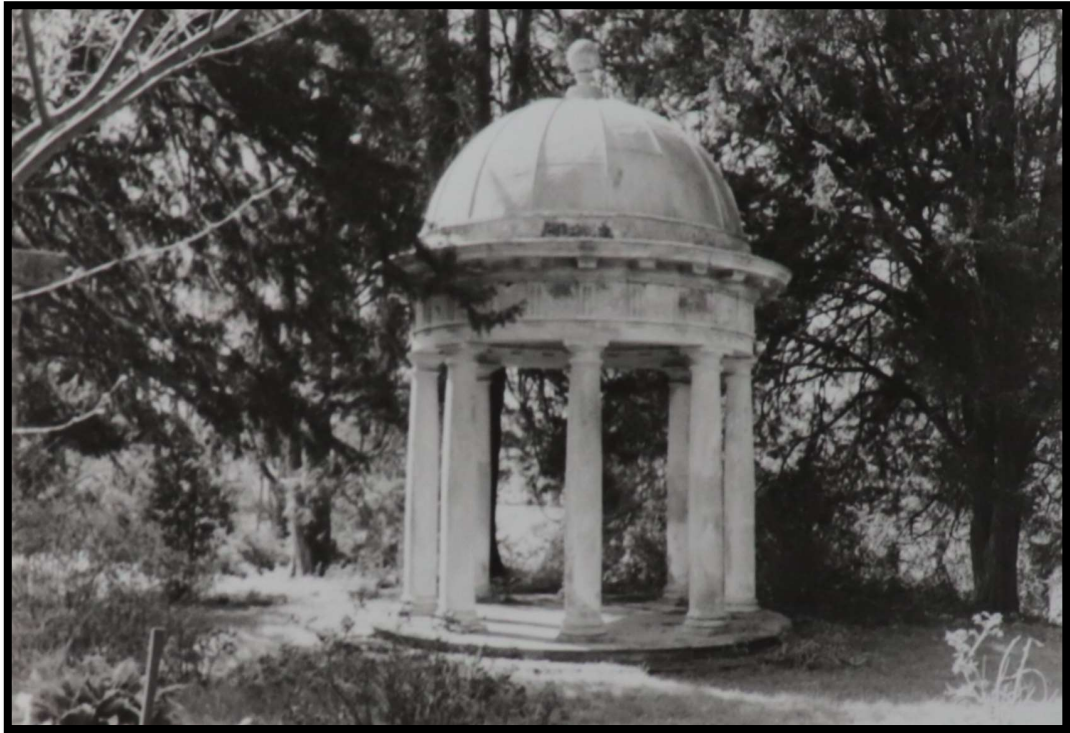
- 5.9 The 1770 Doric Temple forms the centrepiece of the southern garden area. An open rotunda supported on eight Tuscan columns, of Bath stone with a lead-covered cupola, this was carefully rebuilt following a severe storm in late January 1990 in which a falling tree demolished the original structure to ground level. It is almost identical in design to another rotunda at Belcombe Court, near Bradford-on-Avon. The 1770 date indicates that it was built by William Temple II, who inherited the manor in 1755 and died in 1780, and it may have been this William Temple who was responsible for the original laying out of the pleasure grounds broadly as we understand them today in the southern garden area. The temple is placed to command views down the canal which ran off at an angle from the river, and to close the view back from the footbridge which spanned the canal south of the mill, from where it would appear reflected in the water. A grass walk led along the northern riverbank below the temple, extending eastwards to a small garden shelter or pavilion, the now Grade II listed boathouse and pumphouse, from which one could peruse views along the river. The garden shelter was lightly built with stucco and plaster on laths on a timber frame and a slate roof, and the timber-frame, infilled with brick nogging, boat house behind (to the east of) it was added later. The garden shelter, whose woodwork was already in poor condition, and from which some of the stucco had been lost by 1997, was vandalised in 2002. One of its walls was torn down and a hole made through its floor. It is now in very poor condition.

**The temple in 1987, before its rebuilding with a dome which appears slightly higher following the 1990 storm (Wiltshire Buildings Record)**

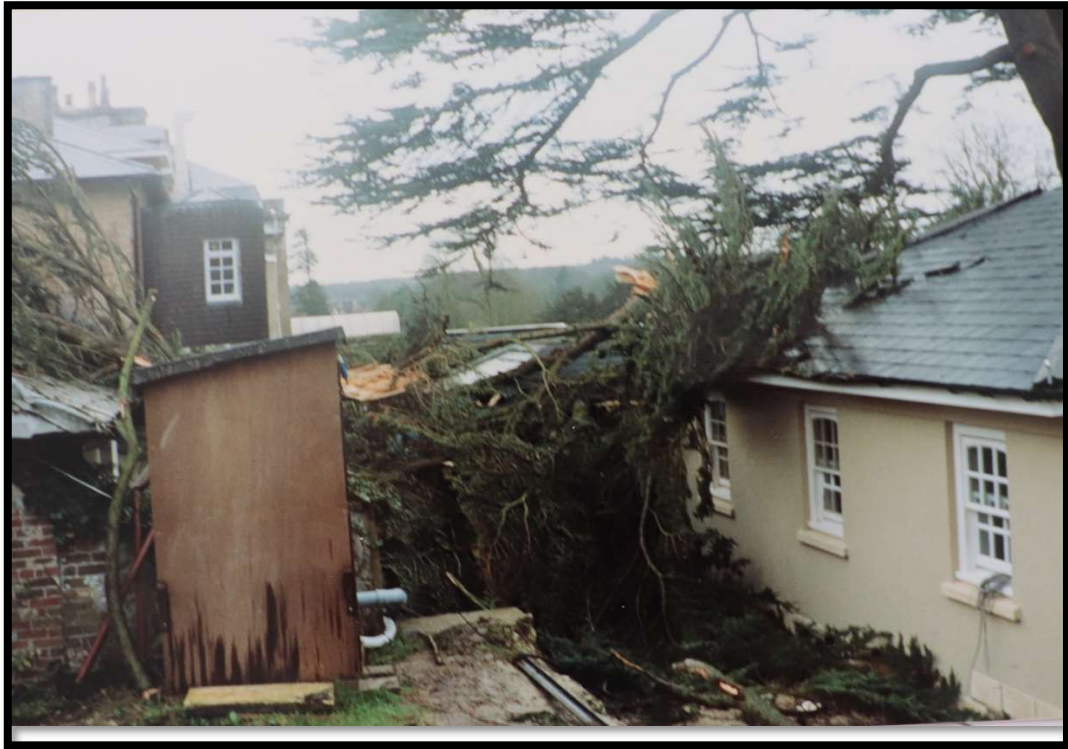
**Storm damage to the annexe, late January 1990 (Wiltshire Buildings Record B688)**

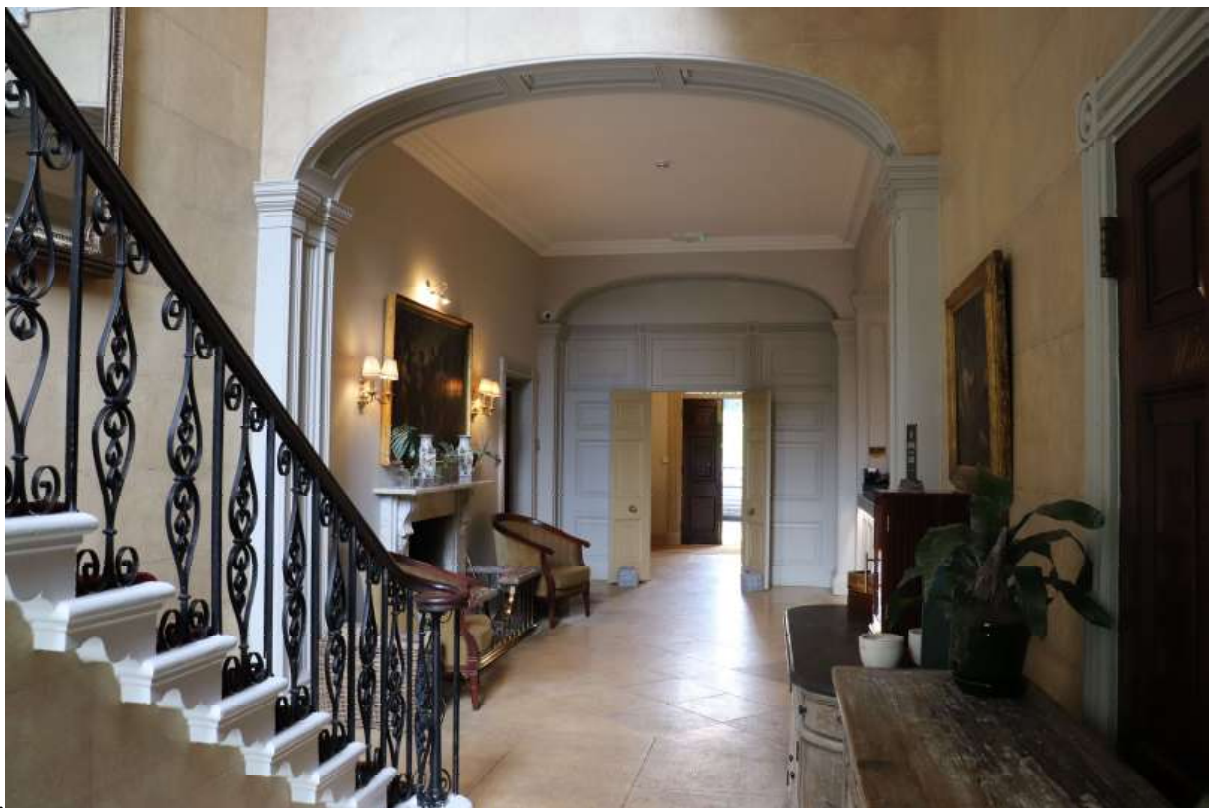
**Figure 26** *The Inner Hall and the repositioned screen, and the replacement fireplace*

- 7.3 The screen in its present position has had the glazing replaced by matching (but simplified) fielded panels and the tympanum filled in to the arch and ceiling (Fig. 26).

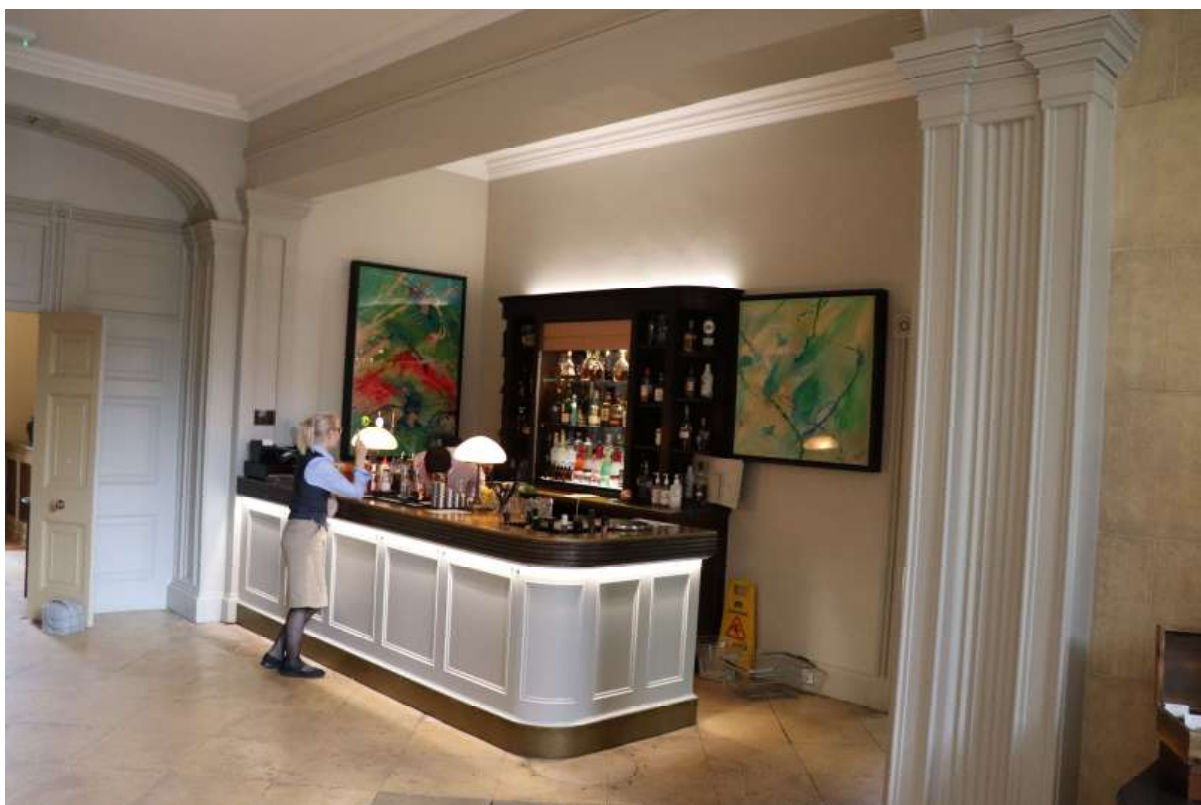
**Figure 30** *The bar in place of the columned recess (cf Fig. 29)*

- 7.10 The columns have been removed and the entablature replaced or repaired with a plainer version, presumably hiding an RSJ. The circles on the floor where the stone floor has been "made good" are very evident. The columns have been replaced by a drinks bar (Fig. 30). Not a good swap.
