# GROUND INVESTIGATION REPORT

**Ashton Keynes**  
Prepared for: Acorn Bioenergy

SLR Ref: 404.11923.00004.0027  
Version No: Final v1  
May 2023

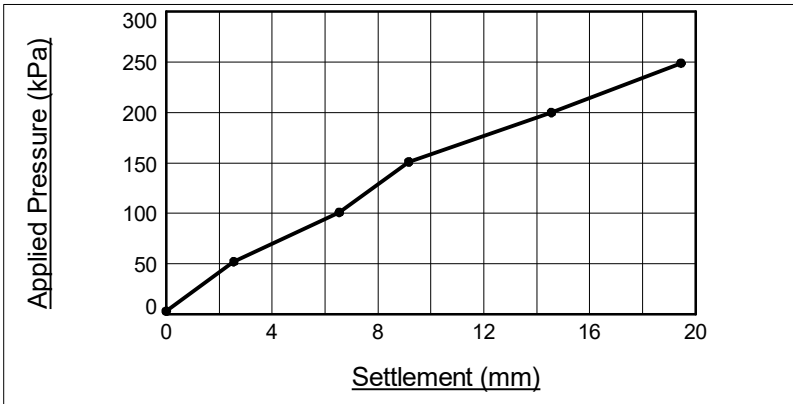
Position ID: **PB1**      Depth (m) : **0.20**      Date of Test : **23/02/23**

| Maximum Applied Pressure (kPa): | 249 | Maximum Applied Deformation (mm) : | 19.447 |

In-situ plate bearing tests were undertaken at five locations, PBT1 - PBT5, across the Site using a 455mm diameter plate and an 8-tonne excavator as the kentledge.

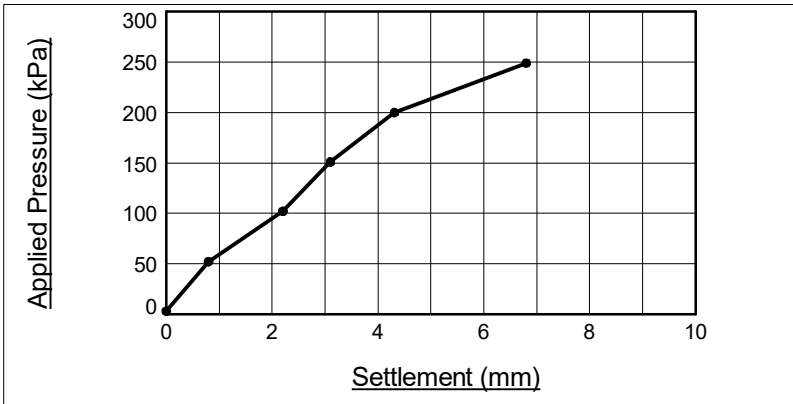
Position ID: **PB2**      Depth (m) : **0.20**      Date of Test : **23/02/23**

| Maximum Applied Pressure (kPa): | 249 | Maximum Applied Deformation (mm) : | 6.803 |

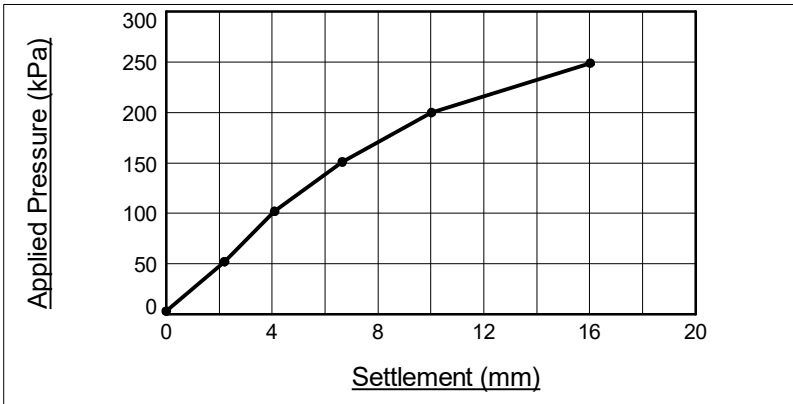
Position ID: **PB3**      Depth (m) : **0.20**      Date of Test : **23/02/23**

| Maximum Applied Pressure (kPa): | 249 | Maximum Applied Deformation (mm) : | 16.023 |

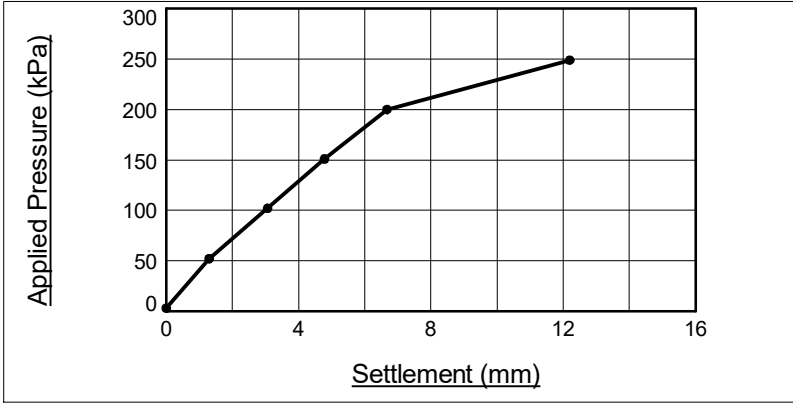
Position ID: **PB4**      Depth (m) :   **0.20**      Date of Test :   **23/02/23**

| Maximum Applied Pressure (kPa): | <b>249</b> | Maximum Applied Deformation (mm) : | <b>12.200</b> |

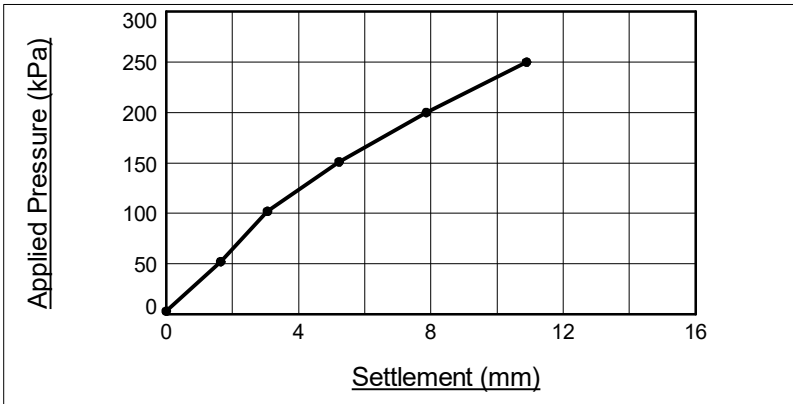
Position ID: **PB5**      Depth (m) : **0.20**      Date of Test : **23/02/23**

| Maximum Applied Pressure (kPa): | 250 | Maximum Applied Deformation (mm) : | 10.890 |
