**SUBJECT                      PHASE 1 DESK STUDY**

**SITE                              LAND OFF BIDDESTONE LANE, YATTON  
KEYNELL**

**PROJECT                      PROPOSED DEVELOPMENT**

**REPORT No.                24031**

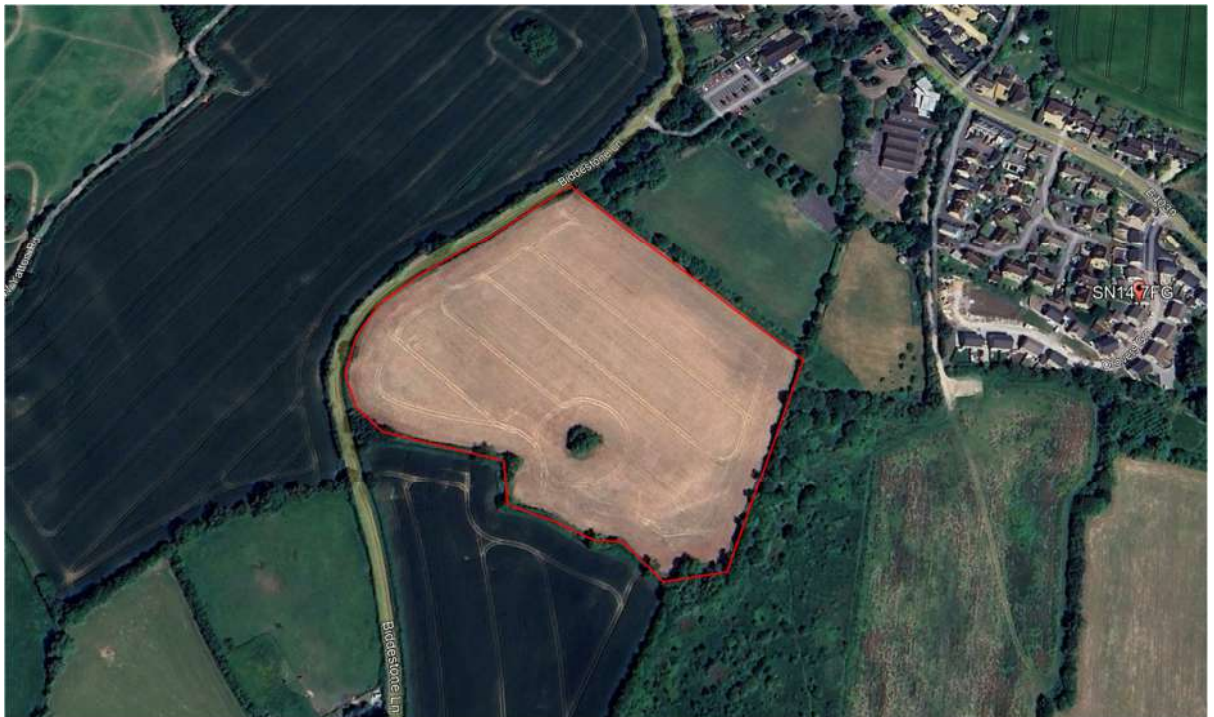
Plate 1 Google Earth aerial image of site dating to June 2023 (site outlined in red)

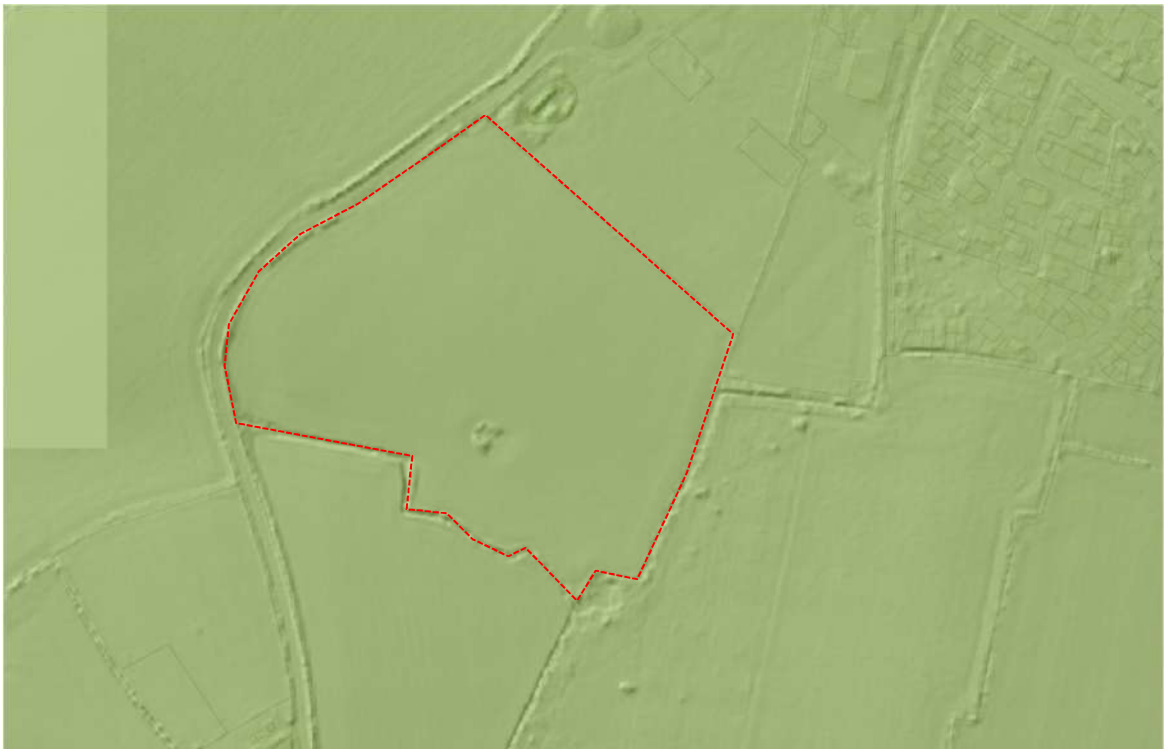
Lidar survey data (1m digital terrain model) shows that the field is relatively flat lying with a ditch located along the length of the southern and majority of the eastern boundaries of the field. A small depression containing a pond is located centrally toward the southern boundary.

**Plate 2 Lidar Digital Terrain Model (1m resolution), site outlined in red**

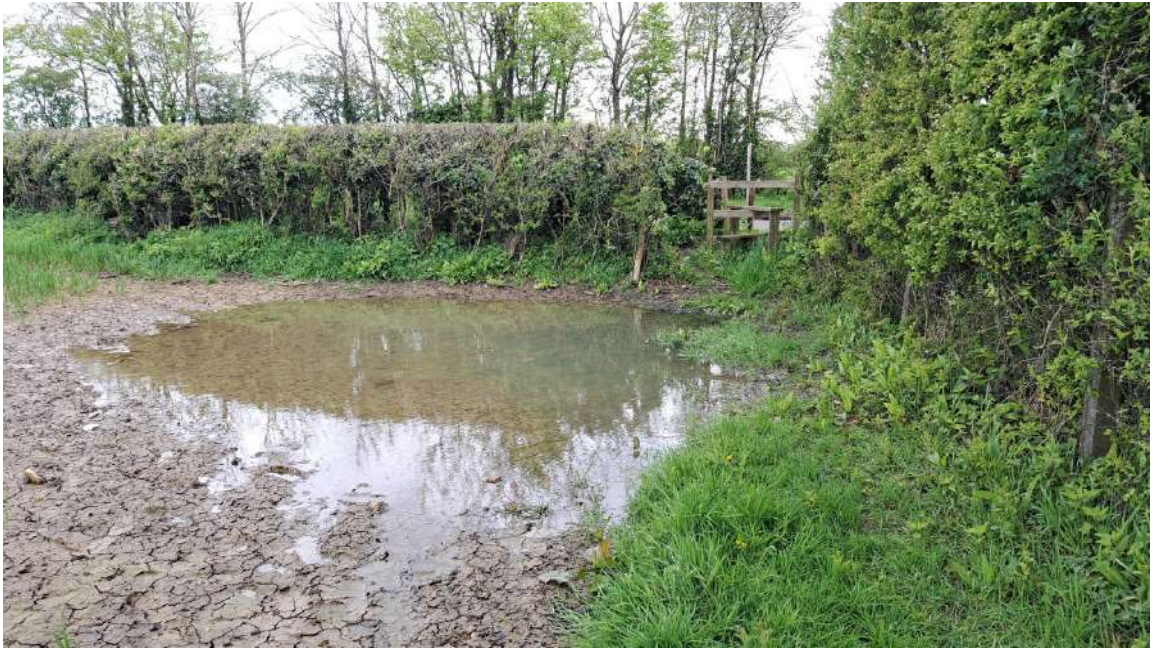
At the time of site walkover, the ground surface was soft and boggy with localised ponding in the north-west, north-east and south-eastern corners of the site. The crop appeared to be in poor health in areas which had been affected by surface water ponding (Photo 1 and 2).

Photo 1 ponding in north-western corner of site adjacent to public footpath

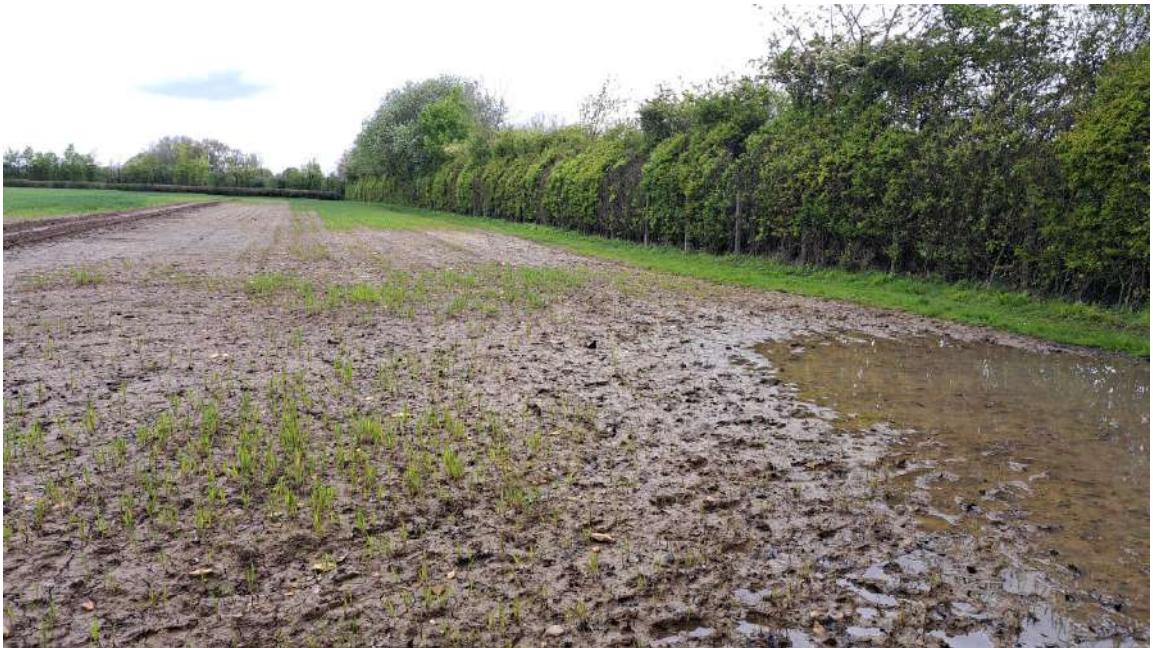
Photo 2 looking northwest along north-eastern field boundary with ponding in north-eastern corner of field and poor crop health resulting from surface water inundation.

The north-eastern field boundary largely comprised hawthorn of around 5m height interspersed with occasional deciduous trees (Photo 2).

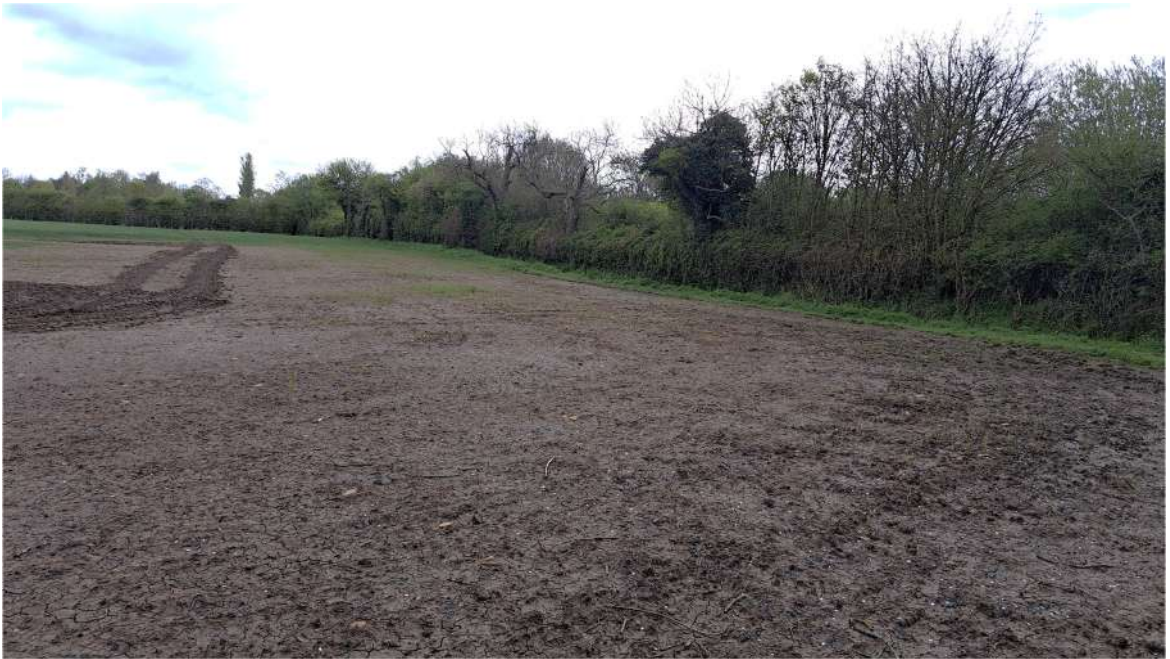
The south-eastern field boundary comprised mixed deciduous hedgerow (including hawthorn) and several trees including oak of around 12-15m in height. Several trees along this boundary appeared to be dead. A ditch approximately 0.75-1.0m deep was located along this boundary (Photo 3).

Photo 3 looking north-east along south-eastern boundary field boundary and area of recent surface water ponding

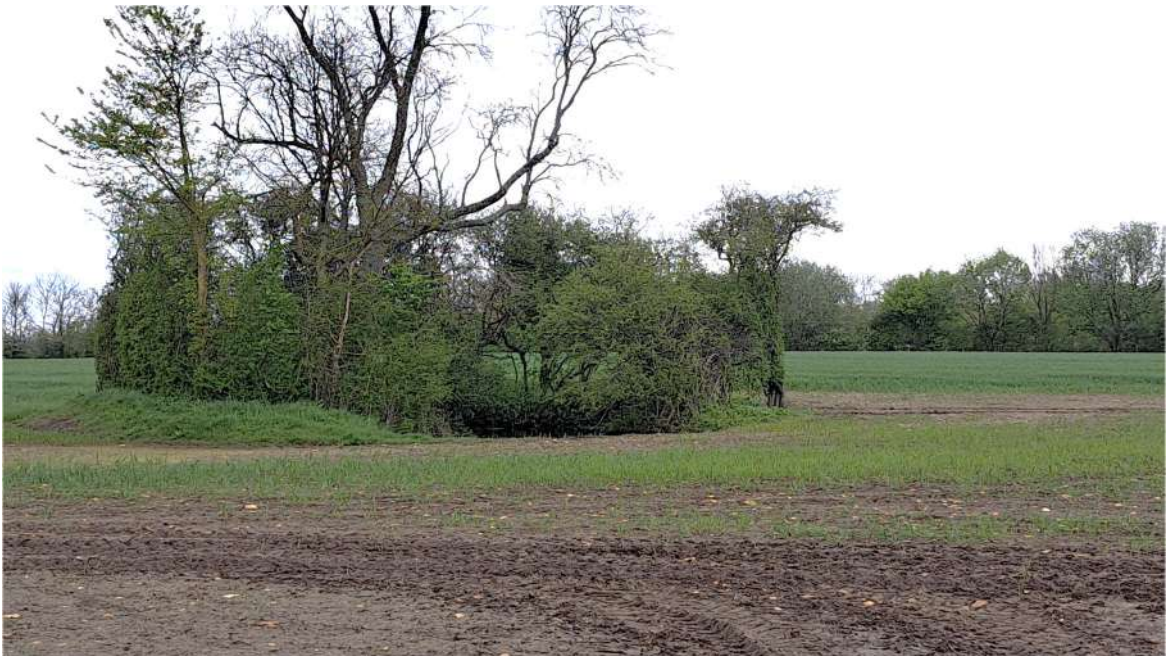
A small pond lies just outside the site boundary in the south-eastern corner of the site and a small pond lies within a wooded copse located centrally within the site toward the southern boundary (Photo 4).

Photo 4 looking north toward pond within small wooded copse within site

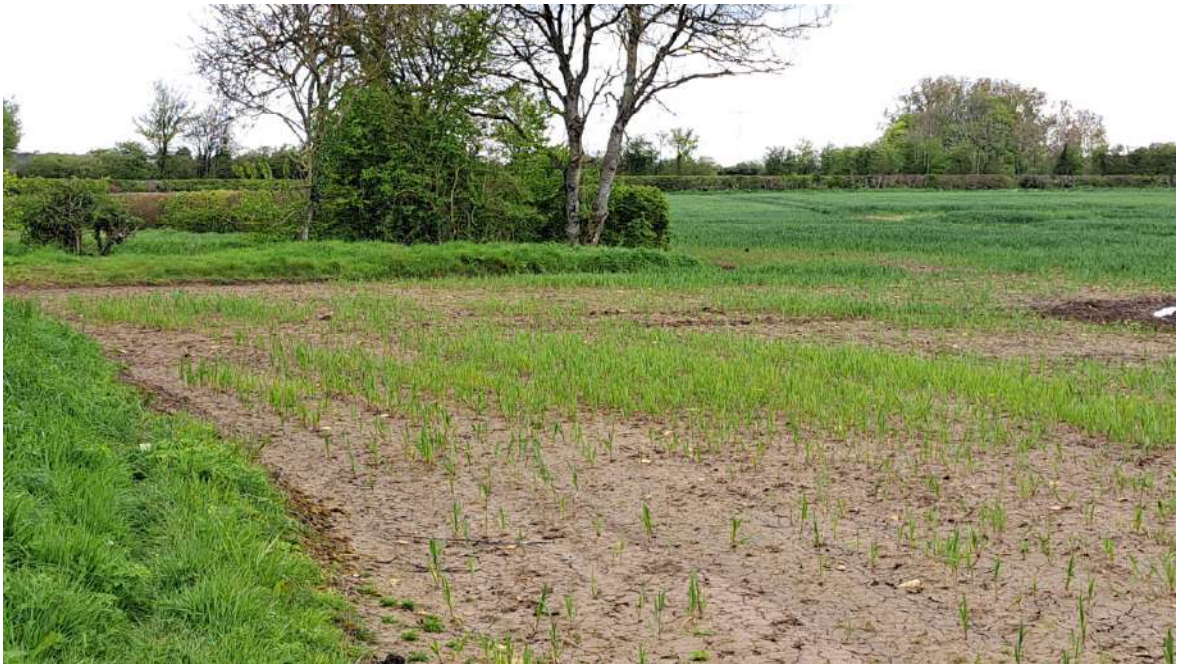
The south-western field boundary is mostly defined by a ditch interspersed with hedgerow and occasional ash suffering dieback (Photo 5).

Photo 5 looking north-east along south-western field boundary

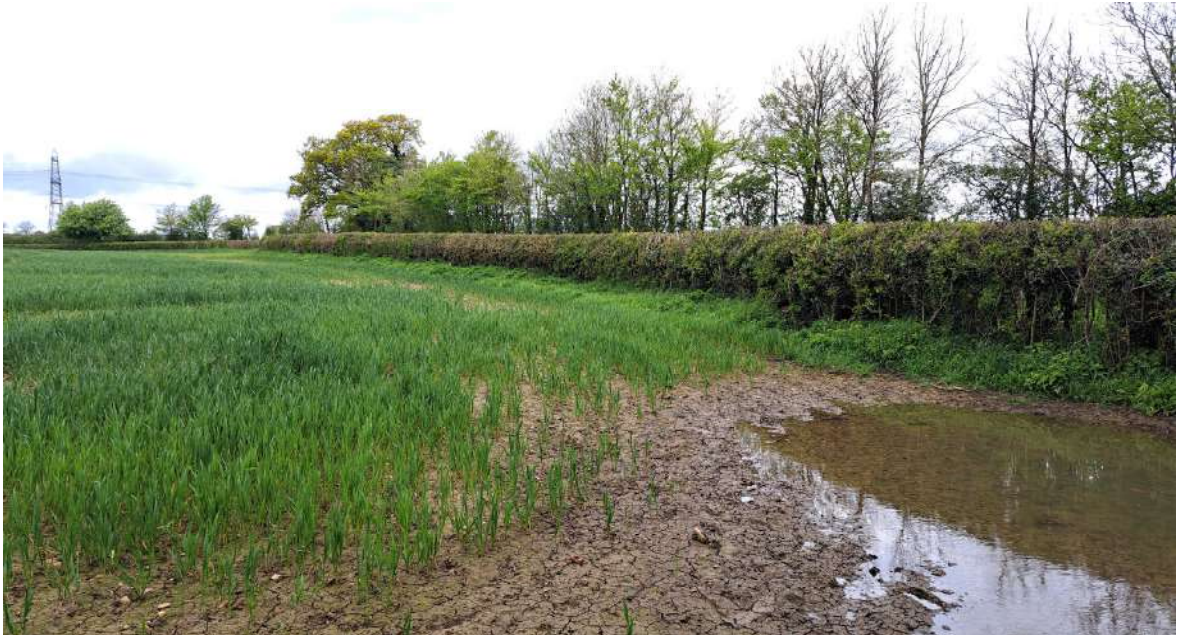
The north-western field boundary with Biddestone Lane comprised mixed deciduous hedgerow with a horse chestnut located part way along its length (Photo 6).

Photo 6 looking south-west along north-western field boundary with Biddestone Lane
