The Springfields Academy, Calne  
Preliminary Ecological Appraisal (PEA)  
*For CMS Group*

23<sup>rd</sup> May 2025

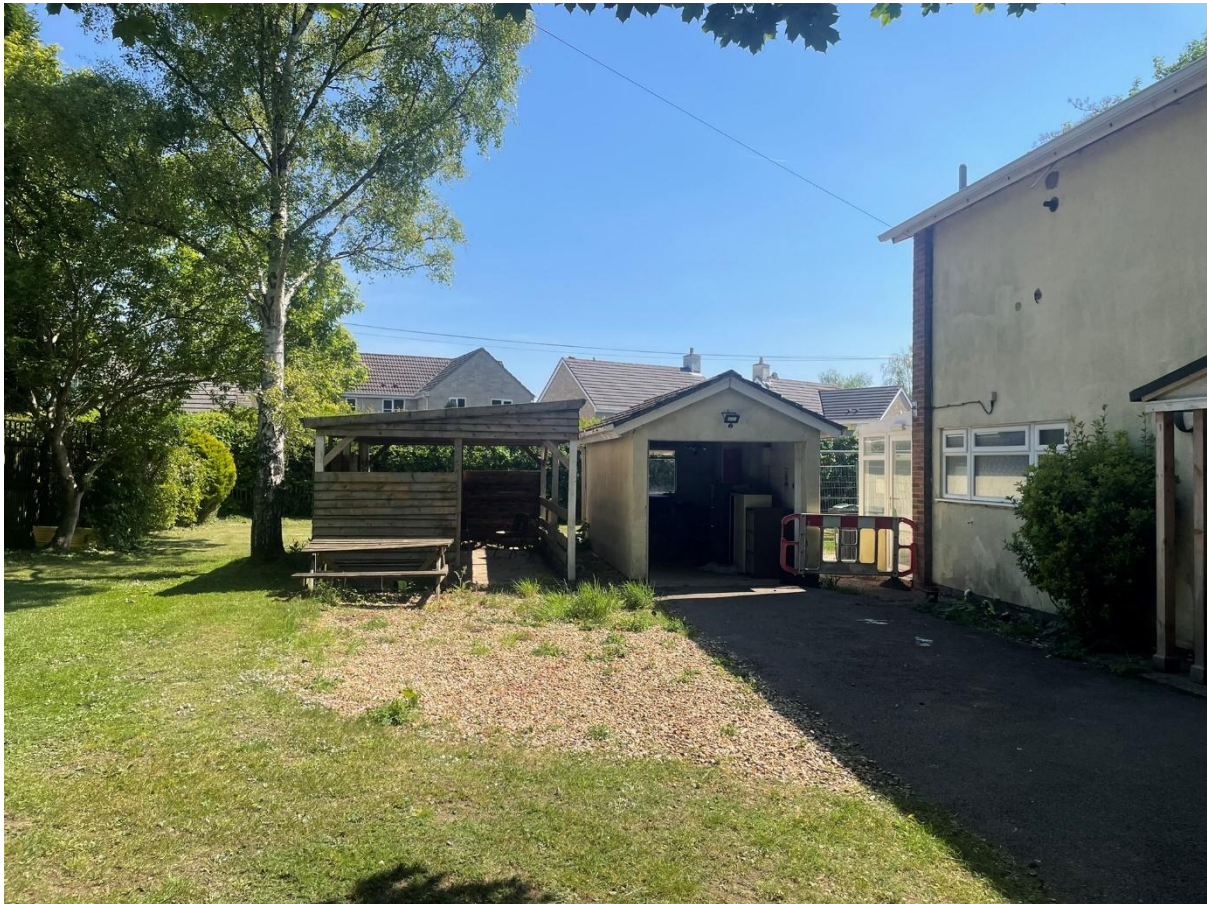
wooden fence with the main area of the site to the south and a smaller area to the north along the edge of the car park. At the time of the survey the sward height was low with species including perennial rye-grass *Lolium perenne*, dandelion *Taraxacum officinale* agg, daisy *Bellis perennis*, ribwort plantain *Plantago lanceolata* and creeping buttercup *Ranunculus repens* all recorded. The habitat was noted to be heavily used which reduces the species diversity.

*Photograph 1: showing a view of the site*

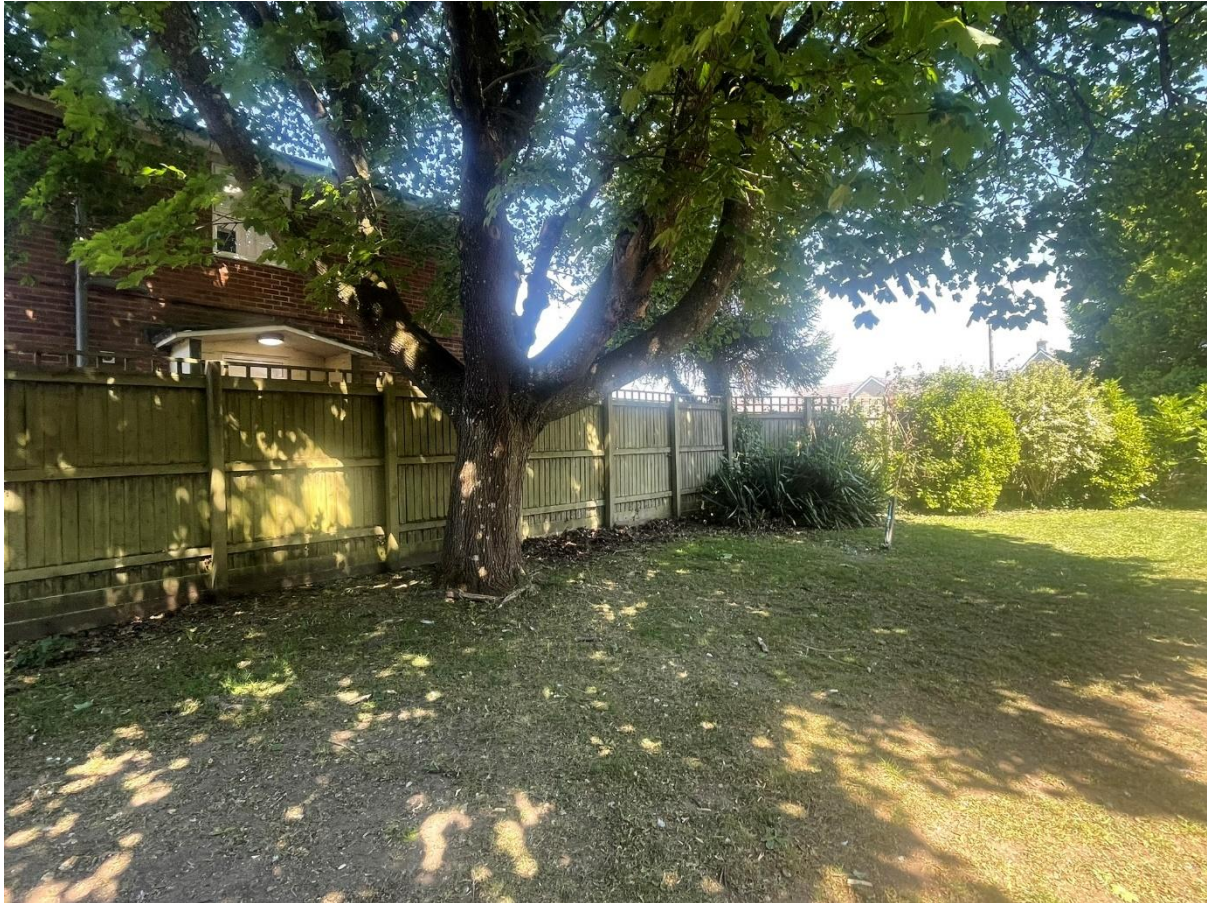
Shrub planting is located along the southern side of the fence line and includes cotoneaster *Cotoneaster spp.*, clematis *Clematis spp.*, peony *Paeonia spp.*, hydrangea *Hydrangea spp.*, Mexican orange blossom *Choisya ternata* and barberry *Berberis spp.*

*Photograph 2: showing a view of the fence and introduced shrub*

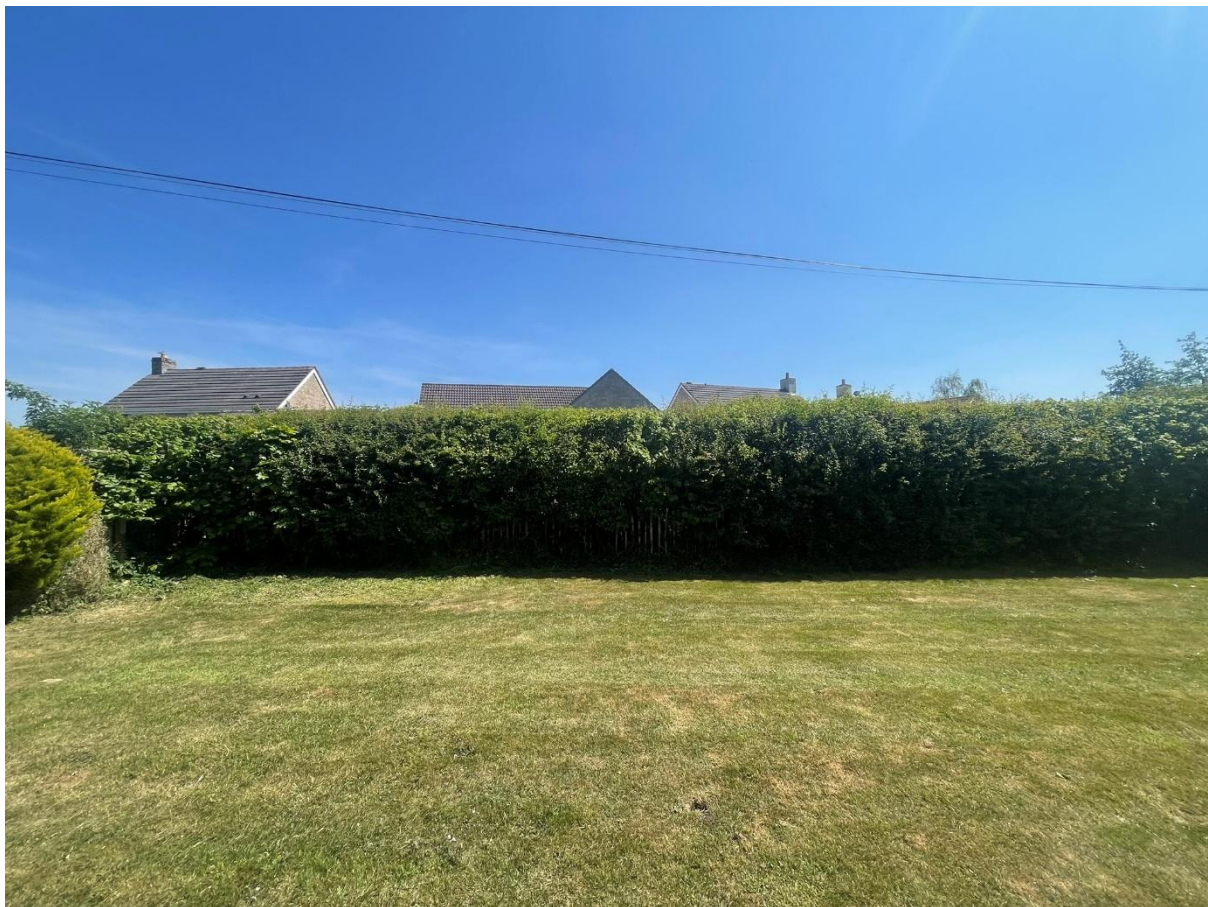
A hedgerow is located along the eastern boundary of the site. Species present here include hawthorn *Crataegus monogyna*, hazel *Corylus avellana*, common dogwood *Cornus sanguinea* and sycamore. Ground flora is limited due to regular mowing of the grassland.

*Photograph 3: showing a view of the hedgerow*

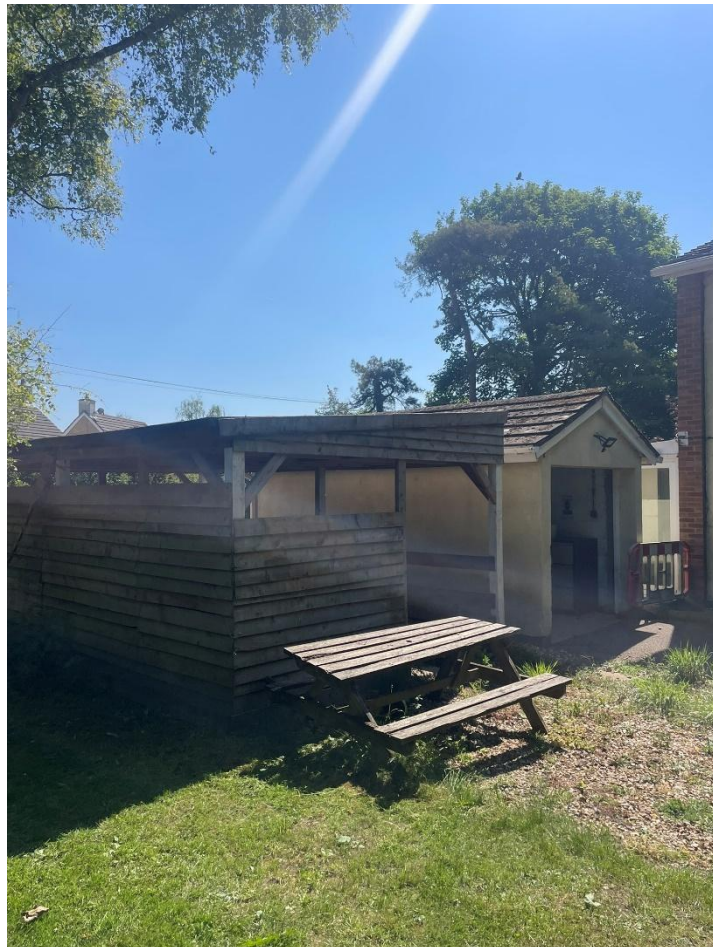
Building 1 is a wooden shelter constructed from a timber frame with wooden slats on the outer surface and a shallow sloped flat roof. The building is approximately 5m long by 3m wide and 2m tall. It is open along the upper walls allowing in wind and rain which makes the internal space suitable for roosting bats.

The building was noted to be damp at the time of the survey, further reducing the suitability for bats. The building has poor thermal properties, thus making it unsuitable for roosting bats.

No evidence of roosting bats was found within the building during the survey and bats are not considered to be present. The building is thus assessed as providing negligible roost potential for bats and no further surveys for bats are recommended.

*Photograph 4: showing a view of Building 1*

Given the findings of the survey, it is very unlikely that bats are roosting in the buildings. However, it is advised that precautionary working methods are undertaken during works to the buildings, including:

- Site personnel will be made aware of the potential presence of bats through a toolbox talk;
- If a bat is found, or the presence of bats is suspected, all work must stop immediately, and a licensed bat worker must be contacted for advice;
- Bats must not be handled under any circumstances; and
- An ecologist will assess a potential roost space (if identified/found) and inform Natural England of the proposed actions to be undertaken.

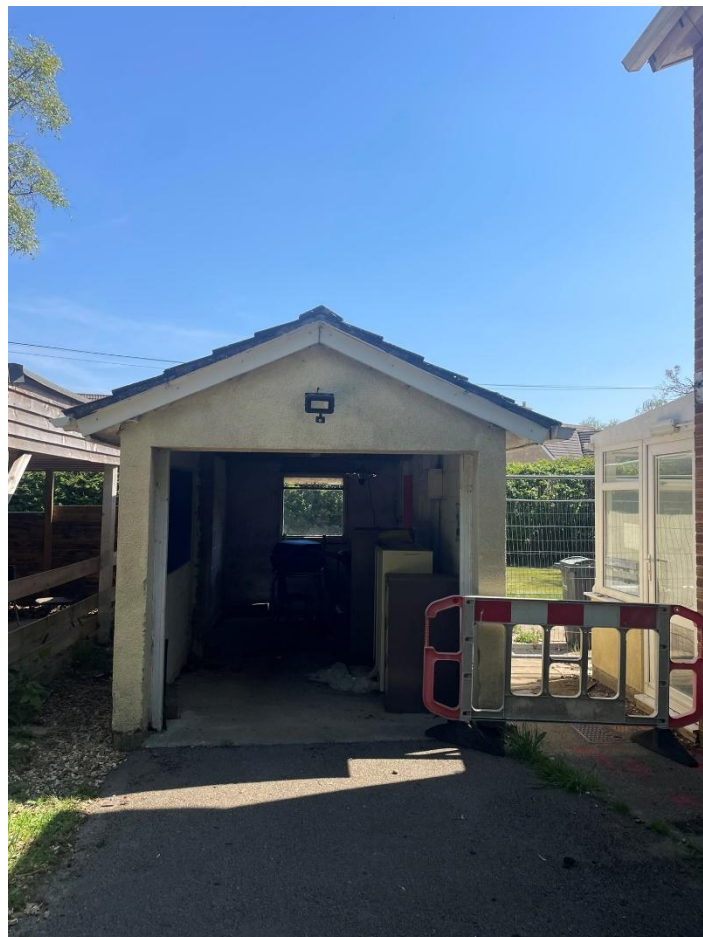
Building 2 is a stone structure approximately 5m long by 3m wide and 2m tall, with a pitched roof covered by tiles. Externally the wall of the building are rendered and was found to be in a good condition with no gaps or cracks which would provide suitable roosting for bat species. The external roof structure was covered in moss indicating that it is wet and unsuitable for bats which require dry and stable conditions for

roosting. In addition, no loose, lifted or missing tiles were noted which would provide opportunities or bats. No evidence of bat activity, such as droppings or feeding remains, was found on the external surfaces of the building.

The building was open on the western side allowing access to the internal space. Dense cobwebs were noted on the walls and ceiling of the building indicating that bats are not present. The open door reduces the suitability by reducing the thermal properties of the building and allowing in wind and rain. No evidence of bat activity was found within the building to indicate that it is used by bats. The building is thus assessed as providing negligible roost potential for bats and no further surveys for bats are recommended.

*Photograph 5: showing a view of the inside of Building 2 (looking south)*
