### ARBORICULTURAL IMPACT ASSESSMENT

### METHOD STATEMENT

Site: Woodborough, Pewsey, Wiltshire SN9 5PH

Project Reference: Woodborough\_2025\_TPP\_V2

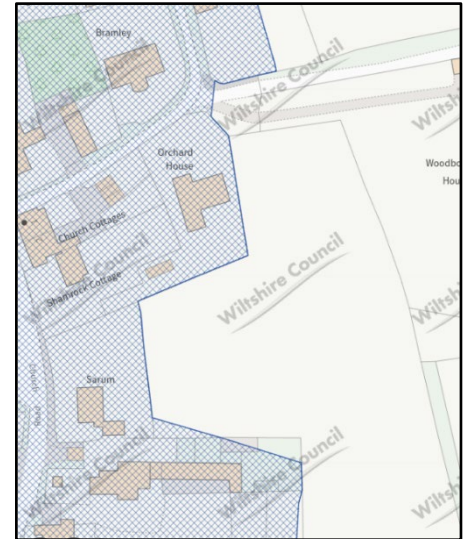
**1.3.4** Most of the site is not located within a conservation area however the area hatched in blue is and all vegetation within these areas will require the necessary permits from Wiltshire CC .

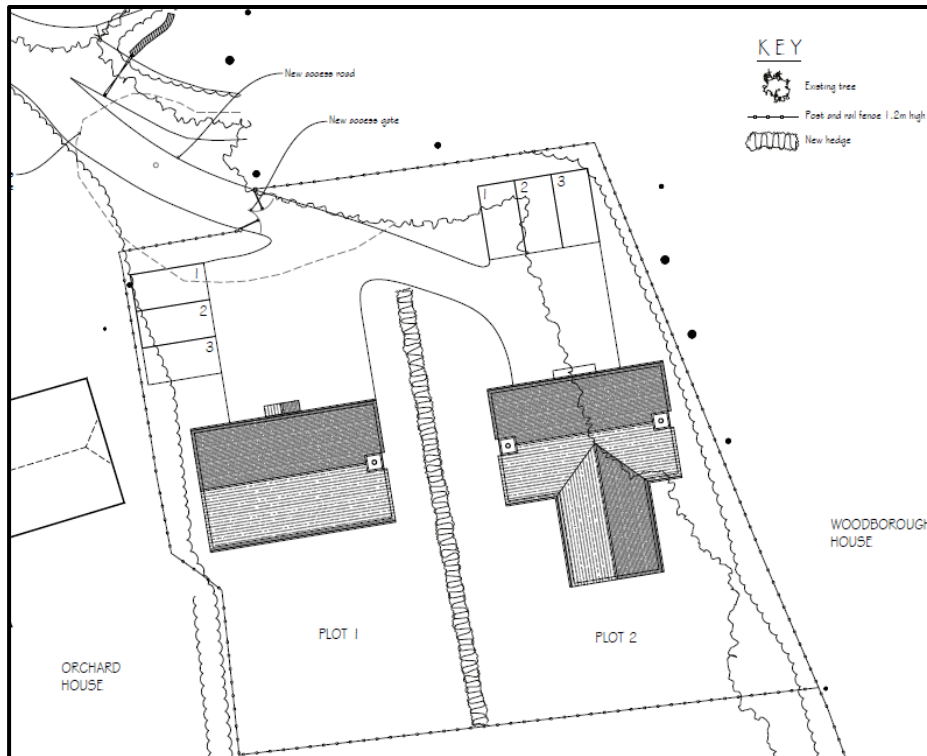
The proposal is for the construction of 2 new residential homes within the property boundary.

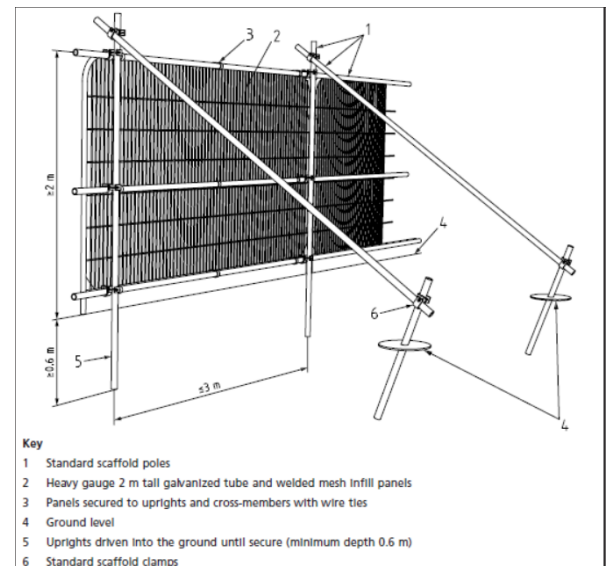
**5.2.3** The barrier is to comprise of a vertical and horizontal framework, well braced to resist impacts, with vertical tubes spaced at a maximum interval of 3m. Weldmesh panels, such as Heras, should be securely fixed with wire or scaffold clamps to this framework. Weldmesh panels on rubber or concrete feet are not resistant to impact and should not be used. Care should be exercised when locating the vertical poles to avoid underground services and, in the case of the bracing poles, also to avoid contact with structural roots. If the presence of underground services precludes the use of driven poles, an alternative specification should be prepared in conjunction with the project arboriculturist that provides an equal level of protection. Such alternatives could include the attachment of the panels to a freestanding scaffold support framework.

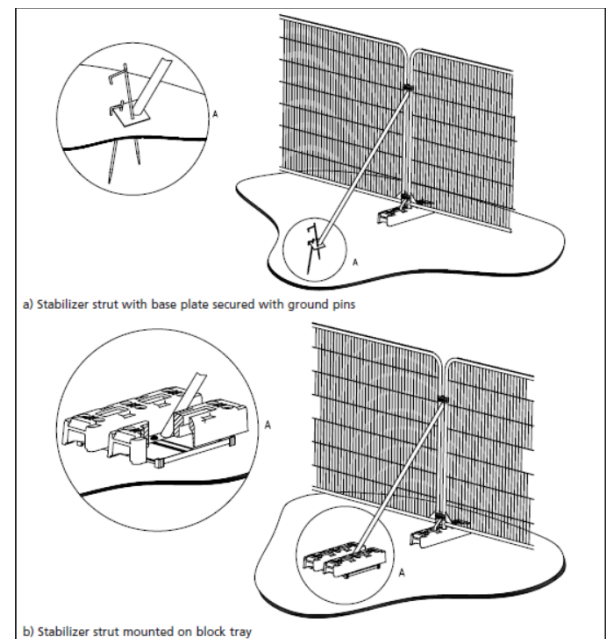
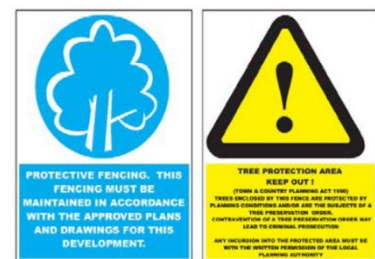
**5.2.5** Where the site circumstances and associated risk of damaging incursion into the RPA do not necessitate the default level of protection, an alternative specification should be prepared by the project arboriculturist and, where relevant, agreed with the local planning authority. For example, 2 m tall welded mesh panels on rubber or concrete feet might provide an adequate level of protection from cars, vans, pedestrians and manually operated plant. In such cases the fence panels should be joined together using a minimum of two anti-tamper couplers, installed so that they can only be removed from inside the fence. The distance between the fence couplers should be at least 1 m and should be uniform throughout the fence. The panels should be supported on the inner side by stabilizer struts, which should normally be attached to a base plate secured with ground pins. Where the fencing is to be erected on retained hard surfacing or it is otherwise unfeasible to use ground pins, e.g. due to the presence of underground services, the stabilizer struts should be mounted on a block tray.

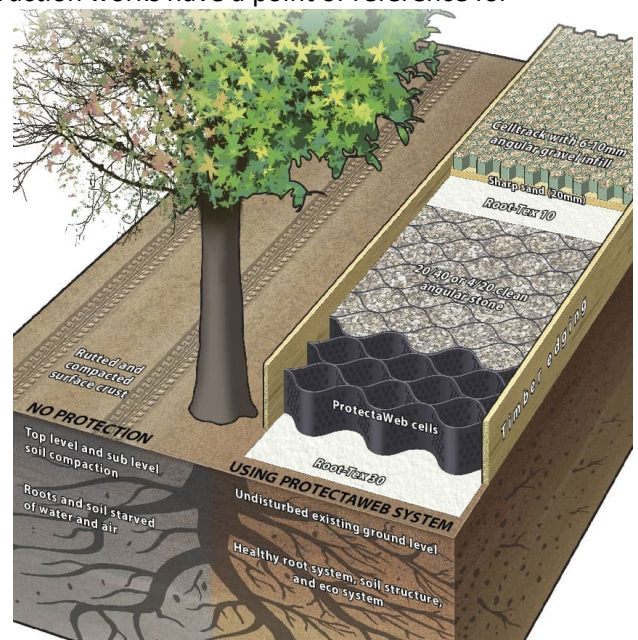
**5.2.7** For pedestrian access within the RPA, the installation of ground protection in the form of a single thickness of scaffold boards over a compressible layer laid onto a geotextile, or supported by scaffold, is likely to be acceptable.

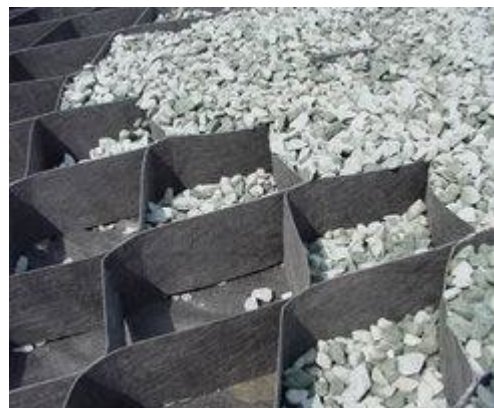
**5.8.3** The most suitable surface will be porous to allow the relatively free movement of gas and water and load spreading to limit compaction damage. The actual specification is an engineering issue that has to be considered in the context of the loadbearing capacity of the soil; this element requires specialised input from the appropriate professional.
