# The Three Daggers, Edington

## Preliminary Ecological Appraisal

June 2025

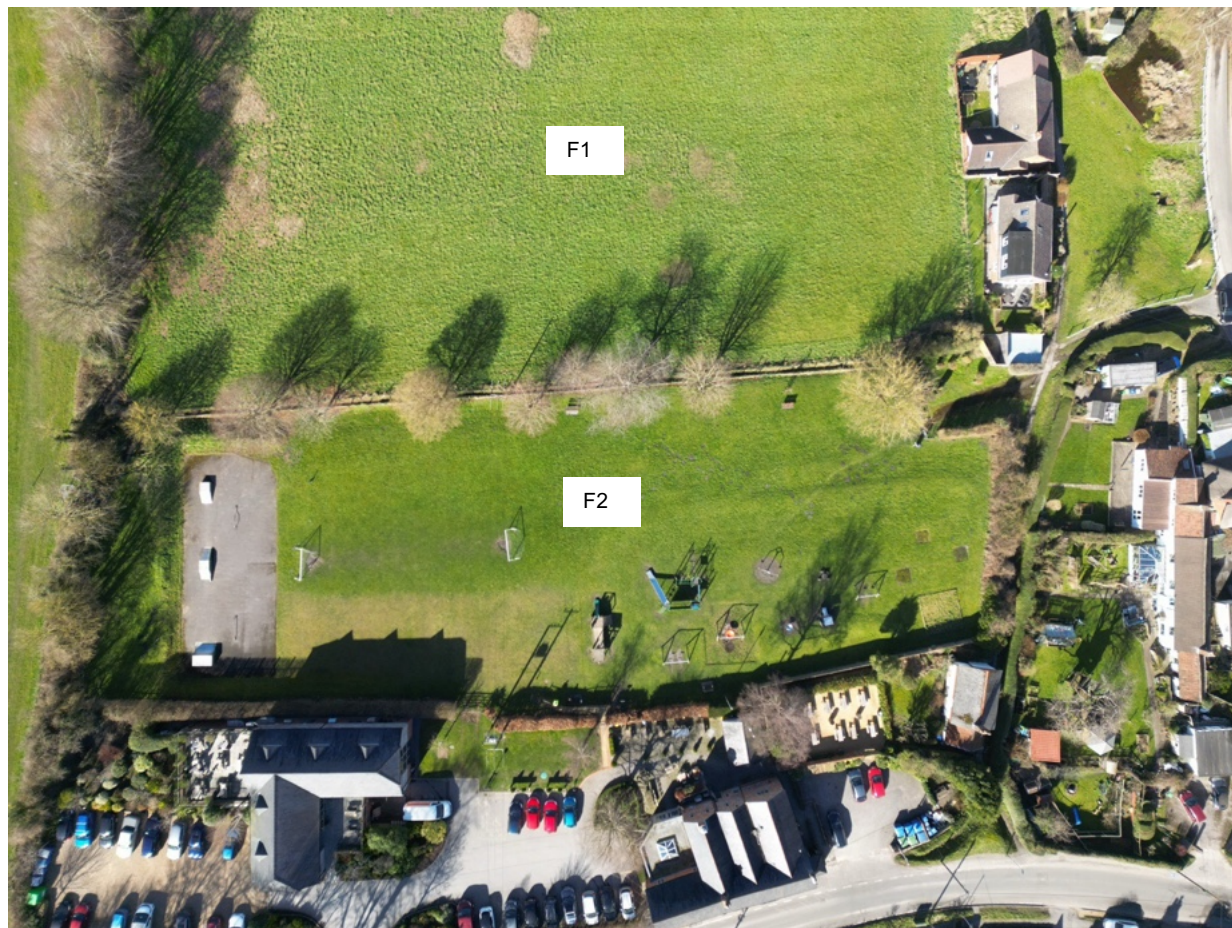
Figure 1: Aerial view of most of the Site

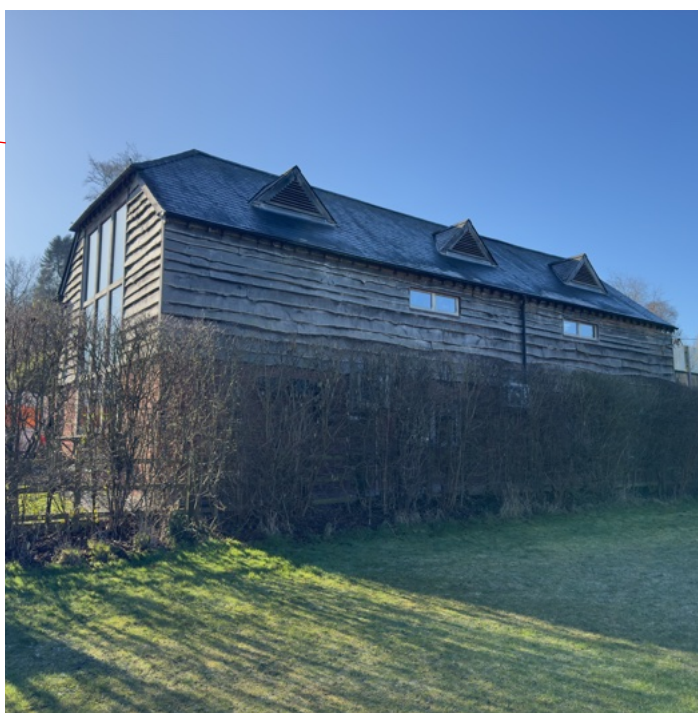
34. Bat roosting features were identified on the western gable end and eastern and northern elevations; these consisted of gaps between overlapping timber boards and gaps between the fascia boards and the timber

boards (Figure 2 & 3). These features were considered to be of high suitability for crevice-dwelling bats only as no roof void was present.

**Figure 3** - The Farm Shops Northern elevation

45. New crevice roosting provision will be provided on the western, eastern and northern elevations of the structure. These will comprise crevices between external timber cladding and either internal timber or internal bitumen lined sections with 5cm x 2cm gaps between external boards included for access. These will measure approximately 50cm x 50cm areas, large enough area to provide roosting opportunities to multiple species and roost types. Additionally, single integrated bat boxes will also be included within the northern, western and eastern elevations. These will create slightly varying internal environments throughout the year. Dimensions will reflect the crevices measurements of the existing fascia boards wherever possible.

- c. three roosts (including two hibernation boxes) on the northern elevation.
47. Further surveys are to be undertaken to characterise any existing roosts, if present. This will further inform the nature of the roosting provision only in the context of whether it forms a mitigation or enhancement measure.
