**Preliminary Roost Appraisal & Barn Owl Survey, Outbuilding 6  
Lower Bridmore Farm, Berwick St John, Salisbury,  
Wiltshire SP7 0HG**

**Prepared for:** TFH Reeve on behalf of Mr and Mrs Marris

**Prepared on:** 10/07/2025

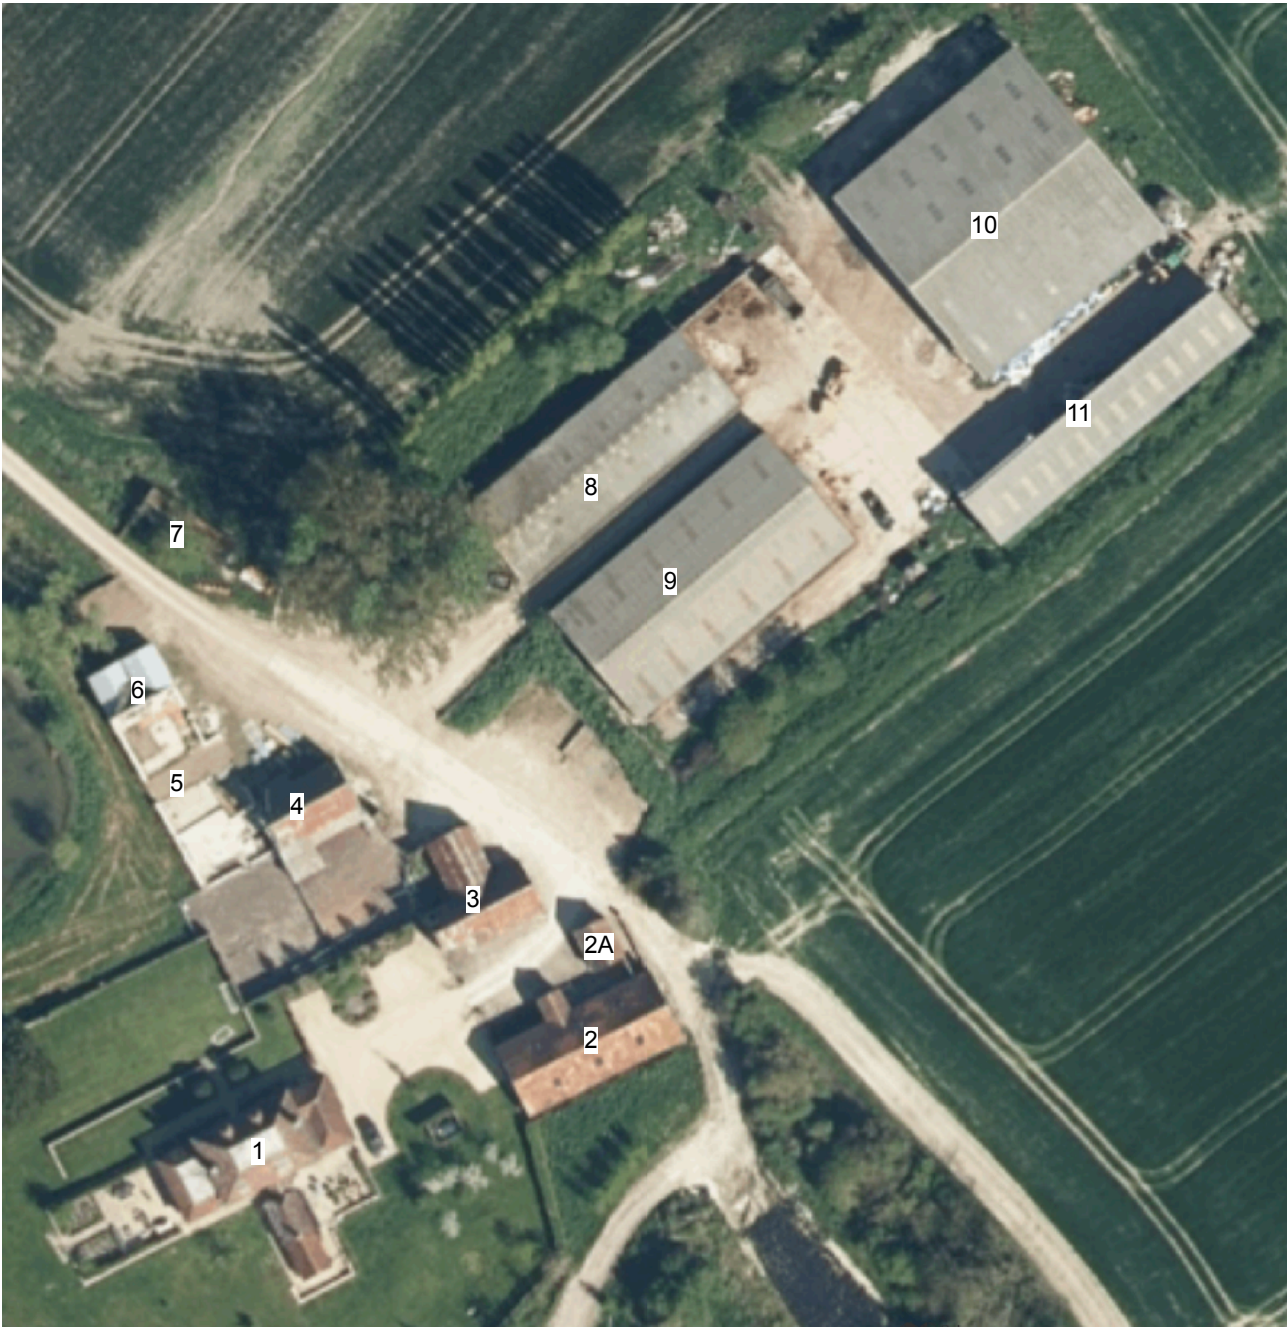
Plan 2 - Existing site plan

- 1 - Farmhouse
- 2 - Stone barn pitched clay tiled roof. No loft. Loft void eastern end. Accessed via opening east gable end
- 2A - Stone barn pitched clay tiled roof. No loft
- 3 - Stone & brick barn, cross pitched corrugated sheet roof, hay loft & open to the ridge. Open window & doors
- 4 - Barn - Single wooden panels set on brick plinth. Pitched corrugated sheet roof. No loft. Open windows & doors
- 5 - Building removed by previous owner
- 6 - Double skin wooden panels set on brick plinth. No loft. Open windows & doors
- 7 - Field shelter pitched clay tiled roof. No loft. Open on north, east and south elevations
- 8 - Modern Agricultural Building (MAB)
- 9 - MAB
- 10 - MAB
- 11 - MAB

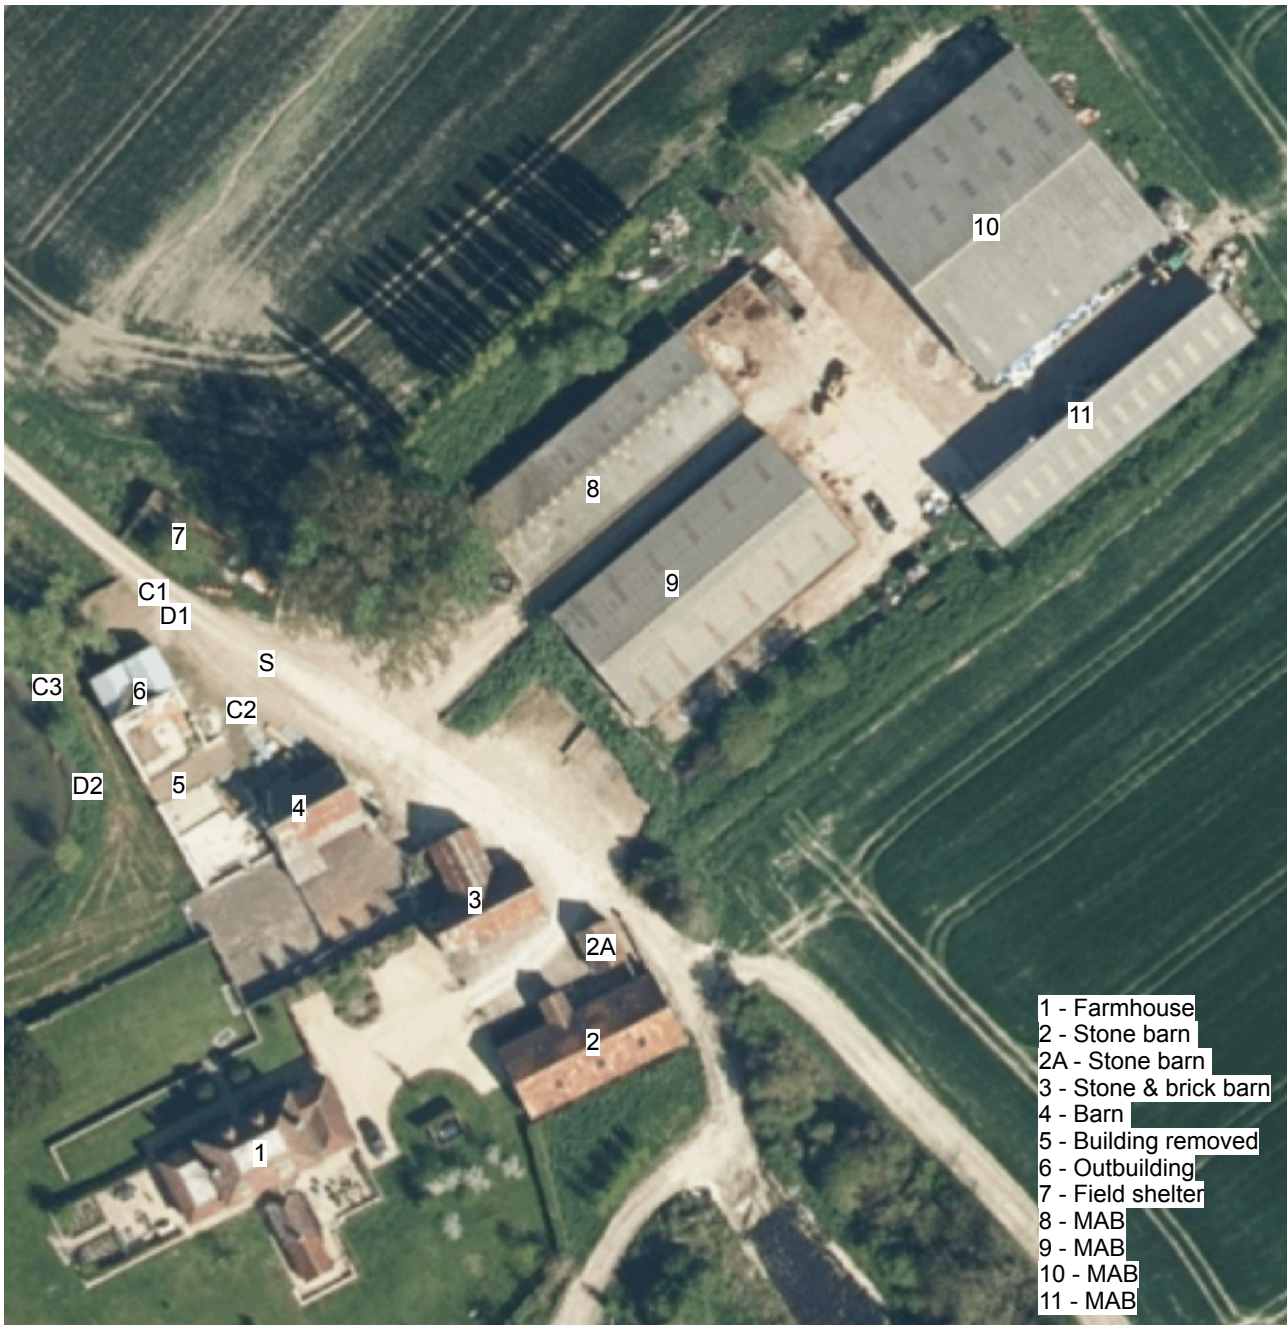
Plan 4 - Location of IR cameras, surveyor and bat detectors during dusk emergence surveys 12/05/2025

C1 = Camera 1 with Batbox baton - to view the northeast and northwest elevations of the Outbuilding 6

D2 = Song Meter Mini Bat detector 2 was placed on the southwest side of the site

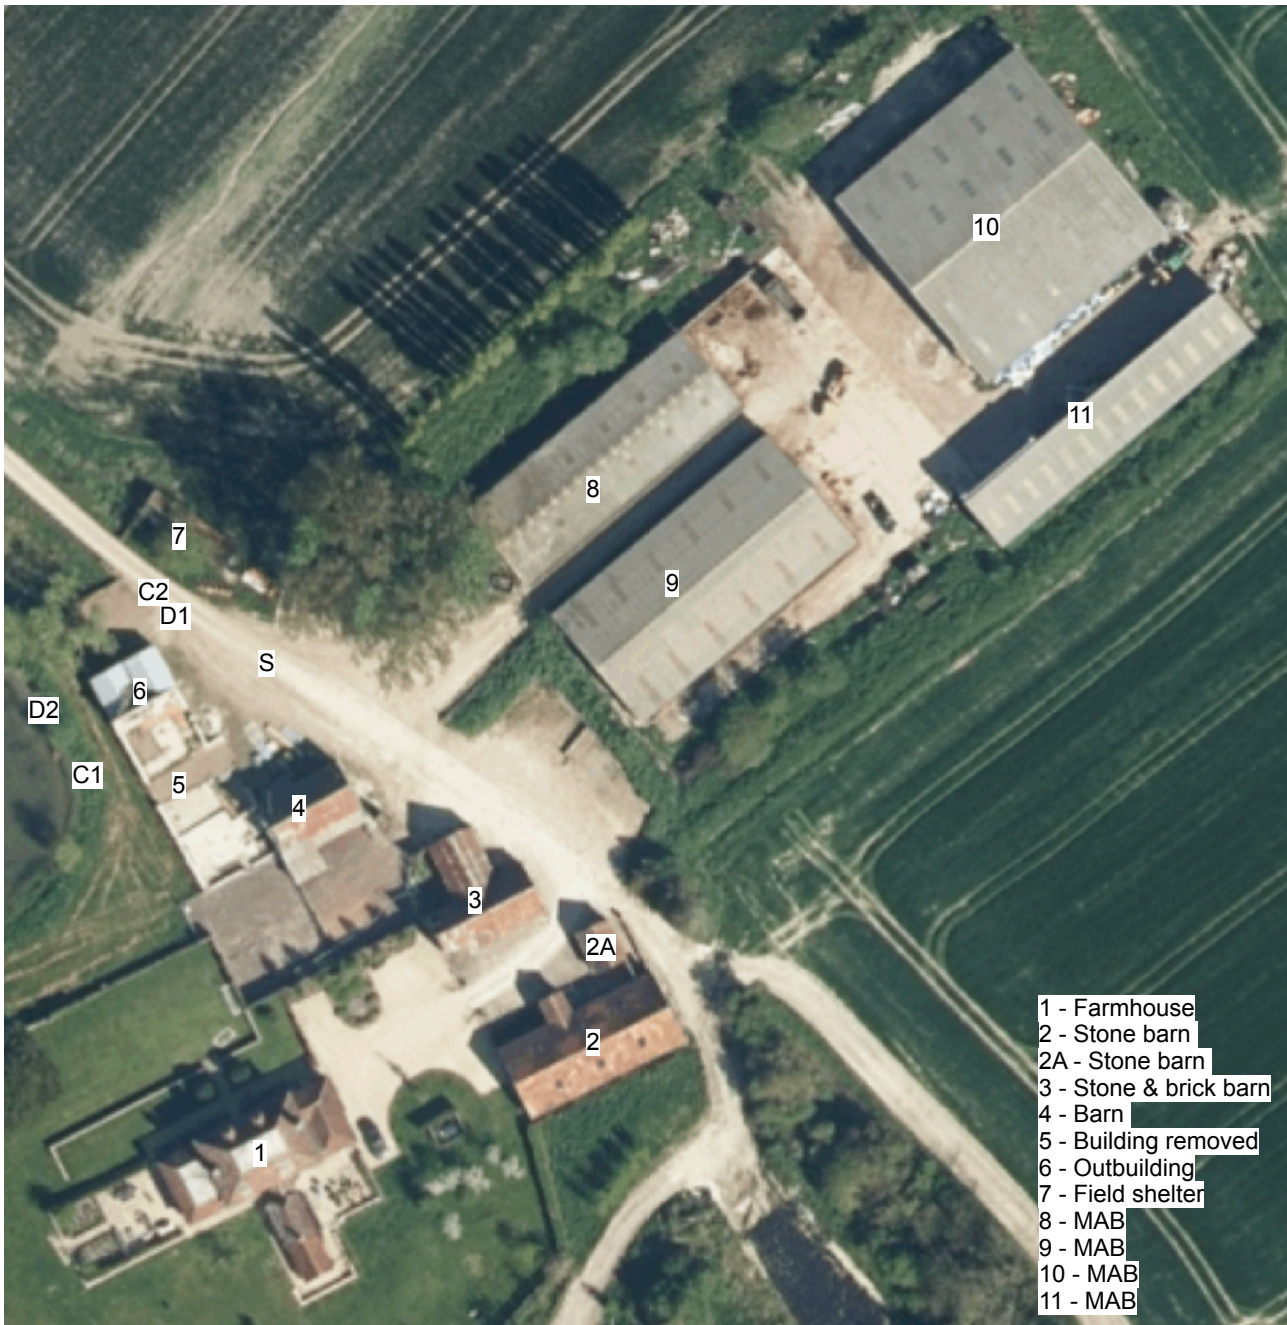
Plan 5 - Location of IR cameras, surveyor and bat detectors during dusk emergence surveys 02/06/2025

C1 = Camera 1 with Batbox baton - to view the southeast and southwest elevations of the Outbuilding 6

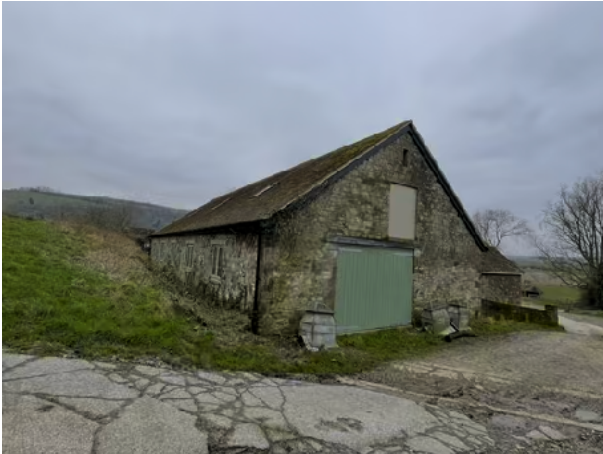
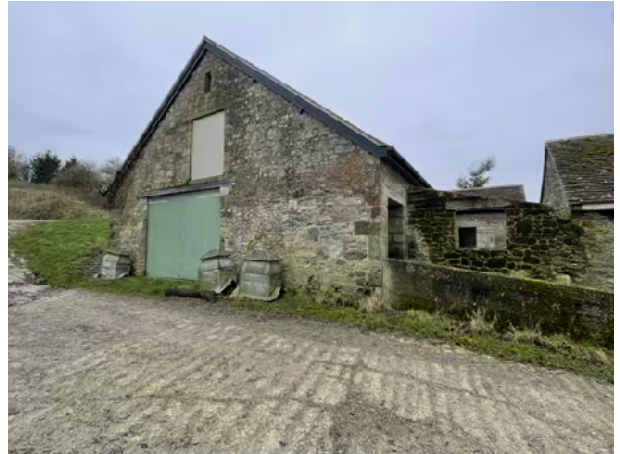
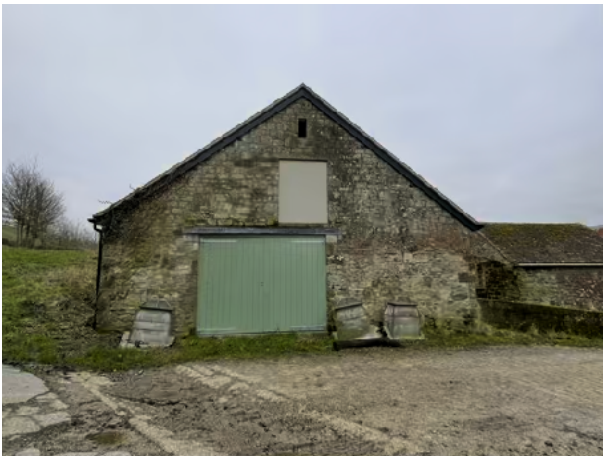
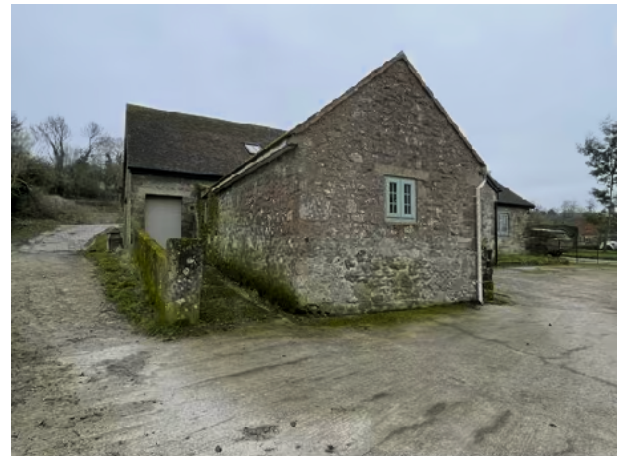
Outbuilding 2 is constructed of stone; it has a pitched clay tiled roof, with Velux windows. The tiles are lined with breathable membrane. The roof is open to the ridge at the western end. There is a loft void at the eastern end. There is a small opening on the east and west gable ends. The window frames, door frames and soffits are wooden. The building was re-roofed in 2012. The building is in a good state of repair.

The outbuilding has high levels of natural light throughout the barn. The loft void at the northeastern end of the building also has high light levels from the Velux window. No evidence of bats (staining, bat droppings, feeding remains and live or dead bats) was found. There are no gaps between the rafters or holes in the stone or brickwork that could be used by crevice-dwelling bats. There is no staining on the breathable membrane. Externally, there are no raised or missing roof tiles.

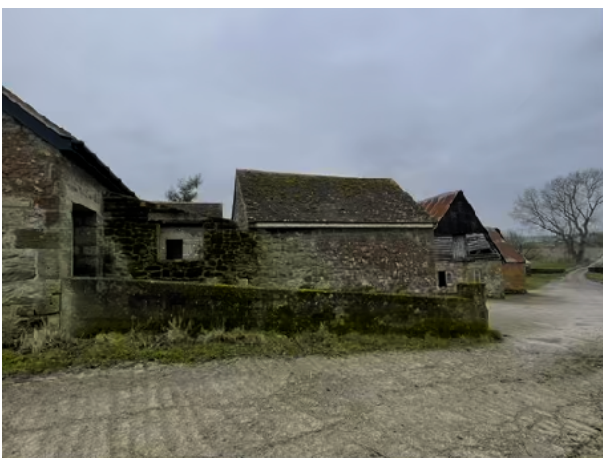
Figure 5 - Outbuilding 2A

Outbuilding 2A is constructed of stone; it has a pitched clay tiled roof, lined with bitumen underfelt. It is open to the ridge. The window and door frames are wooden. The building is in a good state of repair.

The owner of the site reported that scattered bat droppings had previously been at the eastern end of the building. The most likely access is via the missing mortar on the ridge tiles. The building will be retained.

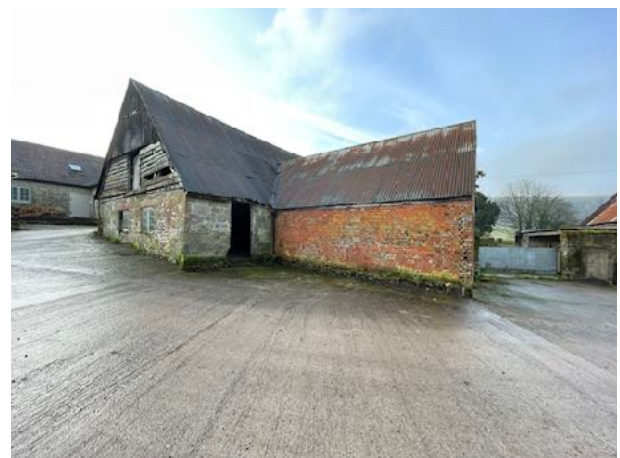
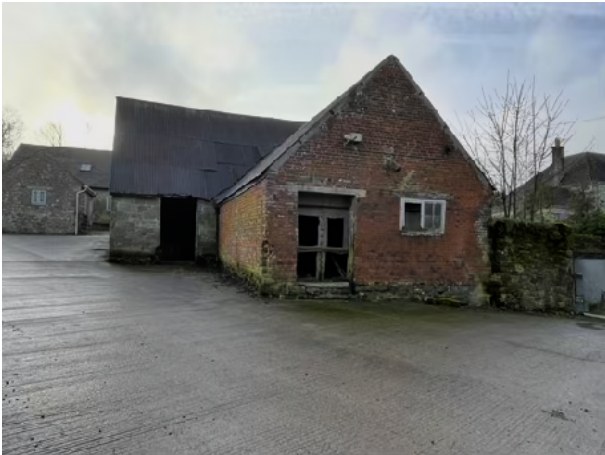
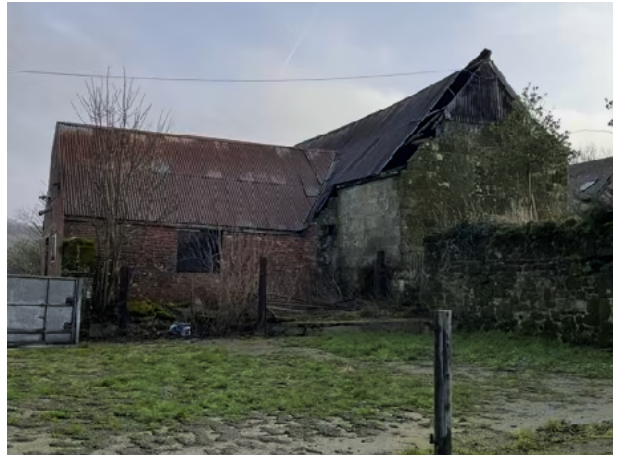
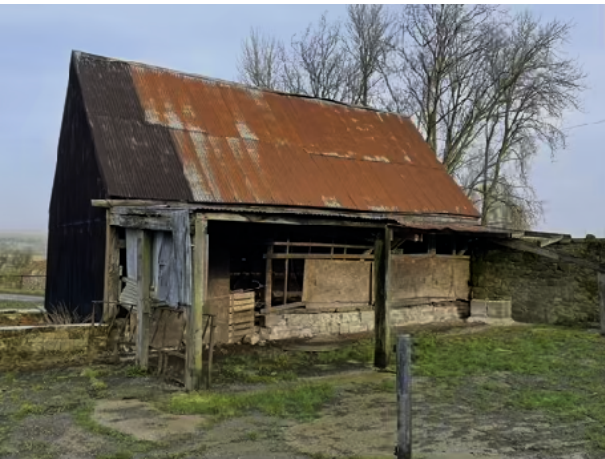
Outbuilding 3 is constructed of stone, with a later brick extension. It has a cross-pitched corrugated iron sheet roof. All of the doorways and windows are open. There is a hay loft area that is partially open. The outbuilding is in a poor state of disrepair. It forms part of an upper courtyard set of buildings adjacent to the Grade II Listed farmhouse.

Outbuilding 3 has high levels of natural light and is extremely draughty from the open windows and doorways. There are no gaps between the rafters or holes in the stone or brickwork that could be used by crevice-dwelling bats. No evidence of bats (staining, bat droppings, feeding remains and live or dead bats) was found.

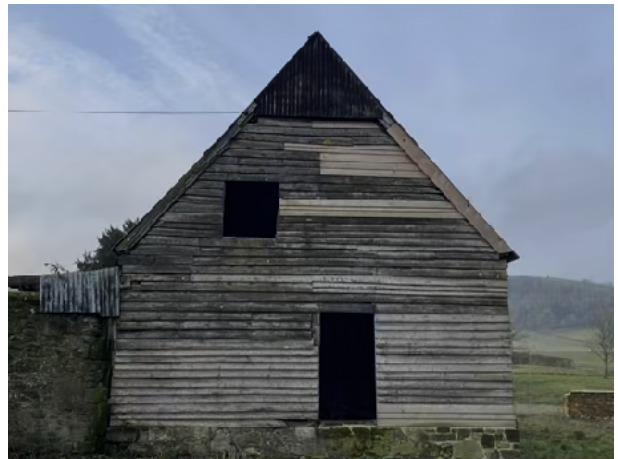
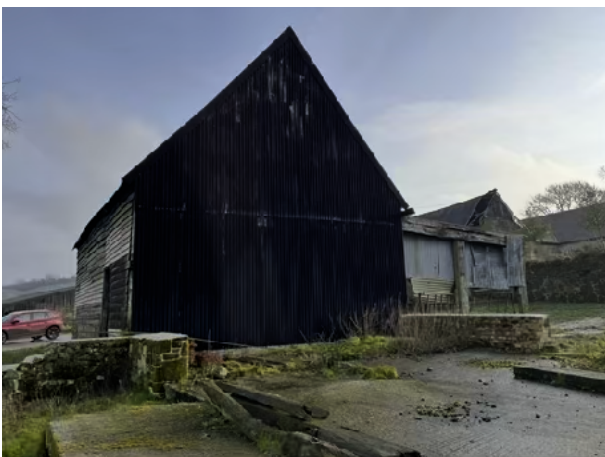
Outbuilding 4 is constructed of single-skin wooden panels set on a brick plinth. It has a pitched corrugated iron sheet roof. It is open to the ridge. All of the windows and doorways are open. The building is in a poor state of disrepair.

Outbuilding 4 has high levels of natural light and is draughty from the open window and doorways. There are no gaps between the rafters that could be used by crevice-dwelling bats. No evidence of bats (staining, bat droppings, feeding remains and live or dead bats) was found.

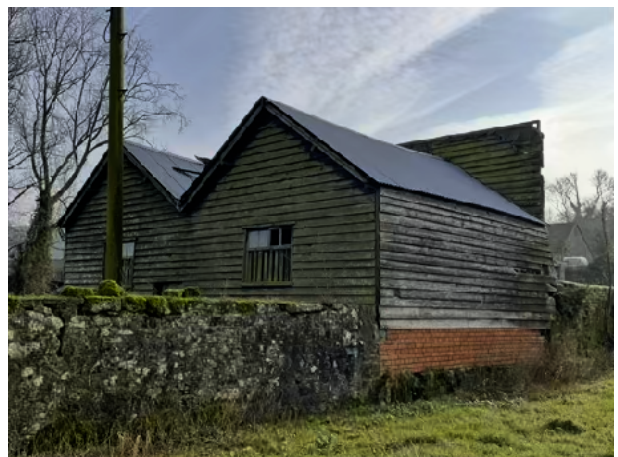
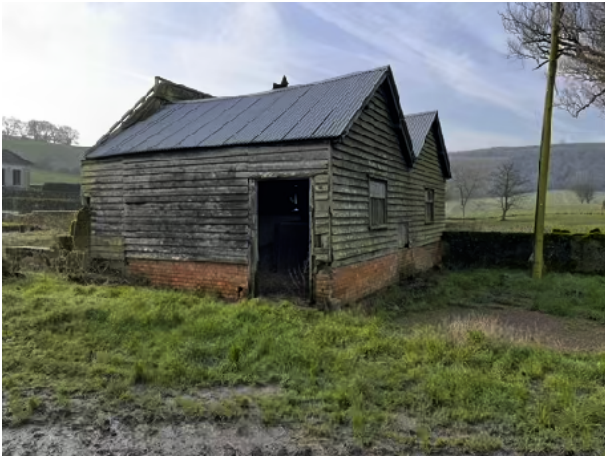
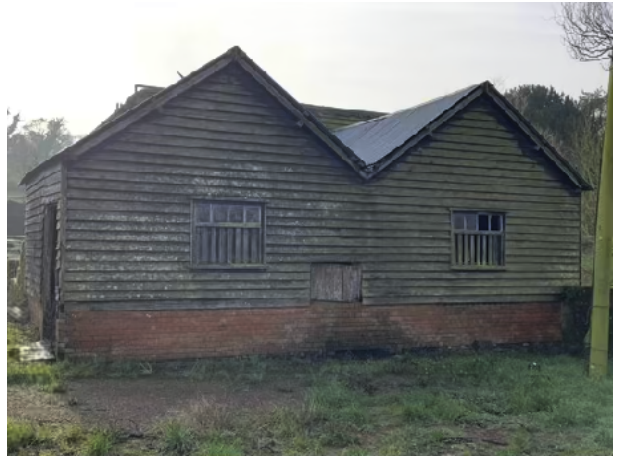
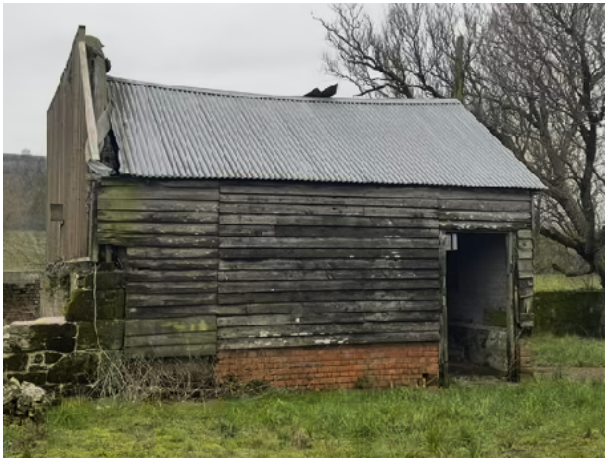
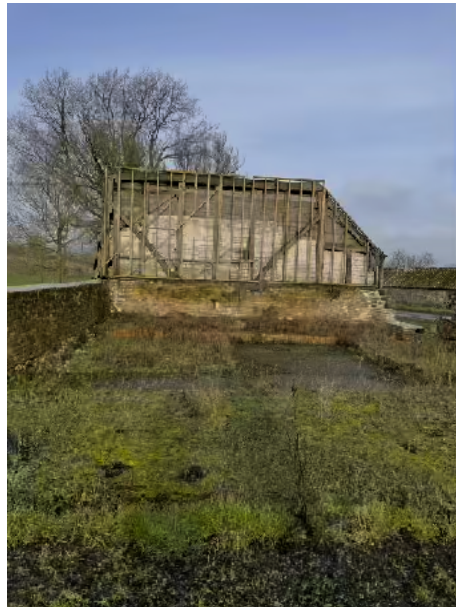
Outbuilding 6 is constructed of double-skin wooden panels set on a brick plinth. It has a double-pitched corrugated iron sheet roof. The window and door frames are wooden. The doorways and windows are partially open. There is no loft space. The building is in a poor state of disrepair.

There are no gaps between the rafters that could be used by crevice-dwelling bats. No evidence of bats (staining, bat droppings, feeding remains and live or dead bats) was found within the building during any of the surveys. However, the gaps between the wooden boards have a low potential to be used by crevice-dwelling bats.

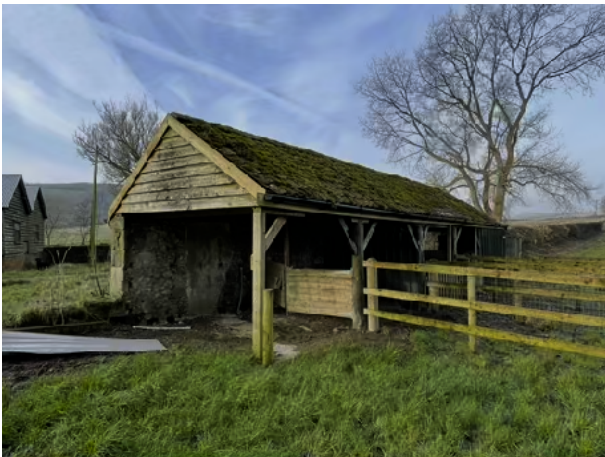
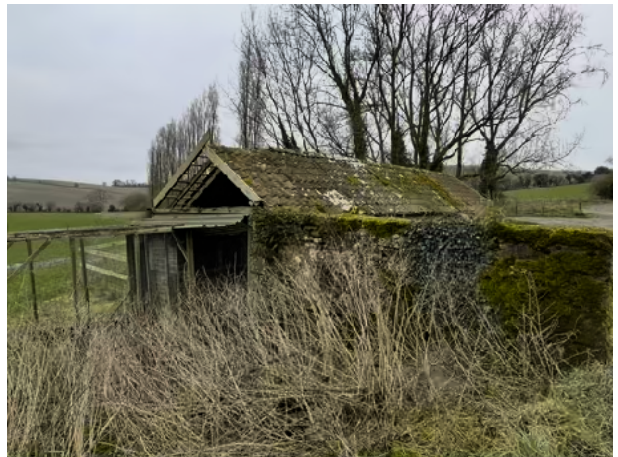
Outbuilding 7 is constructed of a stone elevation with wooden posts. It has a pitched clay tiled roof. It is open on the north, east and south elevations. The building is in a poor state of disrepair.

Outbuilding 7 was found to have a negligible potential for use by bats.

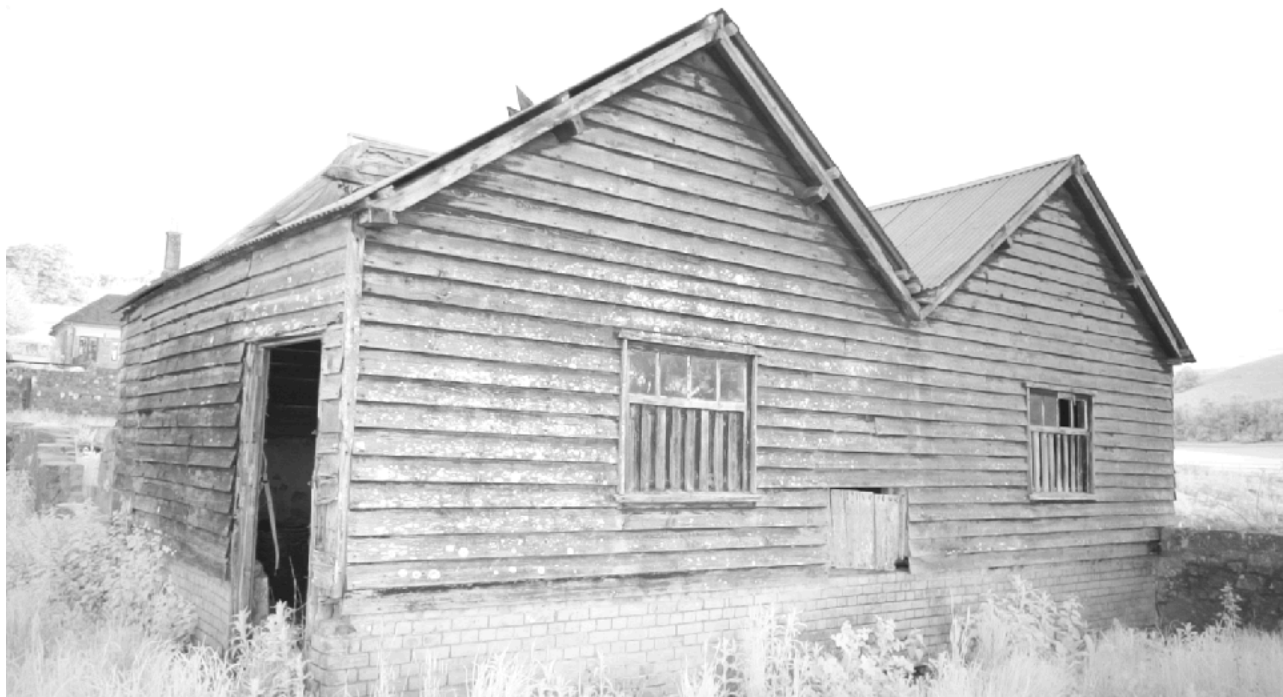
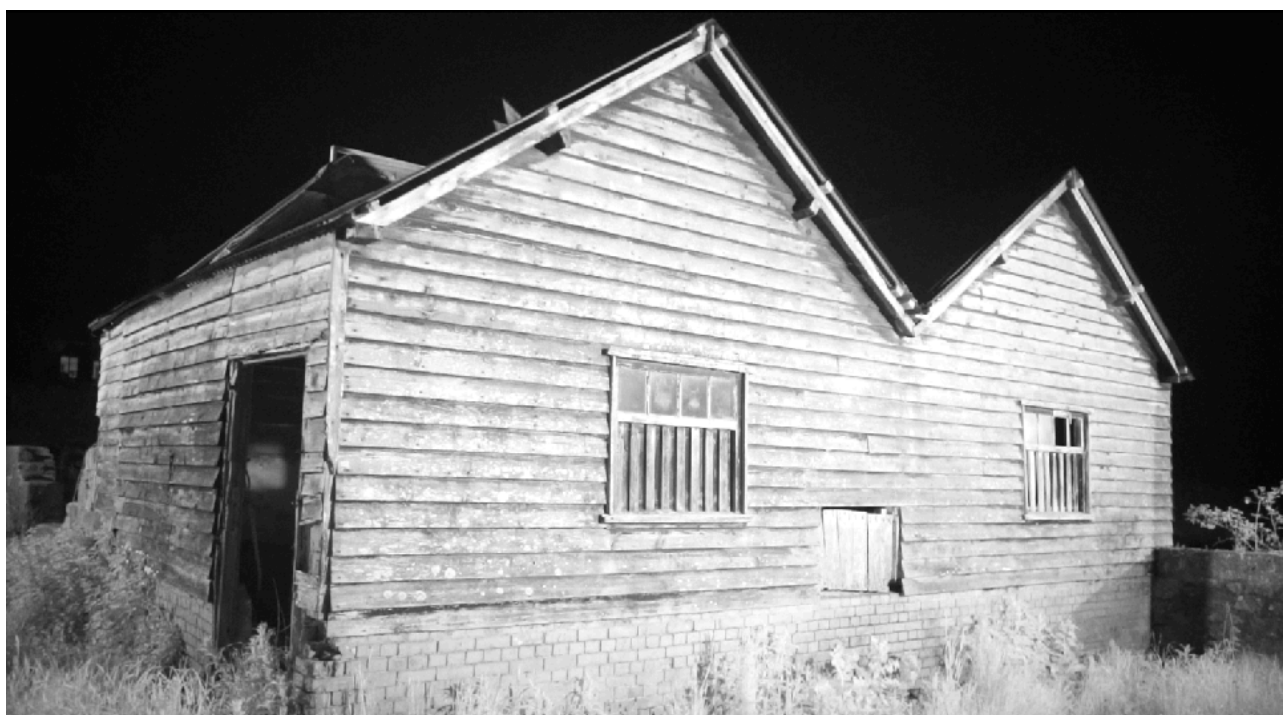
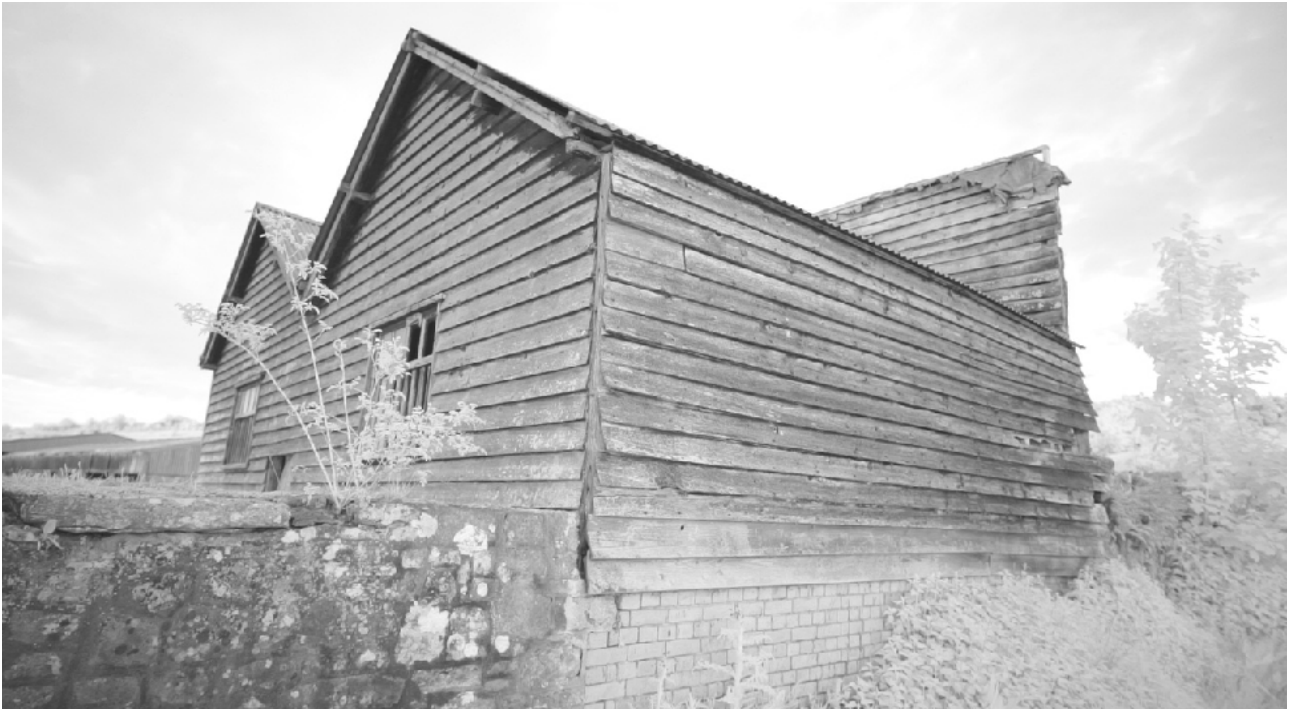
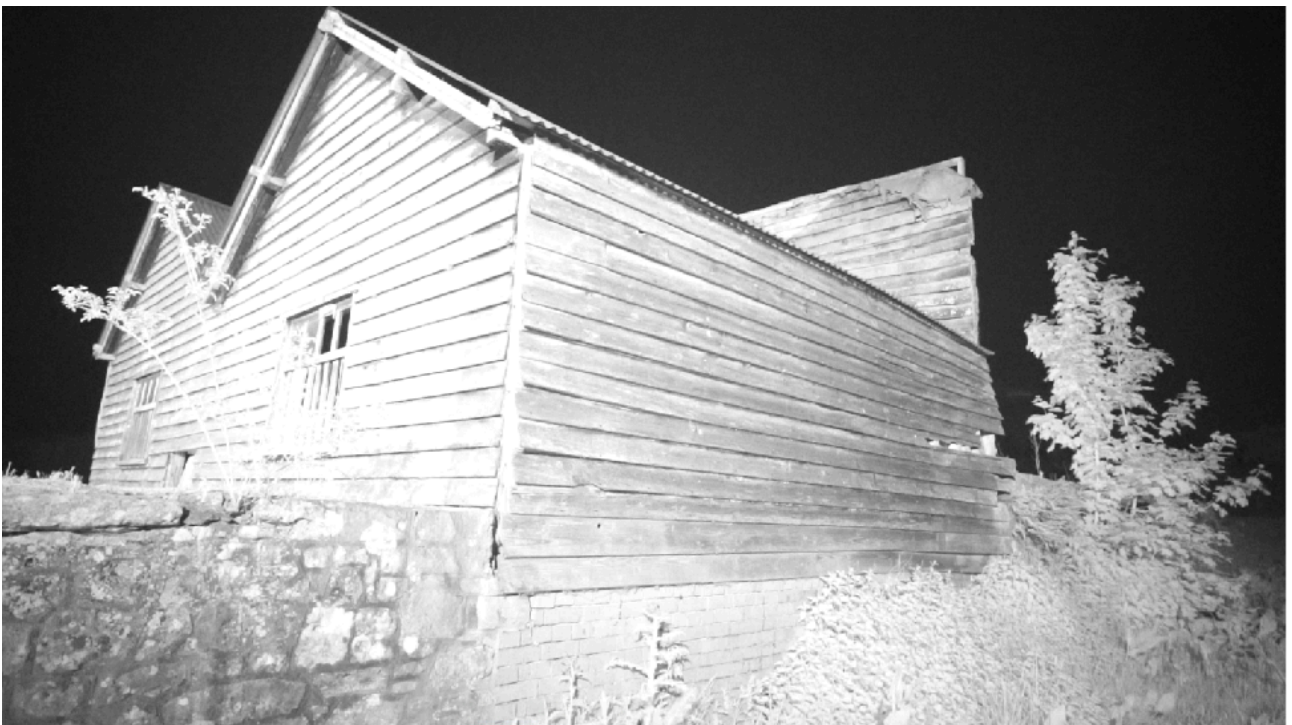
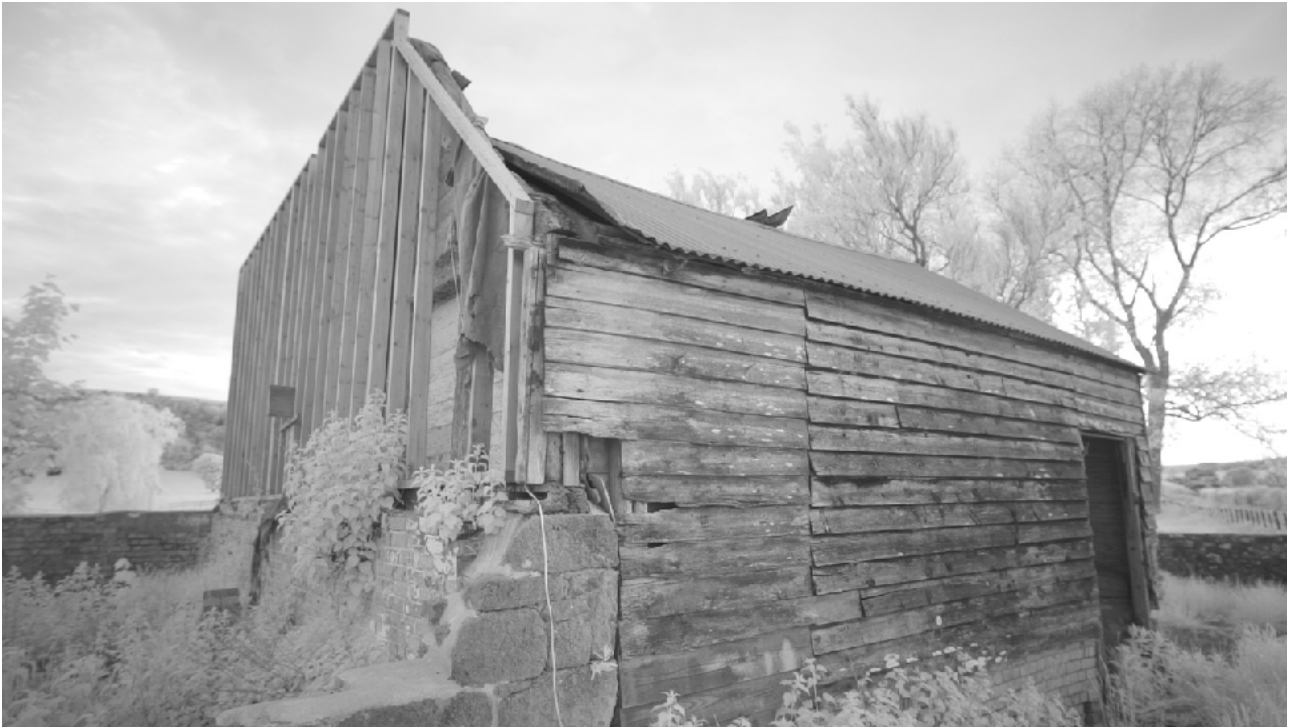
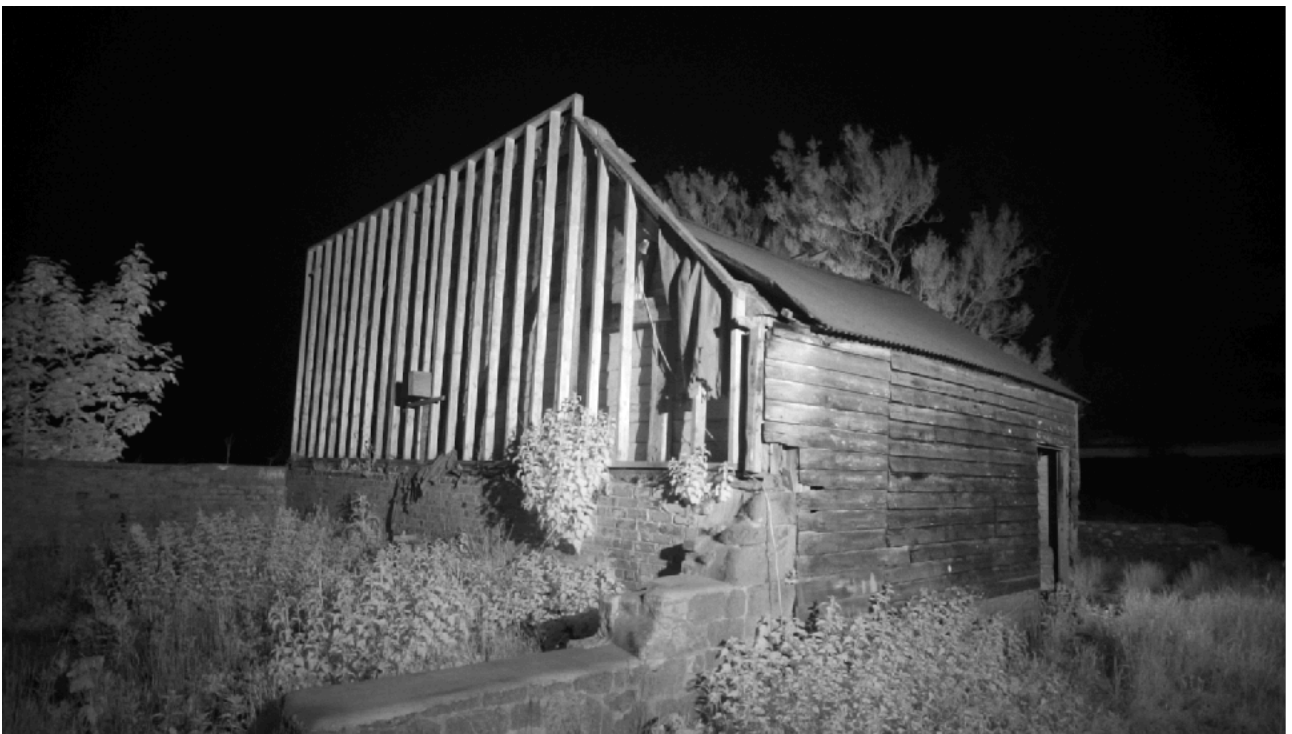
- No bats were observed emerging from the outbuilding. Common pipistrelle and Soprano pipistrelle bats are feeding around the outbuilding.

Figure 19 - Camera 1 Northeast and northwest elevations of Outbuilding 6. Start of survey 12/05/2025

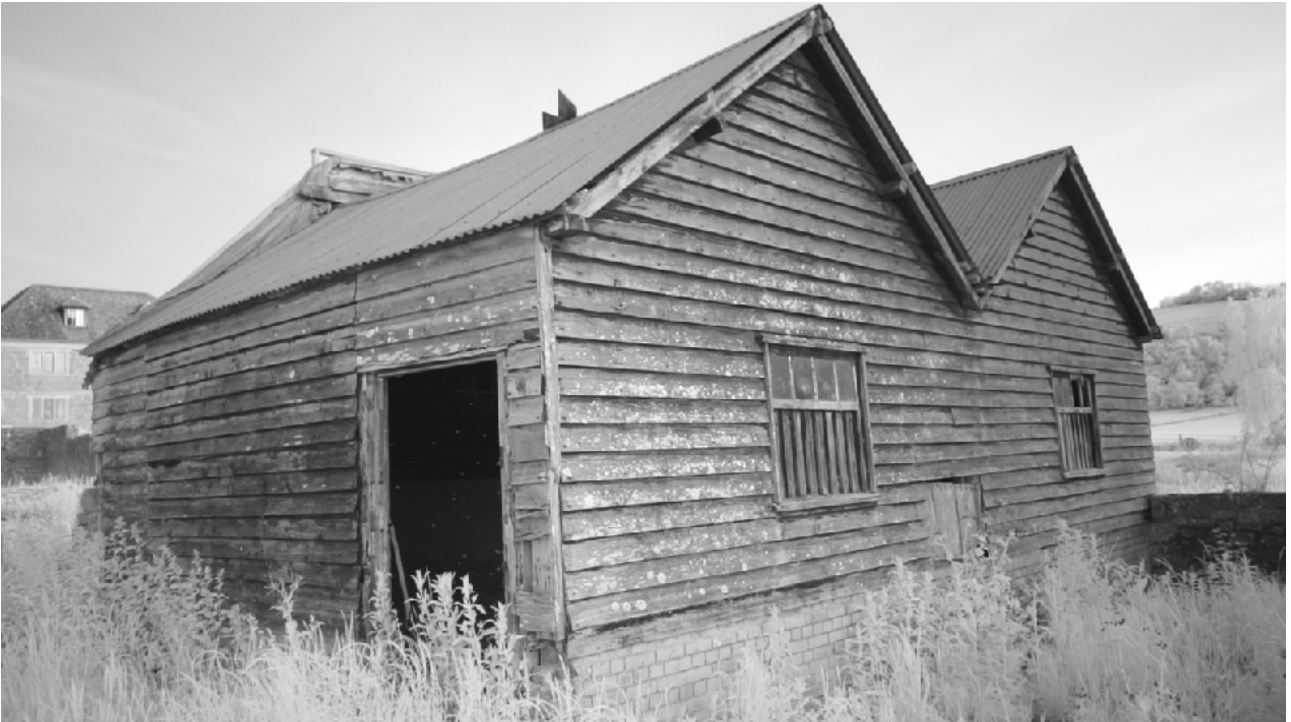
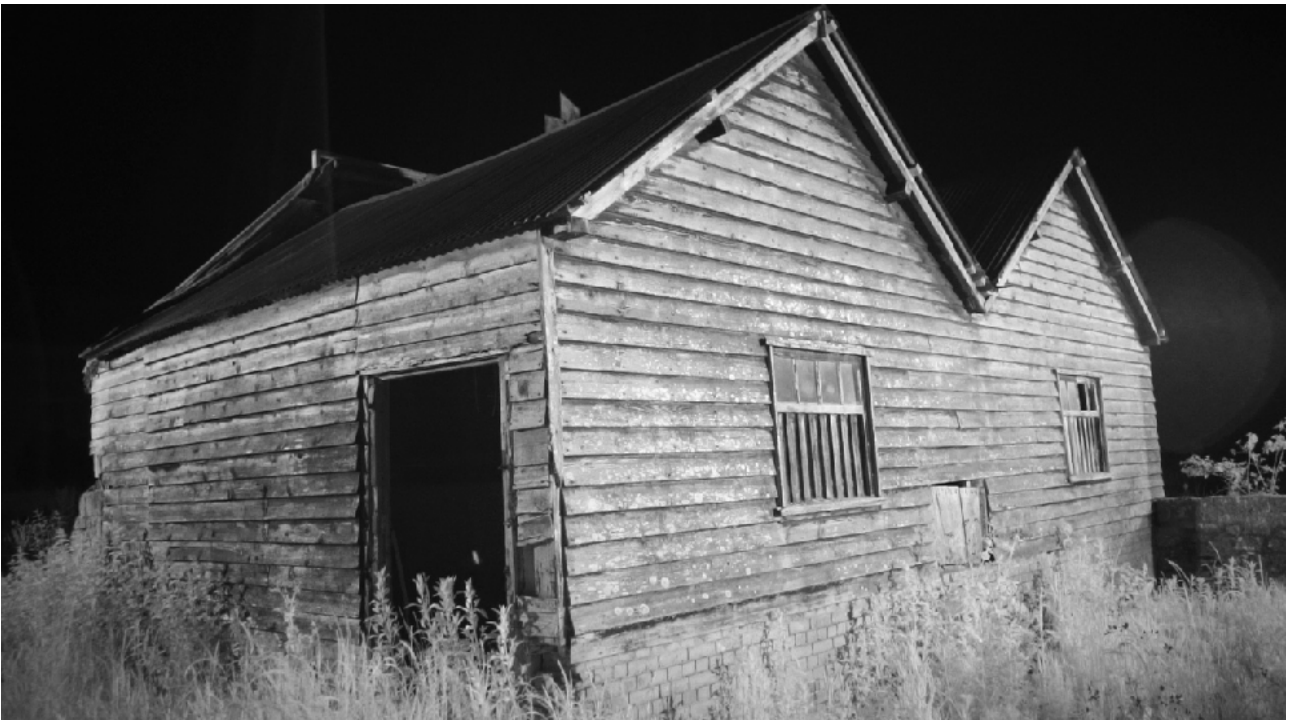
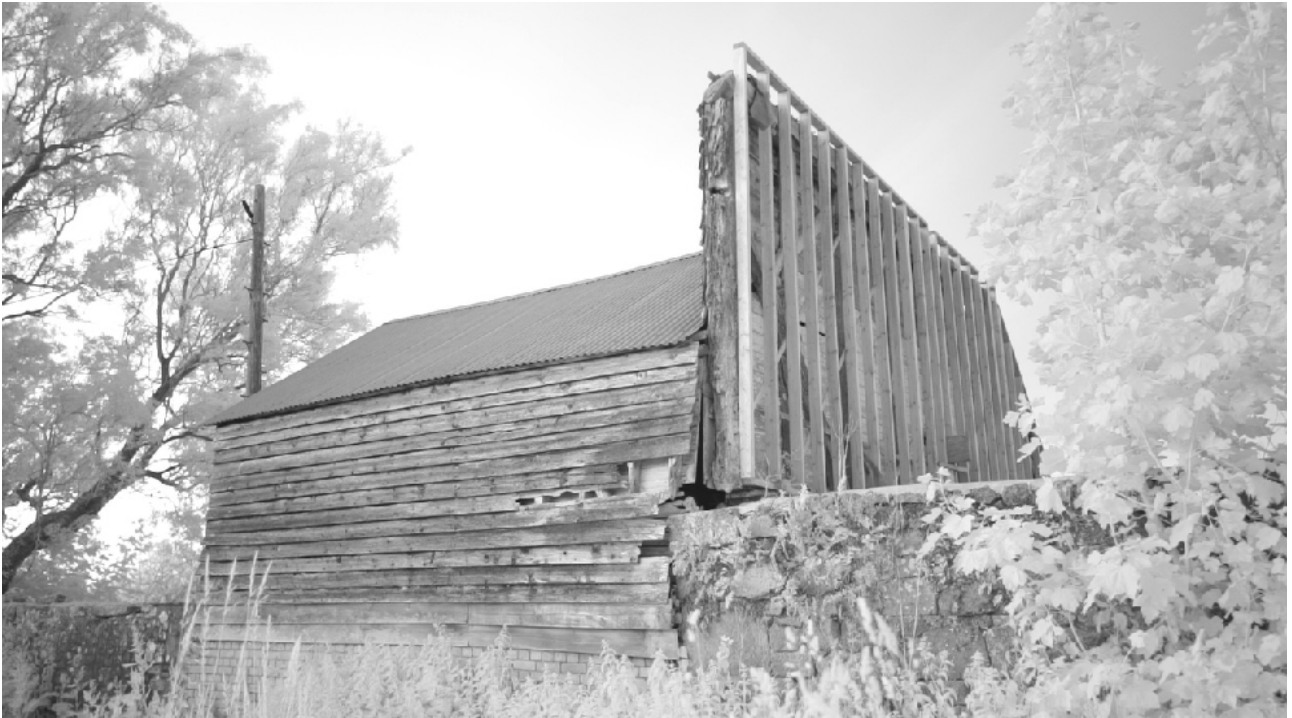
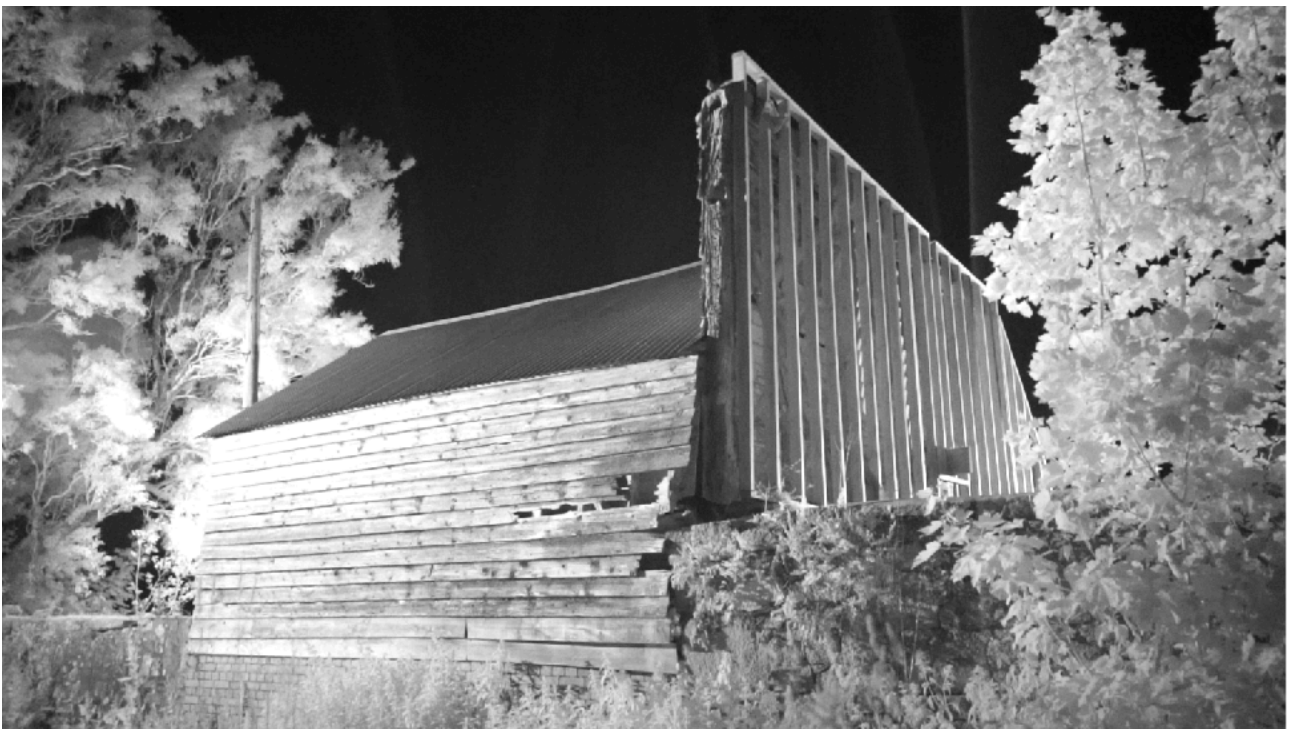
- No bats were observed emerging from the outbuilding. Common pipistrelle and Soprano pipistrelle bats are feeding around the outbuilding.

Figure 25 - Camera 1 Northeast and northwest elevations of Outbuilding 6. Start of survey 02/06/2025
