## SURFACE WATER DRAINAGE STRATEGY

Proposed Residential Development, Manor Farm,  
Collingbourne Kingston, Marlborough, Wiltshire on  
Behalf of Ben and Sarah King

Date: October 2025  
Issue No. 2

**Document Title:** Surface Water Drainage Strategy

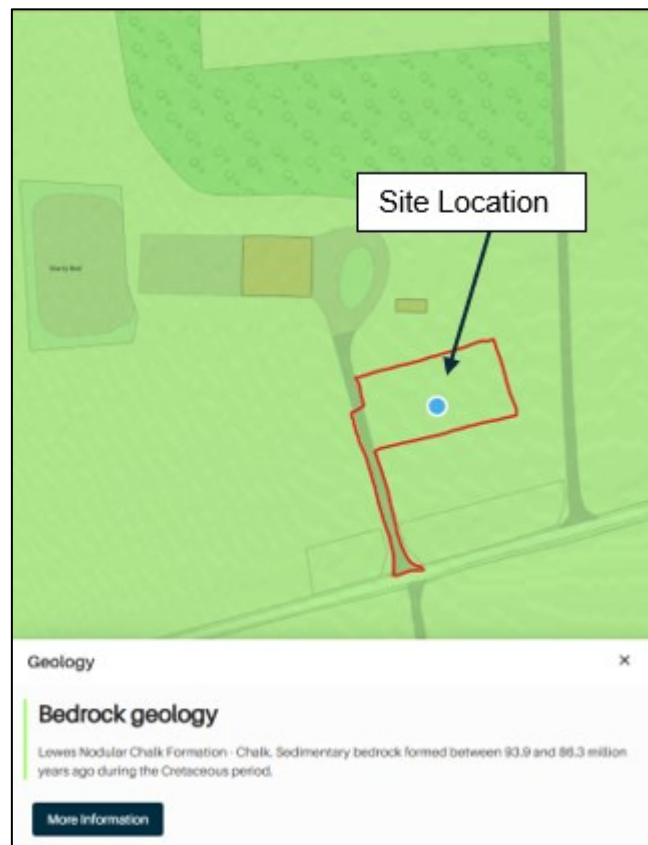
**Figure 2.1 BGS Bedrock Geology Map**  
Source: <https://geologyviewer.bgs.ac.uk>

- 2.7 British Geological Survey (BGS) mapping indicates that the site is underlain by bedrock geology comprising Lewes Nodular Chalk Formation. No superficial geology has been identified on site. Refer to Figure 2.1 below.

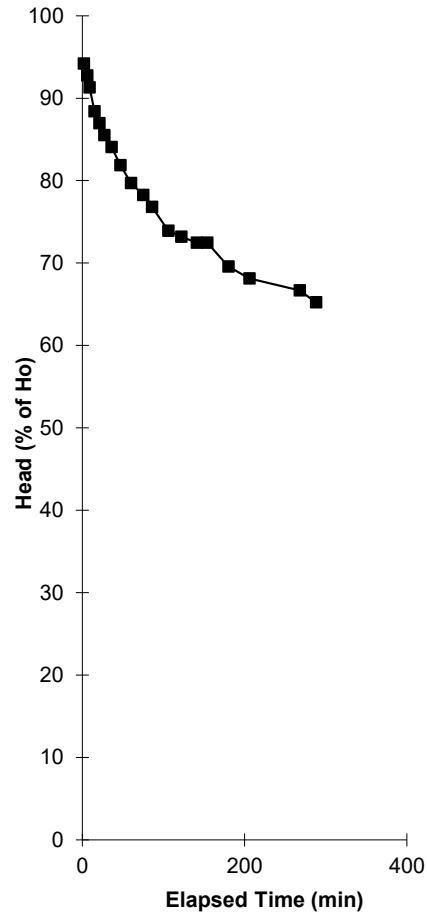
T75 75  
T25 25  
T75-25 98.500 Derived from Best Fit

Infiltration testing was undertaken in TPSK1 within the shallow soils of the Lewes Nodular Chalk Formation as agreed with the Client. Due to 75% drainage not being achieved during the first test, the two subsequent tests were not undertaken. TPSK1 did not achieve full soakage in accordance with BRE DG 365 and an infiltration rate was not calculated for this shallow trial hole location (1.00m bgl deep).

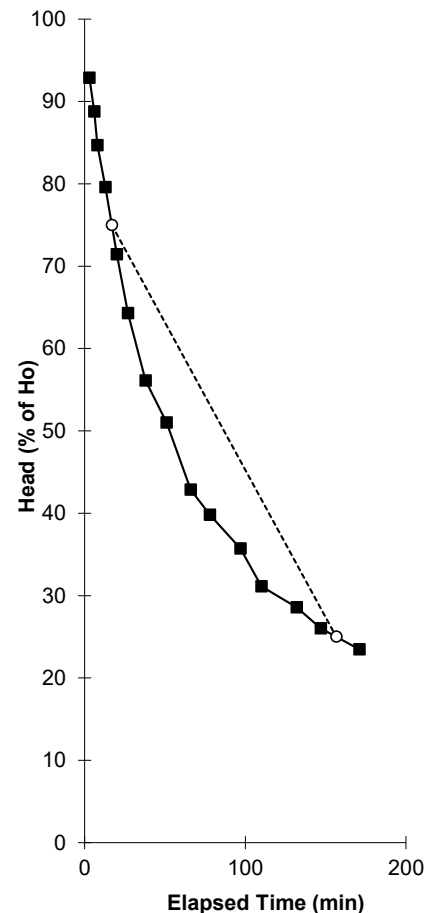
| T75 | 16.938 | 75 |
| T25 | 156.600 | 25 |

Infiltration testing was undertaken in TPSK2 within the soils of the Lewes Nodular Chalk Formation as agreed with the Client. Three full tests were undertaken, each test achieving >75% drainage head of water, and therefore the testing was in full compliance with BRE DG 365. Infiltration rates were calculated between 1.7E-05m/s and 1.9E-05m/s.

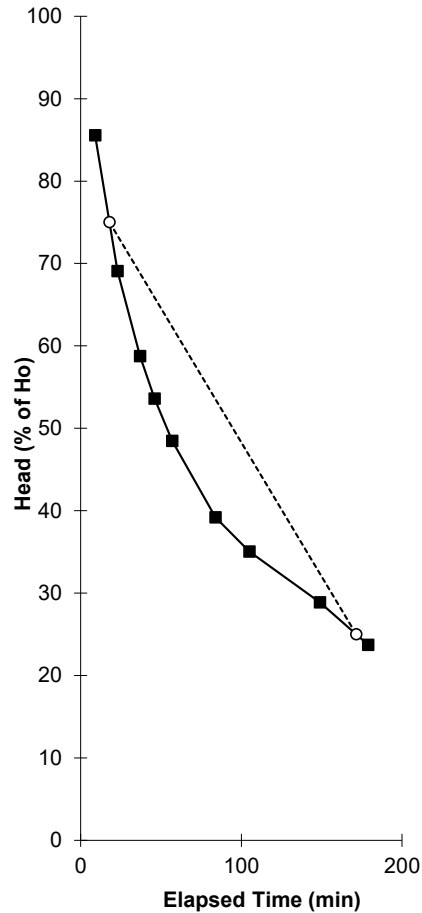
T75 17.969 75

T25 171.500 25

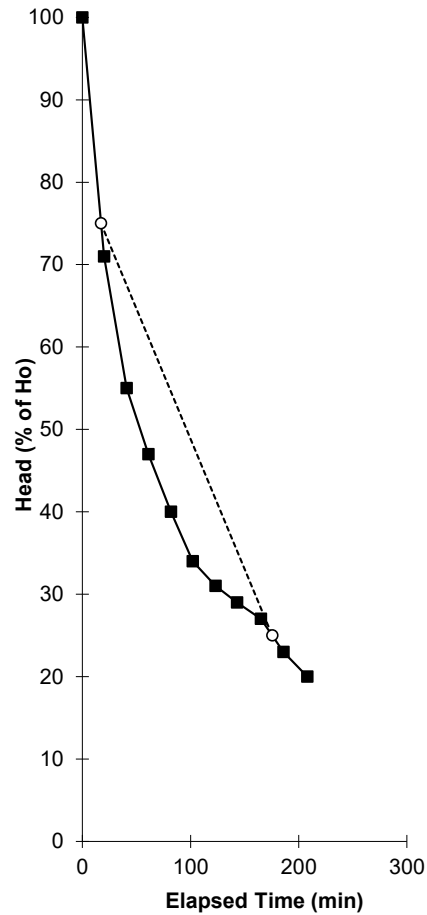
T75 17.241 75

T25 175.500 25

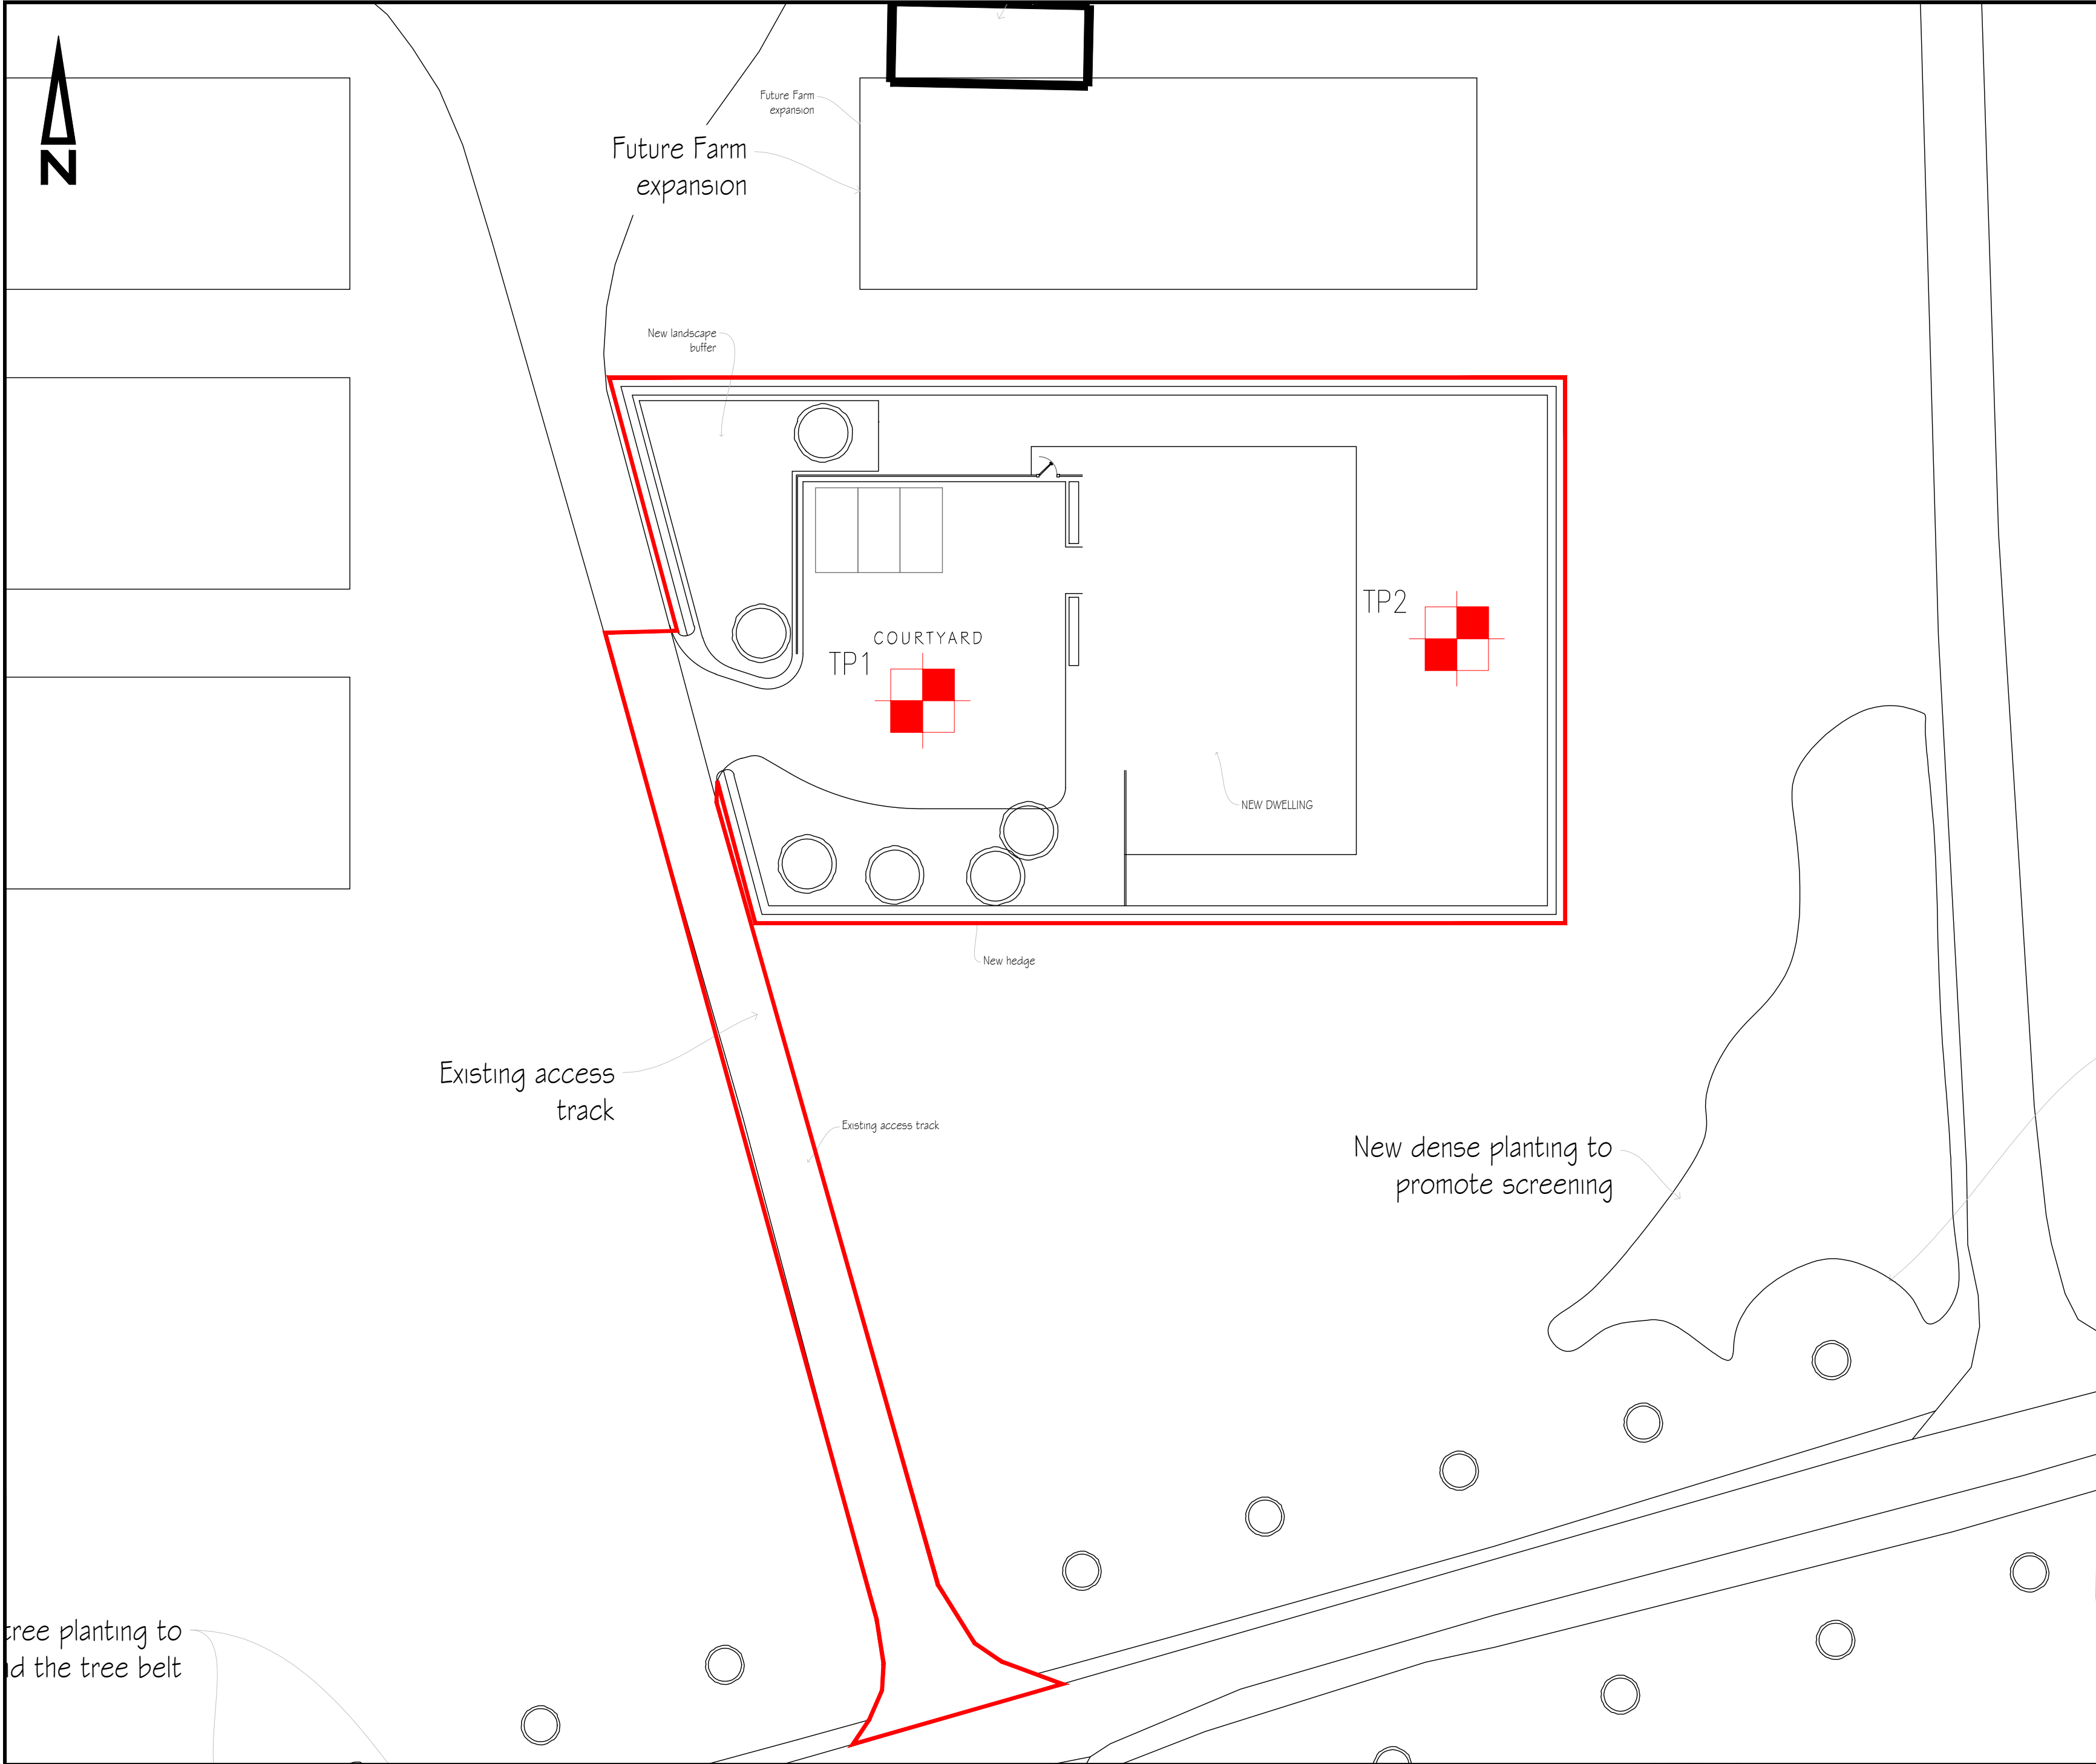
- Site boundary
- TP1 Trial pit location and reference
- TP2 Trial pit location and reference
