# The Corner Cottage, Shaftesbury

Bat Survey Report  
Jack Mogridge

| Document: | Bat Activity Survey Report |
| Project: | The Corner Cottage, New Road, Donhead St Andrew, Shaftesbury, SP7 9EG |

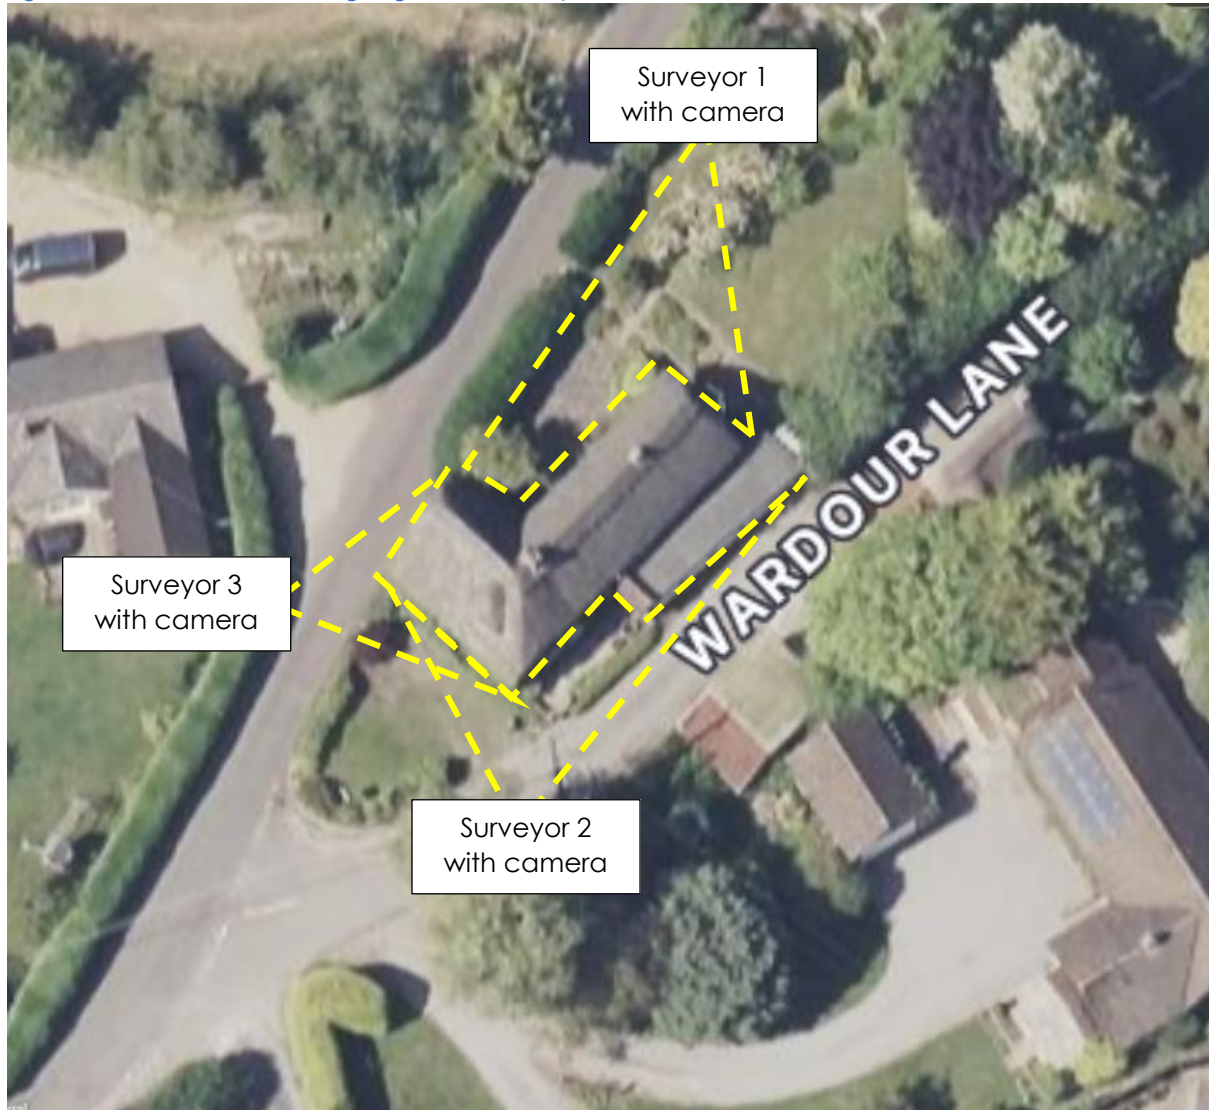
Figure 2. The location and viewing angles of the surveyors.

The surveyors were located in such a way as to achieve coverage of the required areas of the buildings during the survey. See Figure 2, below, for the location.
