8 - Flight Commander's Office

Appendix E

Detailed advice for the modification and repair of buildings

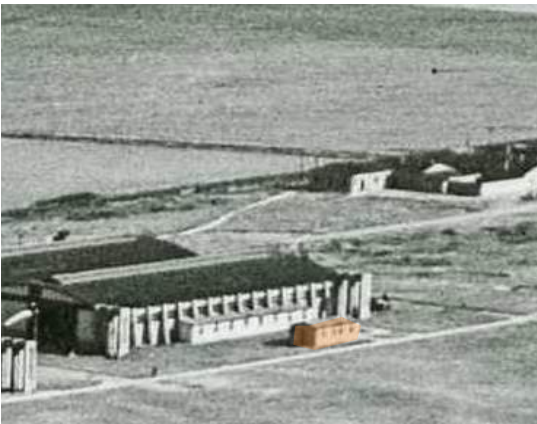
c.1923-1925 (RAF Museum P 1117) with the Flight Commander's office highlighted

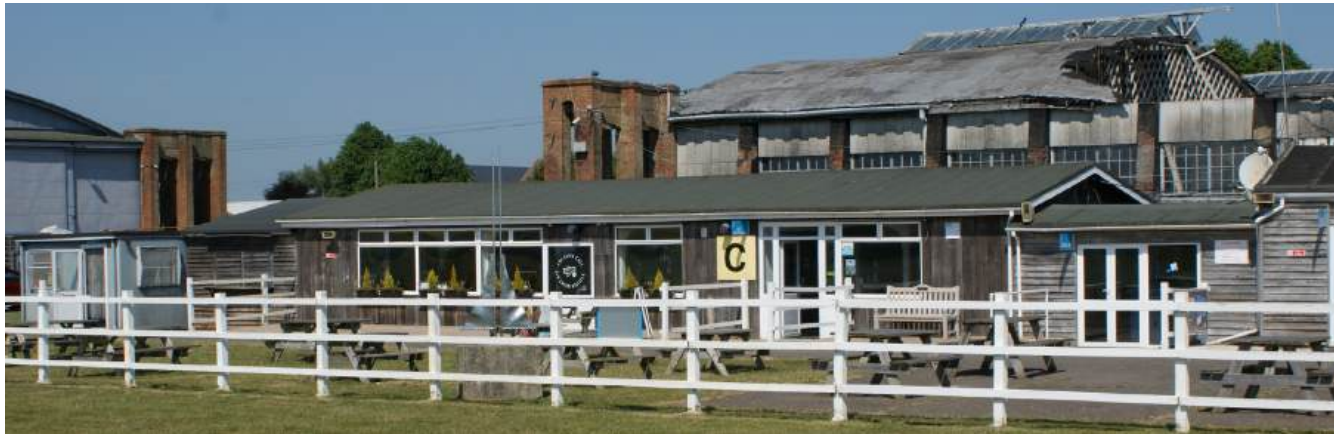
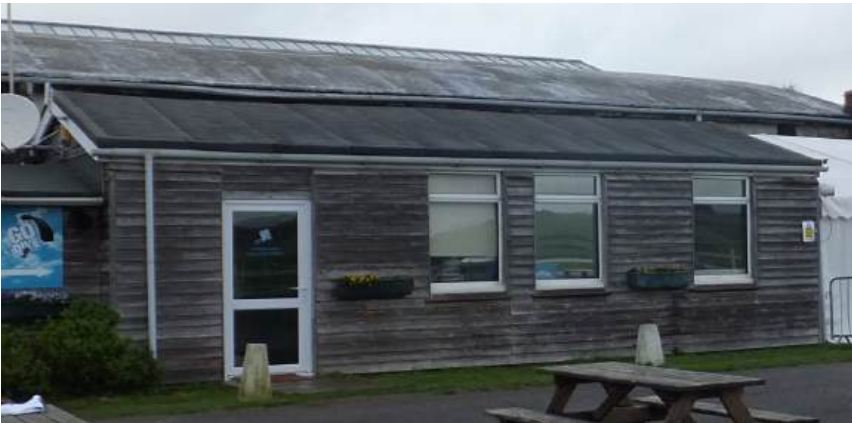
| Previous uses | <p>Flight Commander's office, described on the RAF site plan of 1939 as the "Flight Commander's Office and gas chamber". The building was originally free standing and placed centrally on axis with the south east Hangar 3 (see extract from aerial view).</p> <p>All three coupled aeroplane sheds had a small (16ft span) detached Flight Office built c.1917 on the shed centreline close to the side elevation facing the aerodrome (south). This is the office of the Flight Commander and his staff. Construction is of temporary brick walls with double-hung timber sashes. The roof has a simple arrangement of timber purlins (supported by internal temporary brick walls), covered with boarding and covered in slate. This is the only survival of the three.</p> |
| Brief description | Timber clad, felt roof and half brick walls single storey. The timber cladding is modern. |
| Condition | Fair. Now extended with link to similar building dating from the 1950-60s. This additional building is described as a "Vic Hallam" Hut in the CAA appraisal by WS Atkins. Later additions have been built to link this hut with the former Flight Commanders Office |

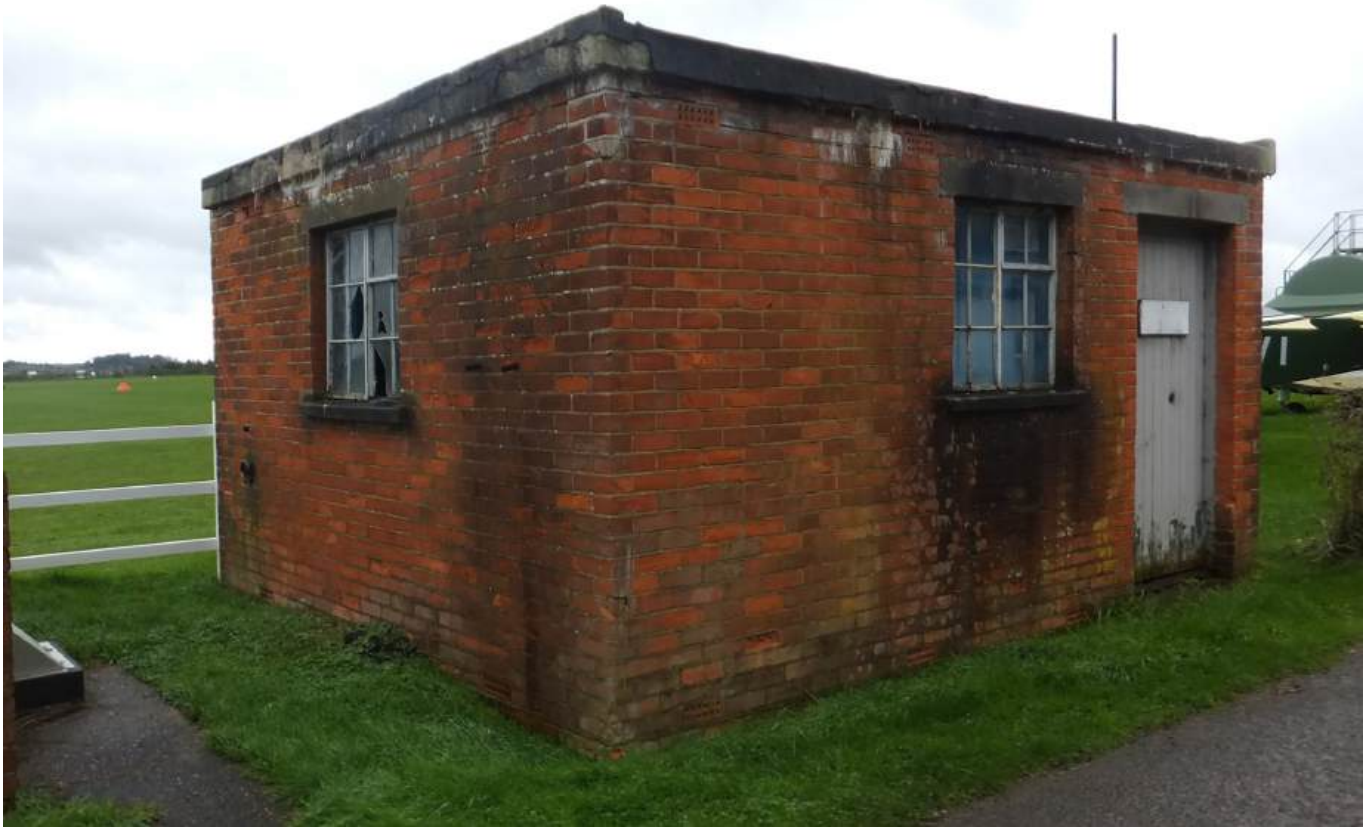
| Brief description | Single storey brick building with concrete roof |
| Condition | Poor. The concrete to the roof is now reported to be porous. Equipment associated with previous training use has not survived. |

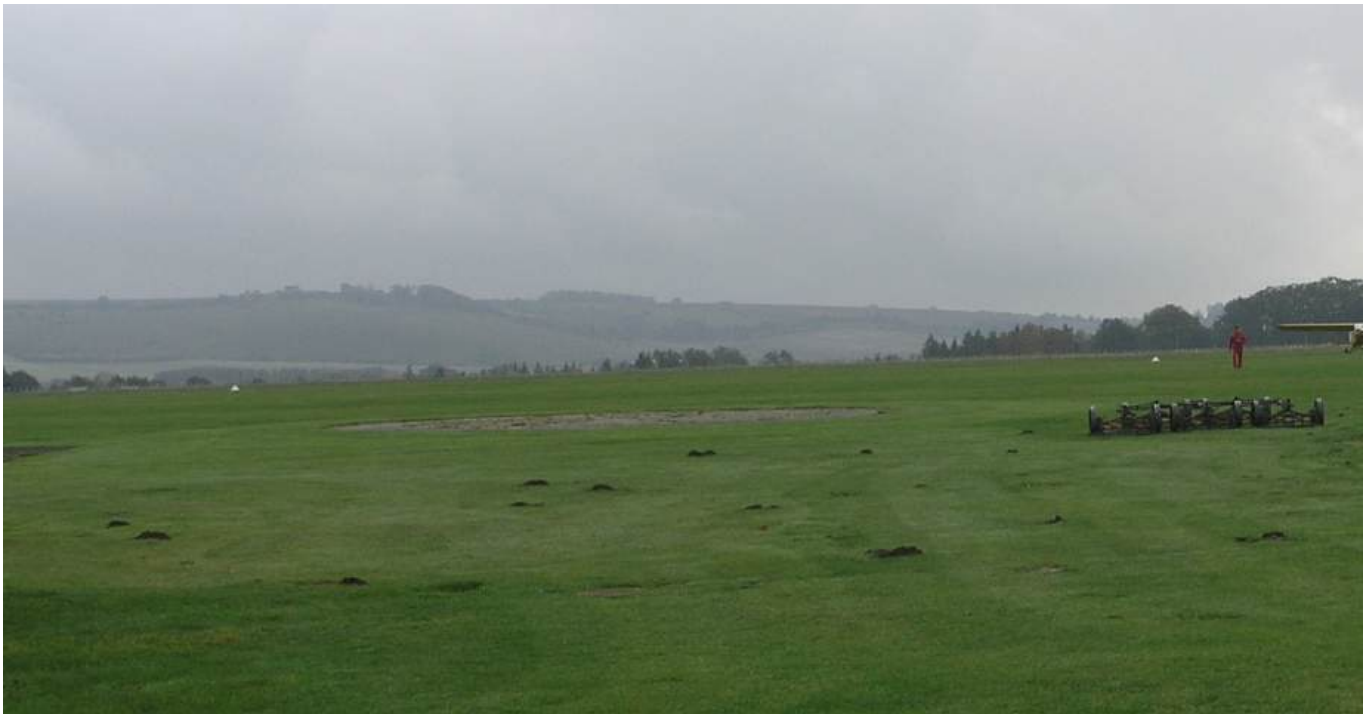
| Brief description | Circular plan hard standing in the hangar apron area |
| Condition | Fair |

Photograph of 1927-31 compass base in 2006

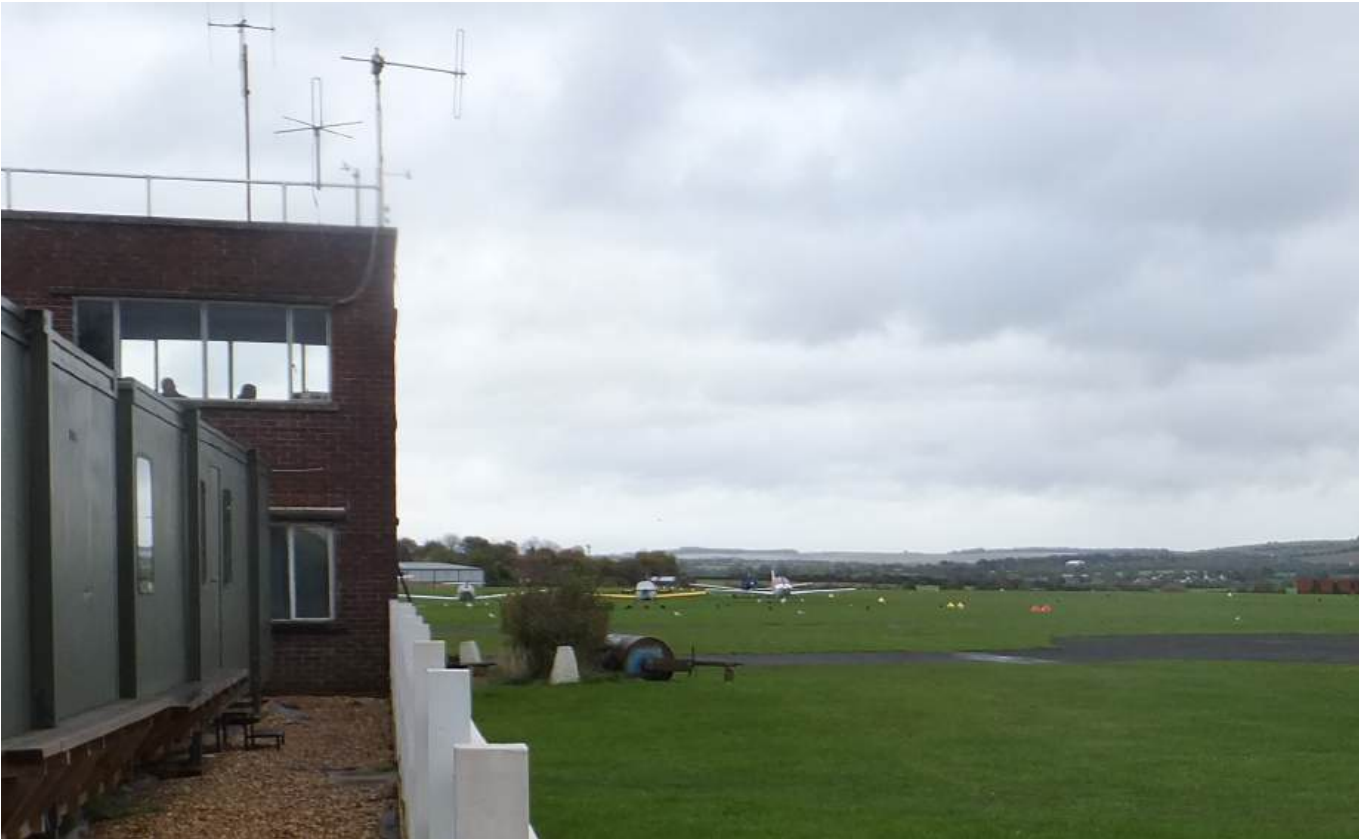
South west elevation

| Brief description | Rectangular two-storey brick construction. Replaced the location of former WWI Flight Office |
| Condition | Poor |

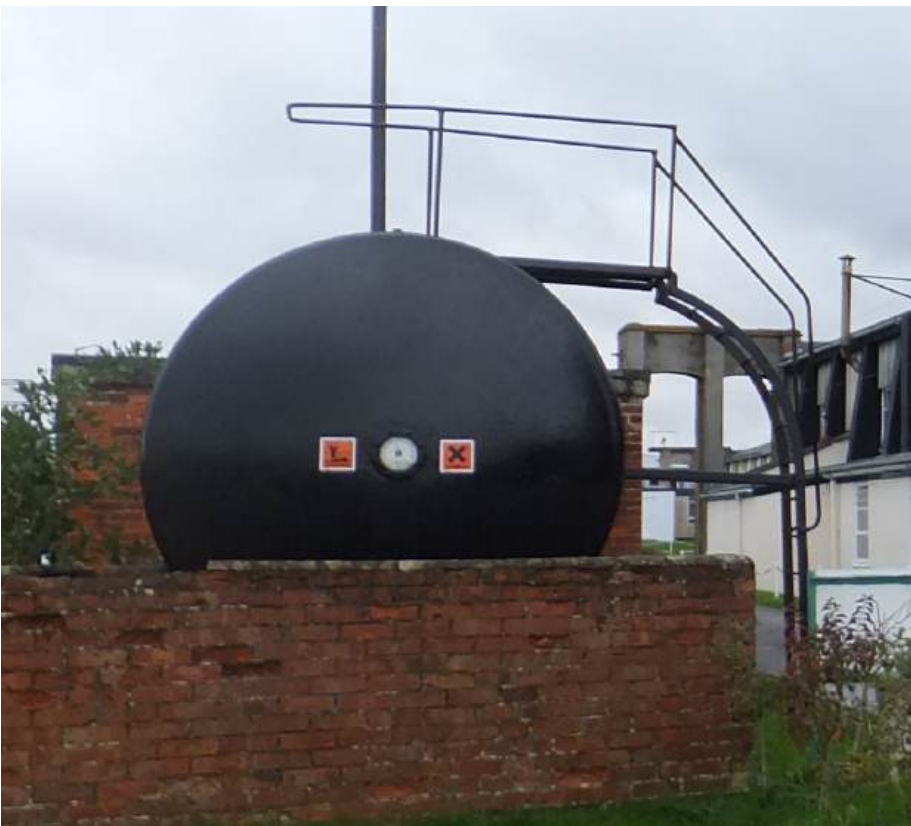
View from north west

| Brief description | Large diameter steel tank within a low red brick enclosure. with simple concrete rounded coping to the enclosure. Metal steps to give access to top of tank (presumably for checking oil level and re-filling) |
| Condition | Tank still in use, therefore presumed in good condition. The brickwork to the low level enclosure is spalling or damaged and some sections of the coping missing. Tank re-painted black since 2007 |

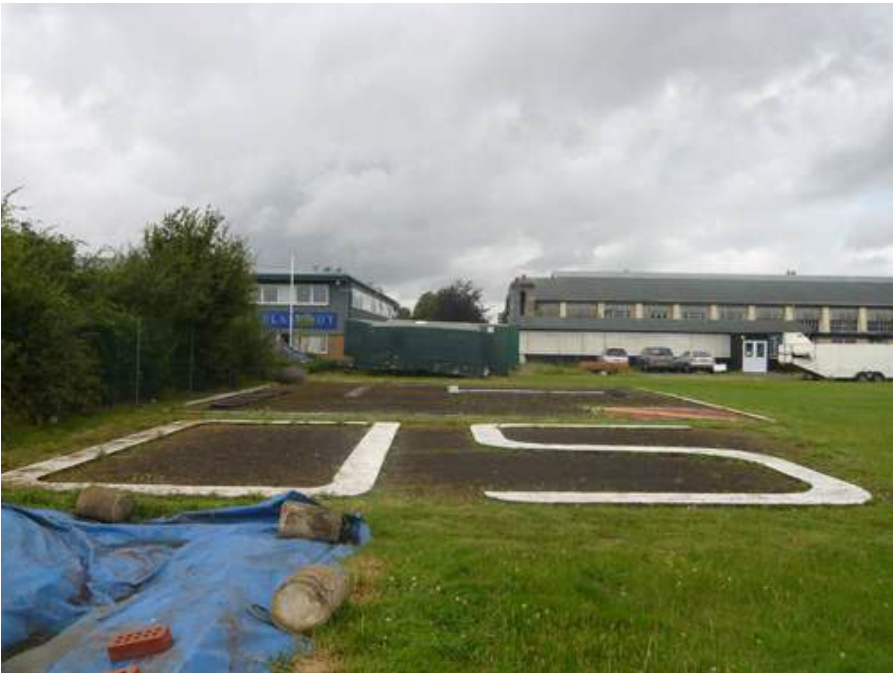
View in 2007

| Brief description | Painted letters and markings visible from the air |
| Condition | Overgrown and partially concealed |

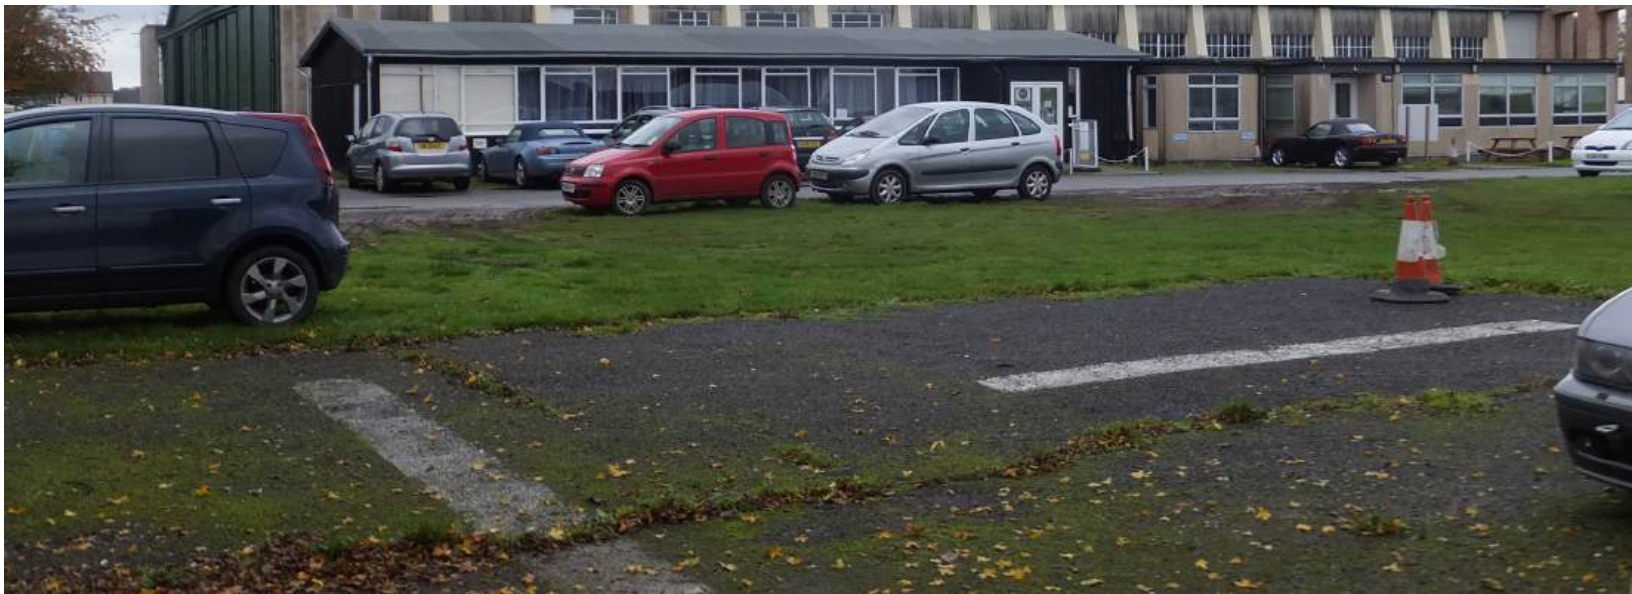
Markings partially concealed

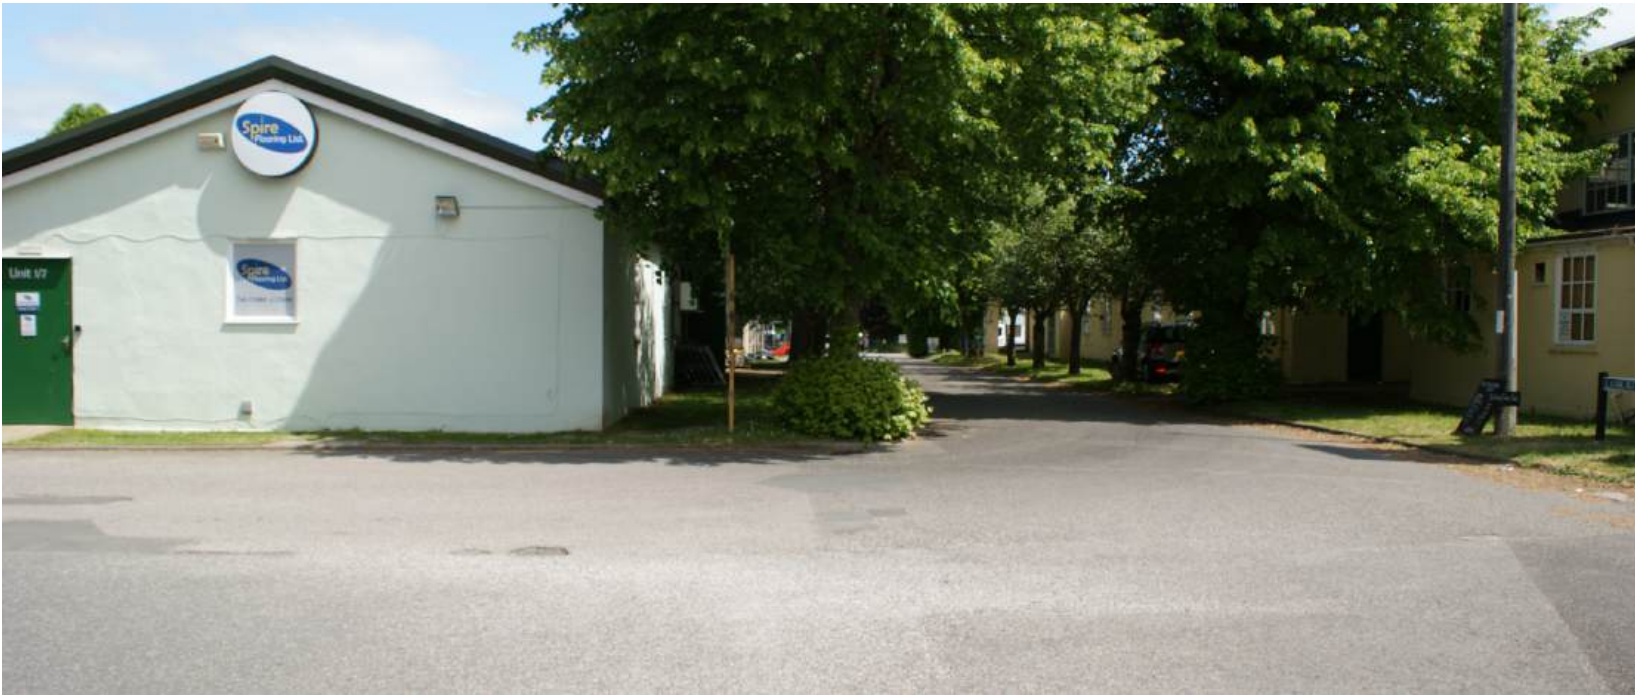
May 2023 east elevation

| Brief description | Rectangular shaped plan-form on single-storey. In its original form it was arranged mainly open-plan with two rows of storage racks and partitioned areas to include a tyre store, storeman's rest room and clerk's office. The north elevation had two lean-to covered yards (metal & timber and packing cases) separated by an open yard. These are extant but the open yard has been roofed over. Construction is temporary brick with internal piers arranged at 10ft centres. These support standard timber trusses. These support three skylights and a roof covering of asbestos sheeting. Original windows were 16-pane metal casements. |
| Condition | Good, but windows etcetera altered |

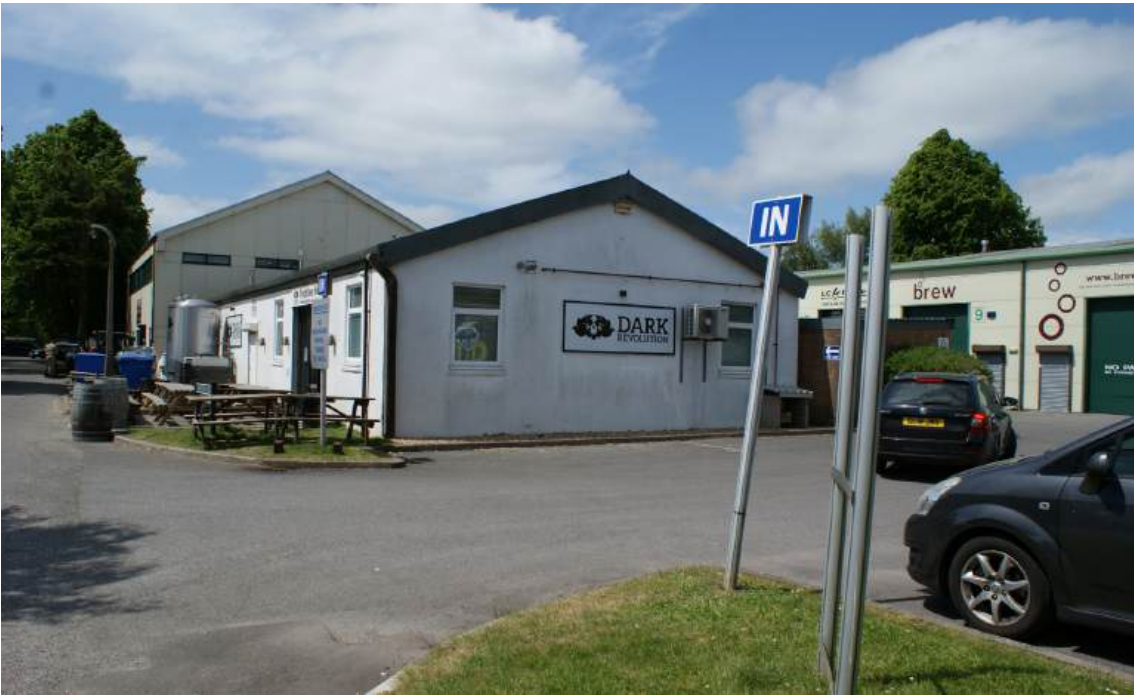
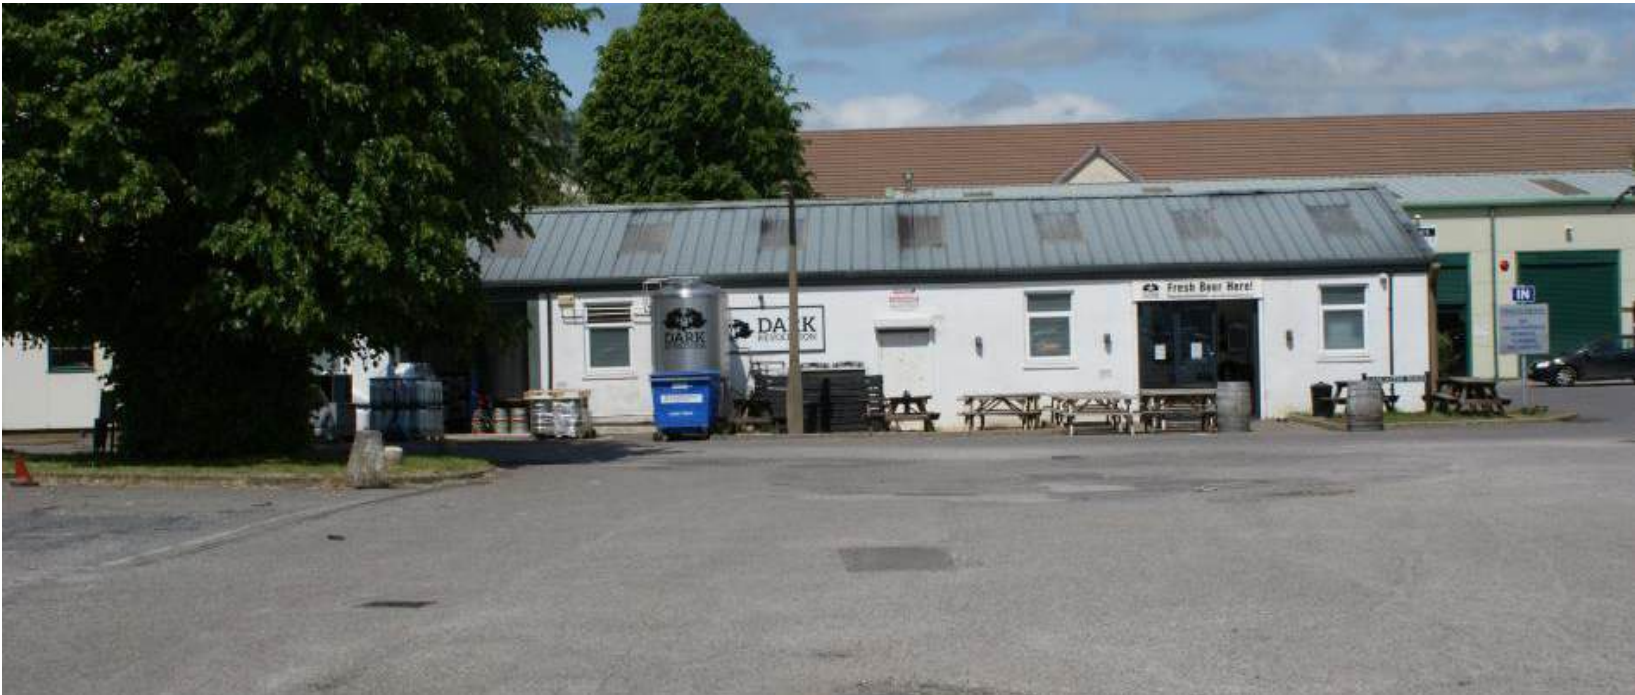
| Brief description | Rectangular based plan-form, eight 10 feet wide bays with internal brick piers supporting 30 feet span composite trusses. Roof covering in 2006 was corrugated asbestos sheeting with rooflights and metal cowls. Temporary brick walls with rendered finish. There are two 10ft wide openings on the south facing elevation which are original. Originally 16-pane steel casements have been replaced. |
| Condition | Fair. The roof has been replaced since 2006 with profiled metal sheeting and rooflights and cowls removed/replaced. The large opening in the east gable has been filled in |

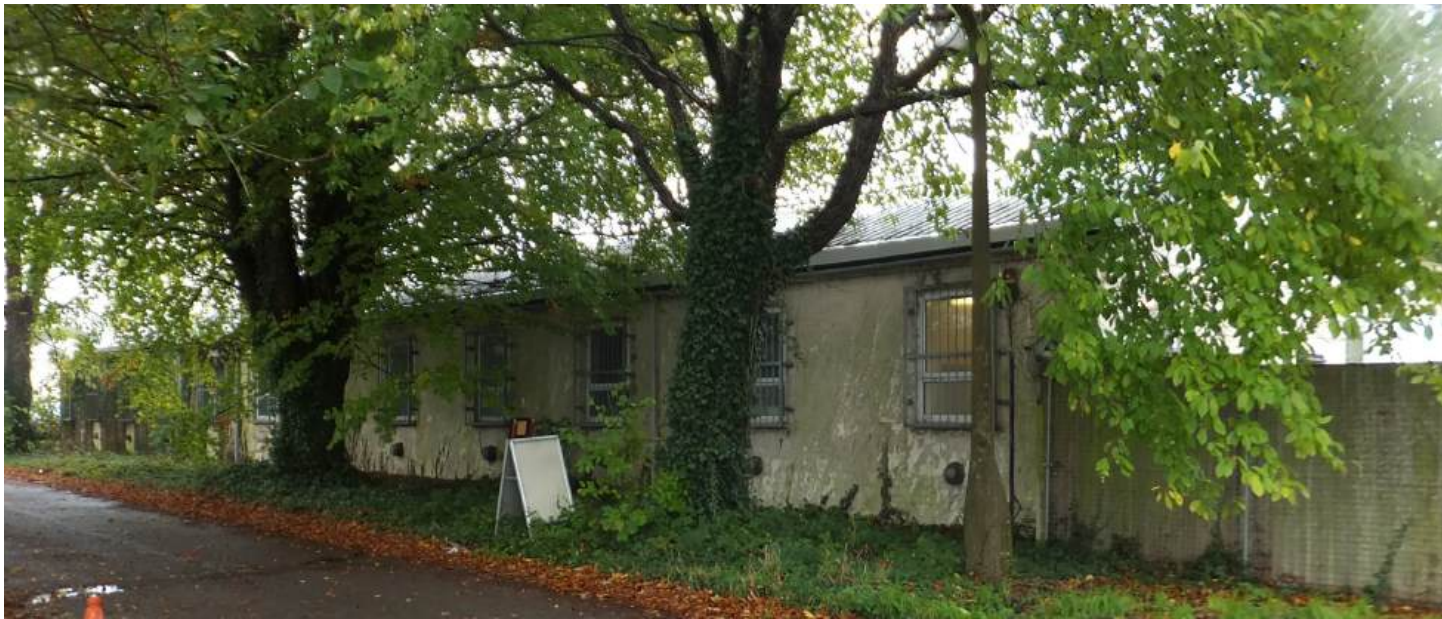
North and south east elevations

| Brief description | This is a standard RFC TDS Metal Workshop. The main part (8-bays) functioned as an engine repair shop, but 3-bays at one end were divided by a partition into separate the coppersmiths shop and a blacksmith's shop. A small acetylene plant room annexe was located against the outside wall of the coppersmith's shop – but this is now demolished |
| Condition | Fair externally - but no close access available |

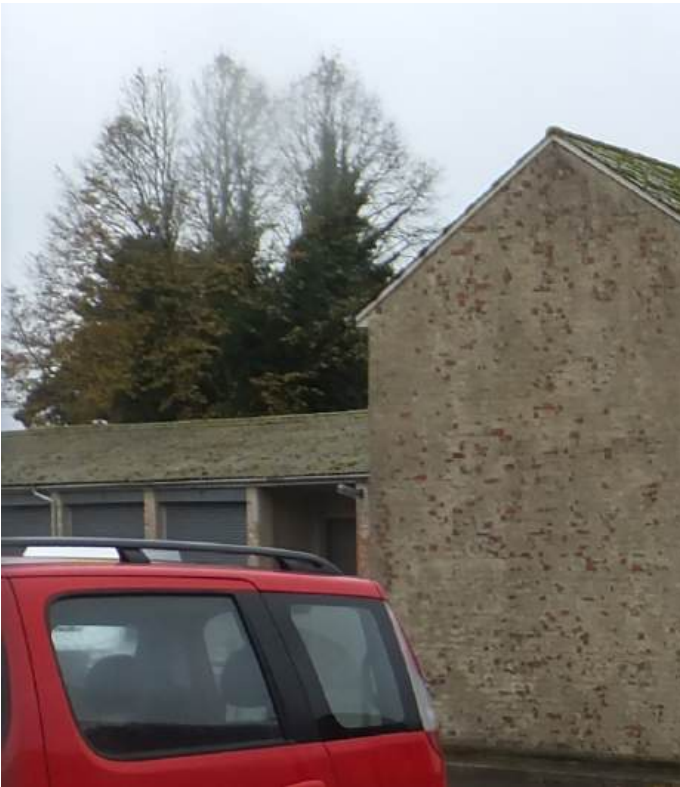
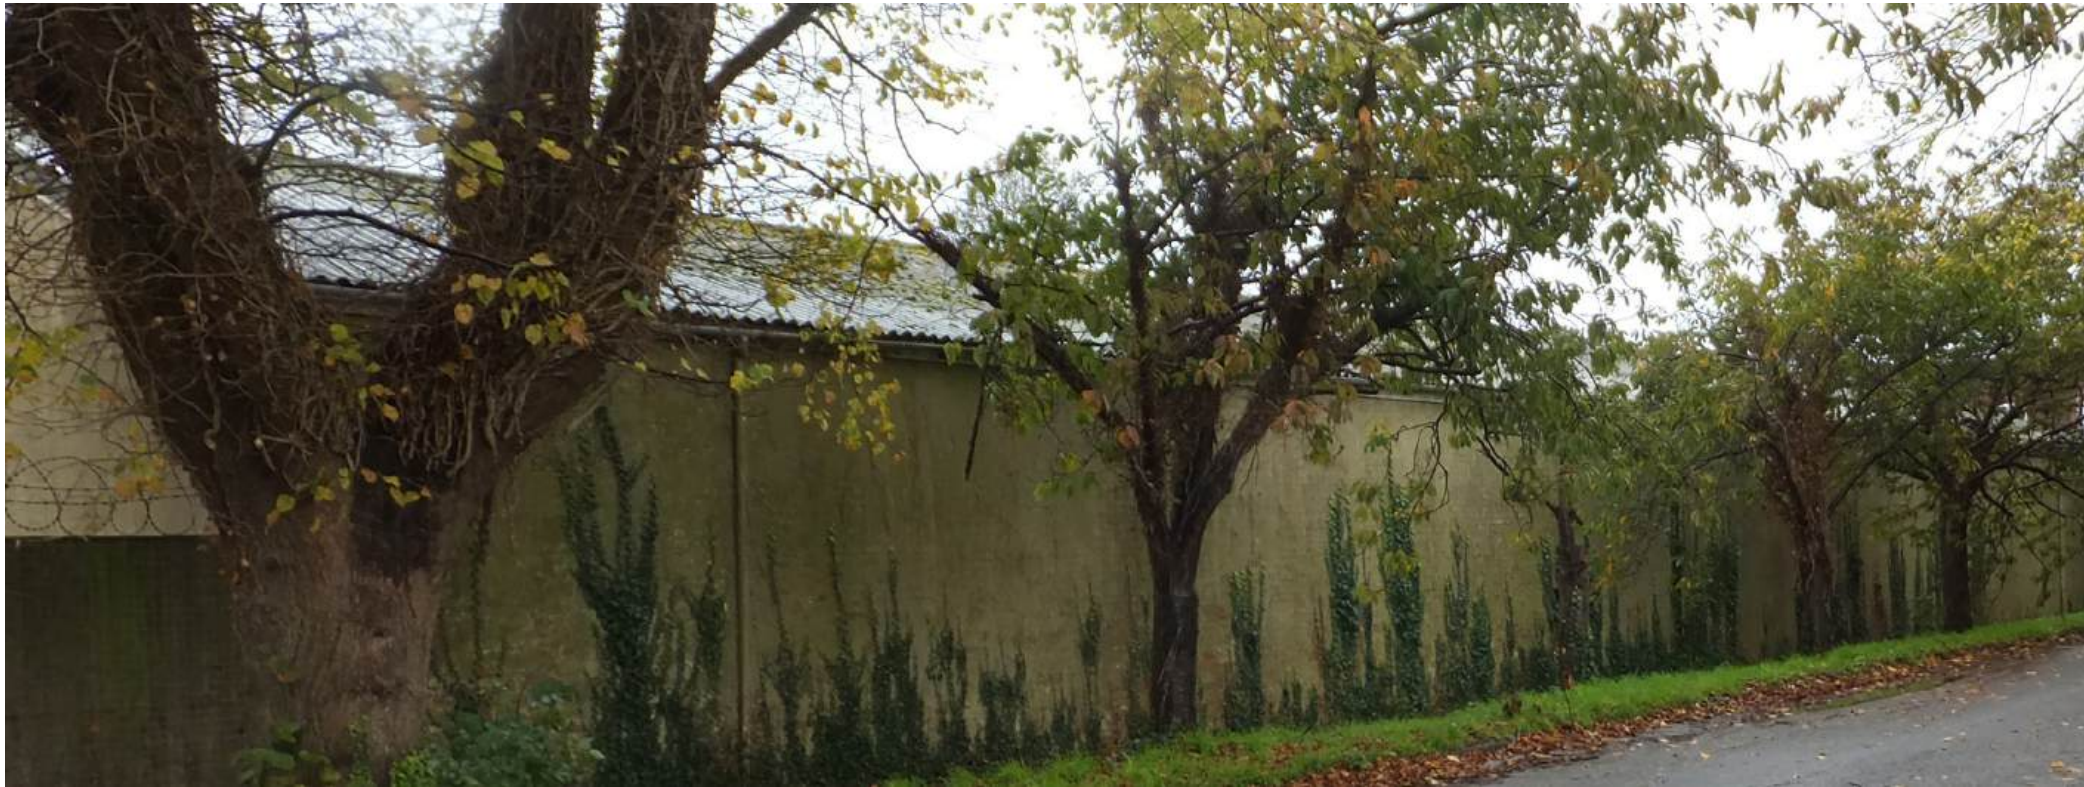
| Brief description | <p>Two standard RFC TDS-style 13-bay MT vehicle sheds are built facing each other and separated by an 80ft wide motor vehicle manoeuvring area or yard. The site of the washing table at the extreme east end of the complex is now occupied by the Engine Test House. In November 1918 the following vehicles were housed in these sheds:1 touring car, 12 light tenders &amp; 12 heavy tenders, 9 motor cycles 8 sidecars, 5 trailers, 2 ambulances and 2 tractors.</p> <p>Construction is of brick piers at 11ft centres with temporary brick in-fill on three sides. Along the front are brick pillars that support the trusses. Like all the WWI buildings at Old Sarum the trusses are not composite types as used elsewhere but all-timber types and these support a roof cladding of corrugated asbestos sheeting - this arrangement was similar to Andover.</p> <p>Both sheds are similar but the northern one has two repair bays at the west end and a pair of motor-cycle bays. The west end bay of the northern shed is in-filled with brick for use as an office. Adjacent to the western gable is a brick-built Fuel Attendant's Shelter.</p> |
| Condition | Good |

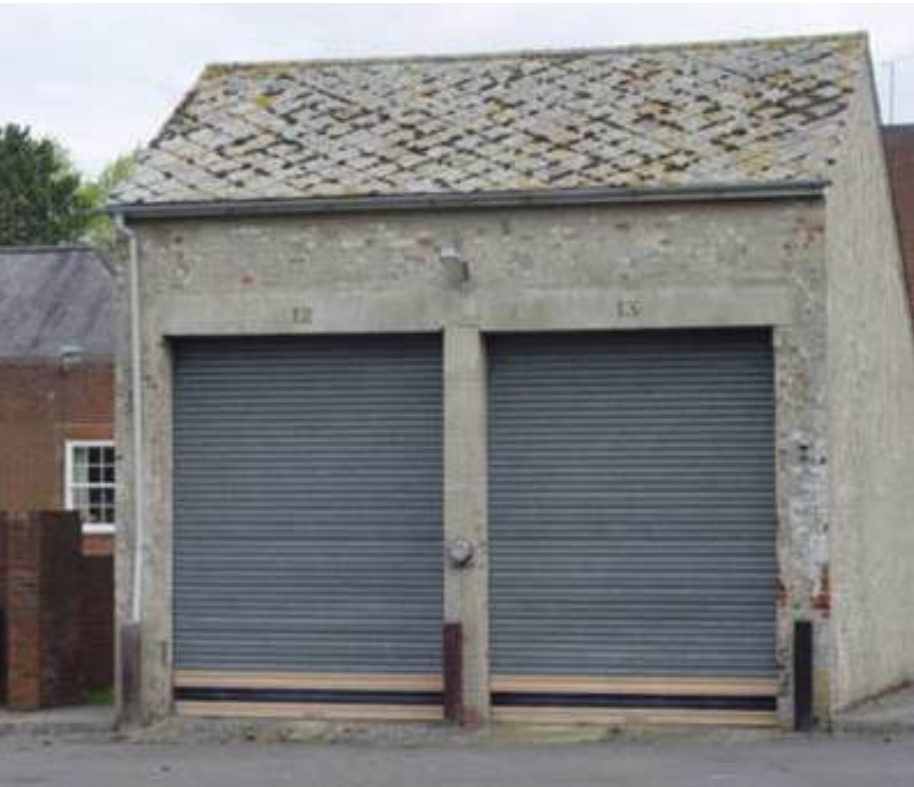
| Brief description | Brick piers with temporary brick in-fill. The roof is a close-couple timber truss supporting diamond-shaped cement asbestos tiles. |
| Condition | Fair, but no close access available |

Engine Test house viewed from south-west Photograph from the Old Sarum Airfield Character Area Appraisal and Assessment for Eligibility for Conservation Area Designation August 2006

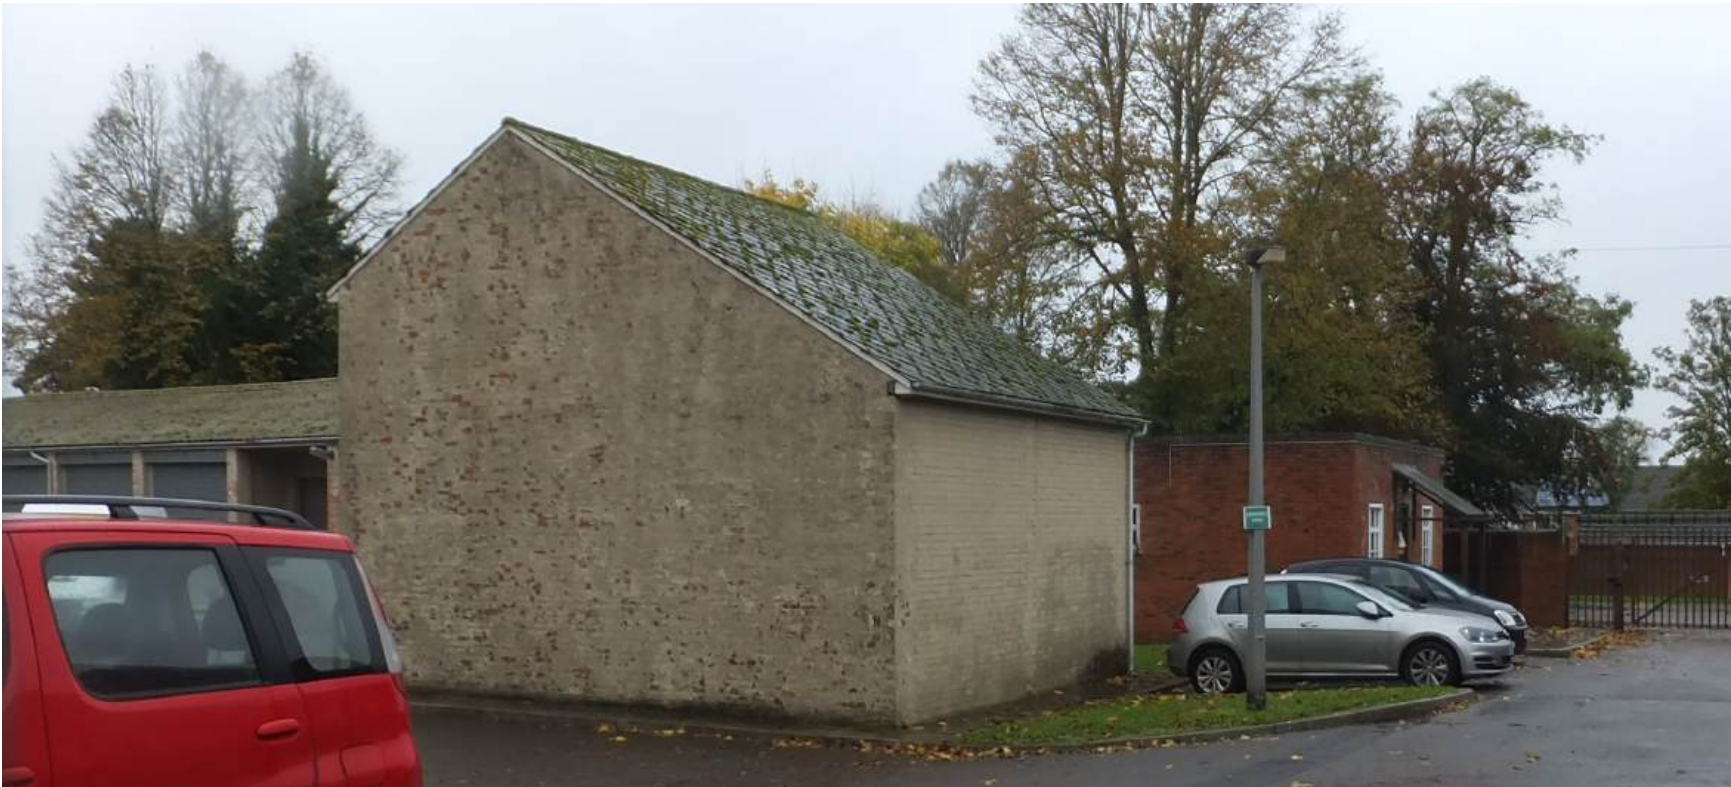
Engine Test house and unknown building to the right, probably a Guard House

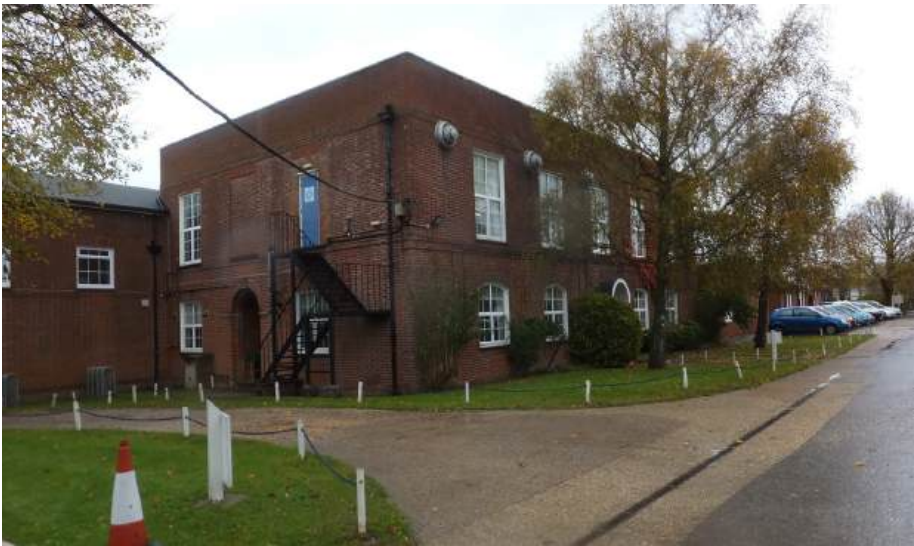
Elevation facing Lysander Road

| Brief description | <p>Construction is of 15in cavity brick which gives the impression of Flemish bond but the headers are cut so the outer leaf is 4.5in (this is an indication that the building was built before 1938 when the Air Ministry changed from Flemish to an outer leaf of Stretcher bond. The roof is reinforced concrete slab with a brick parapet wall. Today the original windows have been replaced with UPVc of a casement style at odds with the original fenestration pattern. Enough of the viewing galleries of both Haskard ranges survive to recognise their function.</p> |
| Condition | Good, but not inspected internally. |

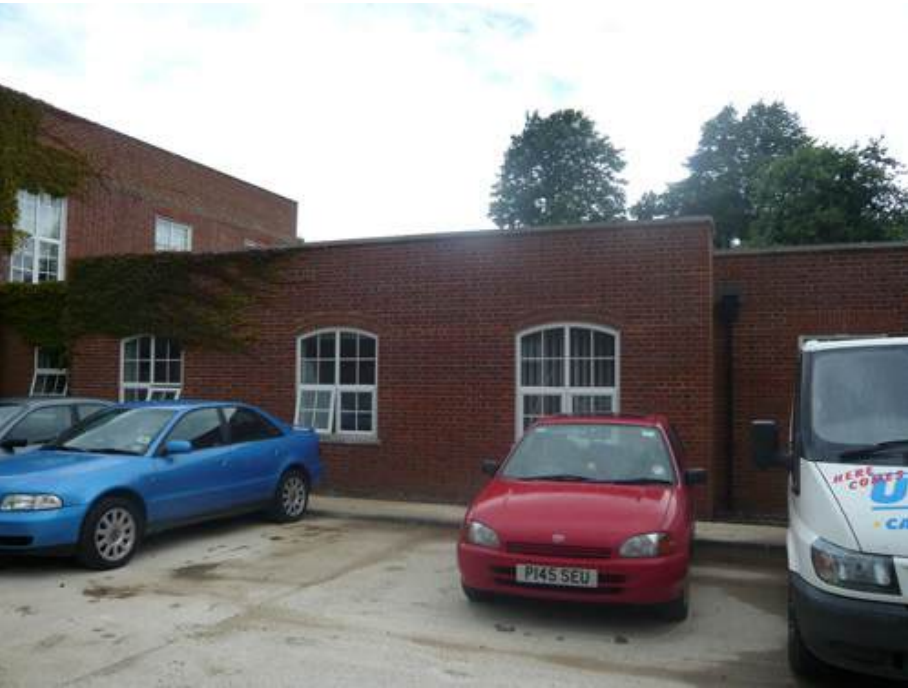
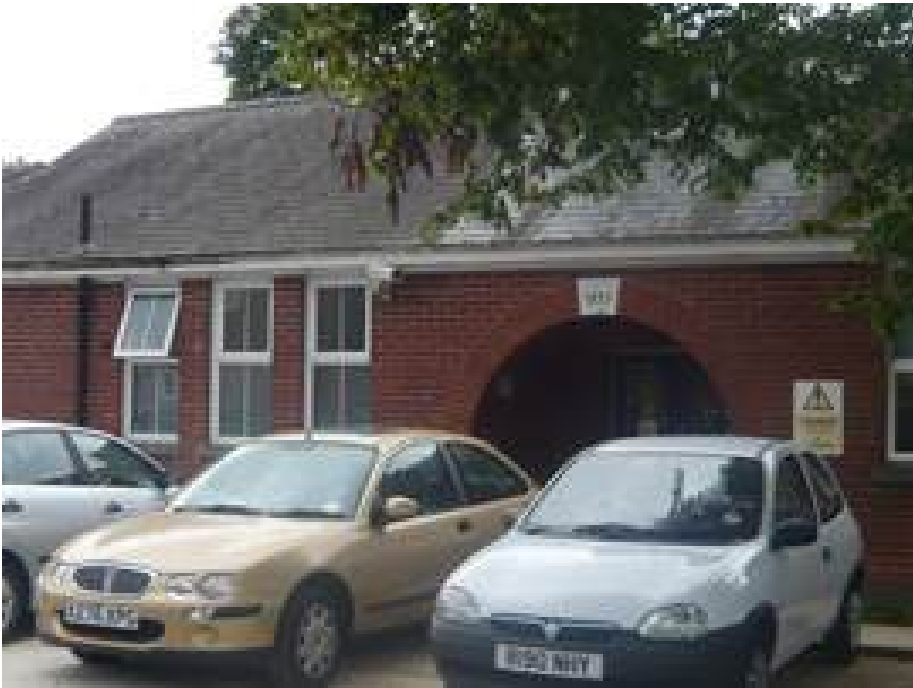
Entrance porch from Lysander Road

| Brief description | <p>This building has a 'T'-shaped plan-form, its size and internal arrangement is for a two-squadron station. There is a central internal entrance porch leading to an octagonal-shaped hall that is lit from a lantern light above. From here corridors run both longitudinally and laterally. Construction is of 11in cavity external walls with timber trusses having hipped-shaped rafters at the gable ends.</p> |
| Condition | Good, but not inspected internally |

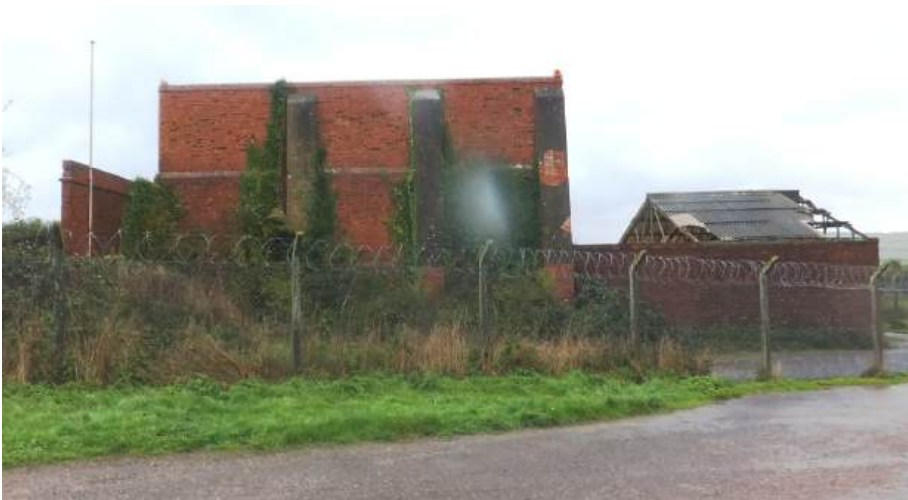
West elevation

| Condition | Fair |
