BAT SURVEY REPORT

**10 LINLEYS, GASTARD**

Client: Matt Bollen

Our Ref: B25\_055\_BSR

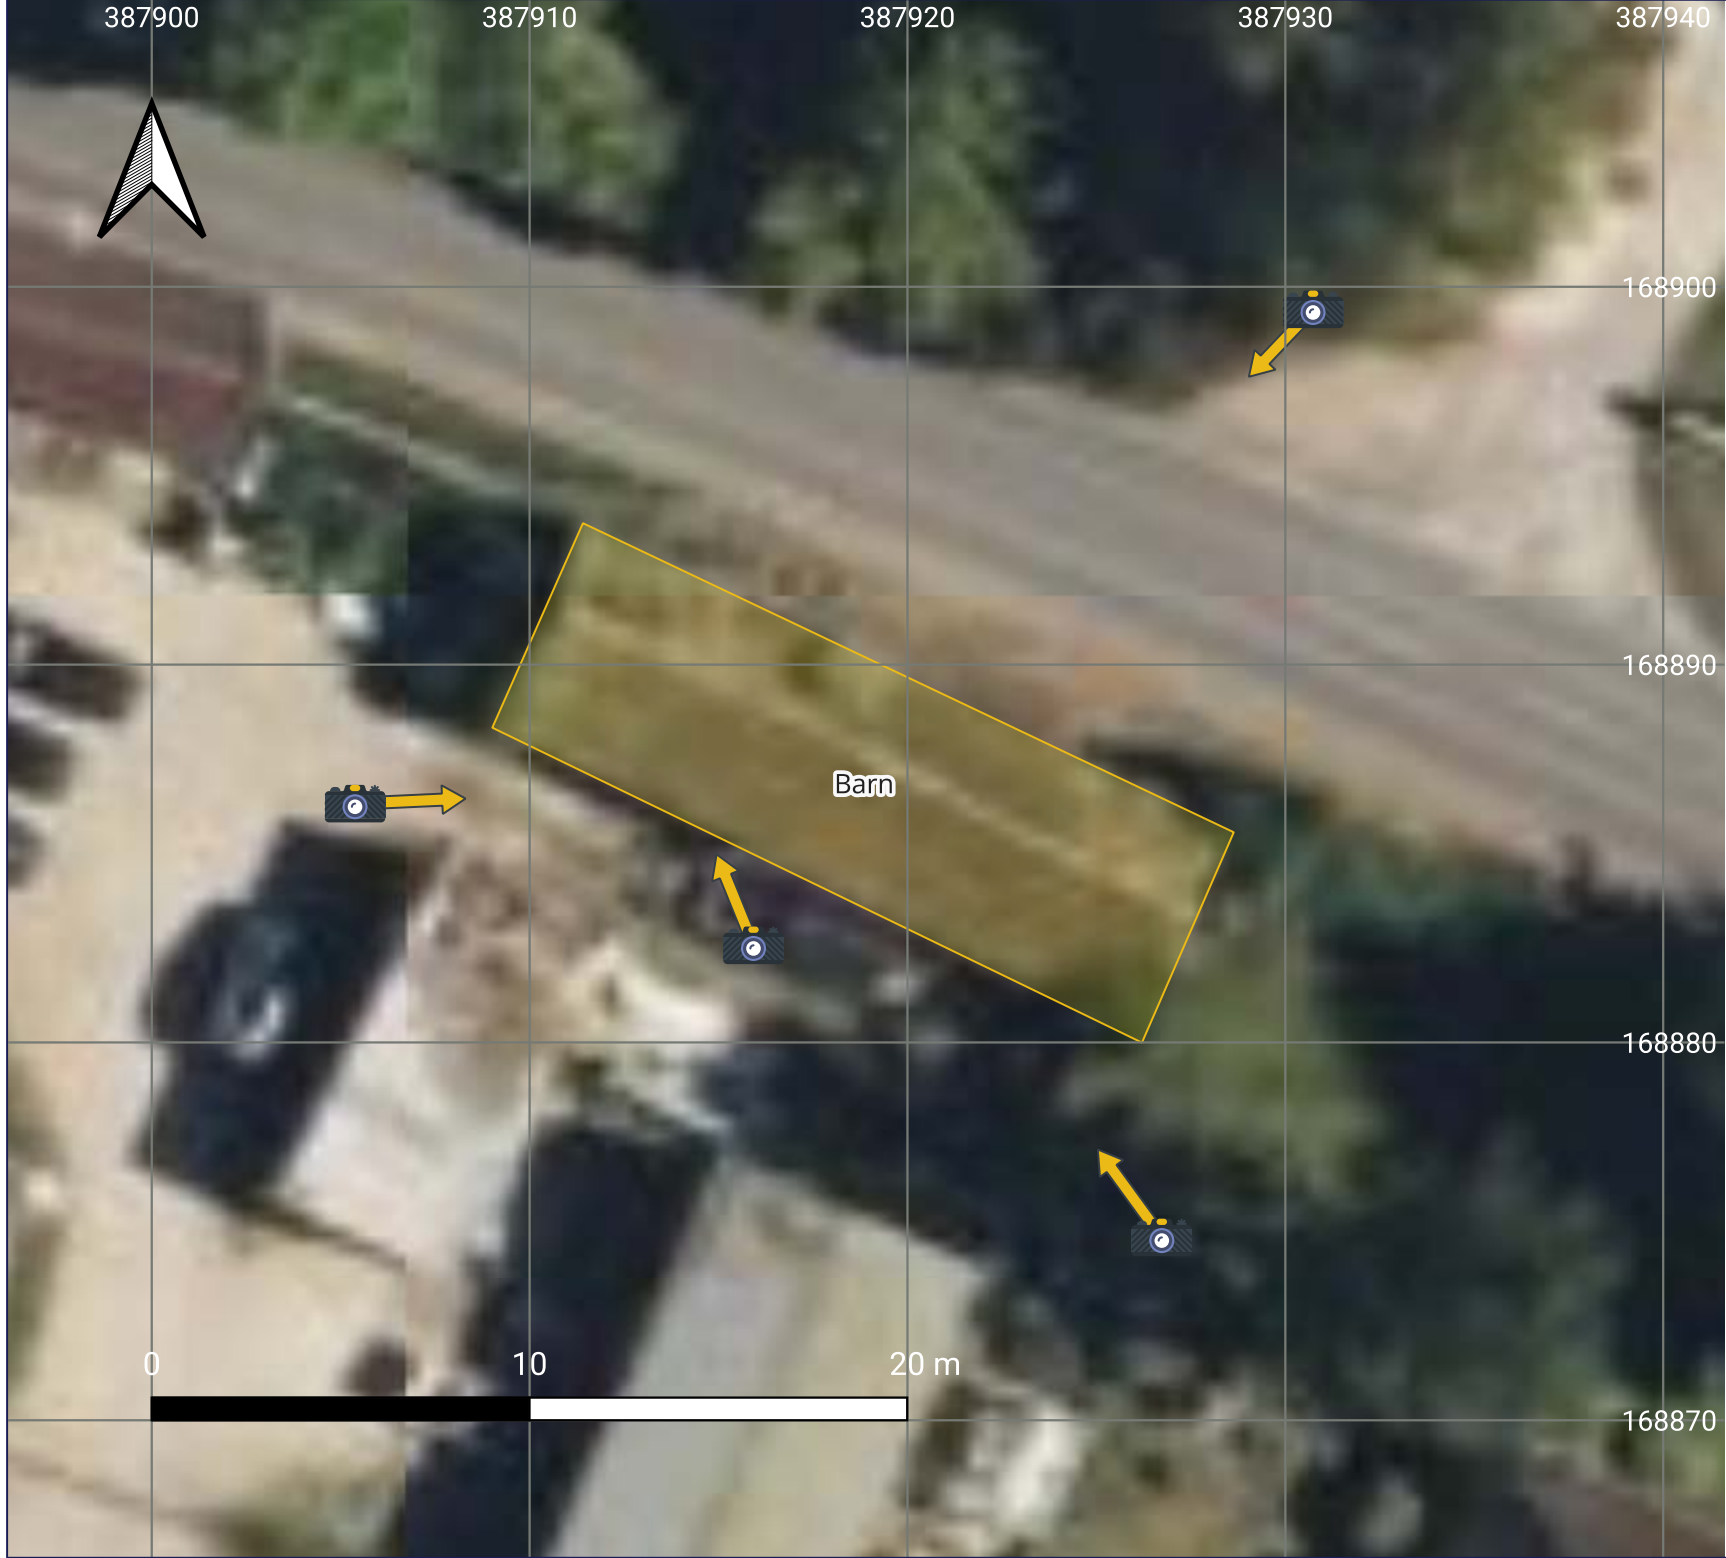
| Title | PRA Viewpoints Plan |

The survey methods followed those set out in the Bat Conservation Trust's guidelines and made use of the latest thermal imaging cameras and analysis software. The site layout, barn location, emergence survey camera positions, and still images of their fields of view, are all shown in the **PRA Viewpoints Plan** (overleaf).

- To ensure the best possible chance of detecting roosts and identifying bats, the latest thermal imaging cameras were used, specifically three **FLIR A70 thermal imaging cameras** with 51-degree fields of view, connected to a tablet equipped with FLIR's Research Studio software to record video files in GigE format, which provide thermal images suitable for further analysis (as opposed to the video files recorded by most other devices). The cameras were mounted on tripods and positioned to record footage of the three main potential roosting areas: the south-facing roof pitch and both internal gable walls, as shown in the PRA Viewpoints Plan.

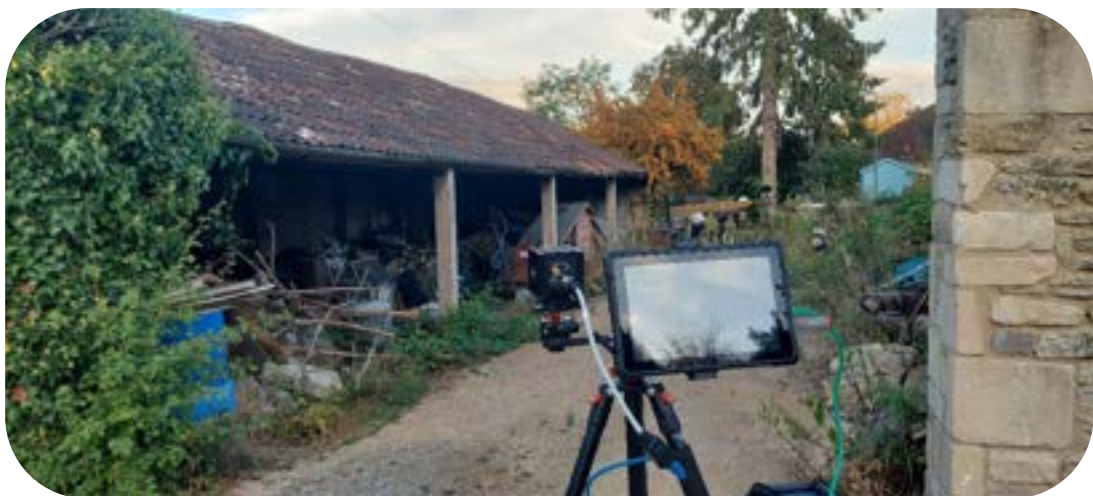
**Photo 2-1: Thermal camera setup with video recording software**

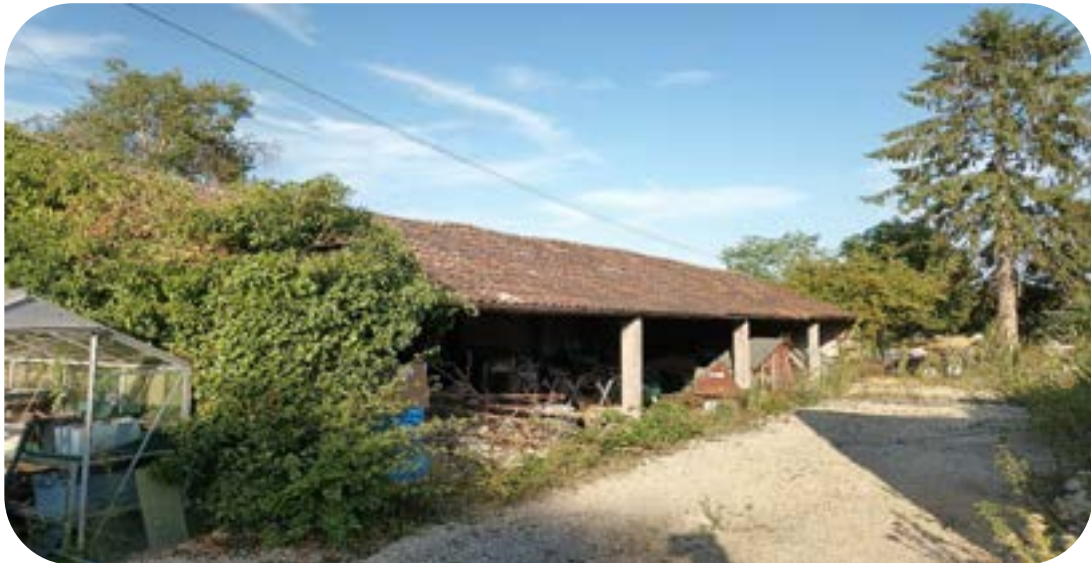
- 3.1.2 The barn has stone walls supporting a tiled roof with a single pitch. The front (facing to the south) is completely open and the roof on this side is supported on steel beams with timber uprights.

- 3.1.3 The roof tiles rest on timber battens and the roof is lined with bitumen roofing felt. The felt is ripped and falling away in places between the wooden rafters and purlins.

**Photo 3-1: front (south facing) elevation of the barn**

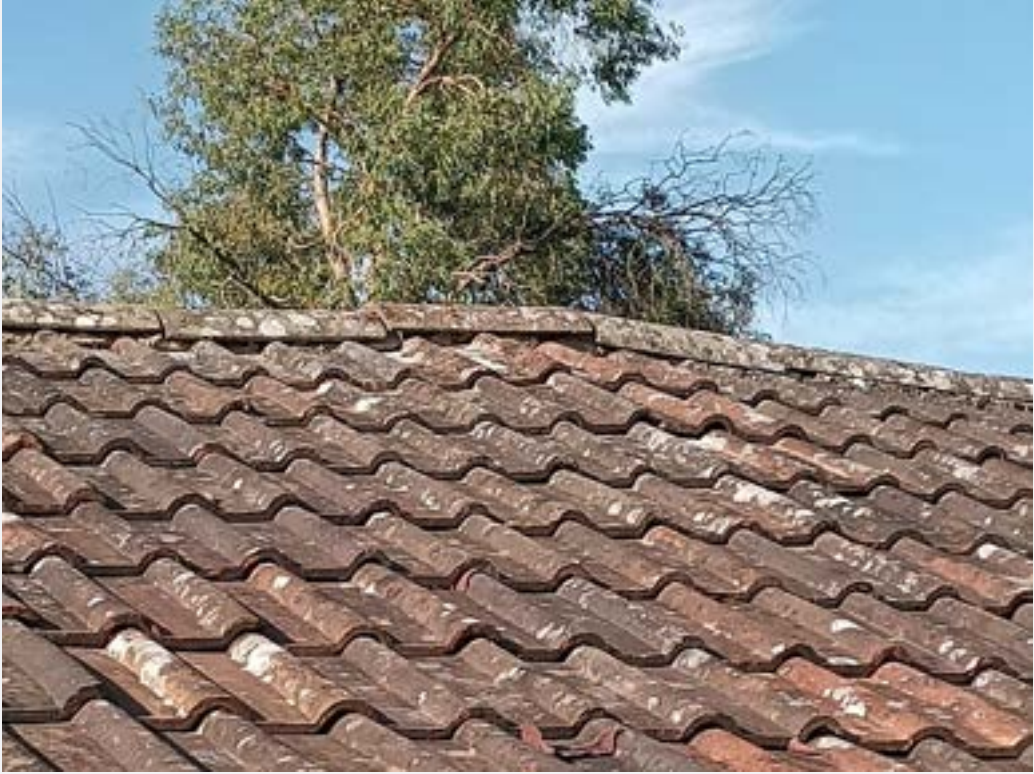
| Target Note | Description | Photo |
|---|---|---|
| TN2 | One of the ridge tiles is slightly lifted and there is a gap that could allow bats to crawl underneath it to roost. | |

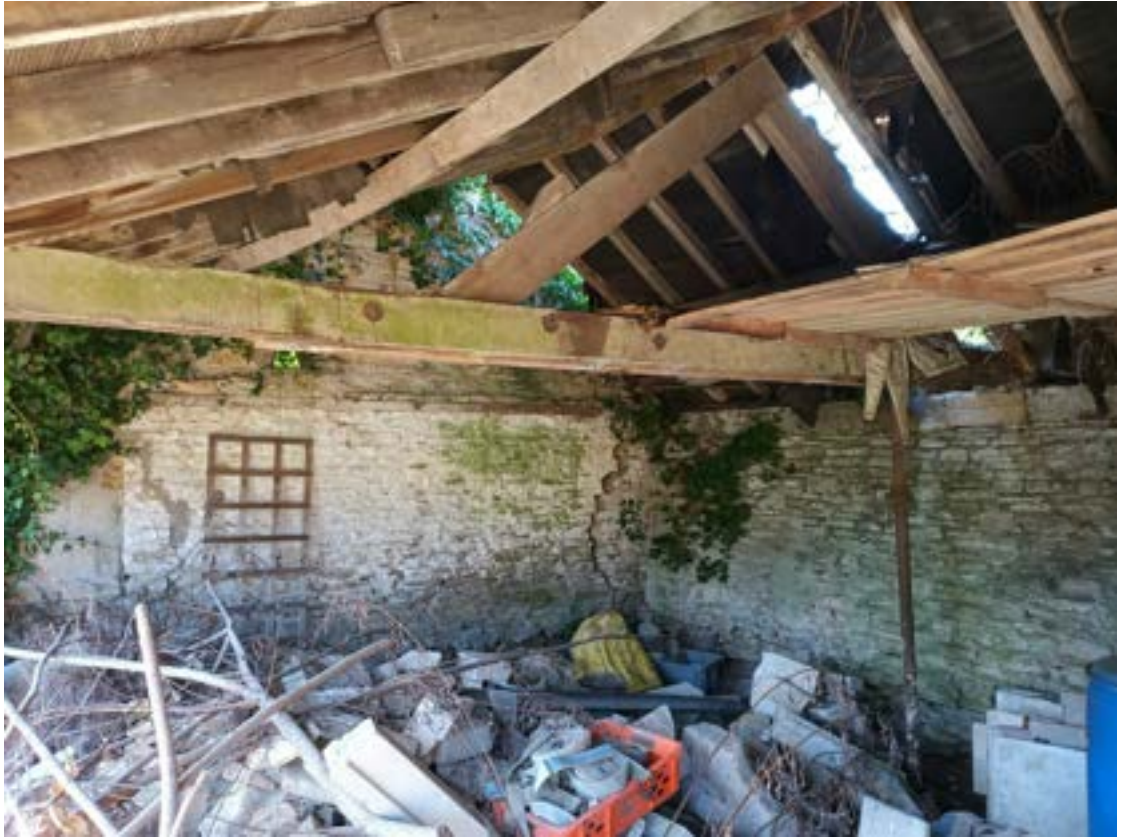
| Target Note | Description | Photo |
|---|---|---|
| TN3 | There is a vertical crack in the stonework in the north-west corner of the barn. Most of this is exposed and unlikely to be used by bats but there are small areas where individual bats or small numbers of bats could roost. | |

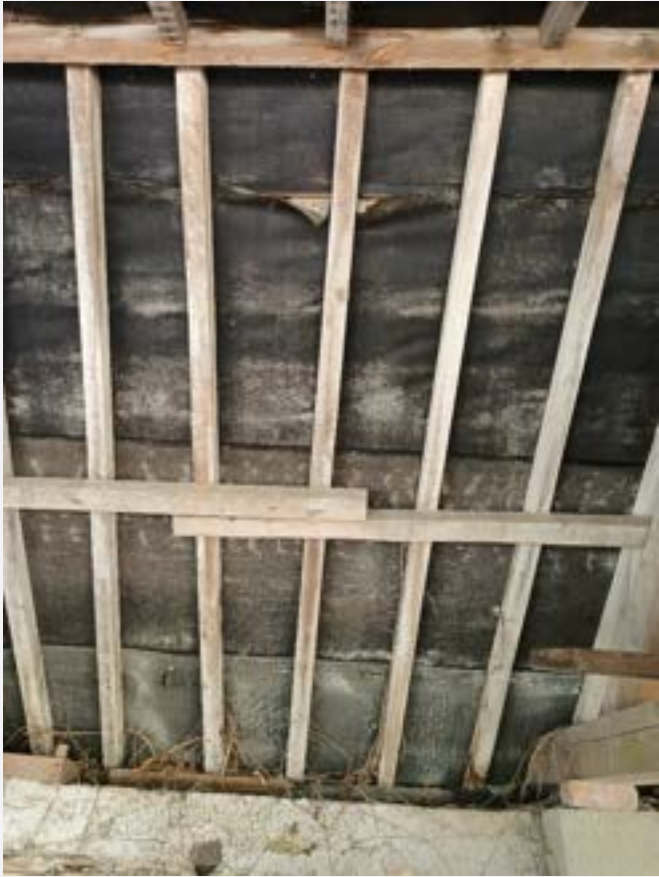
| Target<br>Note | Description | Photo |
|---|---|---|
| TN4 | There are tears and gaps in the bitumen roofing felt that would allow bats to crawl into the gap between the felt and the tiles | |

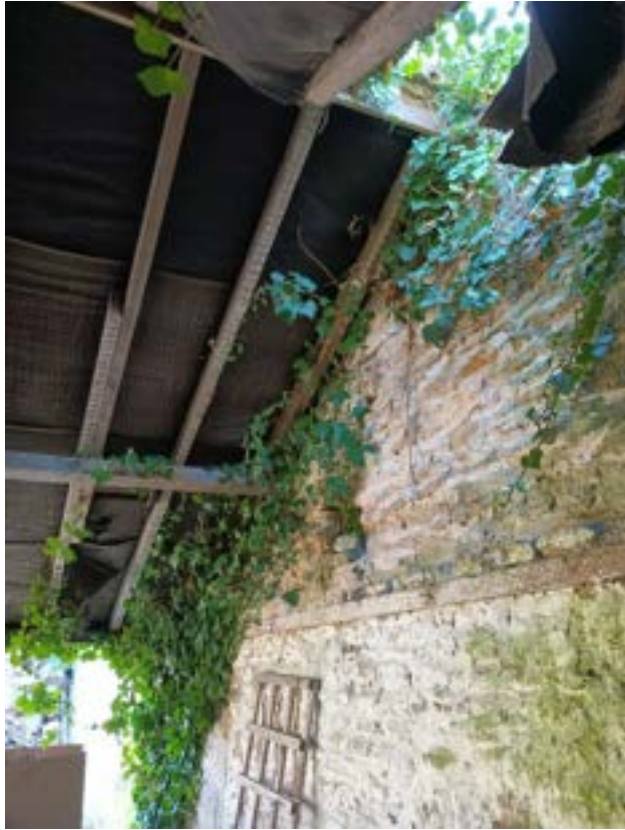
| Target Note | Description | Photo |
|---|---|---|
| TN5 | There is a gap between the end rafter and the wall: small numbers of bats could crawl into this space to roost | |

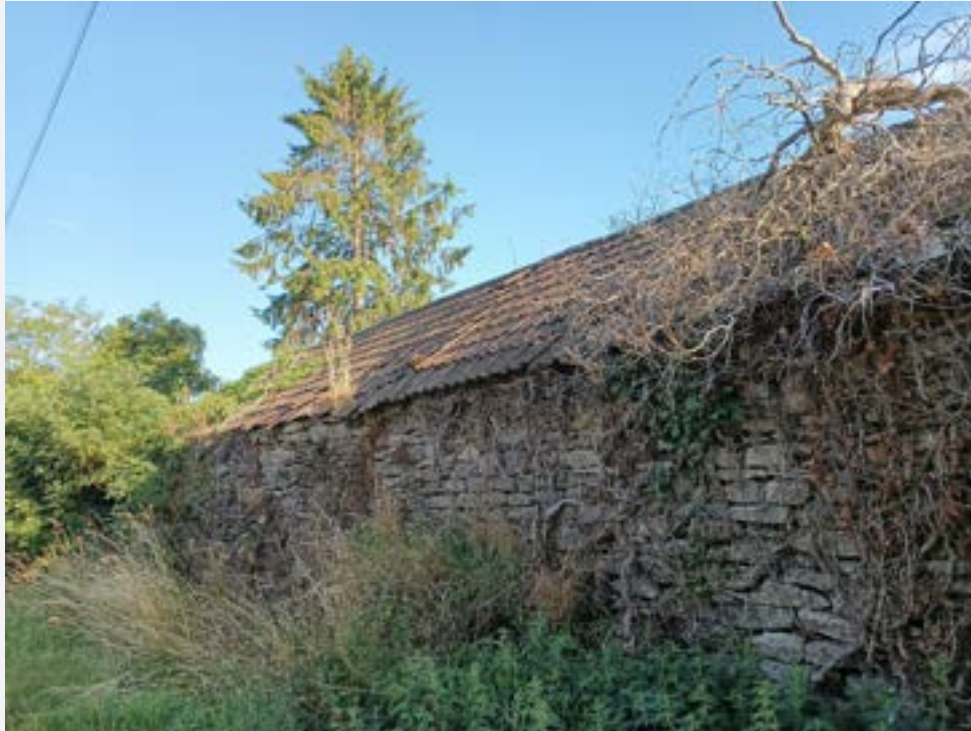
| Target Note | Description | Photo |
|---|---|---|
| TN6 | The tiles on the rear roof pitch are mostly gap-free, but there are many small gaps in the mortar joints where small numbers of bats could roost | |
