PRELIMINARY ROOST ASSESSMENT

# 10 LINLEYS, GASTARD

Our Ref: B25\_055\_PRA

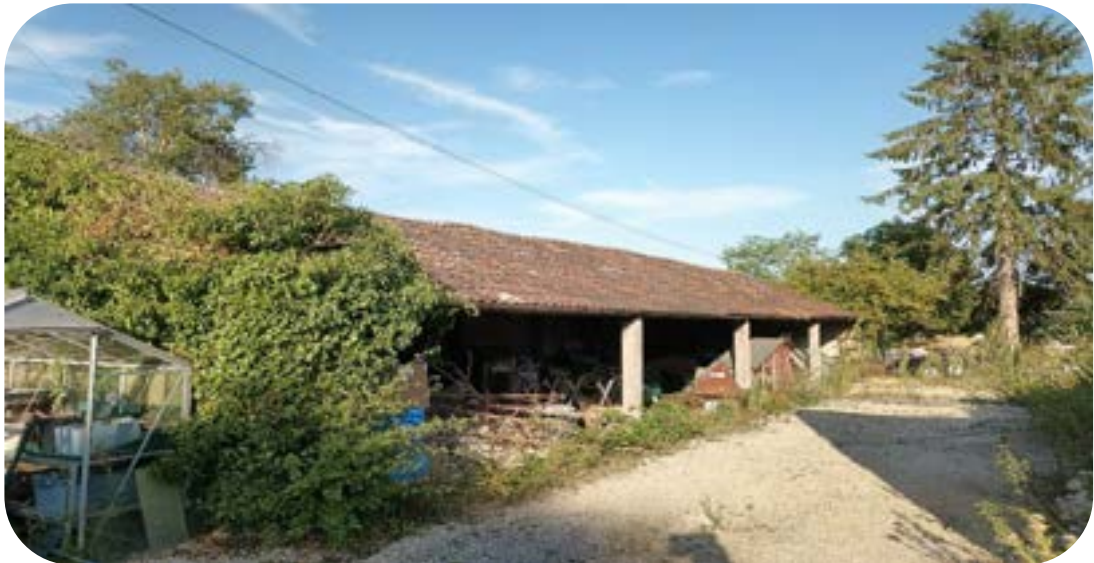
- 3.1.2 The barn has stone walls supporting a tiled roof with a single pitch. The front (facing to the south) is completely open and the roof on this side is supported on steel beams with timber uprights.

- 3.1.3 The roof tiles rest on timber battens and the roof is lined with bitumen roofing felt. The felt is ripped and falling away in places between the wooden rafters and purlins.

**Photo 3-1: front (south facing) elevation of the barn**

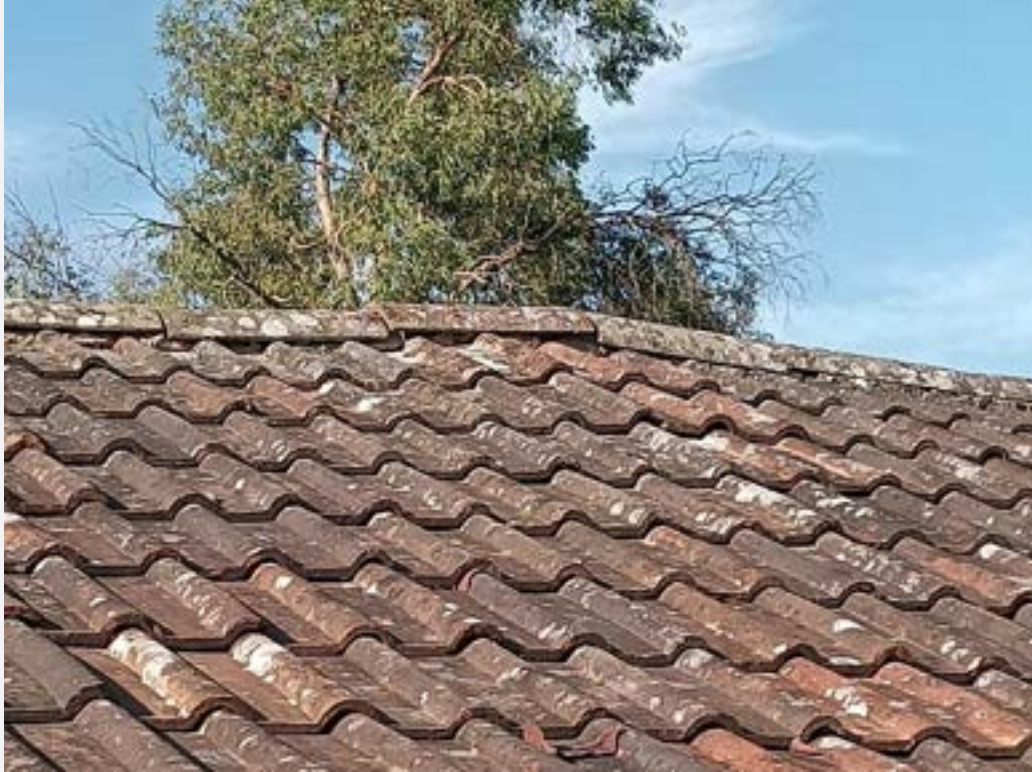
| Target Note | Description | Photo |
|---|---|---|
| TN2 | One of the ridge tiles is slightly lifted and there is a gap that could allow bats to crawl underneath it to roost. | |

- the interior of the north-west gable wall
- the interior of the south-east gable wall
- the ridge tiles from the south, looking north
- the rear wall from the north, looking south

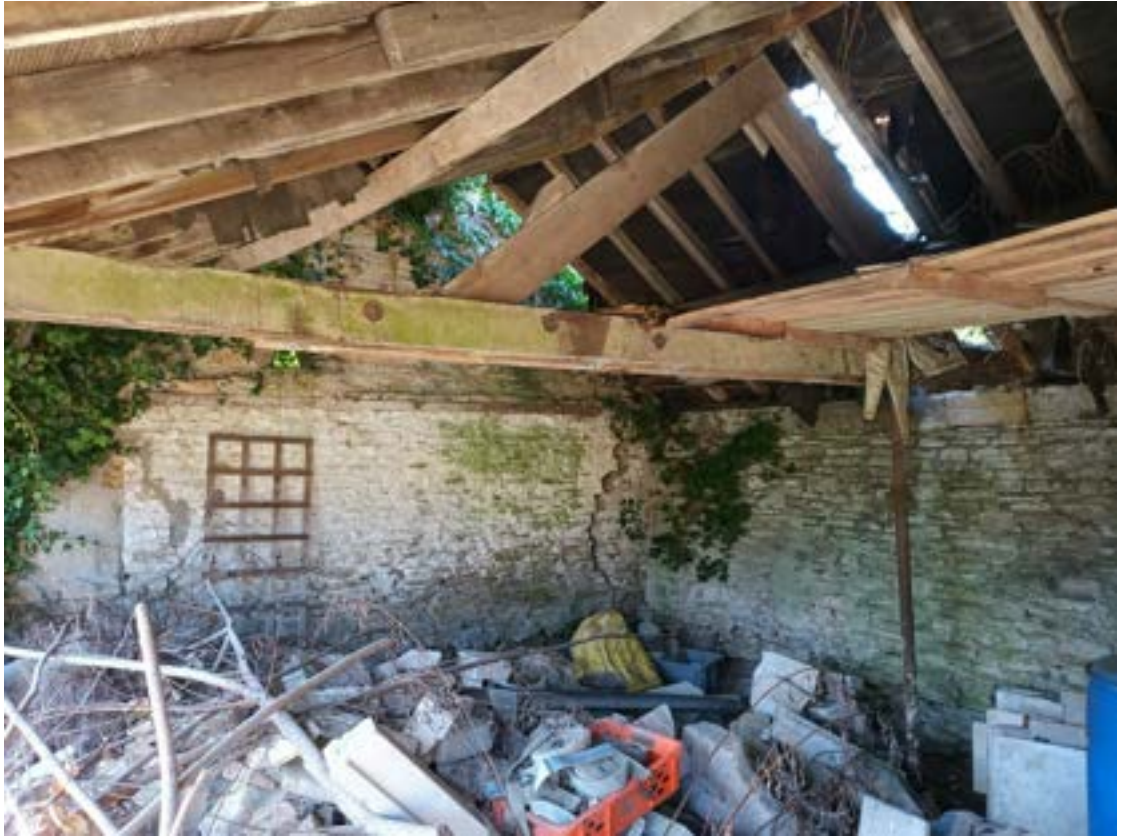
| Target Note | Description | Photo |
|---|---|---|
| TN3 | <p>There is a vertical crack in the stonework in the north-west corner of the barn. Most of this is exposed and unlikely to be used by bats but there are small areas where individual bats or small numbers of bats could roost.</p> | |

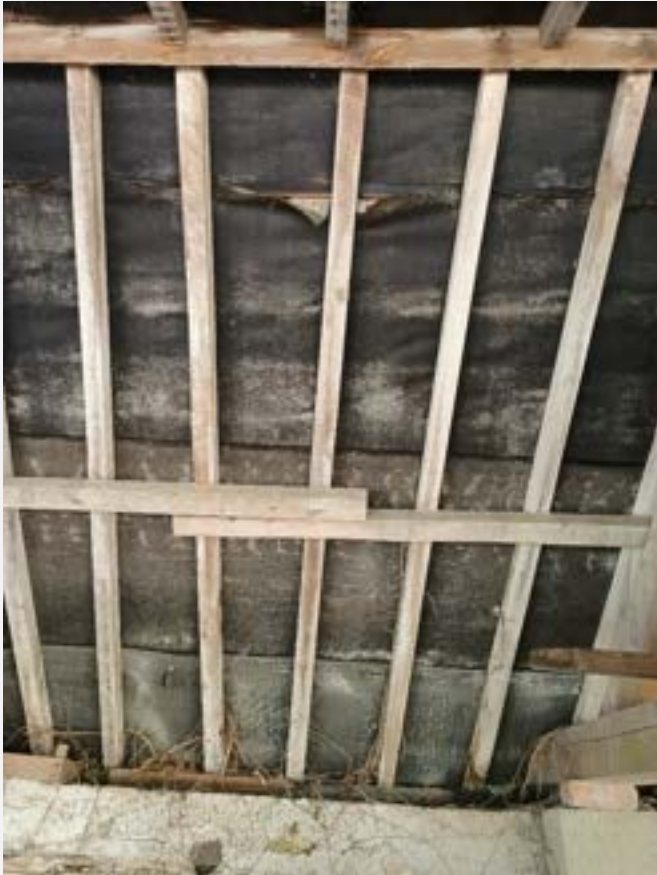
| Target Note | Description | Photo |
|---|---|---|
| TN4 | There are tears and gaps in the bitumen roofing felt that would allow bats to crawl into the gap between the felt and the tiles | |

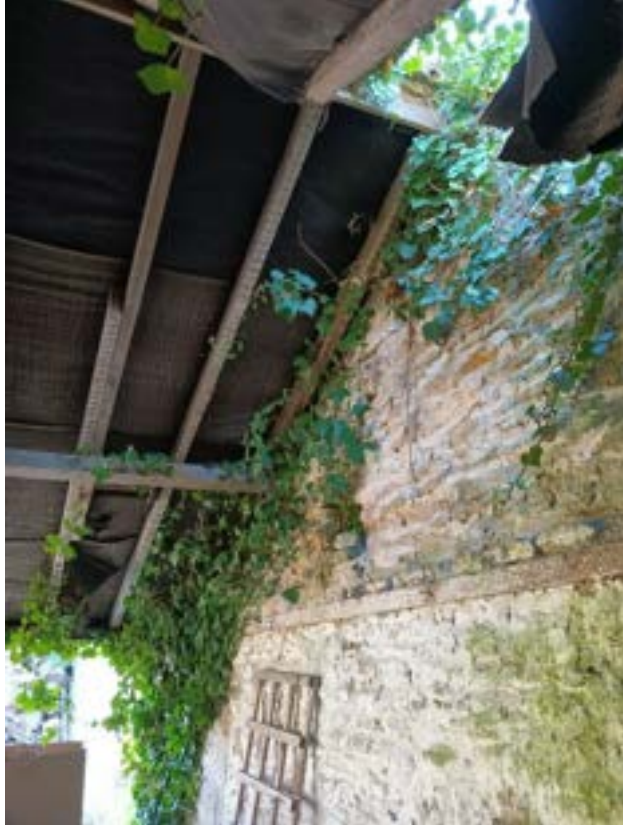
| Target Note | Description | Photo |
|---|---|---|
| TN5 | There is a gap between the end rafter and the wall: small numbers of bats could crawl into this space to roost | |

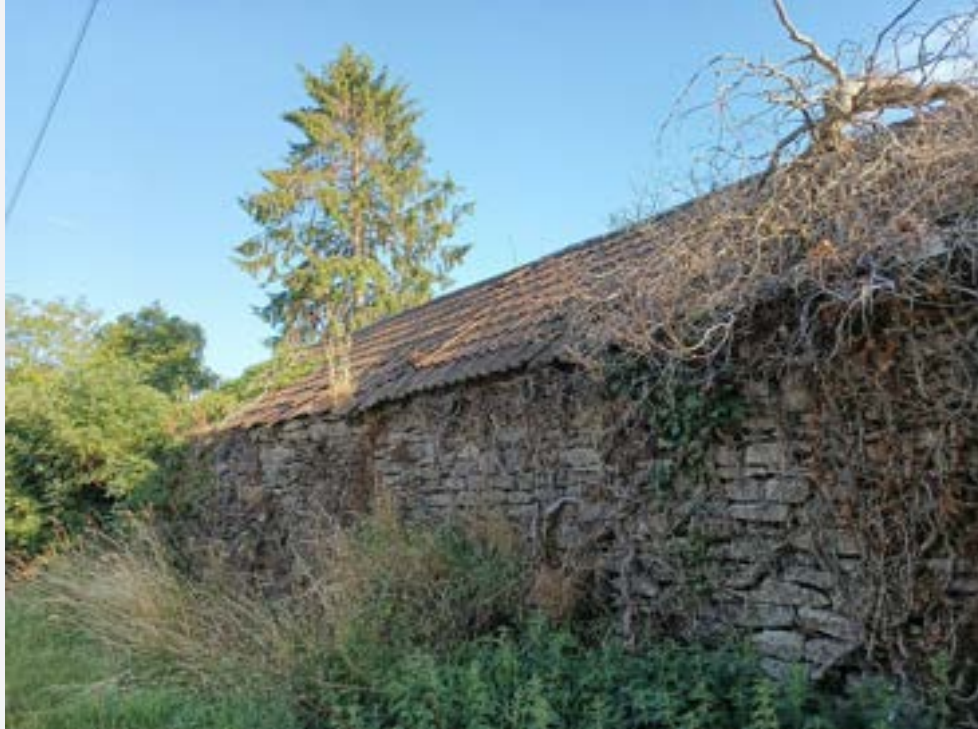
| Target Note | Description | Photo |
|---|---|---|
| TN6 | The tiles on the rear roof pitch are mostly gap-free, but there are many small gaps in the mortar joints where small numbers of bats could roost | |

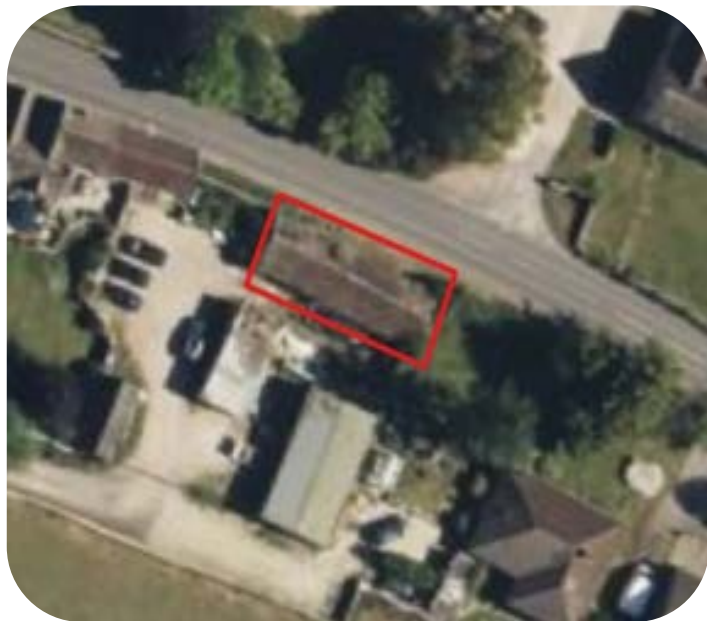
**Photo 4-1: the immediate surroundings of the barn**

and the absence of tree cover over the barn, also reduce the likelihood of bats roosting here.
