## **Historic Building Impact Assessment**

**97 Brown Street,  
Salisbury, Wiltshire**

November 2025  
Reference: 25963A

**Heritage Building Heritage Impact Assessment**

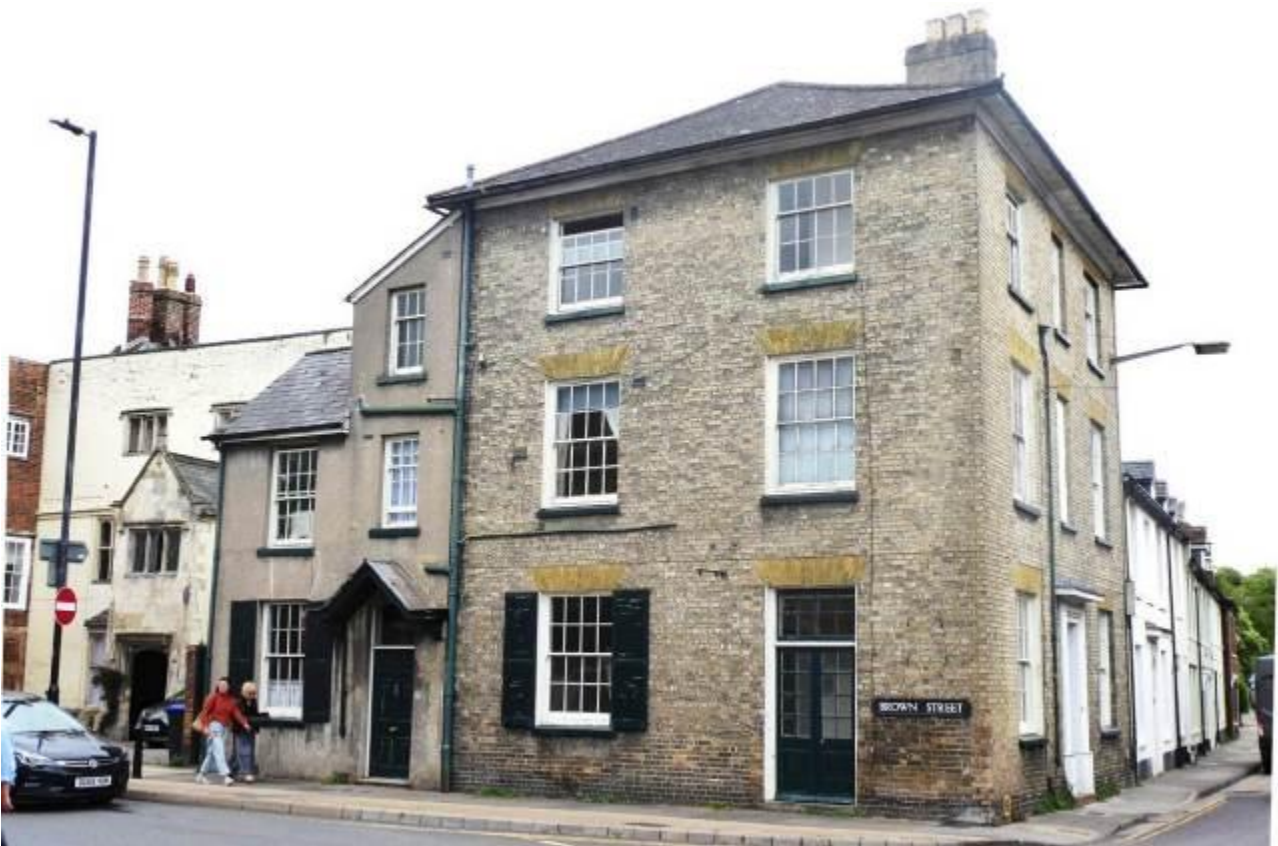
Fig: 97 Brown Street from the southwest

The main part of the building is early to mid 19<sup>th</sup> C structure that was possibly originally built as N° 9 St Ann Street as can be seen by how the frontage on to St Ann Street presents a very balanced faced on either side of a central front door. The elevation on to Brown Street originally only contained windows to what were probably front and back rooms and was changed when the split occurred and internal doors between the parts were closed-up.

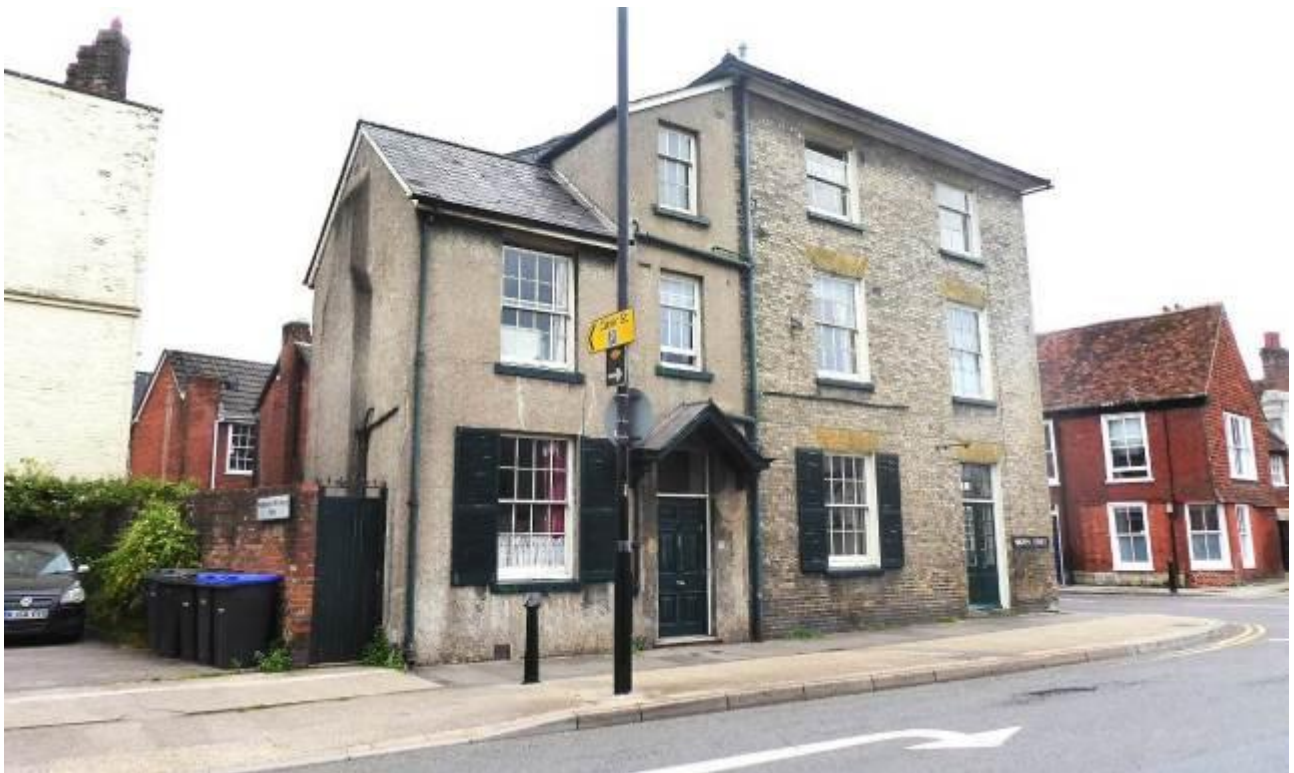
To the now divided part of N° 9 was added a two and three storey block on the north side, which contains the staircase and internal access block and new main entrance to form what is now N° 97 Brown Street. This section was added in the first quarter of the 20<sup>th</sup> C and was probably built to allow the separation of the main part of this from this house from what was all part of N° 9. It also contained the ancillary accommodation to what is now a separate house, such as bathroom and kitchen.

Fig; 97 Brown Street from the northwest

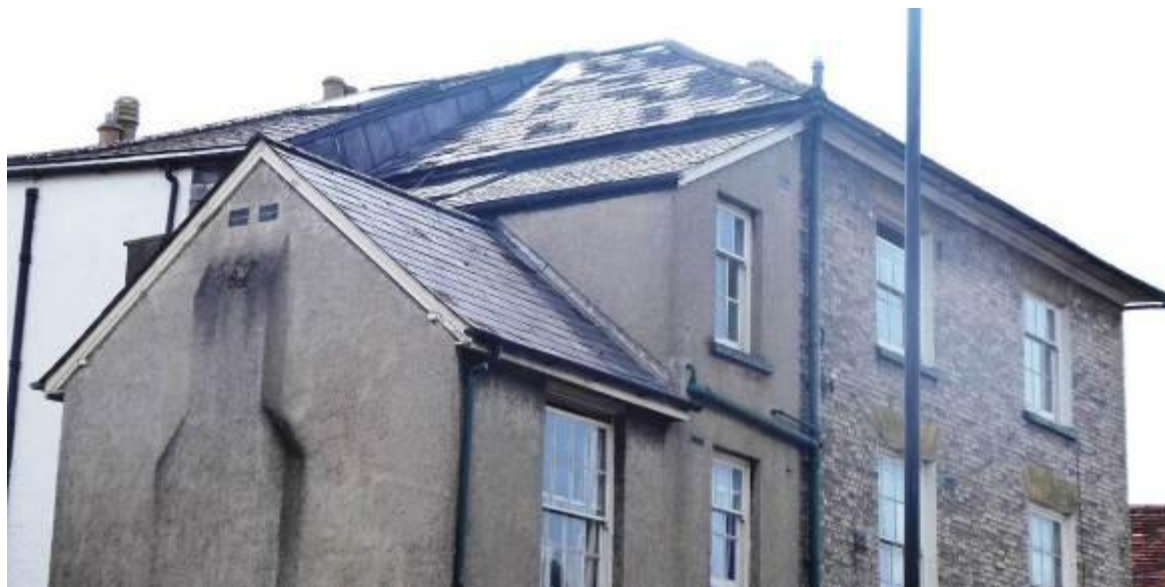
Fig 3.1: Roof arrangement showing north end addition

- 3.1.1 The roof to N° 97 is the west part of the former combined building with N° 9 St Ann Street on its east side where it is a visually balance structure to this group and covered with grey natural slates with running up to ridges and hips dressed with clayware angle ridge tiles. This part is largely the west hip, where each part of the building has even roof slopes between them on the south side.

- 3.1.2 On the north side there is a distinct change in the form of roof where the pitch flattens to the roof structure over N° 9 as the house widens, but still retains the same common ridge line at the top. Where this steps-up against that to N° 97 the face is dressed down with natural slates as a weatherproofing.

- 3.1.3 On the northeast corner of this building there is a slight overlap of this roof to the corner of N° 9, before that house widens on the north side.

- 3.1.4 On the north end of this building a mono pitch roof runs down from under the main roof eaves over the second floor part of the north section, which contains the mezzanine bathroom. Then, on the north side of this two storey addition, a gable ended roof structure continues over the first floor north end rooms. These roofs are covered with slates, as the main roof

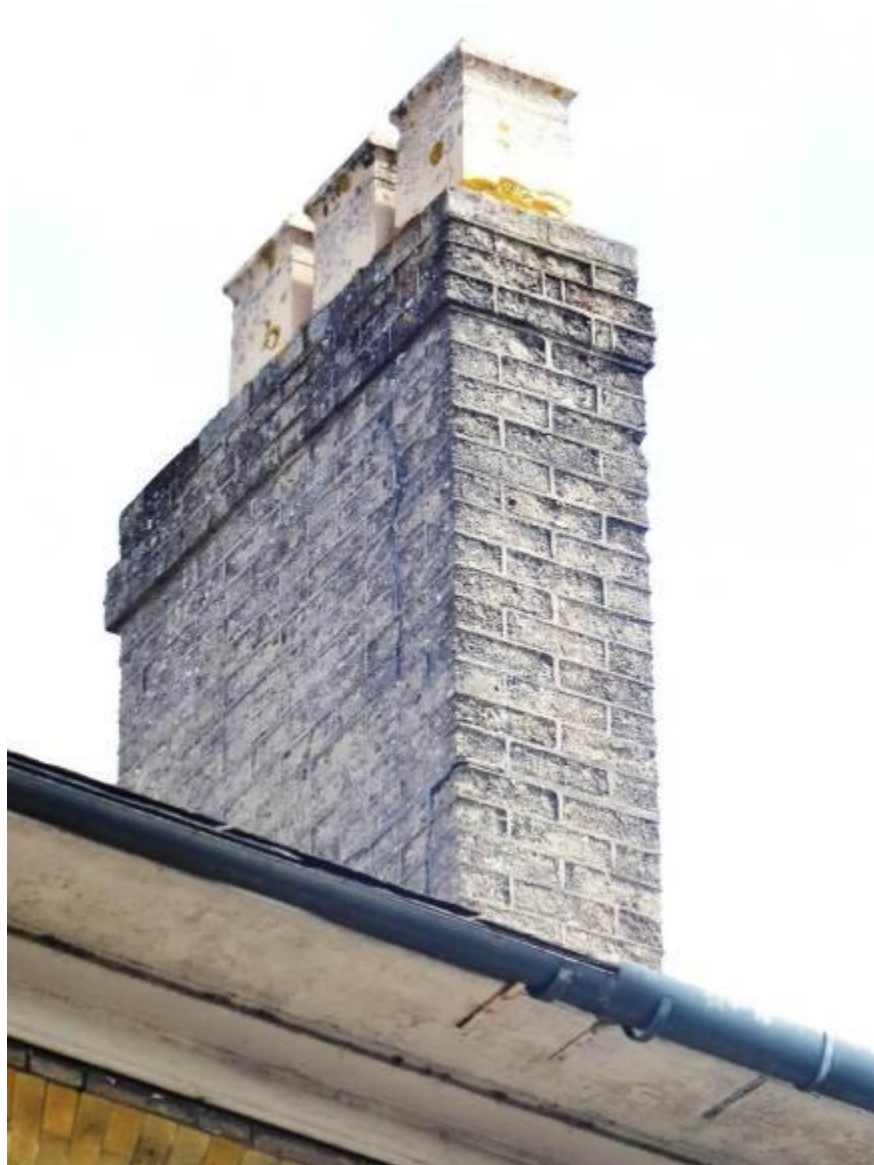
Fig 3.2: Chimney

- 3.2.1 There are apparently no functioning chimneys associated with this part of the larger building, although there is a three flue stack above the fireplaces seen in the south rooms on each floor. This is in brickwork of a type similar to that to the main walls, but of a lower quality as this is severely weather eroded. It is surmounted by three square clayware pots.
- 3.2.2 Running up the north gable of the north addition is the lower portion of a chimneybreast that has been cut off below roof verge level.

- 3.2.3 A further former chimneystack runs up on the northeast corner of the building on the junction with that to the rear of N° 9 St Ann.

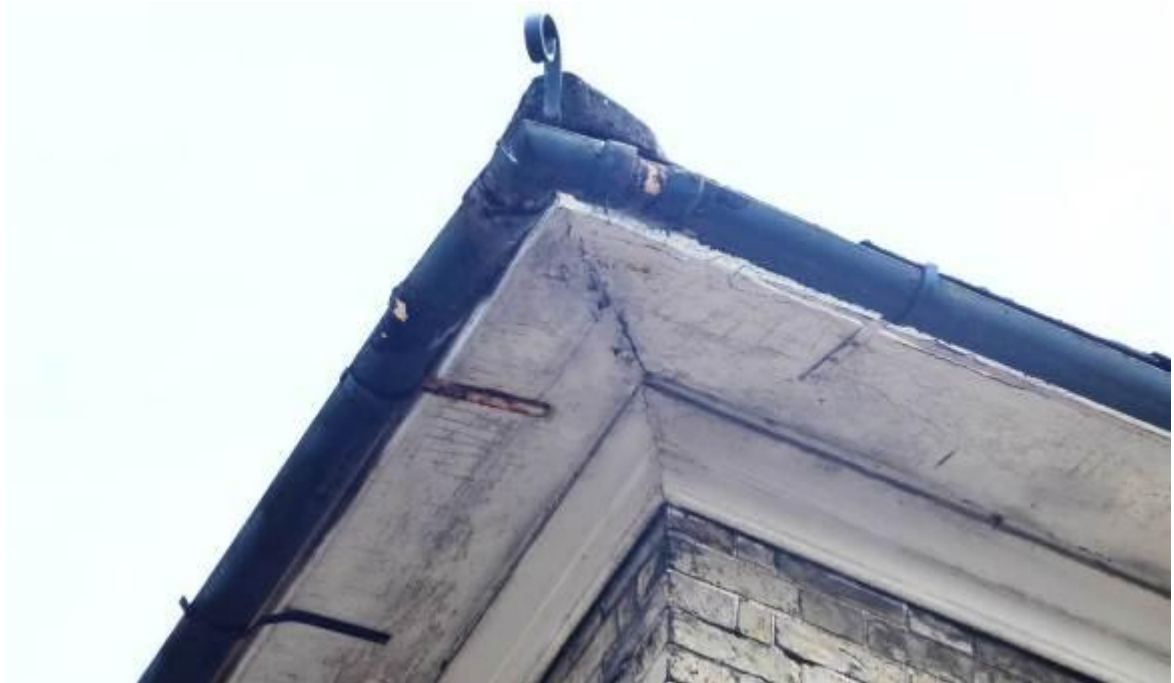
Fig 3.3.1: Main eaves

- 3.3.1 To the perimeter of the main roof to this block and N° 9 St Ann Street there is a wide overhang eaves, apparently of painter timber, that is over a painted timber cornice on the junction between the underside of this and the head of the wall closing. These eaves has a very shallow fascia board to the front that supports small section half round section cast iron guttering on projecting metal brackets.
- 3.3.2 To the north side mono pitch roof there is a simple unpainted timber fascia board fixed to the head of the wall under the eaves drip, supporting half round section cast iron guttering.
- 3.3.3 The eaves to the two storey section is a traditional boxed out timber structure of fascia and soffit with painted barge boards to the underside of the verge on that side. To this the rainwater goods are a mixture of uPVC and cast iron.

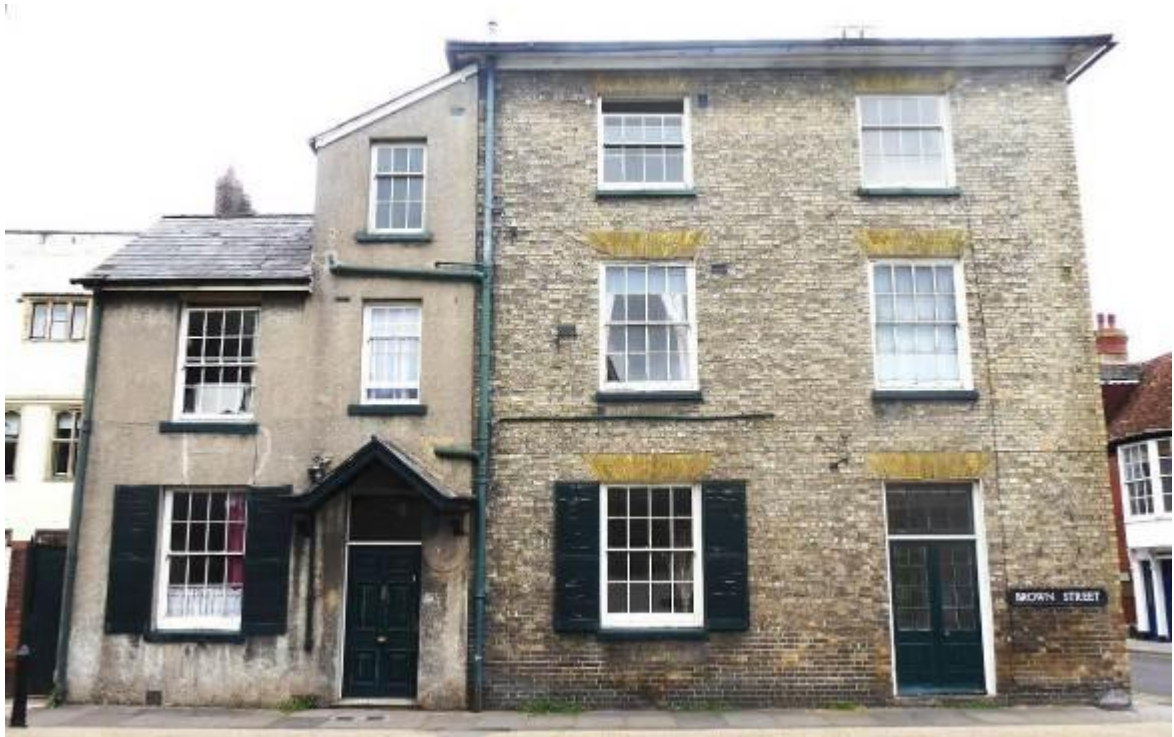
Fig 3.4: Front elevation

- 3.4.1 To the main part of N° 97 and St Ann Street the walls are in brickwork of a creamy buff colour laid in what would appear to be a lime mortar in Flemish bond. There

are flat rubbed arches over all the openings to doors and windows that employ a slightly contrasting yellow stick brick.

- 3.4.2 The north end two and three storey addition has solid wall finished with an undecorated fine pebble or spatter dash render from pavement level to eaves. There is a distinct construction joint on the junction between this part and the main building.
- 3.4.3 The general style of the brickwork to the walling would suggest a dating to the early part possibly second quarter of the 19<sup>th</sup> C whilst that to the northern section is of early 20<sup>th</sup> C.

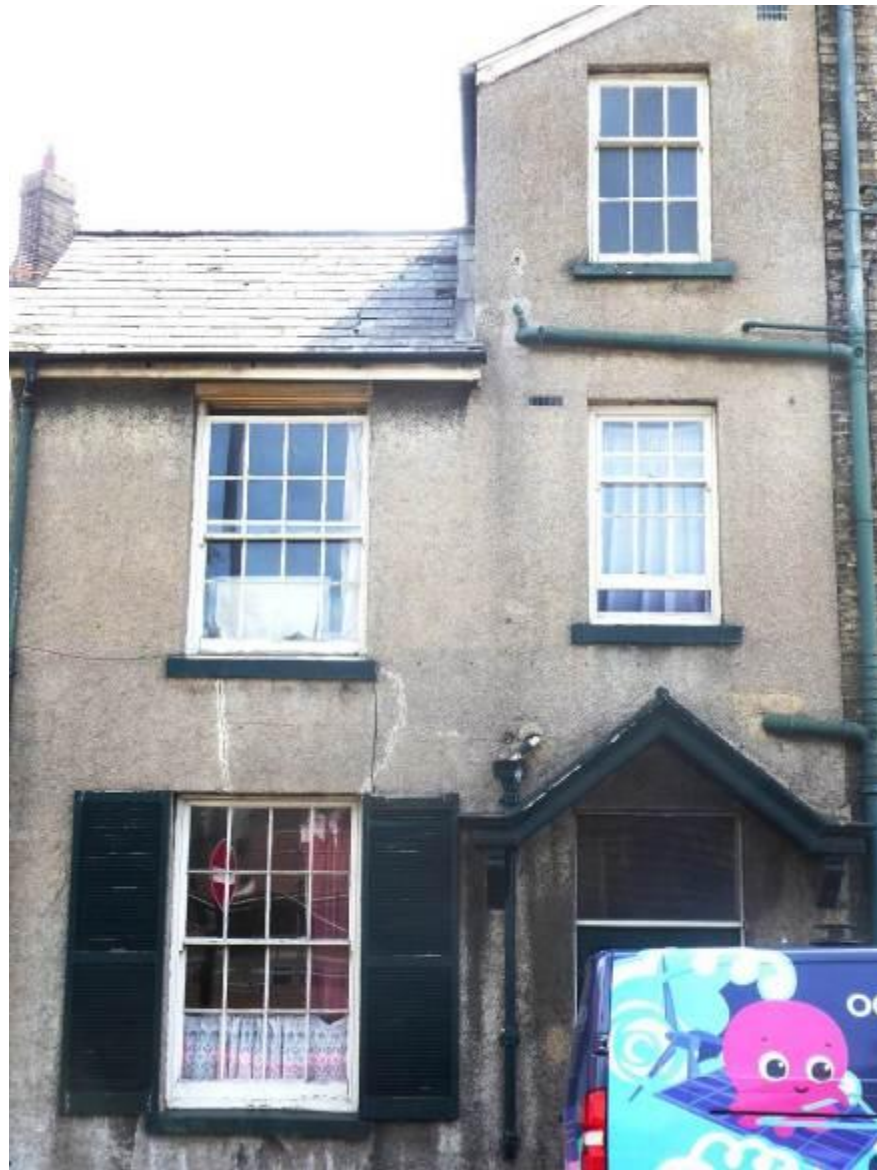
Fig 3.5.2: North end windows

- 3.5.2 To the northern addition the front windows are eight –over-eight vertical sliding sash to the main bedrooms with three-over-six sashes to the bathrooms on each level.
- 3.5.3 There are modern standard joinery dummy shutters rigidly fixed to the side of the front north window.

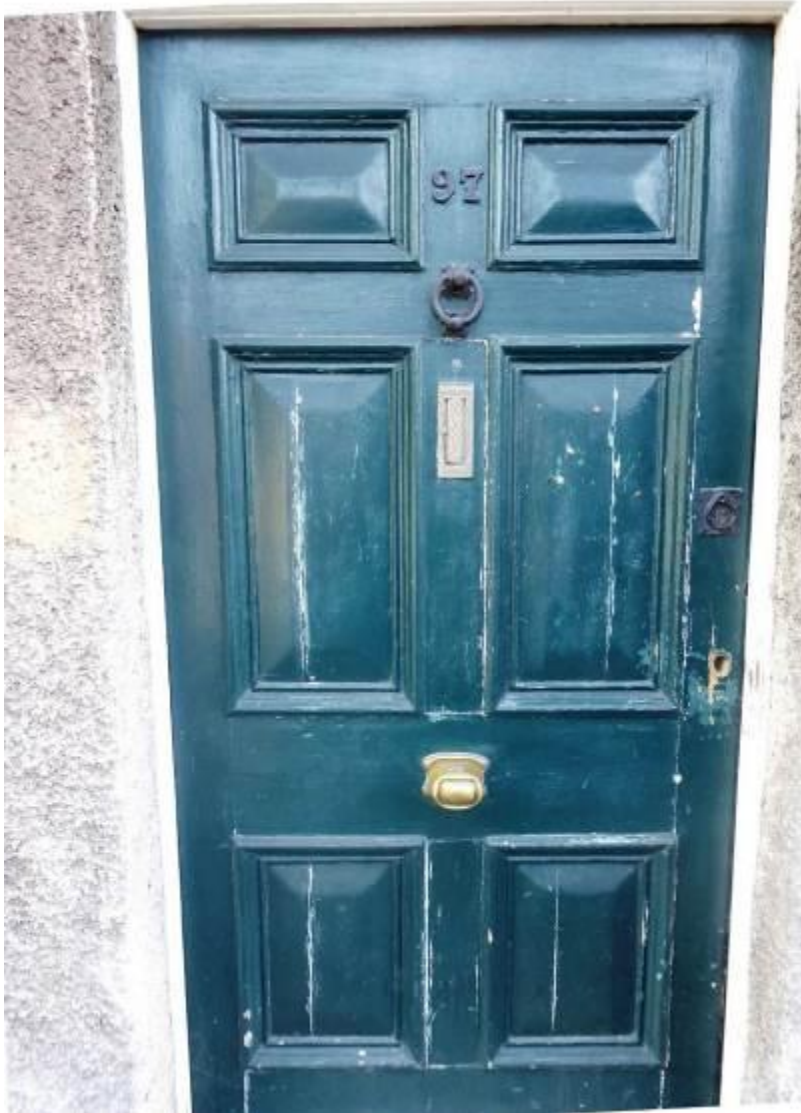
Fig 3.6.1: Front door

- 3.6.1 The main door into the property is a six panel door with raised panels within a beaded surround in a modern door lining under a large single glazed transom light.

The door is fitted with a central Art Nouveau knob, small ring knocker with strike plate, brass letter plate which is very much below Post Office recommended size, numerals 9 and 7, escutcheon plate for Yale type lock and mortise lock.

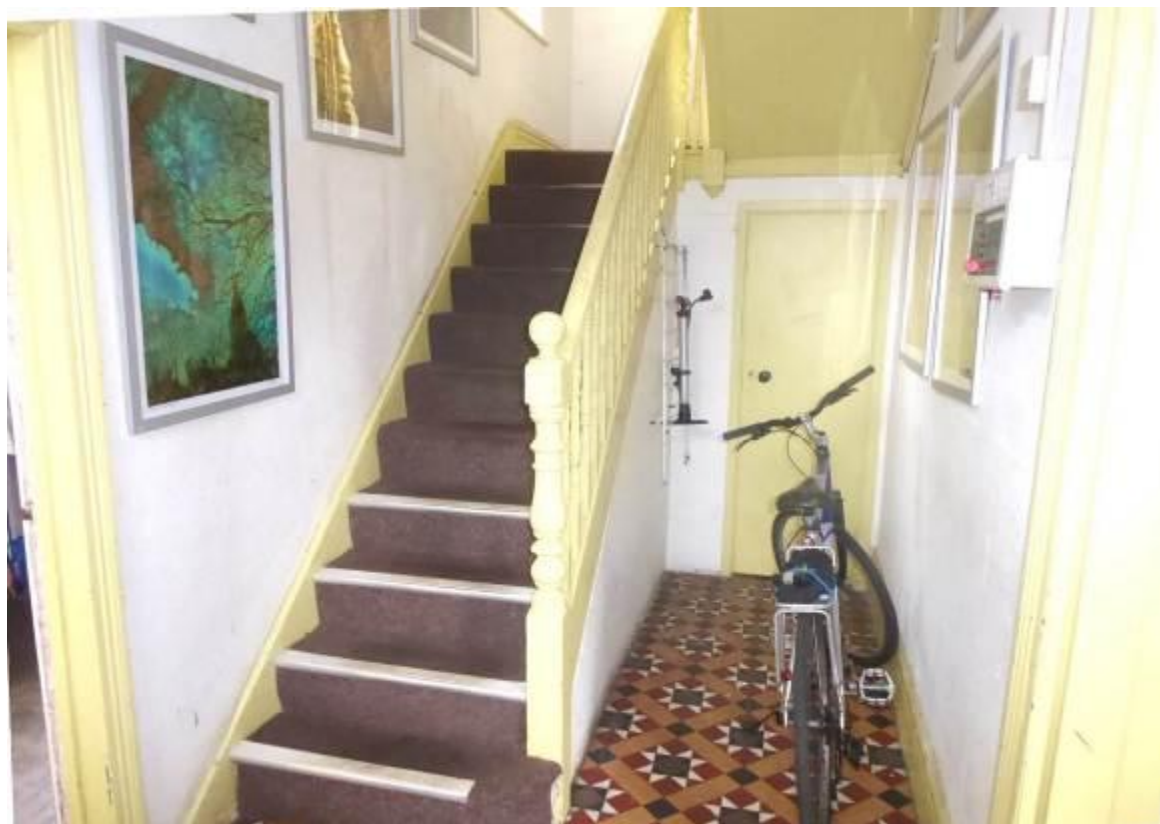
Fig 4.2: Entrance hall

- 4.2.1 This is approached by means of the main external door from the pavement to Brown Street and it extends to the back from where the stairs rise to the first floor.

- 4.2.2 Floor is of solid construction surfaced with decorative early 20<sup>th</sup> ceramic tiling, with mat well at the door end.
- 4.2.3 The walls are of solid construction and run are covered with painted woodchip paper. To some walls there is a painted torus profile skirting board to the base

- 4.2.4 The ceiling is flat soffit of lath and plaster construction covered with painted woodchip paper.
- 4.2.5 Leading off this area are doors to the existing kitchen to the left hand side and a large room on the right hand side, where both are modern standard joinery flush faced fire doors fitted with automatic door closers. The door linings have painted timber ogee profile architraves. At the back of the hall, under the stairs, a is standard flush with door to the ground floor cloakroom hung in a simple late 20<sup>th</sup> C door lining with painted bull nose profile architraves.

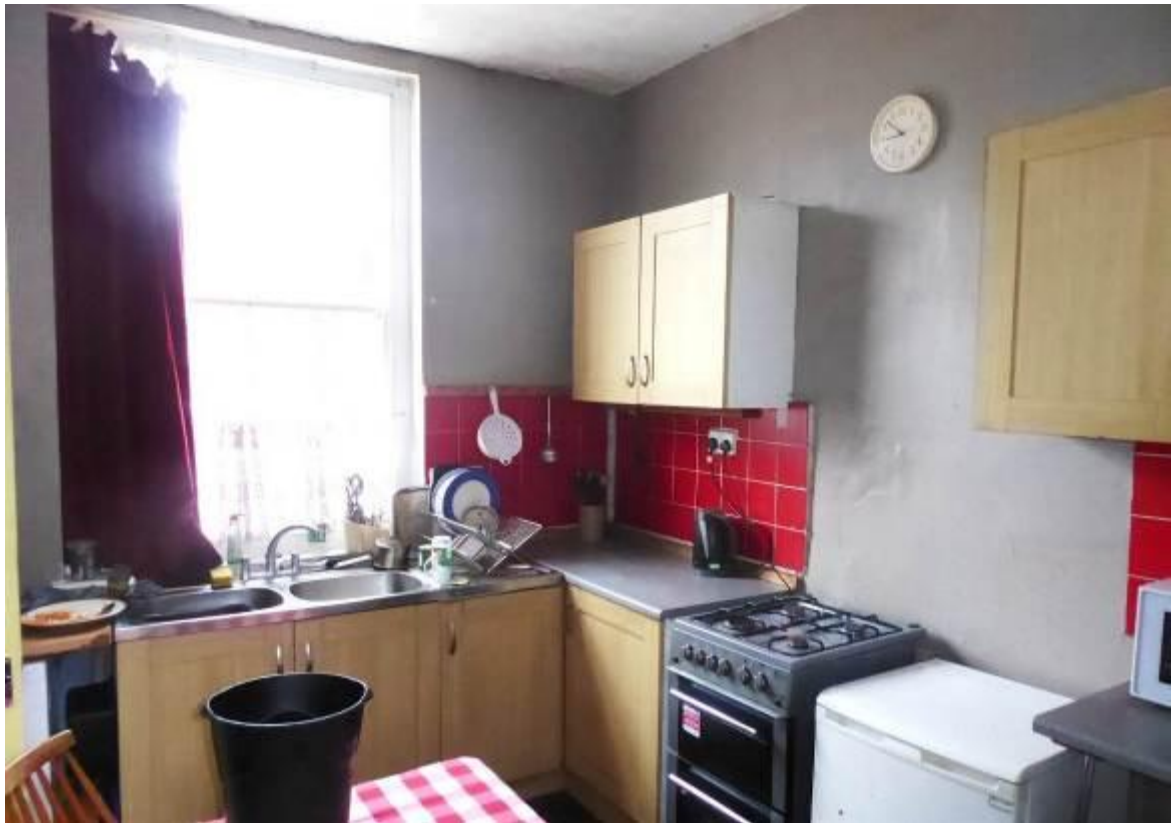
Fig 4.3: Kitchen

- 4.3.1 Floor is solid construction covered with vinyl fitted sheet.
- 4.3.2 The walls are of solid construction with painted plaster finish.
- 4.3.3 The ceiling is a flat soffit with decorative Artex type textured paint finish.
- 4.3.4 Leading out of this room is a standard joinery glazed panel door, with a large single glazed transom light over the head, which leads to the small back yard.
- 4.3.5 There is an alcove to left hand side of door, which contains a wall mounted Worcester gas boiler with balance flue to external wall. A hot water cylinder is mounted on a shelf above this.
- 4.3.6 Kitchen fittings have modern standard melamine carcasses with paper laminate faced door and drawer fronts under roll edge laminate worktop. There is a separate double bowl single drainer stainless steel sink with swan neck mixer tap over.

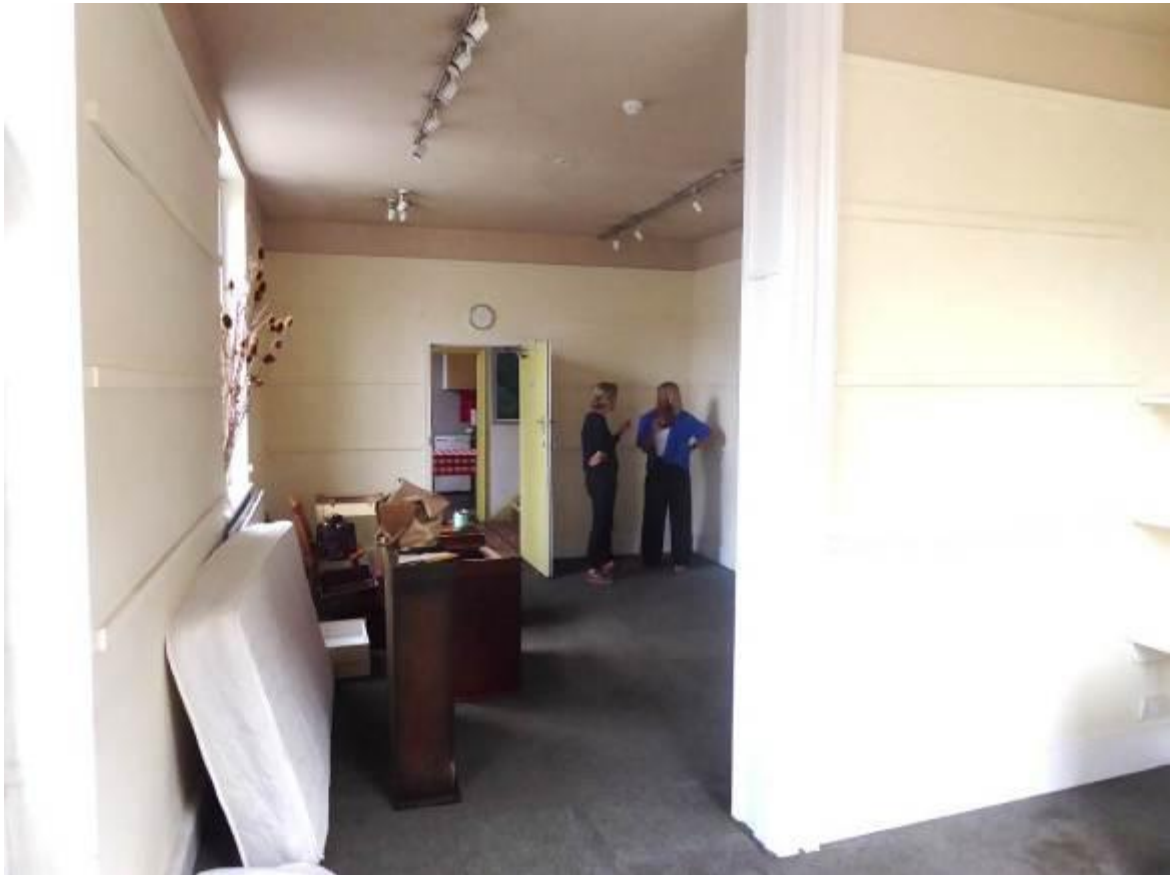
Fig 4.5: Ground floor main room

- 4.5.1 This is to the right (south) of the entrance hall and appears to possibly originally have been two rooms. There is a ghost line in the ceiling, front to back, where the division wall has been removed.
- 4.5.2 The floor is of solid construction and covered with stuck-down carpet tiles.

- 4.5.3 The walls are of solid construction with paint finish and simple torus profile skirting boards to the base and an ogee profile picture rail just below the ceiling. Modern horizontal painted timber battening has fixed to walls all the way round.
- 4.5.4 A fire breast runs up the wall to N° 9 St Ann Street, at the south end, and to the right of this is a corner cupboard.
- 4.5.5 The ceiling is a flat soffit, where it is a mixture of plasterboard, as indicated by straight cracks on joints, and lath and plaster. This has light tracks and down lighters fitted to and in the surface.

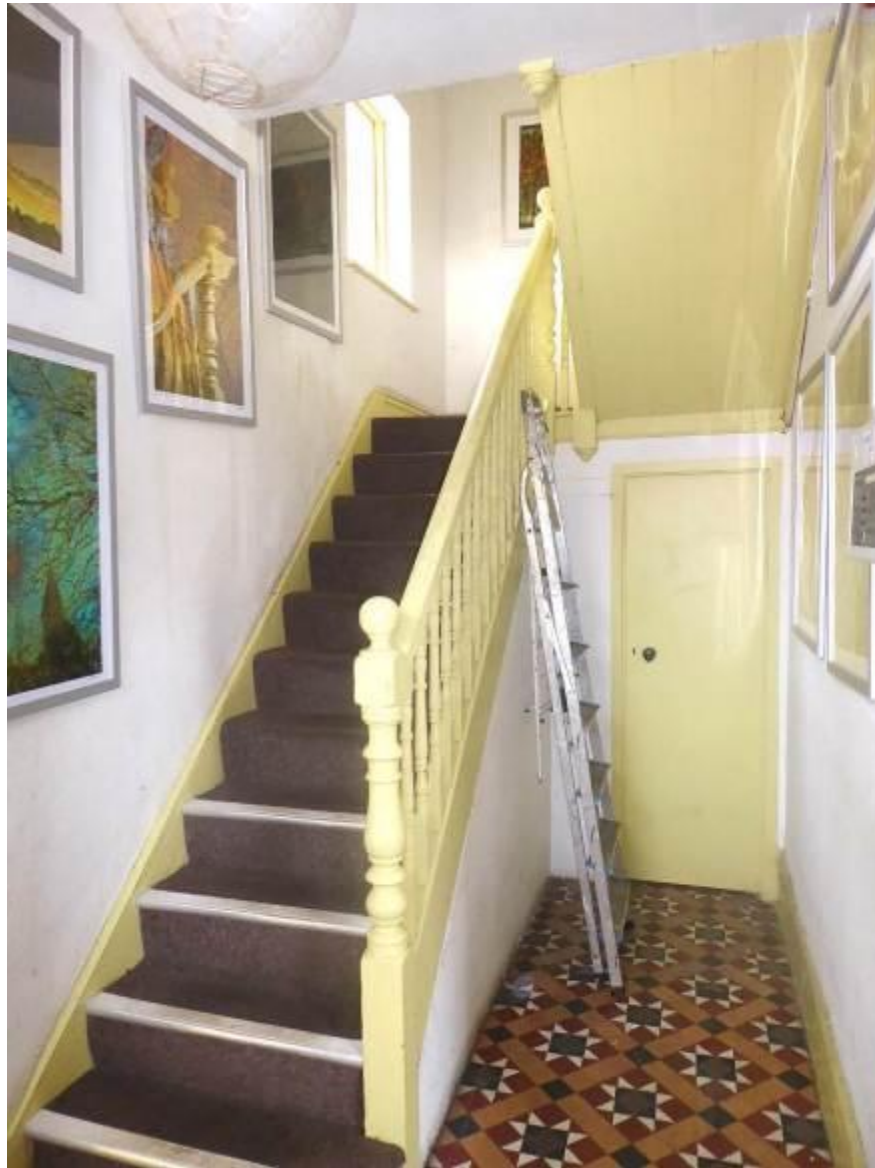
Fig 4.6: Stairs from ground to first floor

- 4.6.1 These have a timber structure of apparently early 20<sup>th</sup> C date as suggested by balusters and newels fitted to balustrade of this. They rise against the north side party wall to N° 9 St Ann Street.

- 4.6.2 These rise as a straight flight from the ground floor to a half space landing where they return and then run to first floor landing another straight flight, where the timber construction is covered with fully fitted carpets.
- 4.6.3 There are turned newel posts and balusters to the balustrade to the open side, all of which has been painted.
- 4.6.4 Where the walls rise up through the stairwell these are of the same construction as noted for the ground floor.

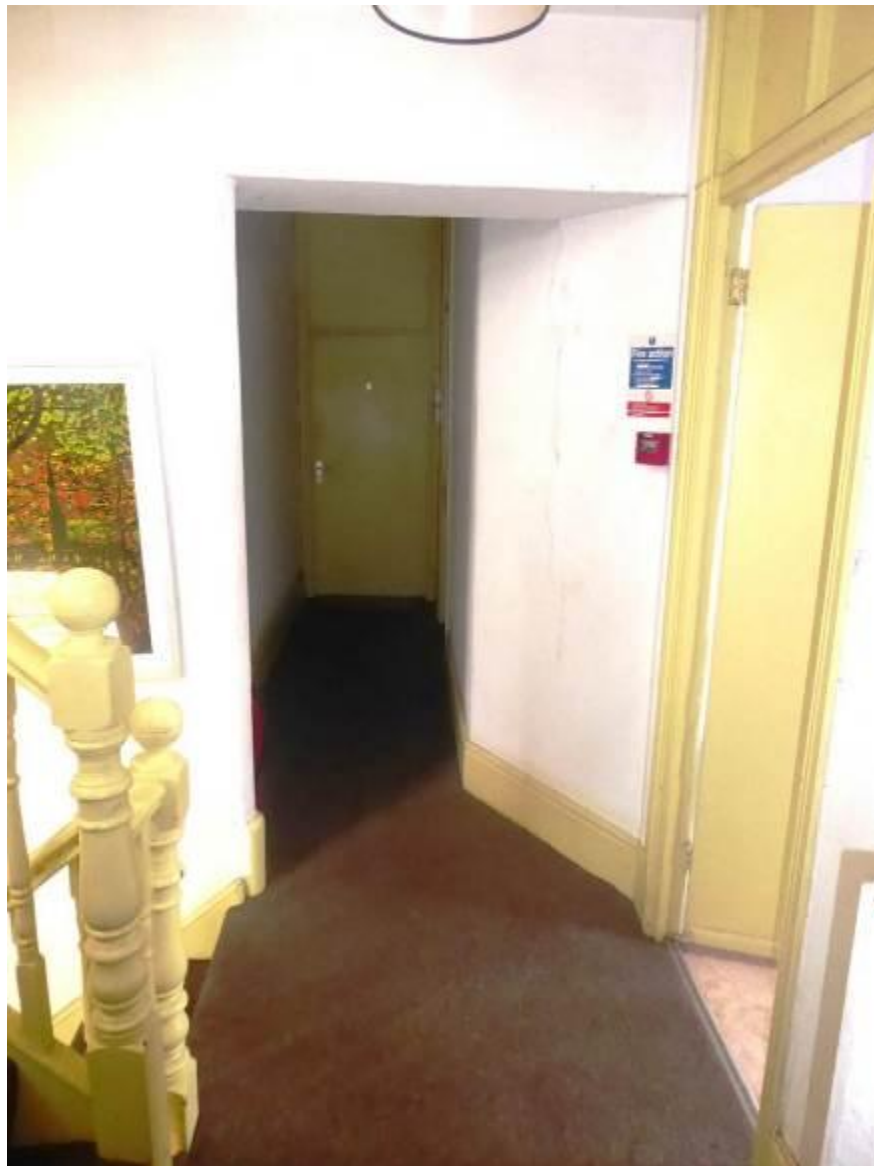
Fig 4.7: First floor landing

- 4.7.1 This is in effectively in two sections, one at the head of the stairs serving the room off it and from where the stairs to the second floor rise. From the south side of this a stub landing runs to the south along the party wall to N° 9 St Ann Street to bedroom in that part.

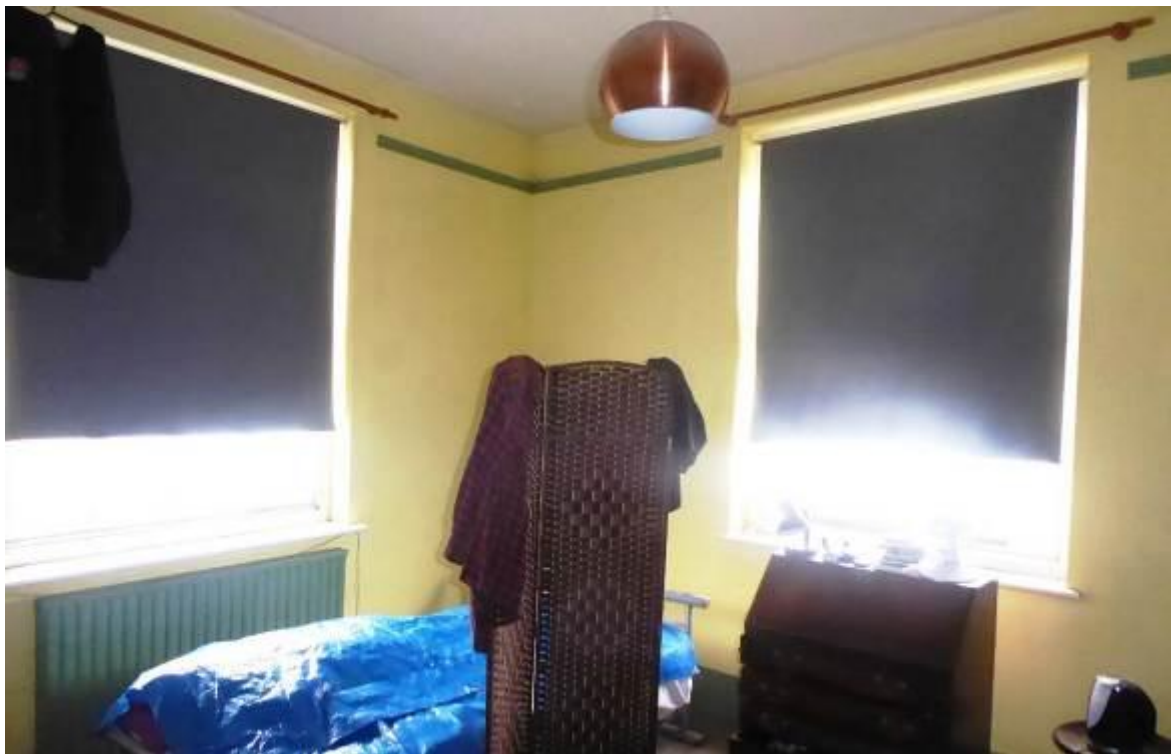
Fig 4.8: First floor south bedroom

- 4.8.1 This has a suspended timber floor covered with fitted carpets, therefore no further comment can be made on construction.
- 4.8.2 The external walls to the exterior and to N° 9 St Ann Street are of solid construction with painted woodchip paper finish. There is a modern hollow internal wall to the first floor centre bedroom. A firebreast runs up the wall to N° 9 St Ann Street with a closed-up fire opening with timber surround in the base. There is painted torus profile skirting boards to base of the walls.
- 4.8.3 The ceiling is a flat soffit with painted woodchip paper finish.

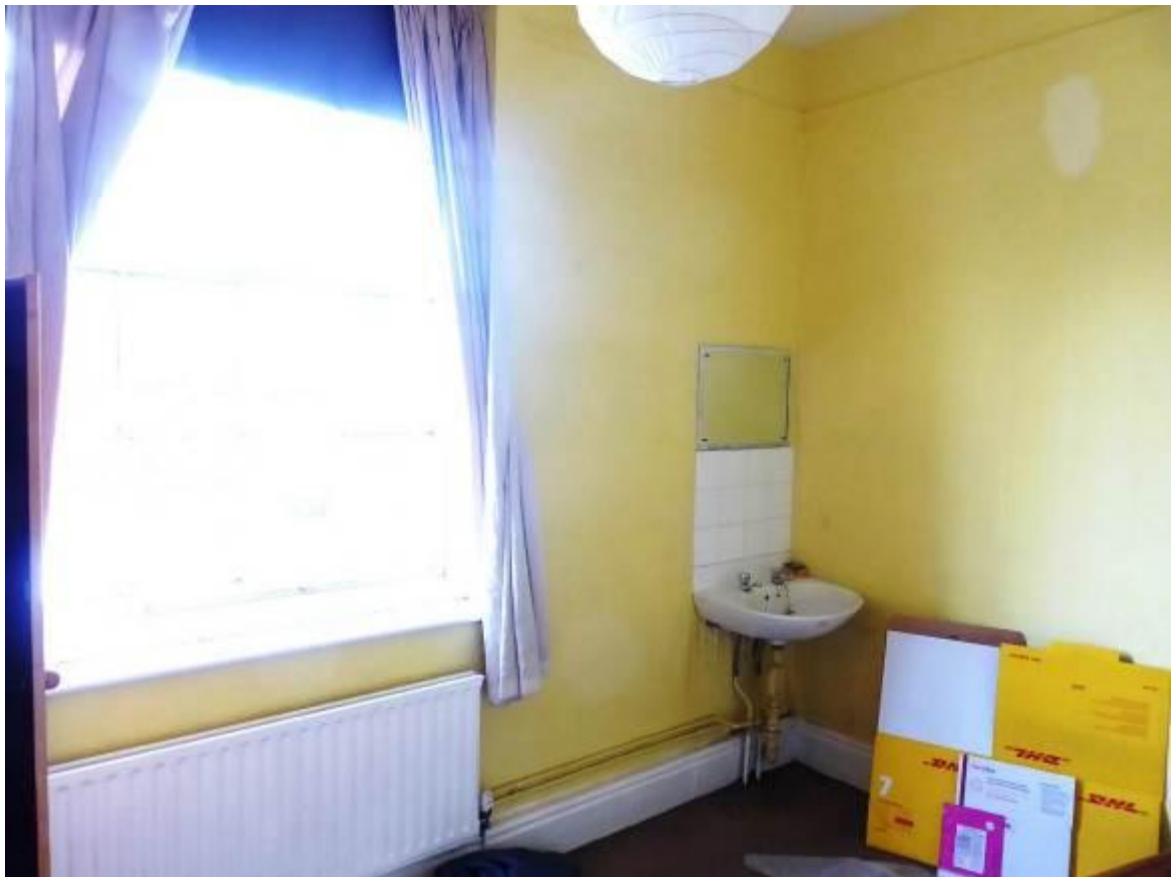
Fig 4.9: First floor centre bedroom

- 4.9.1 This is generally as south bedroom in terms of walls, floor and ceiling. There is boxed ducting in corner adjacent to the landing.
- 4.9.2 A bracketed wash basin is fitted to external wall.

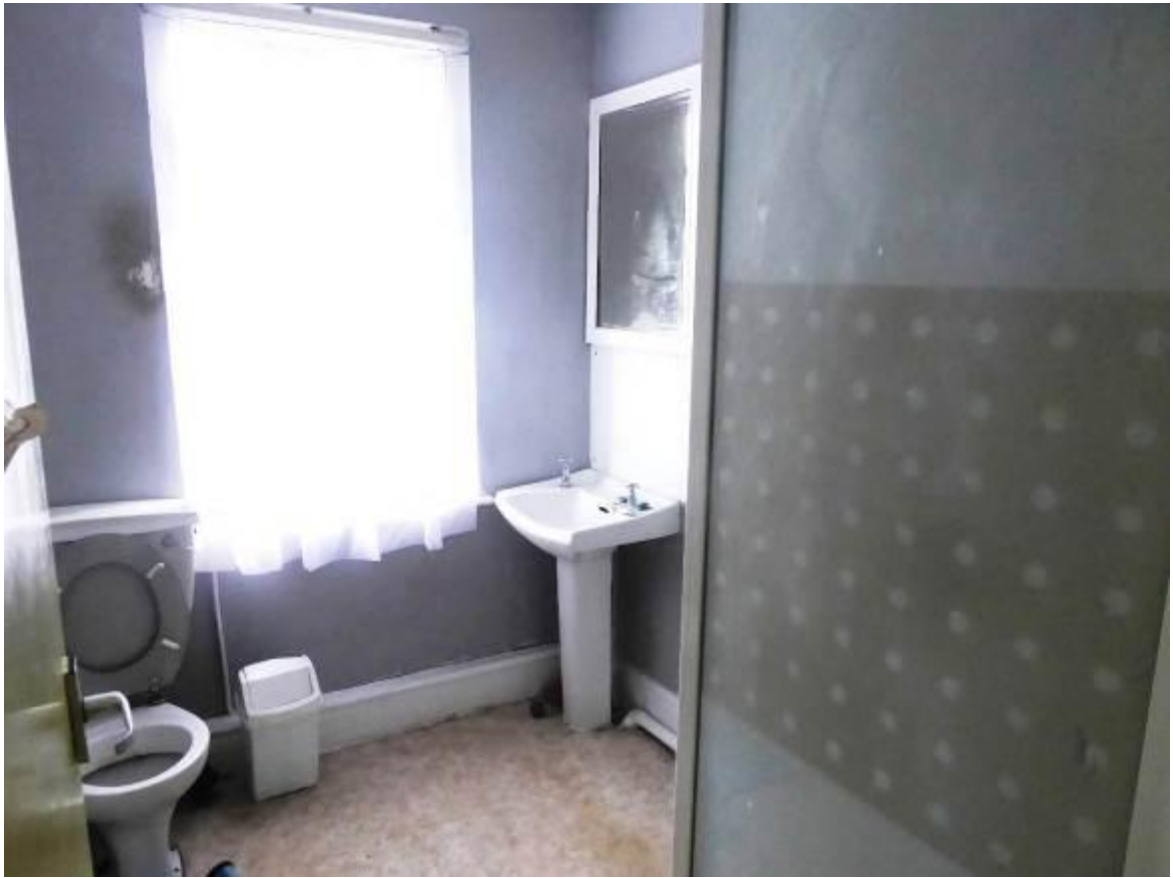
Fig 4.10: First floor shower room

- 4.10.1 In terms of floor, walls and ceiling this is generally as that described for the east bedroom, except there are solid construction walls to the interior.
- 4.10.2 The floor is covered with fitted vinyl sheeting.
- 4.10.3 The ceiling is a flat soffit, possibly of plasterboard or similar, with a paint finish.
- 4.10.4 Sanitary fittings comprise low level WC suite, pedestal wash basin and shower cubicle with no indication of safety marks on the glass.

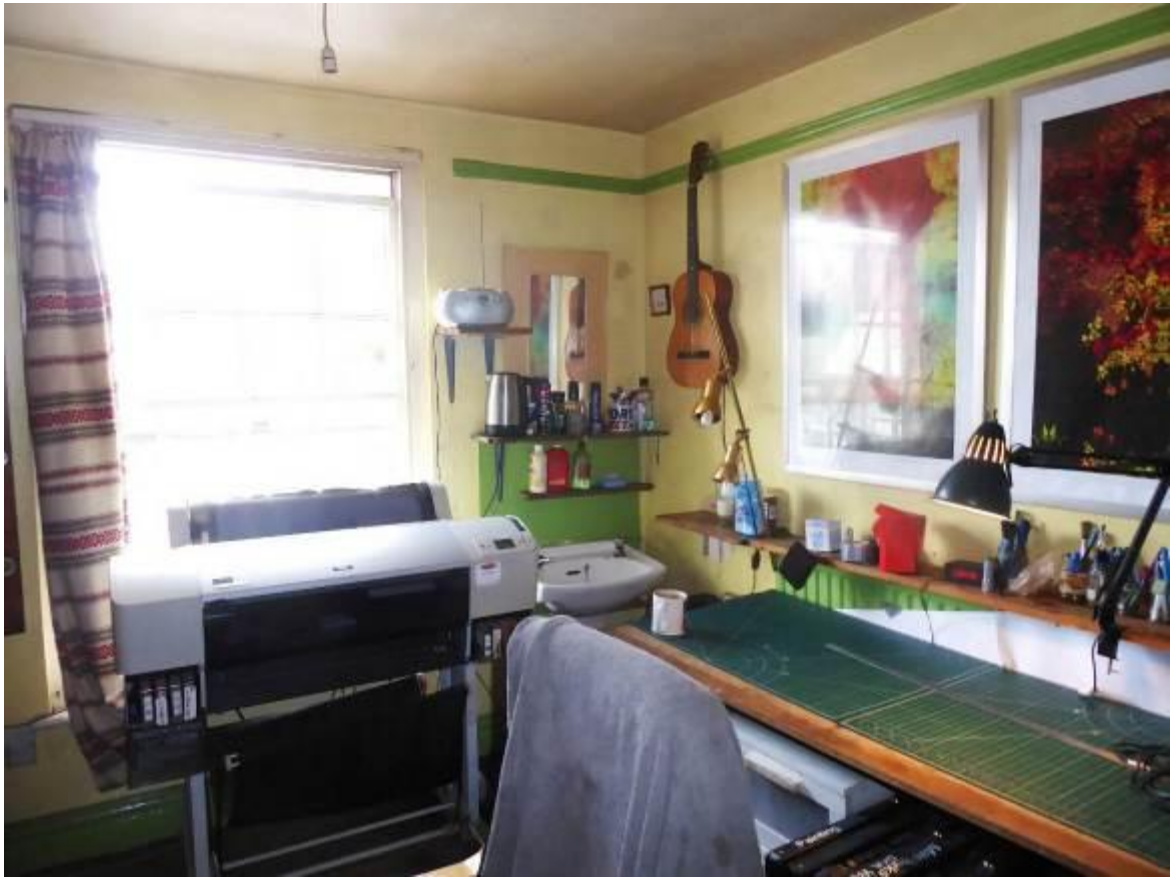
Fig 4.11: First floor north bedroom

- 4.11.1 Generally this room is as described for south bedroom with a suspended timber floor covered with carpet, solid walls on all sides with painted woodchip paper and a flat soffit to the ceiling of lath and plaster with painted woodchip paper.
- 4.11.2 A pedestal wash basin is mounted against the external wall.

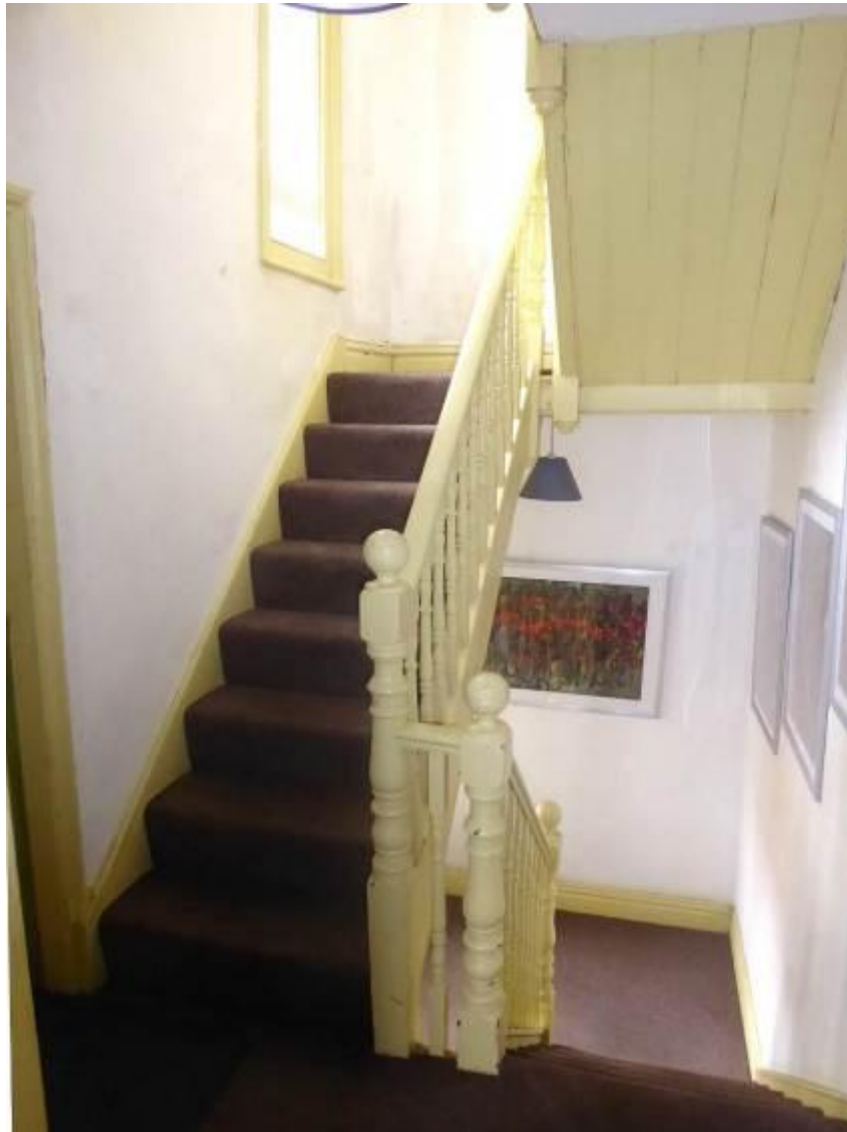
Fig 4.12: Stairs from first to second floor

- 4.12.1 There are similar in overall construction, style and form as those previously described from the ground to first floor.
- 4.12.2 There is a single glazed vertical sash window mounted adjacent to mid landing and similar comments apply to this as made for landing window between ground and first floor.
- 4.12.3 The walls are generally as those described previously where these rise up through the building.
- 4.12.4 The ceiling over this area is a skilling where this follows the underside of the roof slope as this runs down at the north end of the building from the main block to frontage of Brown Street.

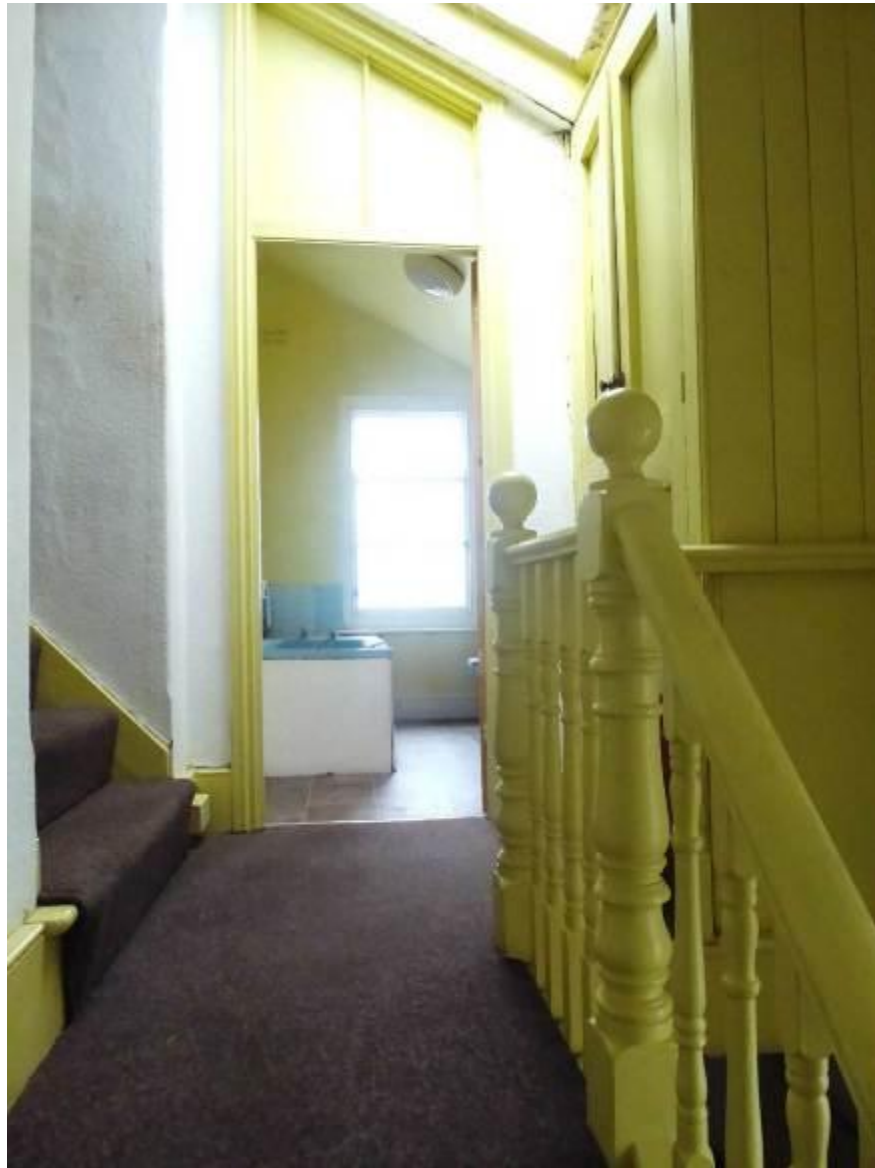
Fig 4.13: Mezzanine landing

- 4.13.1 This is positioned between the head of the main stairs to the second floor level of the north end part of the house and the main second floor level to the south section of the building. These are connected by a short flight of timber construction stairs covered with carpets, where the open side is guarded by an extension of the handrail and balustrade from the main staircase.
- 4.13.2 The walls are generally as that described for the stairs and first floor landing, with a cupboard built in to the landing adjacent to second floor bathroom.

- 4.13.3 The ceiling is a continuation of that from over the stairs, with a traditional single glazed cast iron roof light set within it.
- 4.13.4 The door to the bathroom is a modern standard joinery undecorated four panel door, with a painted glazed transom light over the head.
