## **Historic Building Impact Assessment**

**97 Brown Street,  
Salisbury, Wiltshire**

November 2025  
Reference: 25963A

**Heritage Building Heritage Impact Assessment**

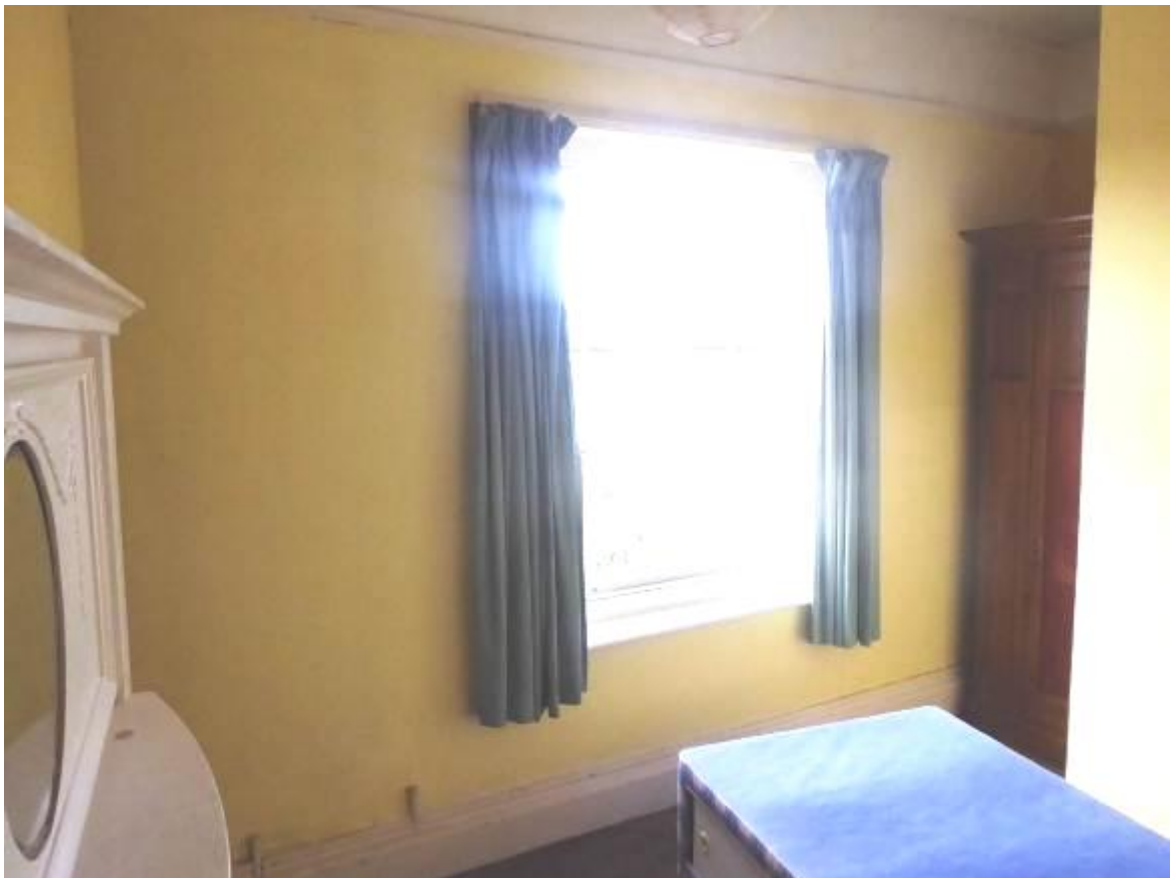
Fig 4.16: Second floor south bedroom

- 4.16.1 Generally the structure of this room as that described for bedrooms on the first floor with suspended timber floor covered with fitted carpets.
- 4.16.2 It has solid walls to the exterior and modern hollow wall construction to the interior, where all are covered with woodchip paper that has been painted and torus profile skirting profile boards to the base.
- 4.16.3 This has a picture rail running around just below ceiling level also with fire breast running up wall to N° 9 St Ann Street, with a cast iron fireplace with a decorative timber fire surround with inset tiling suggesting dating to 19<sup>th</sup> C or very early 20<sup>th</sup> set in to the base.

- 8.2.4 At the south end of the second floor the two current bedrooms are divided by a late 20<sup>th</sup> C lightweight stud partition wall on a very poor alignment that results in an almost unusable space for each room. This division is to be replaced with a new

8.3.8.5 On the second floor the earlier division of the south room is in late 20<sup>th</sup> materials, but installed in a manner that make efficient use of the space very difficult. The removal of this and its replacement with a wall on a new alignment will greatly improve both rooms. This will not adversely affect the historic character of significance of the building.

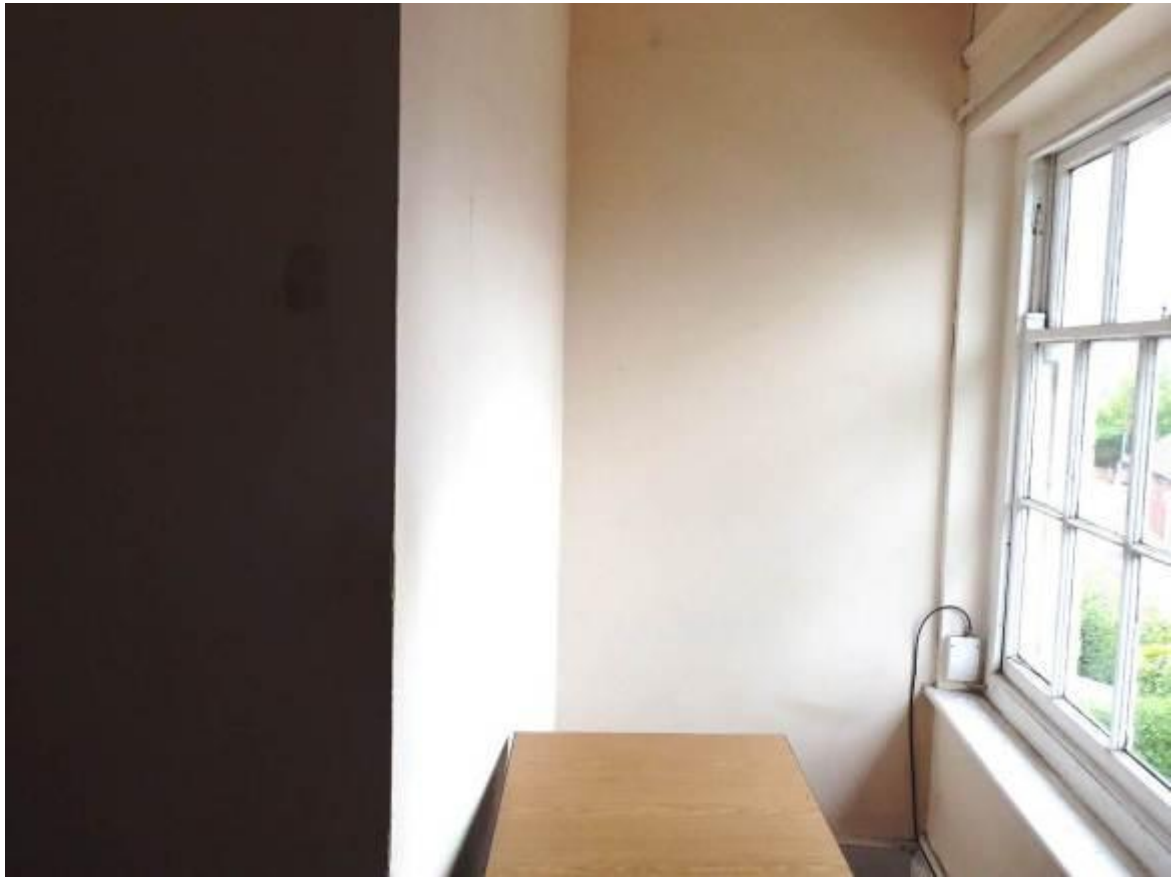
Fig 4.17: Second floor centre bedroom

- 4.17.1 Both this room and south bedroom would have been within the former single bedroom on this level.
- 4.17.2 The construction of this room is generally as described for the second floor south bedroom.

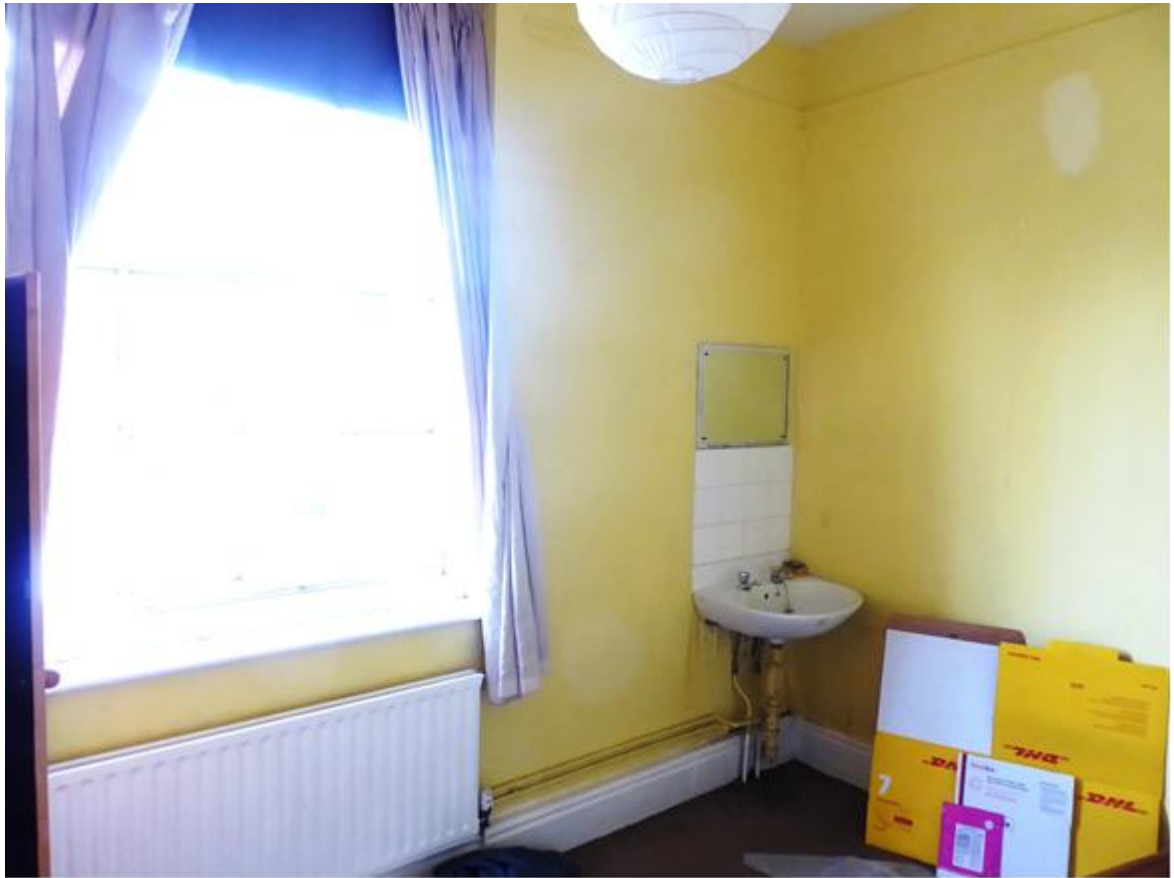
Fig 4.18: Second floor north bedroom

- 4.18.1 Generally this room is as that described for bedrooms on the first floor, with suspended timber floor covered with fitted carpets.
- 4.18.2 The ceiling is a flat soffit possible of lath and plaster construction with access hatch to roof space above.
- 4.18.3 A pedestal wash basin mounted against wall to mezzanine bathroom.

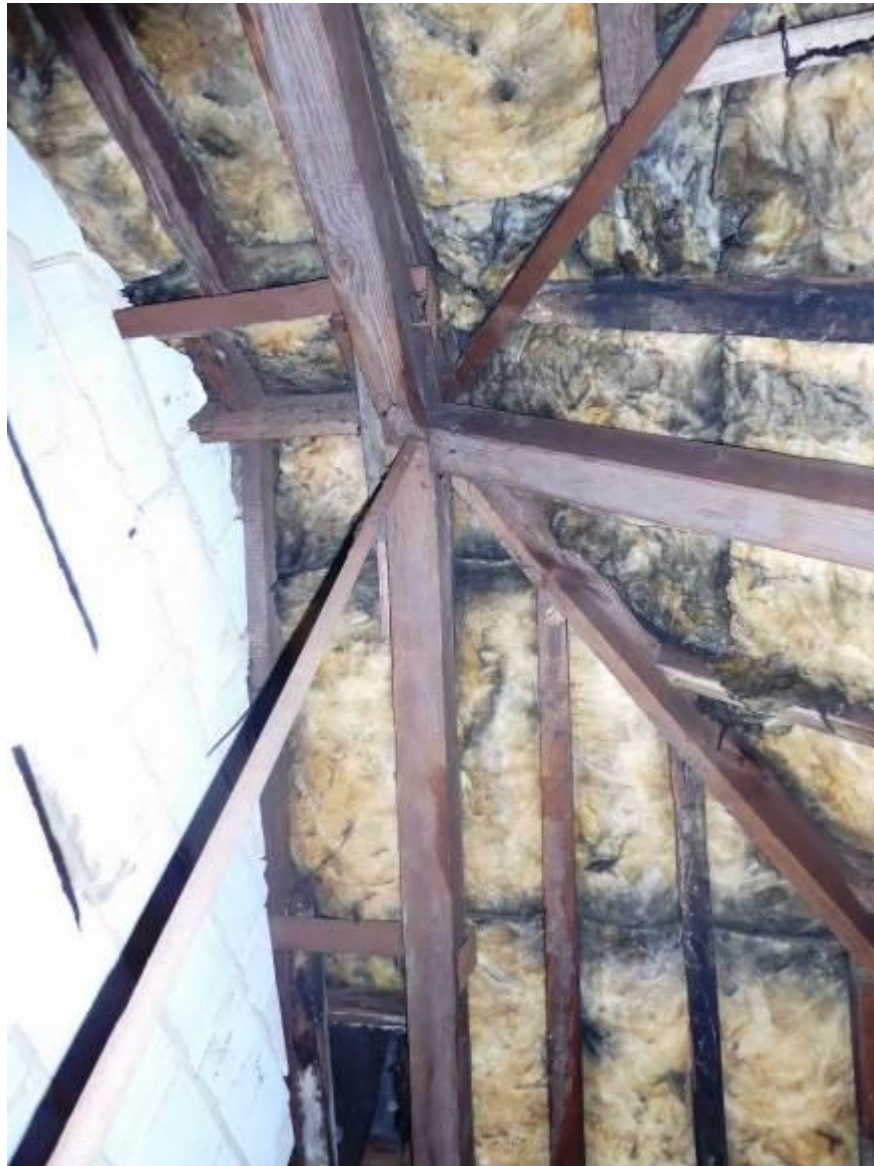
Fig 4.19: Main roof space

- 4.19.1 This is accessed from the main second floor landing under the west end of joint roof between this building and N° 9 St Ann Street on the east.
- 4.19.2 At this point it is mostly under the west hip end, where there is a simple queen post truss with central metal tie rod supporting hip rafters and central principal rafter to the outer roof slope. This has purlins running between the trusses with rafters spanning up from eaves over them to hip or ridge board as appropriate.

- 4.19.3 There is a modern lightweight concrete block dividing wall between this and N° 9 St Ann Street roof void.
- 4.19.4 The roof coverings are underlined with material known as 'Cosy Felt', which is fibreglass quilt backed bituminous sarking felt. From what could be seen the roof space overlaid with approximately 300 mm of fibreglass quilt.
- 4.19.5 Many of the rafters are apparently reused, possibly from earlier structures.
