## Preliminary Roost Assessment

Bincknoll Farm, Bincknoll Lane, Royal Wootton Bassett, Wiltshire, SN4 8QT

This report is prepared to inform a planning application with the Wiltshire Council. The proposal is described as:  
The conversion of two agricultural buildings into residential dwellings (Class Q).

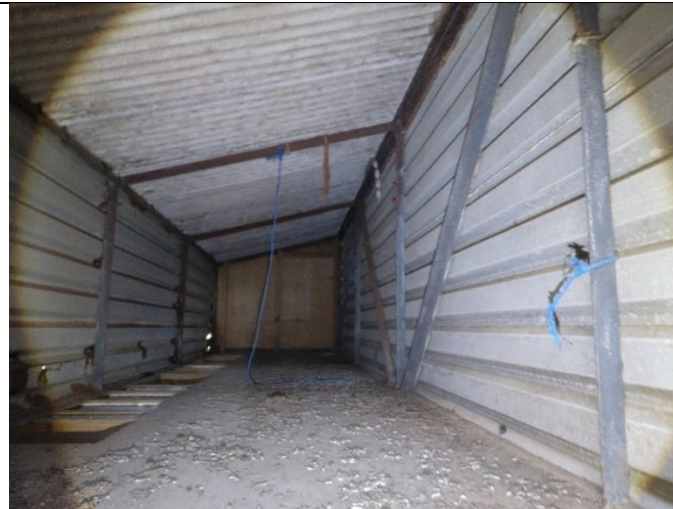
| | <p>The farmland within the ownership boundary, as well as ponds, hedgerows and deciduous woodland within the local area, could provide suitable foraging and commuting habitats for bats. Due to the rural location of the site, there is limited artificial light spill (no streetlamps).</p> <p><b><u>Roosting habitats</u></b></p> <p>There are two designated buildings (B1 and B2) within the development boundaries and another building within the ownership boundary (B3).</p> <p><b><u>Building B1 (Negligible roost suitability – no evidence)</u></b></p> <p>Building B1 is a metal-framed milking parlour with metal panels on the elevations and a pitched corrugated roof. The majority of the building was vaulted. There were two crawl spaces above the north-eastern and south-eastern elevations of B1.</p> <p>Crawl space CS1 extended around the edge of the south-eastern elevation. It was 1m high, 1m wide, and 5m long. The space had lining (exposed corrugated sheeting) and some light spill. There were no crevices for crevice-dwelling bats and no perches for void-dwelling bats. The internal temperature of the void was 15°C, and the humidity was 70%.</p> |

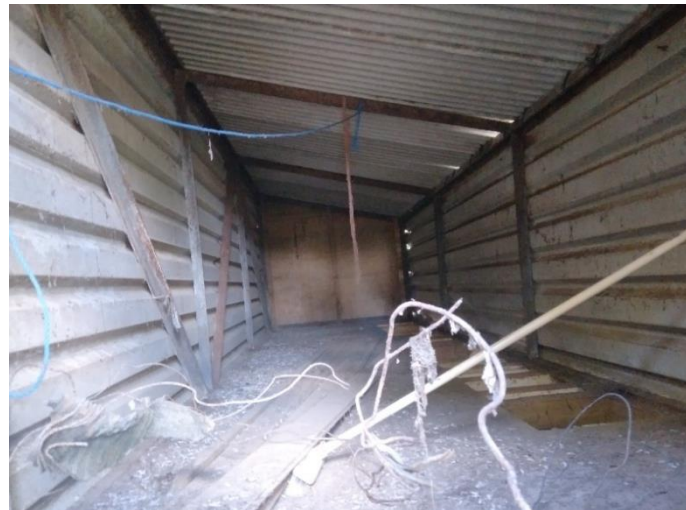
Crawl space CS2 extended around the edge of the north-eastern elevation. It was 1m high, 1m wide, and 5m long. The space had lining (exposed corrugated sheeting) and some light spill. There were no crevices for crevice-dwelling bats and no perches for void-dwelling bats. The internal temperature of the void was 15°C, and the humidity was 71%.

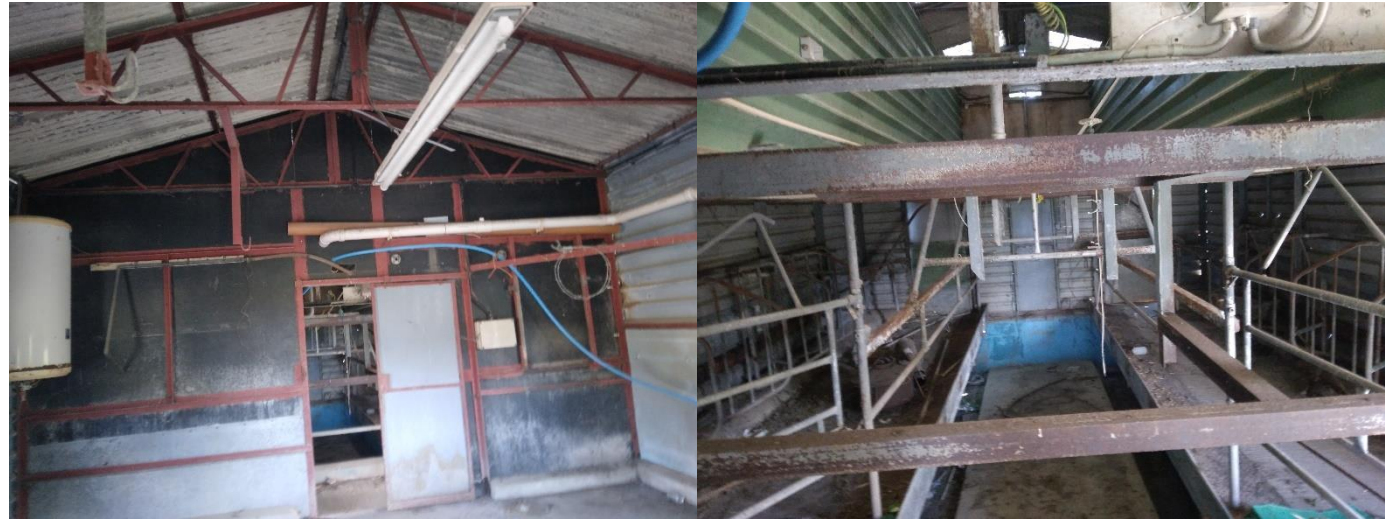
The remainder of the internal space is well-lit, with no roosting features suitable for crevice or void-dwelling bats. There were multiple access points into the building (open elevations). However, there are no suitable interior crevice features for crevice-dwelling bats or perching features for void-dwelling bats in the building.

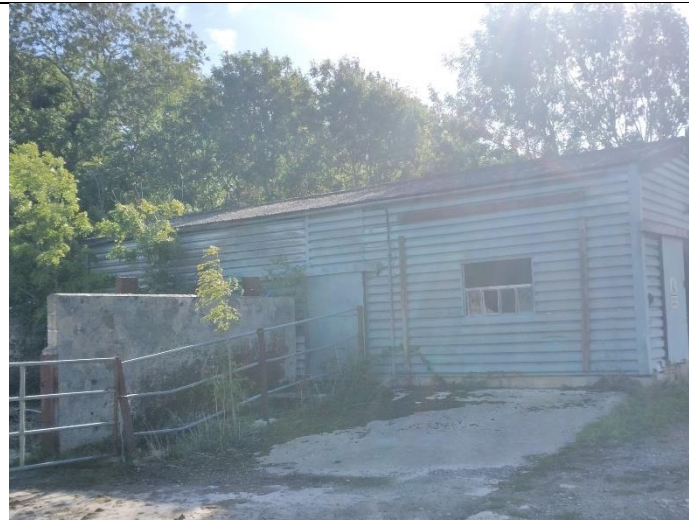
Northern elevation

There were multiple access points into the building (open doors and windows). However, there are no suitable interior crevice features for crevice-dwelling bats or perching features for void-dwelling bats.

The building was assessed as having negligible roosting habitat value as it lacked suitability for crevice- and loft-dwelling bats (due to the absence of roosting points, unstable conditions and significant light spill).

| <i>Recommendations</i> | <p><b><u>Buildings B1</u></b></p> <p>In the unlikely event that a bat or evidence of bats is discovered during the development, all work must stop, and a bat-licensed ecologist must be contacted for further advice.</p> <p><b><u>Buildings B2</u></b></p> |

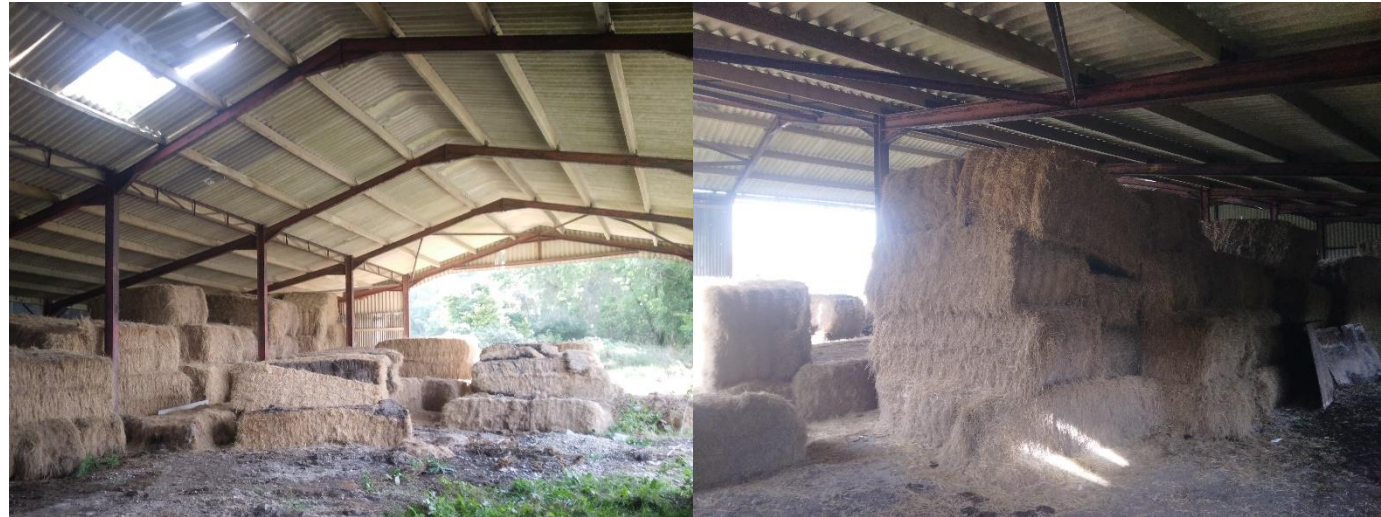
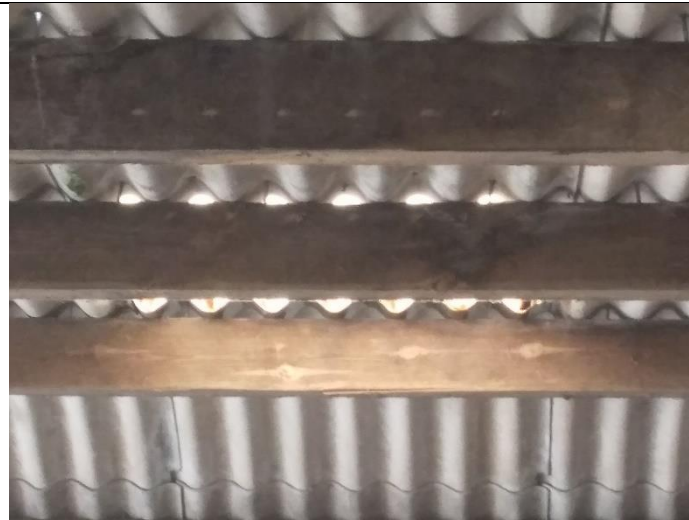
Building B2 is a metal-framed barn with a corrugated saltbox roof. There was no separate void (vaulted). The internal space is well-lit, with no roosting features suitable for crevice or void-dwelling bats. There are small gaps between the beams and the corrugated sheeting. However, the gaps had been blocked, so they are unsuitable for crevice-dwelling bats.

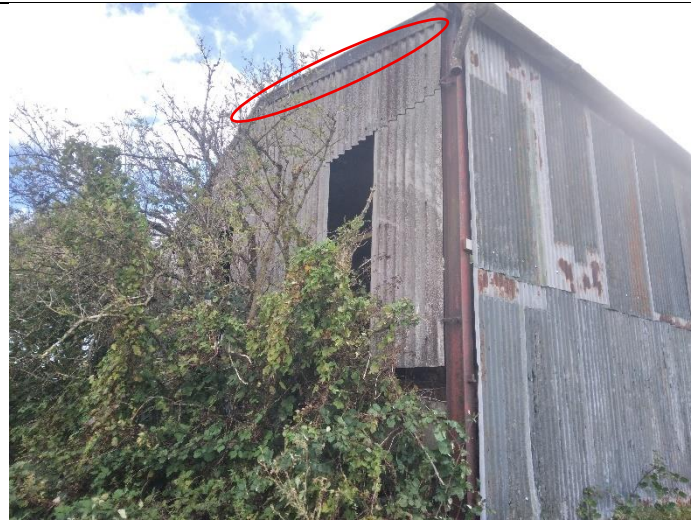
Northern elevation

There were multiple access points into the building (open elevations). There are external and internal features that may provide roosting opportunities for crevice-dwelling bats. The roosting and access features of B2 include:

- Gaps underneath verge boarding (circled in red)

The building was assessed as having low roosting habitat value due to the suboptimal external crevice-dwelling roost features, absence of internal roosting points, unstable conditions, and significant light spill.

| | <p>Due to the low numbers of suboptimal features and conditions for bat species to roost within B2, further surveys are considered disproportionate. Instead, a precautionary approach is advised to ensure that no bats or roosts are present or impacted by the works. This includes a toolbox talk to all contractors and inspection of all suboptimal roosting features immediately before the commencement of any soft demolition work (removal of exterior corrugated panels and verge boarding) by a suitably qualified professional. This should include the use of an endoscope and torch to fully inspect both under the verge boarding. In the unlikely event that a bat is identified during this inspection, work must cease, a full suite of 3 surveys must be completed, and a license must be acquired before work can proceed.</p> <p><b><u>Lighting</u></b></p> <p>A low-impact lighting strategy will be adopted for the site during post-development, which outlines the areas of the site that will be retained as dark corridors. Parameters can be found on the Bat Conservation Trust website: <a href="https://www.bats.org.uk/our-work/buildings-planning-and-development/lighting">https://www.bats.org.uk/our-work/buildings-planning-and-development/lighting</a></p> <p><b><u>Enhancements</u></b></p> <p>The installation of one bat box on the site will provide additional roosting habitat for bats. The bat box will be installed on a retained building. Bat boxes should be positioned 3-5m above ground level, facing in a south or south-westerly direction with a clear flight path to and from the entrance, away from artificial light.</p> |

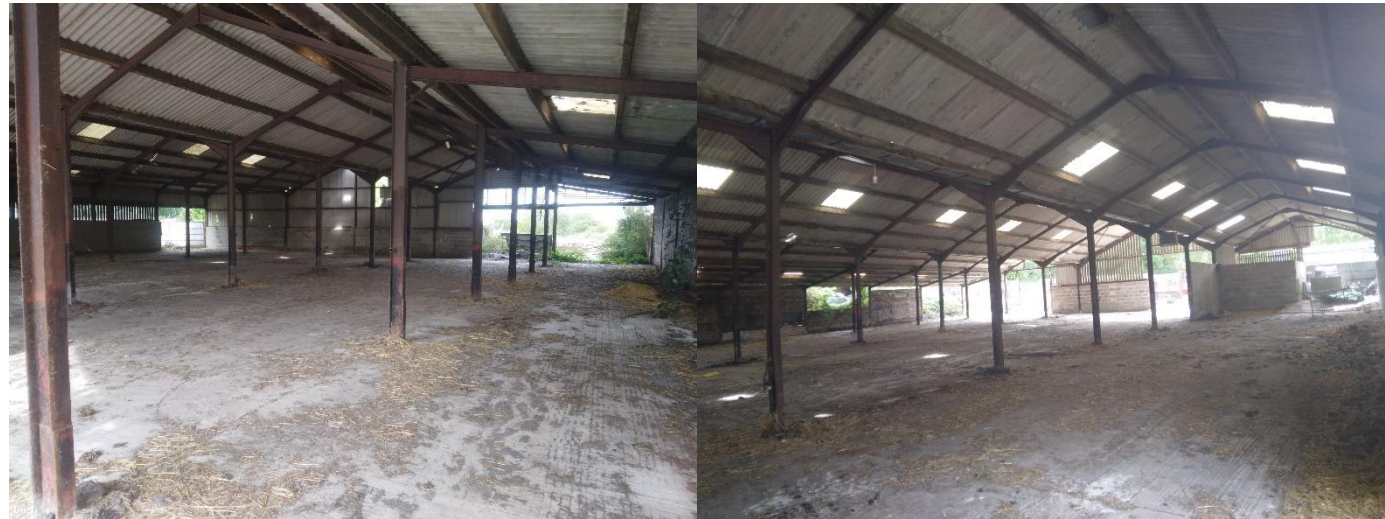
Building B3 is a metal-framed barn with a corrugated 'M' shaped roof. The internal space is well-lit, with no roosting features suitable for crevice or void-dwelling bats.

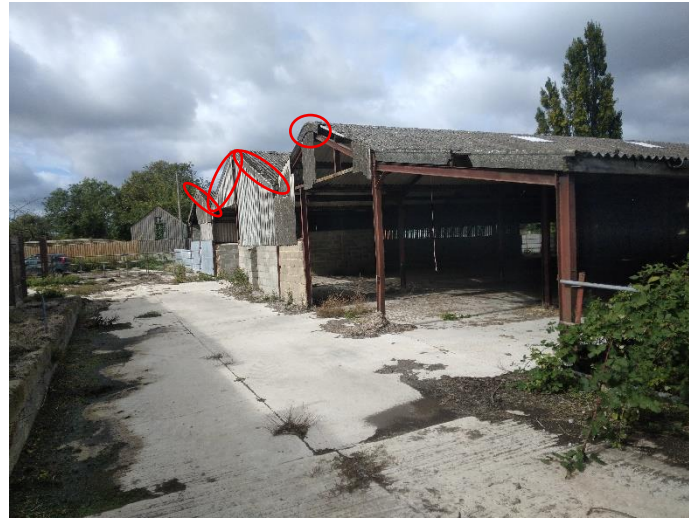
Southern elevation

There were multiple access points into the building (open elevations). There are external and internal features that may provide roosting opportunities for crevice-dwelling bats. The roosting and access features of B3 include:

- Gaps underneath verge boarding (circled in red)
- Overlapping corrugated sheeting (circled in orange)

| | <p>The building was assessed as having low roosting habitat value due to its suboptimal crevice-dwelling roost features and access points. Building B3 is currently not included in the proposed plans.</p> |

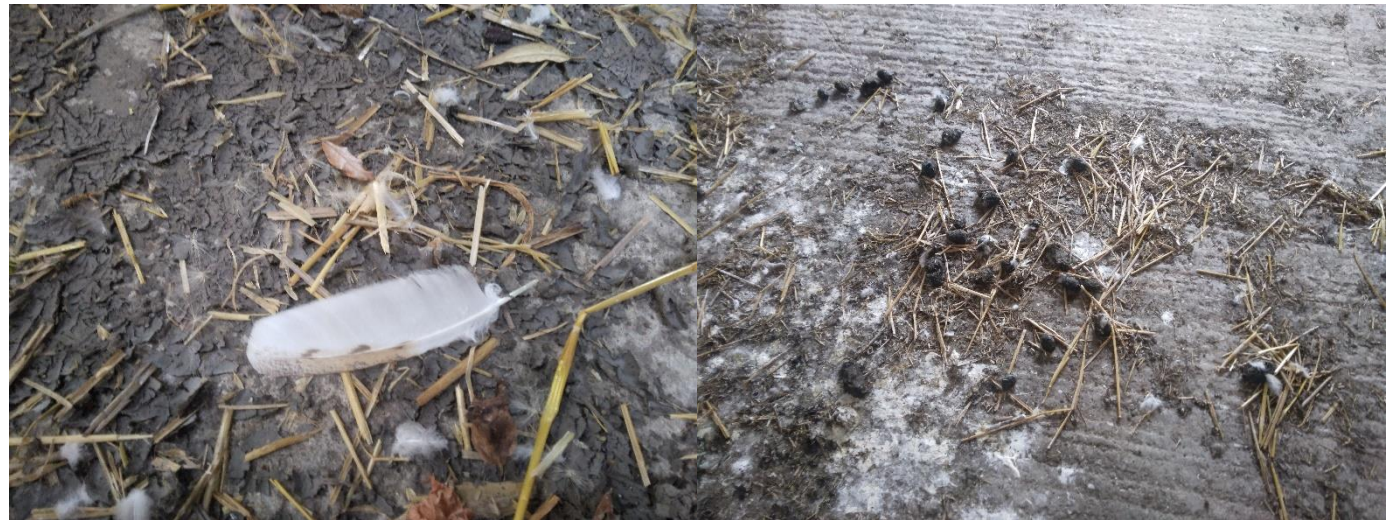
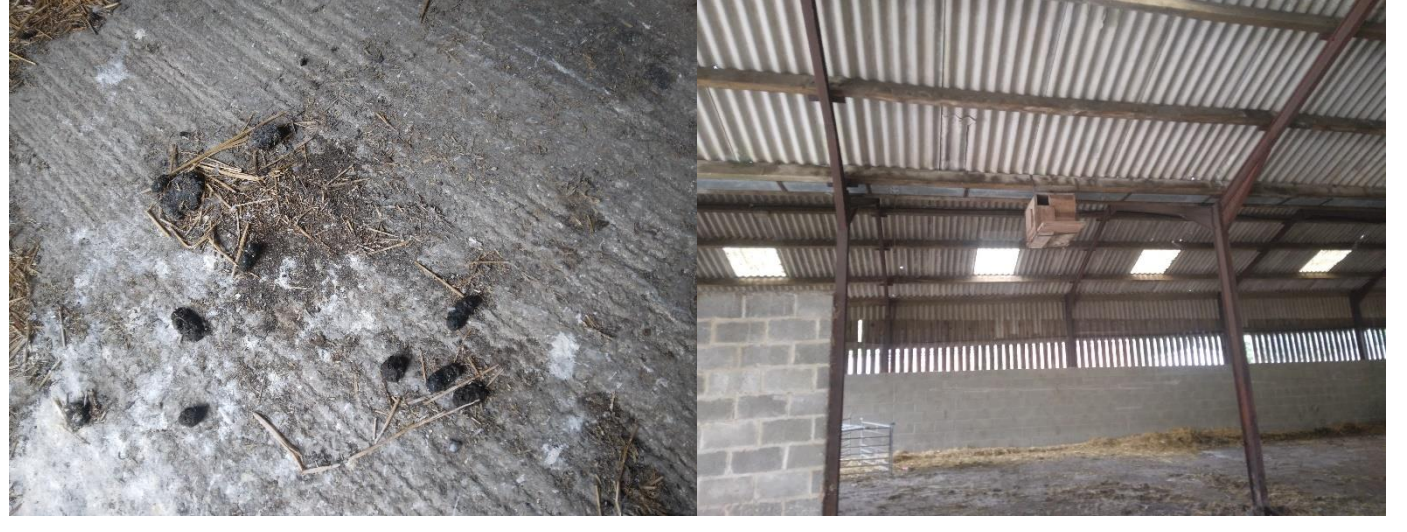
Evidence of barn owls was identified within the ownership boundary (B3) during the site visit (~30 pellets TN1, feathers TN2 and a nesting box TN3). Building B3 is currently not included in the proposed plans and will be retained.

| | <p>Due to the close proximity of barn owls in building B3 to the proposed dwellings, a precautionary working method will be implemented during construction to minimise indirect impacts to barn owls as a result of the proposed development, including the following measures:</p> <ul style="list-style-type: none"><li>- The building will be retained as existing, and no works are to take place on the building.</li><li>- If works are taking place during nesting season, a 40m buffer will be implemented around the building during construction. If a 40m buffer cannot be implemented, work must commence outside of nesting season.</li><li>- The development works must avoid night-time working and take place in daytime hours (between 8 am and 6 pm) to avoid disturbance of feeding and commuting activity.</li><li>- A pre-commencement check of all buildings will be undertaken to check for any new barn owl activity immediately before the commencement of the works by a suitably qualified professional. If new evidence is identified, works must cease and advice must be sought from a suitably qualified ecologist.</li></ul> |
