## Bat Emergence and Re-Entry Surveys (BERS)

Monksfield, Monkton Farleigh, Bradford on Avon, BA15 2QH

This report has been produced to support a planning application for Wiltshire Council. The development is described as: *'Reroof of the main house and demolition and rebuild of existing garage'*.

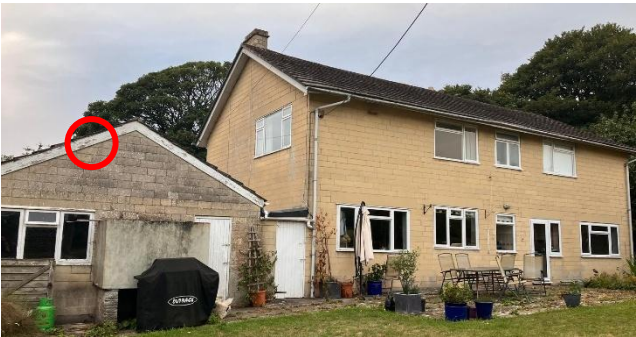
| Results | | |
|---|---|---|
| Surveyor 1 | <p><b>Emergence Observed</b></p> <p><b>Roost 1:</b> Common pipistrelle (<i>Pipistrellus pipistrellus</i>)</p> <p><b>Number:</b> 9</p> <p><b>Time(s):</b> Between 20:50 and 21:07.</p> <p><b>Location of access point(s):</b> From the bargeboard of the garage's North-east gable end (red circle on photo).</p> <p><b>Direction(s) of travel on emergence:</b> Bats typically flew East and Northeast</p> <p><b>Species ID confirmed on site or by sound analysis post survey?</b><br/>Confirmed on site.</p> <p><b>Summary of general activity:</b><br/>At 21:03 a common pipistrelle was observed commuting Southeast in the back garden along the buildings Northeast elevation. At 21:15, 21:21 and 21:39 a common pipistrelle was observed foraging in the back garden along the buildings Northeast elevation. Common pipistrelles were then heard not seen until 22:12. At 21:10 a soprano pipistrelle was observed commuting Southeast in the back garden along the buildings Northeast elevation. At 21:15 a serotine was observed commuting Northwest along the buildings Northeast elevation. Later between 21:24 and 21:32 a serotine was seen foraging in the field Northeast of the site. A Leisler's bat was heard no seen between 21:31 and 22:05. At 21:42 a Myotis sp. was heard not seen.</p> | |

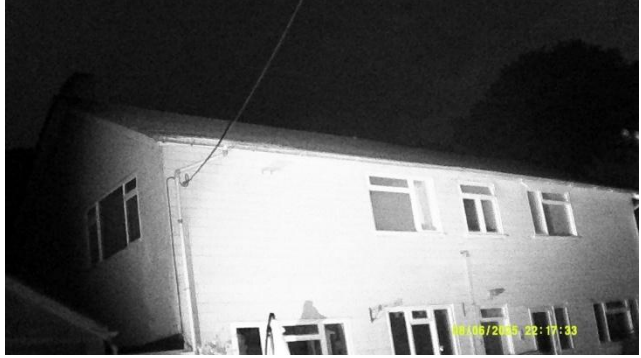
| <i>IR position 1</i> | <p><b>No additional emergences or re-entries seen.</b></p> <p>Footage confirmed bat activity seen by surveyor, with no additional activity seen.</p> | |

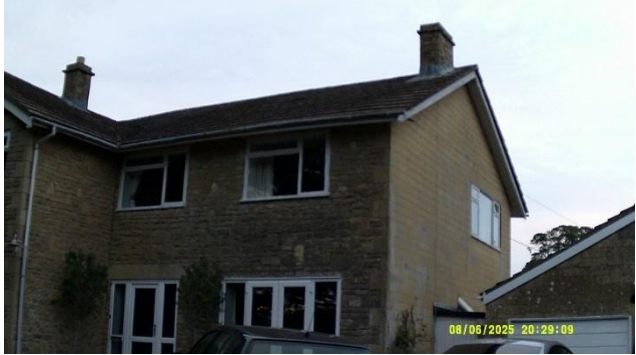
| <i>Surveyor 2</i> | <p><b>No emergences or re-entries observed.</b></p> <p>The first bat detected was a common pipistrelle, heard but not seen (HNS) at 21:41. At 20:44, a common pipistrelle was seen commuting south-east to north-west, from the neighbouring garden to the trees in the client's property. At 20:46, a common pipistrelle was then seen reappearing from this area and headed south, and at 20:49, a common pipistrelle took the same route. At 20:50, a common pipistrelle commuted from the trees in the front garden, over the garage, west to east. At 20:50 and 20:58, common pipistrelle were HNS. At 21:06, a common pipistrelle was seen foraging in the front garden, making its way from north-west to south-east. At 21:10, a common pipistrelle was HNS. At 21:15 and 21:18, serotines were seen, originating from the neighbouring garden to the south, moving west to the trees in the front garden, and in front of the south-west elevation, respectively. At 21:21, a common pipistrelle was seen foraging and moved from above the garage, to the trees, east to west. All detections from this point were HNS, and occurred between 21:39 and 22:17. These included six common pipistrelle detections (three passes, three foraging), one myotis species pass at 21:42, eight soprano pipistrelle detections (five passes, three foraging), eight serotine calls (two passes, six foraging), and one noctule pass at 21:57.</p> | |

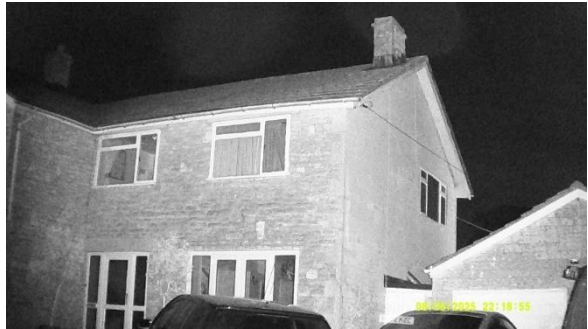
| <i>IR position 2</i> | <p><b>No emergences or re-entries seen.</b></p> <p>Footage confirmed bat activity seen by surveyor, with no additional activity seen.</p> | |

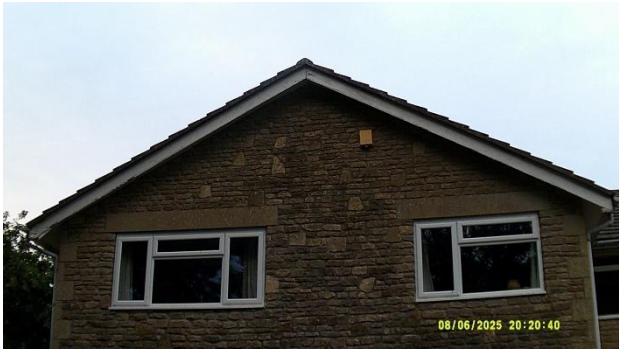
| Surveyor 3 | <p><b>No emergences or re-entries observed.</b></p> <p>Activity commences at 20:41 with a Common Pipistrelle heard not seen (strong call) heard again at 20:52. Visual activities begin at 20:43 with single CP H+S commuting from E to W from neighbouring property along identified common flight path 2 (E&lt;&gt;W). 20:45 CP is noted commuting over surveyor 2 from W to SE. 20:50, 20:55, 21:11 &amp; 21:54 CP commutes through garden along flight path 1 (SE&lt;&gt;NW). 21:00 &amp; 21:39 CP commutes from NW elevation travelling south along flight path 3 (NE&lt;&gt;SW). 21:04, 21:06, 21:21 &amp; 21:40 CP noted foraging in garden using flight path 2 along SW elevation. 21:42, 21:49, 21:58, 22:10, 22:16 &amp; 22:17 CP calls were heard not seen. 21:15 Serotine noted foraging along flight path 2. 21:16 SER commutes along flight path 1 from SE. 22:04, 22:07, 22:11 SER were heard not seen</p> | |

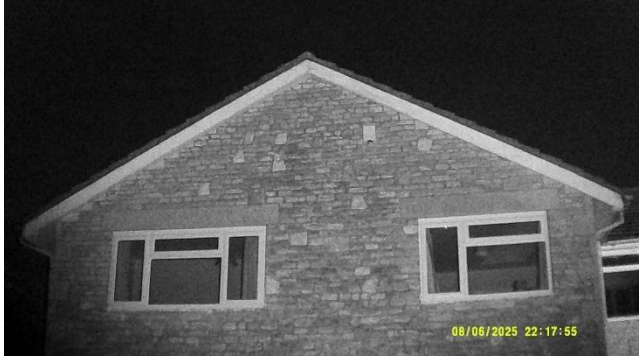
| IR position 3 | <p><b>No emergences or re-entries seen.</b></p> <p>Footage confirmed bat activity seen by surveyor, with no additional activity seen.</p> | |

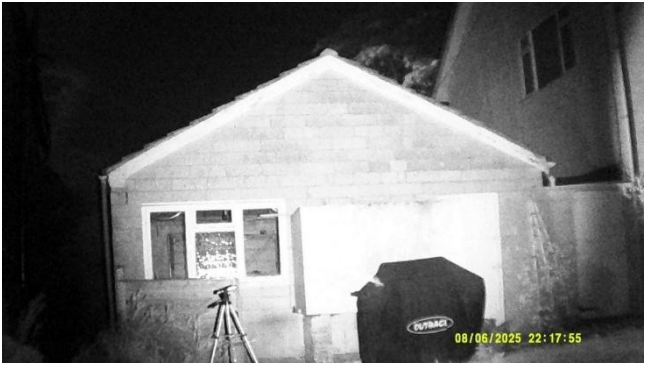
| <i>Position 4 Unmanned IR<br/>Nightfox Whisker</i> | <b>Confirmed emergences of x9 common pipistrelle from surveyor 1.</b><br><br>No additional emergences or re-entries recorded after full review. | |

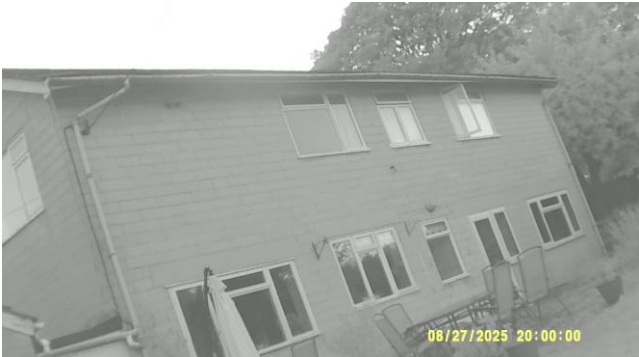
| Results | | |
|---|---|---|
| Surveyor 1 | <p><b>No emergences or re-entries seen.</b></p> <p><b>Summary of general activity:</b></p> <p>The first bat was recorded was a soprano pipistrelle at 20:28 commuting south to north across the site. A common pipistrelle was also recorded commuting west to east across the rear of the site at 20:28 and over the garage at 20:42. Myotis spp. were heard but not seen across the site at 20:29, 20:54, 21:16 and 21:30. Two greater horseshoe bats were recorded commuting north to south in the rear garden at 20:32, and again at 21:02, with lesser horseshoe also recorded foraging along the north boundary field at 20:39. A long-eared bat spp. was heard but not seen at 20:43. A serotine was recorded commuting northwest to southeast in the rear garden at 20:43.</p> | |

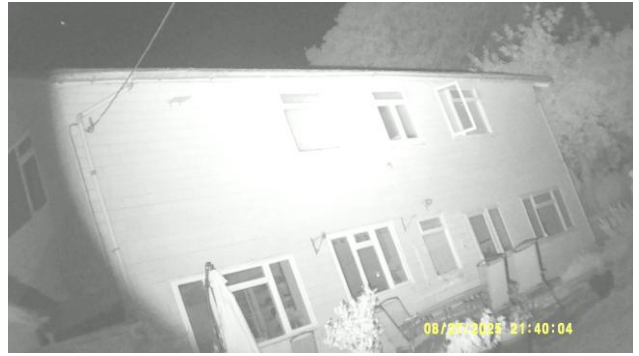
| Results | | |
|---|---|---|
| IR position 1 | <p><b>No emergences or re-entries seen.</b></p> <p>Footage confirmed bat activity seen by surveyor, with no additional activity seen.</p> | |

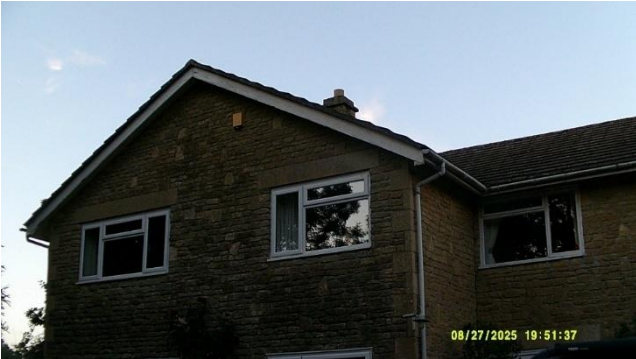
| <i>Surveyor 2</i> | <p><b>No emergences or re-entries observed.</b></p> <p>The first bat activity recorded during the survey was a common pipistrelle seen commuting west in front of the garage at 20:21. Two more common pipistrelles were seen at 20:24, one commuting along the same flight path and the second south to north along the western treeline. From 20:25 to 20:31 two common pipistrelles were observed continuously foraging throughout the front garden. Common pipistrelle foraging activity was recorded again at 20:40 and continuously from 20:47 till 21:00. Between 20:31 and 20:38 three bats were heard and not seen: one serotine, one greater horseshoe and one lesser horseshoe. From 20:42 to 20:44 serotines were seen continuously foraging throughout the front garden. This was seen again at 21:04 till 21:09. At 20:55 a brown long eared was seen commuting north in front of the western gable end. There were nine occurrences of bats heard and not seen from 20:54 to 21:36: three myotis sp., one greater horseshoe, four soprano pipistrelles and one common pipistrelle.</p> | |

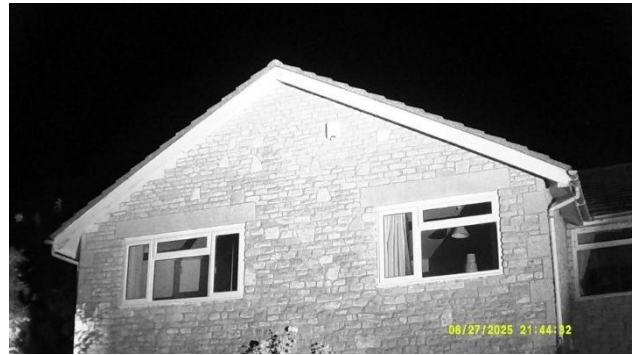
| <i>IR position 2</i> | <p><b>No emergences or re-entries seen.</b></p> <p>Footage confirmed bat activity seen by surveyor, with no additional activity seen.</p> | |

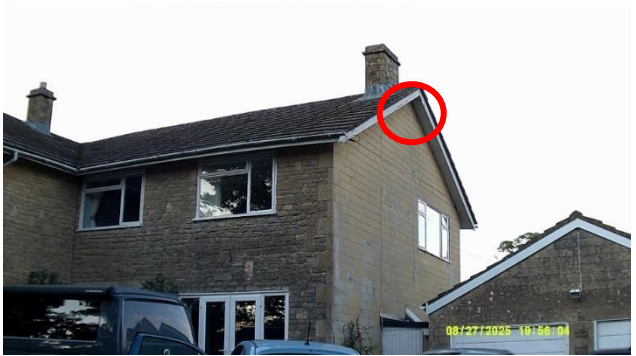
| Surveyor 3 | <p><b>Emergence Observed</b></p> <p><b>Roost 1:</b> Common pipistrelle (<i>Pipistrellus pipistrellus</i>)<br/><b>Number:</b> 2<br/><b>Time(s):</b> 20:24 and 20:26<br/><b>Location of access point(s):</b> Soffit box close to apex of roof on southern gable end (red circle on photo).<br/><b>Direction(s) of travel on emergence:</b> West towards road.<br/><b>Species ID confirmed on site or by sound analysis post survey?</b><br/>Confirmed on site.</p> <p><b>General activity on site</b><br/>The first bat detected was a common pipistrelle at 20:22, seen making a pass from the neighbouring rear garden to the east, over the garage and west towards the road. At 20:24 a common pipistrelle was seen emerging from the soffit box close to apex of roof on southern gable end, then making its way west towards the road. A common pipistrelle was also seen around the same time, commuting from the neighbouring garden to the south, north-west towards the road. At 20:26, another common pipistrelle was seen emerging from the same location as the first, and followed a similar route. At 20:27, two soprano pipistrelles were seen foraging in the front garden for a few minutes. At 20:31, a serotine commuted from the neighbouring front garden to the south, north-west towards the road. Heard but not seen (HNS) detections were made of a myotis species at 20:32, a greater horseshoe at 20:34, a lesser horseshoe at 20:40, and a common pipistrelle at 20:41. At 20:42 a serotine was seen foraging in the front garden. Between 20:43 and 21:34, all detections were HNS, comprising four calls from myotis species, as well as three soprano pipistrelle, four common pipistrelle, and one greater horseshoe</p> | |

| | detections, all making passes. During this time-period, intermittent serotine foraging was also heard. | |

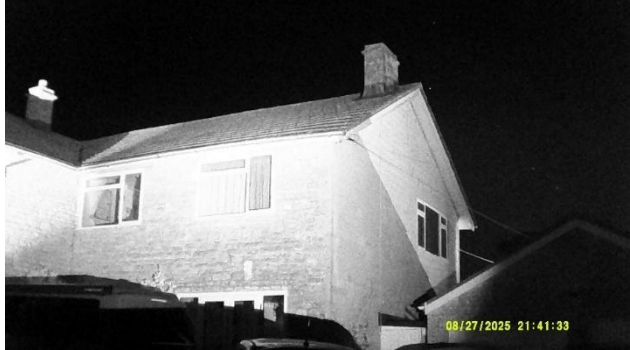
| <i>IR position 3</i> | <b>No additional emergences or re-entries seen.</b><br><br>Footage confirmed bat activity seen by surveyor, with no additional activity seen. | |

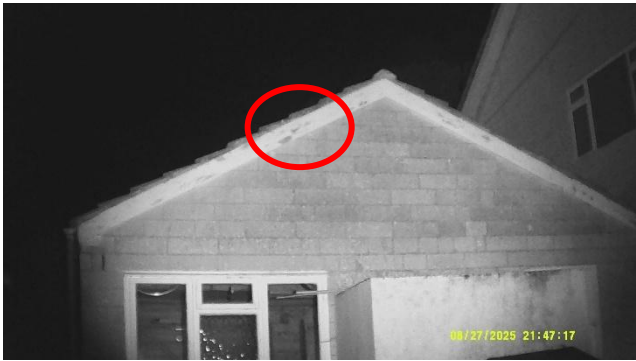
| <i>Position 4 Unmanned IR<br/>Nightfox Whisker</i> | <b>Emergence Observed</b><br><b>Roost 1:</b> Common pipistrelle ( <i>Pipistrellus pipistrellus</i> ).<br><b>Number:</b> 2<br><b>Time(s):</b> 20:10 and 20:12<br><b>Location of access point(s):</b> From the bargeboard of the garage's North-east gable end (red circle on photo).<br><b>Direction(s) of travel on emergence:</b> Bats immediately flew south.<br><b>Species ID confirmation:</b> Confirmed on site. | |

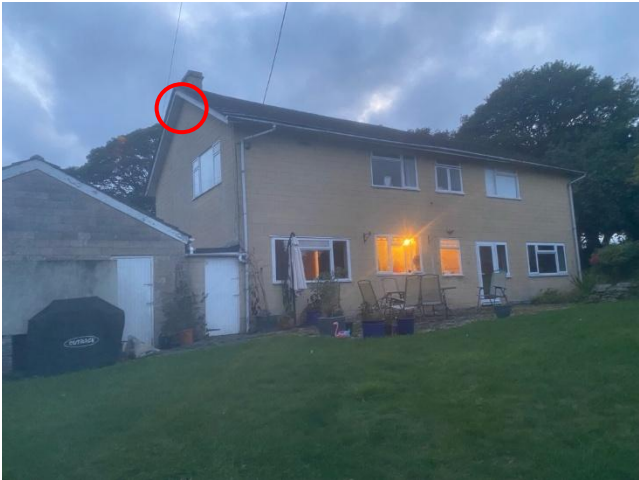
| Results | | |
|---|---|---|
| Surveyor 1 | <p><b>Emergence Observed</b></p> <p><b>Roost 1:</b> Common pipistrelle (<i>Pipistrellus pipistrellus</i>)<br/> <b>Number:</b> 2<br/> <b>Time(s):</b> 19:28 and 19:32<br/> <b>Location of access point(s):</b> Soffit box close to apex of roof on southern gable end (red circle on photo).<br/> <b>Direction(s) of travel on emergence:</b> South towards neighbour house.<br/> <b>Species ID confirmed on site or by sound analysis post survey?</b><br/> Confirmed on site.</p> <p><b>General activity</b><br/> The first bat recorded was a common pipistrelle emerging from a soffit box on the southeastern elevation and commuting southeast. A further ten common pipistrelles were detected between 19:33 and 20:36, with five observed commuting across the garden and over the garage while also foraging, and the remaining five heard but not seen. Six serotines were recorded between 19:32 and 20:57, the first seen commuting east to west along the northeastern boundary, with the others only heard. A noctule was seen commuting over the building at 19:35, followed by additional records at 19:50, 19:52, 19:57, and 20:22, all of which were heard but not seen. Intermittent foraging by Lesser Horseshoe bats occurred between 19:43 and 19:55, with individuals observed foraging along the northeastern hedgerow. A myotis species was recorded at 19:47, 20:03, 20:14, and 20:28, heard but not seen except at 20:03 when it was observed commuting over the garage from</p> | |

| | <p>southwest to northeast. Two Brown long-eared bats were recorded at 20:08 and 20:40, both heard but not seen, and finally, three soprano pipistrelles were detected at 19:47, 20:41, and 21:00, all heard but not seen.</p> | |

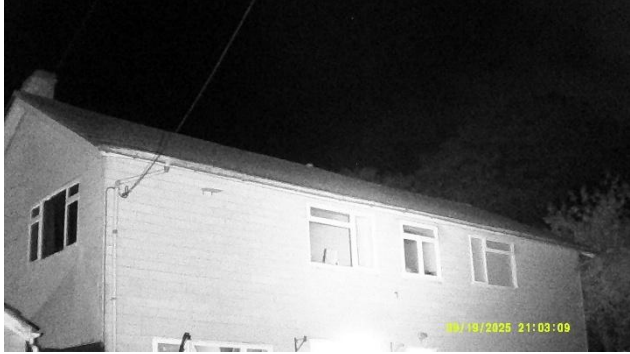
| <i>IR position 1</i> | <p><b>No additional emergences or re-entries seen.</b></p> <p>Footage confirmed bat activity seen by surveyor, with no additional activity seen.</p> | |

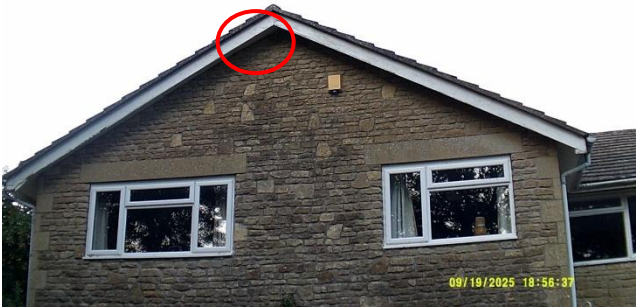
| Surveyor 2 | <p><b>Emergence Observed</b></p> <p><b>Roost 1:</b> Serotine (<i>Eptesicus serotinus</i>)</p> <p><b>Number:</b> 1</p> <p><b>Time(s):</b> 19:27</p> <p><b>Location of access point(s):</b> Soffit box near apex on northwest gable end (red circle on photo).</p> <p><b>Direction(s) of travel on emergence:</b> Bat immediately flew west over tree line.</p> <p><b>Species ID confirmation:</b> Confirmed on site.</p> <p><b>Summary of general activity:</b></p> <p>The first activity recorded was the emergence of the common pipistrelle at 19:27. Common pipistrelles were the most recorded species. From 20:18 to 20:48, two common pipistrelles were observed foraging throughout the front garden and close to the treeline. Social calls were also heard during this time. The last common pipistrelle seen and heard was at 20:48. Serotines heard passing at 19:28 and 19:34. Serotines were also seen foraging in the front garden at 8:28 and 8:42. Soprano pipistrelles were heard infrequently four times at 19:57, 20:03, 20:26, and 20:45. Myotis was heard passing three times at 20:03, 20:14, and 20:16. And Lesser horseshoe seen passing at 19:49 heard and 19:50. Noctule was heard at 19:34, three more times until 20:25. A long-eared species was heard twice at 20:05 and at 20:40. One greater horseshoe bat was seen and heard at 20:28.</p> | |

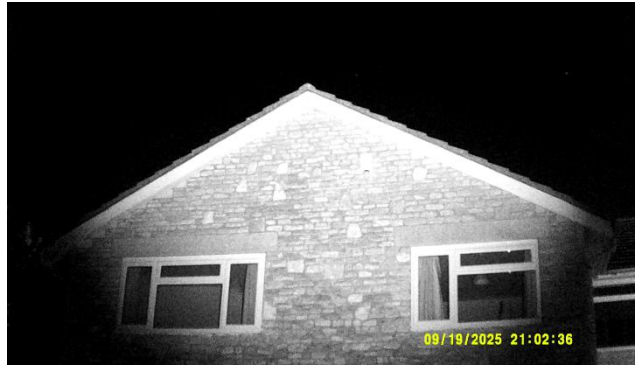
| <i>IR position 2</i> | <p><b>No additional emergences or re-entries seen.</b></p> <p>Footage confirmed bat activity seen by surveyor, with no additional activity seen.</p> | |

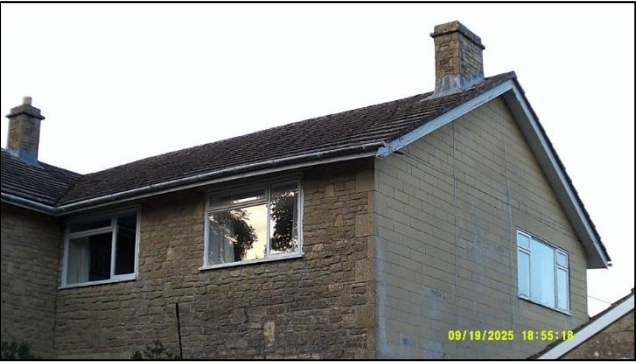
| <i>Surveyor 3</i> | <p><b>No additional emergencies or re-entries observed.</b></p> <p>The first bat detected was a common pipistrelle at 19:27, seen emerging from the soffit box on the south-east elevation, then making its way west towards the road. A serotine was then detected at 19:28, seen commuting from north to south. A second common pipistrelle was seen emerging at 19:28 from the same access point as the first, and then commuted south-east towards the neighbouring property. All detections from this point were HNS unless otherwise stated. Common pipistrelle activity was most common, with a further fourteen detections made between 19:33 and 20:48 and were occasionally seen foraging in the front garden to the south-west. Serotine activity consisted of five detections between 19:34 and 20:57, making infrequent passes. Noctule activity was infrequent with five detections made between 19:35 and 20:22. Lesser horseshoe detections were made at 19:44, 19:54, 20:24 and 20:28. Soprano detections were infrequent, with three detections being made between 19:57 and 20:45. Four calls from myotis species were heard, at 20:01, 20:14, 20:40 and 21:00. Two calls from a long-eared species were heard close together at 20:02 and 20:05, with a third detection also made later in the survey at 20:40.</p> | <p>A daytime photograph of a two-story stone house. The house has a dark roof with a chimney on the right side. A window is visible on the front elevation. The timestamp in the bottom right corner reads '09/10/2025 18:55:19'.</p> |

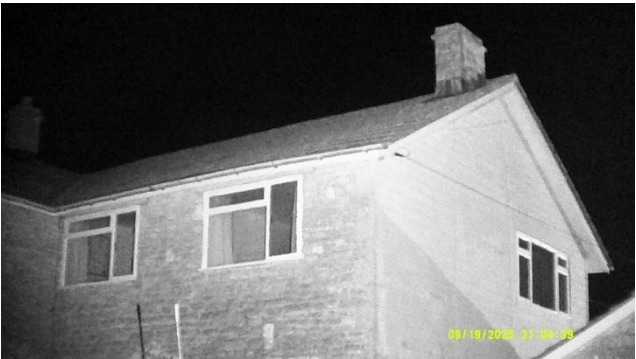
| <i>IR position 3</i> | <p><b>No emergencies or re-entries seen.</b></p> <p>Footage confirmed bat activity seen by surveyor, with no additional activity seen.</p> | <p>A nighttime infrared photograph of the same stone house. The house is illuminated by an infrared light source, making it appear bright against a dark background. The timestamp in the bottom right corner reads '09/10/2025 21:00:09'.</p> |

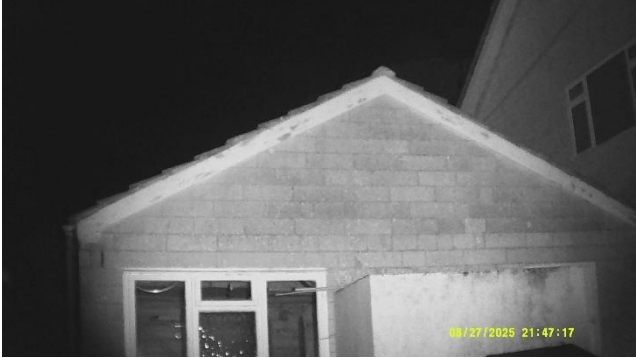
| <p><i>Position 4 Unmanned IR<br/>Nightfox Whisker</i></p> | <p><b>No emergence or re-entry activity recorded after review.</b></p> | |

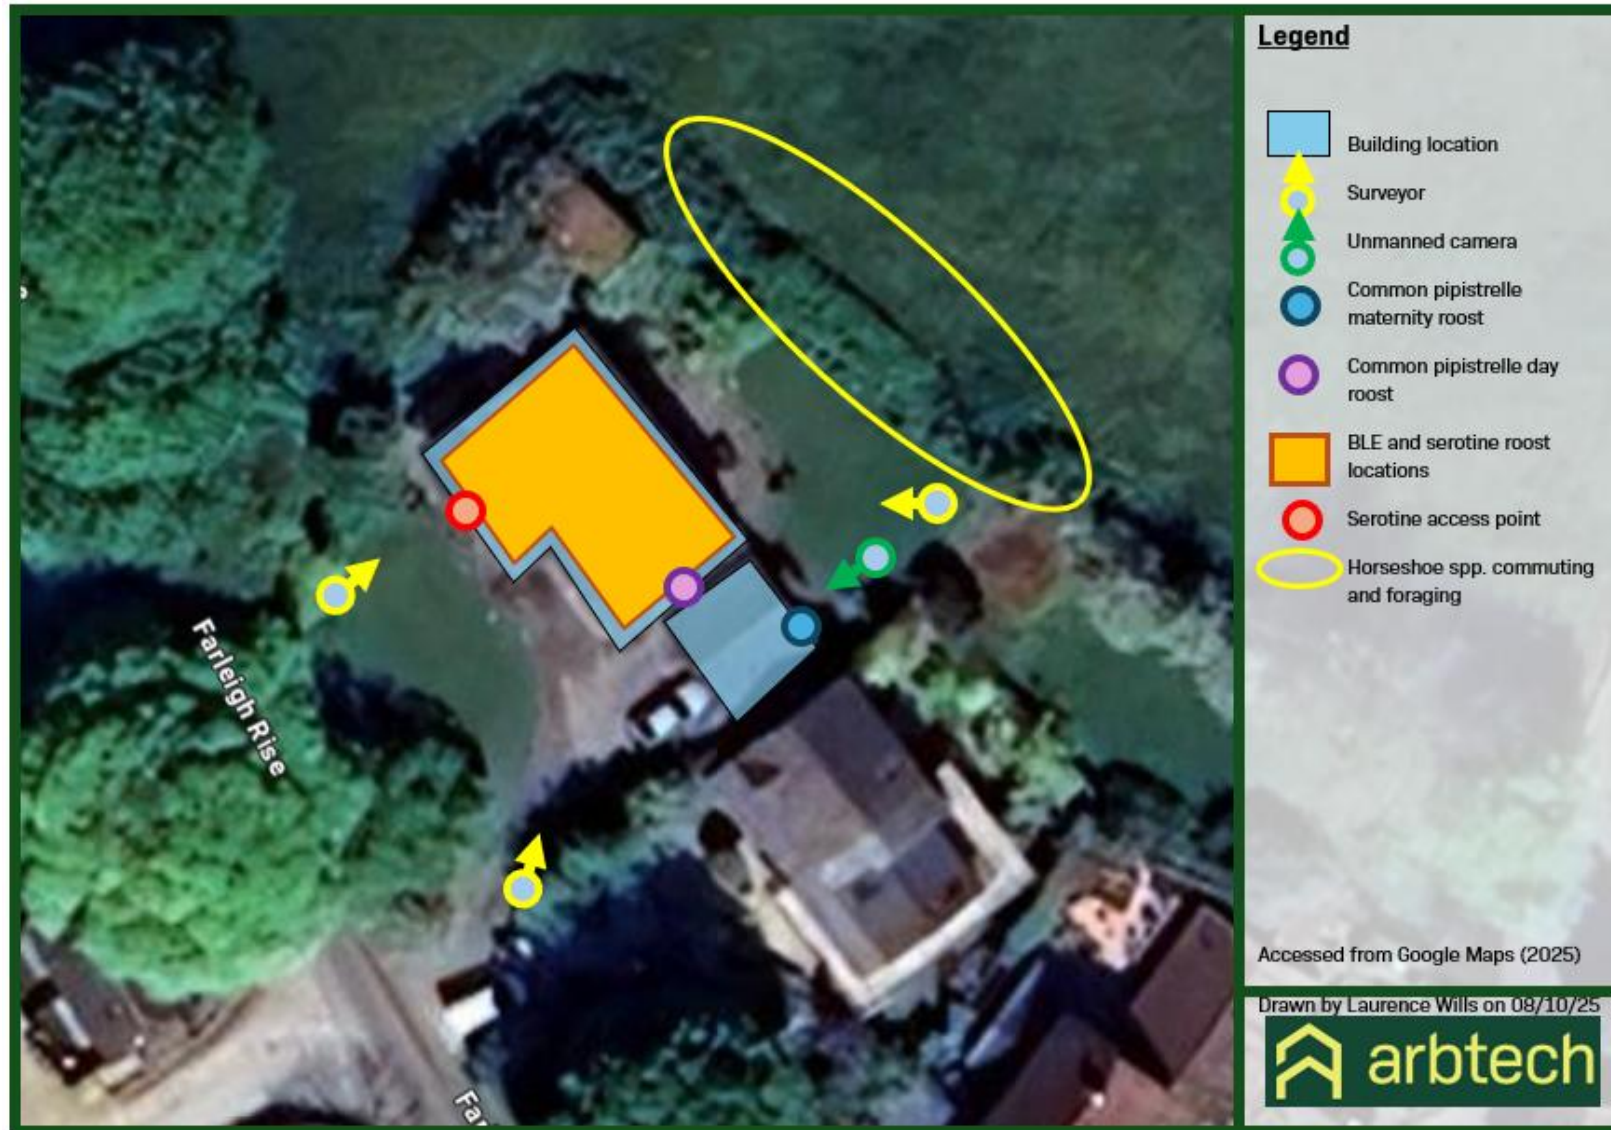
## Appendix A: BERS plan

**See surveyor locations in the** BERS plan in Appendix A and Proposed Plans in Appendix B.
