# Land at Penn Hill, Calne

## Desk Study and Ground Investigation Report

*For Castlewood Properties Ventures Limited*

*Doc ref:* 24863-HYD-XX-XX-RP-GE-1000

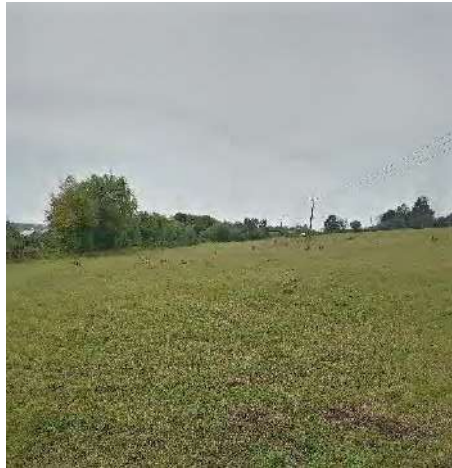
Figure 2-3: South-western field area, with overhead high voltage cables trending roughly north-south and a slope towards the west.

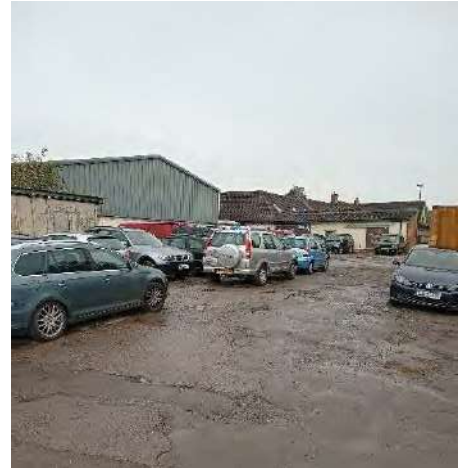
Figure 2-4: Industrial area located towards the centre of the site.

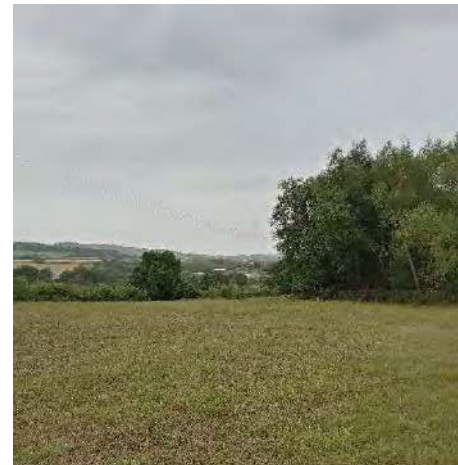
| Item | Brief Description |
|---|---|
| Vegetation | <p>Field areas are covered with grass / vegetation. Surface desiccation cracks were noted towards the south-eastern corner of the site.</p> <p>Mature trees are present predominantly along the field boundaries, along with hedgerows and dense vegetation.</p> |

Figure 2-5: Surface desiccation crack present in the south-eastern corner of the site.

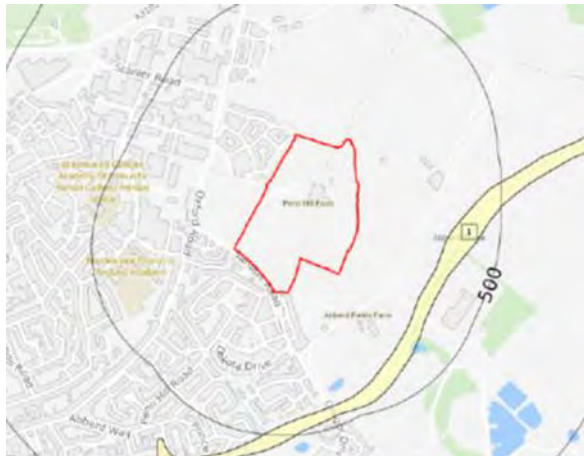
Figure 2-7: Superficial deposits.  
(Reproduced with permission from Groundsure)

The general geology of the site area is shown on the 1:50,000 British Geological Survey (BGS) map extract reproduced as part of the Groundsure report and is summarised in Table 2.4. Extracts from the map are shown in Figure 2-7 and Figure 2-8 .

| Ref. for Figures | Location | Stratigraphic Name | Description |
|---|---|---|---|
| Superficial Deposits (Figure 2-7) | | | |

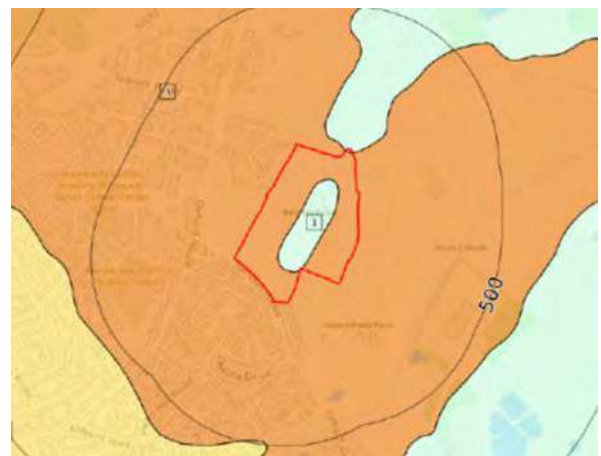
Figure 2-8: Solid geology.  
(Reproduced with permission from Groundsure)

| Ref. for Figures | Location | Stratigraphic Name | Description |
|---|---|---|---|
| Solid Geology (Figure 2-8) | | | |
| 3 | On site. | Kimmeridge Clay Formation | Pale to medium grey mudstone, mainly smooth or silty, with argillaceous limestone nodules.<br>Some alternations of dark grey mudstone. |

Reference to British Geological Mapping (BGS) Sheet 266 - Marlborough, shows the Lower Greensand Formation to be underlain by the Kimmeridge Clay Formation. This is subsequently followed by Upper Calcareous Grit, Coral Rag, Lower Calcareous Grit and the Oxford Clay Formation with Kellaway's Beds.

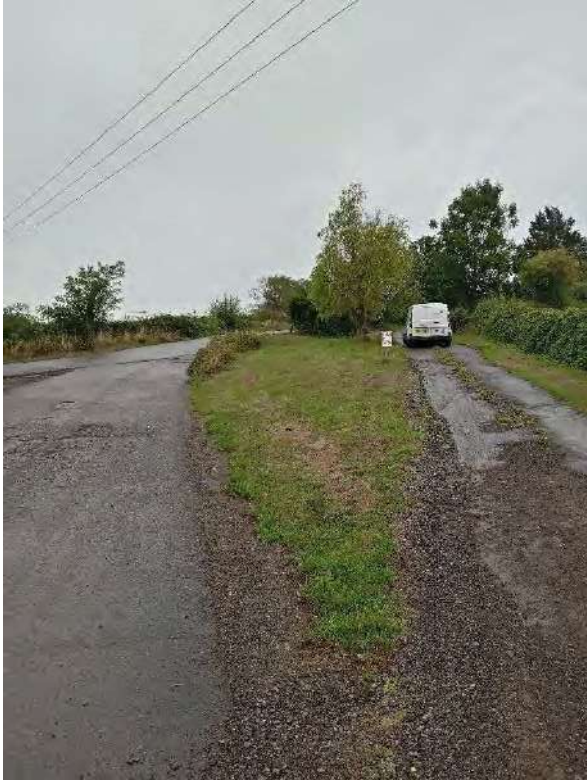
| <b>Desk Study<br/>Photograph 1</b> | |

| <b>Description:</b> Access roads with overhead services running across. | |

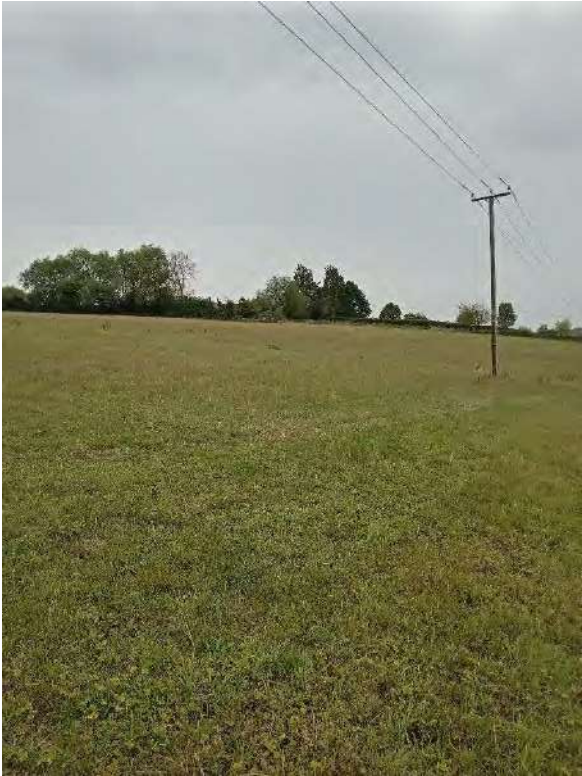
| <b>Desk Study<br/>Photograph 5</b> | |

| <b>Description:</b><br>Overhead services present in the north-western field. | |

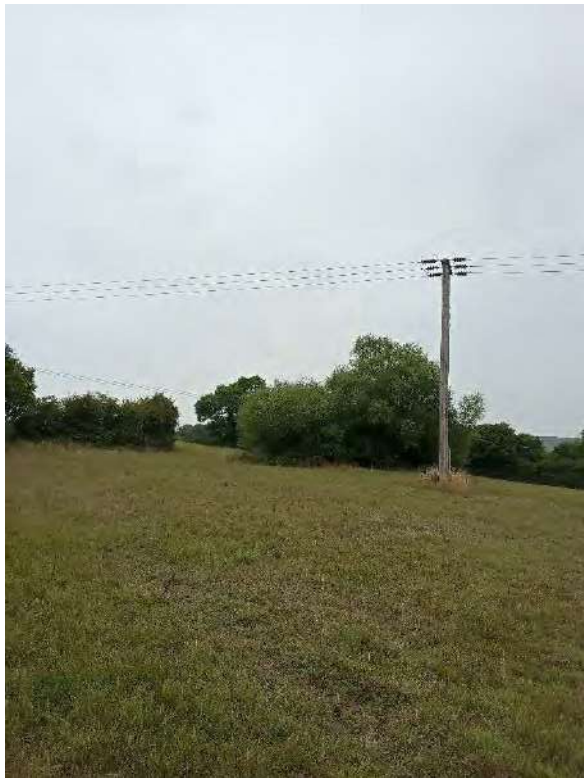
| <b>Desk Study<br/>Photograph 7</b> | | |

| <b>Description:</b><br>Overhead services present in north-eastern field. | | |

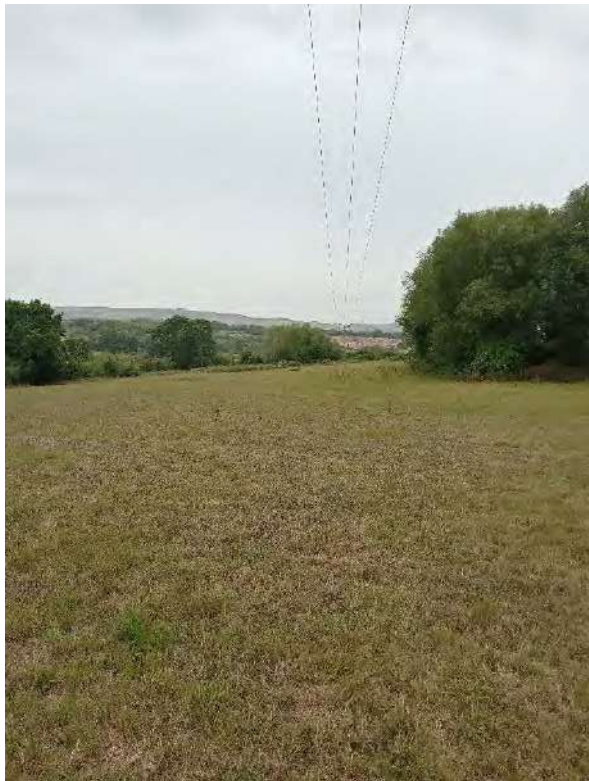
| <b>Desk Study<br/>Photograph 8</b> | | |

| <b>Description:</b> North-eastern field area with overhead services running through. | | |

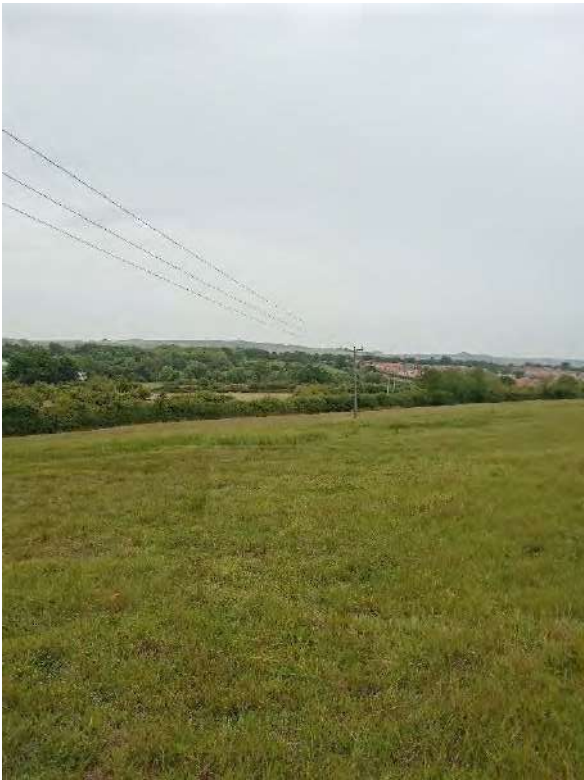
| <b>Desk Study<br/>Photograph 9</b> | |

| <b>Description:</b> South-eastern field area with overhead services running through. | |

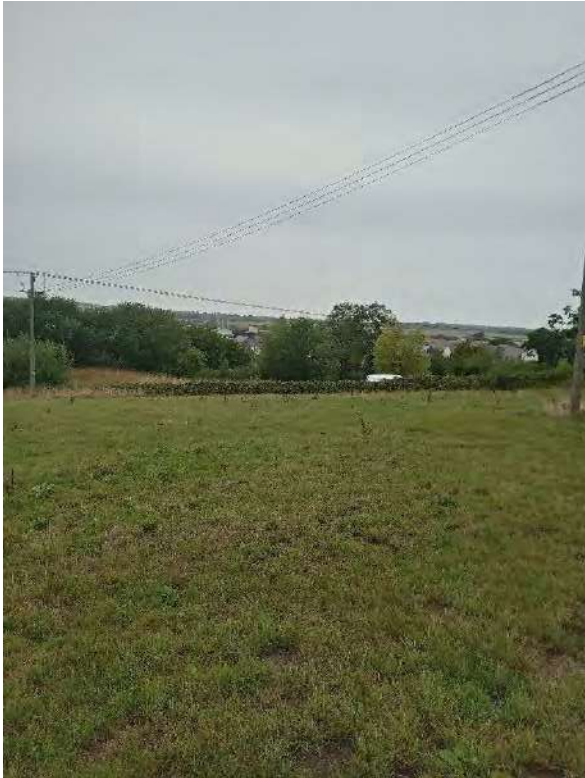
| <b>Desk Study<br/>Photograph 16</b> | |

| <b>Description:</b><br>Overhead services present in the south-western field area. | |

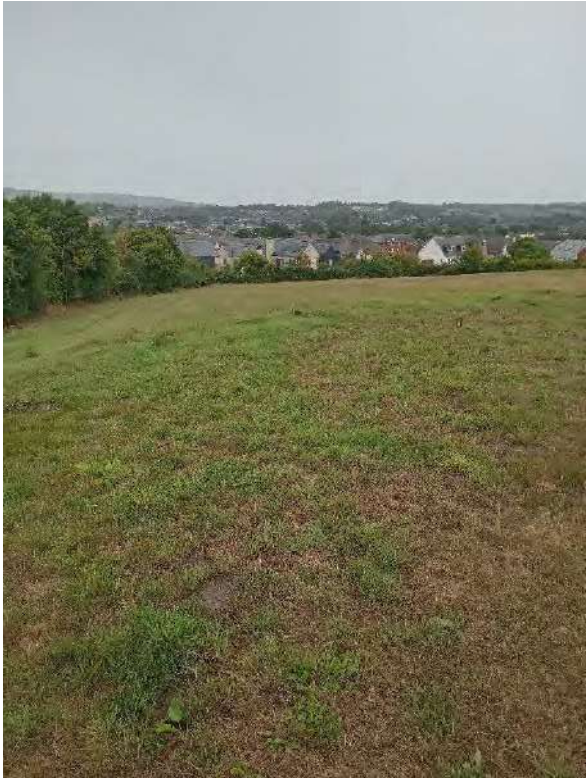
| <b>Desk Study<br/>Photograph 17</b> | |

| <b>Description:</b> South-western field area, sloping towards the south. | |

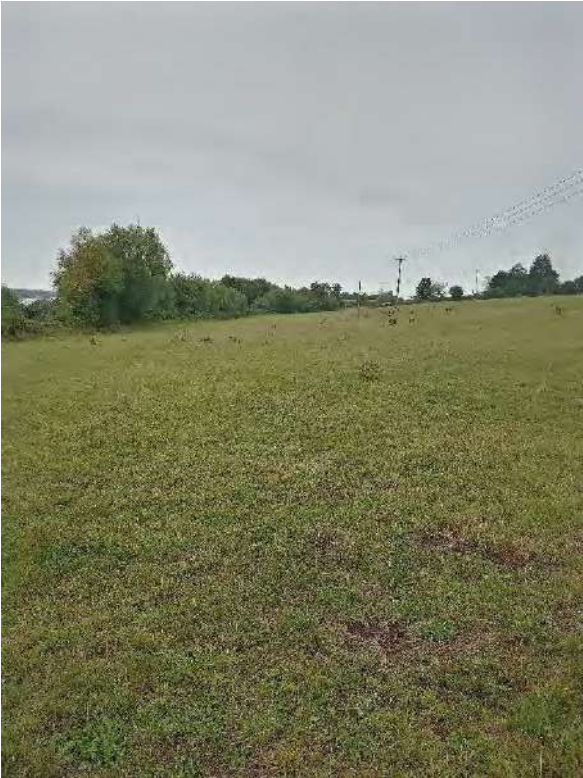
| <b>Desk Study<br/>Photograph 19</b> | |

| <b>Description:</b> South-western field area with overhead services running through. | |

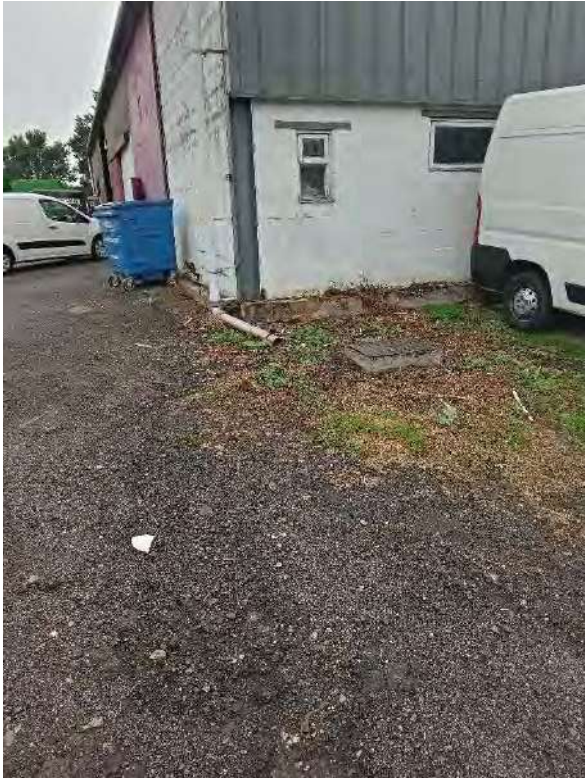
| Desk Study<br>Photograph 27 | | |

| Description: Cover<br>and drainage pipe | | |
