49-53 Rowden Hill, Chippenham Hospital  
Preliminary Ecological Appraisal (PEA)  
*For Artel31*

12<sup>th</sup> August 2025

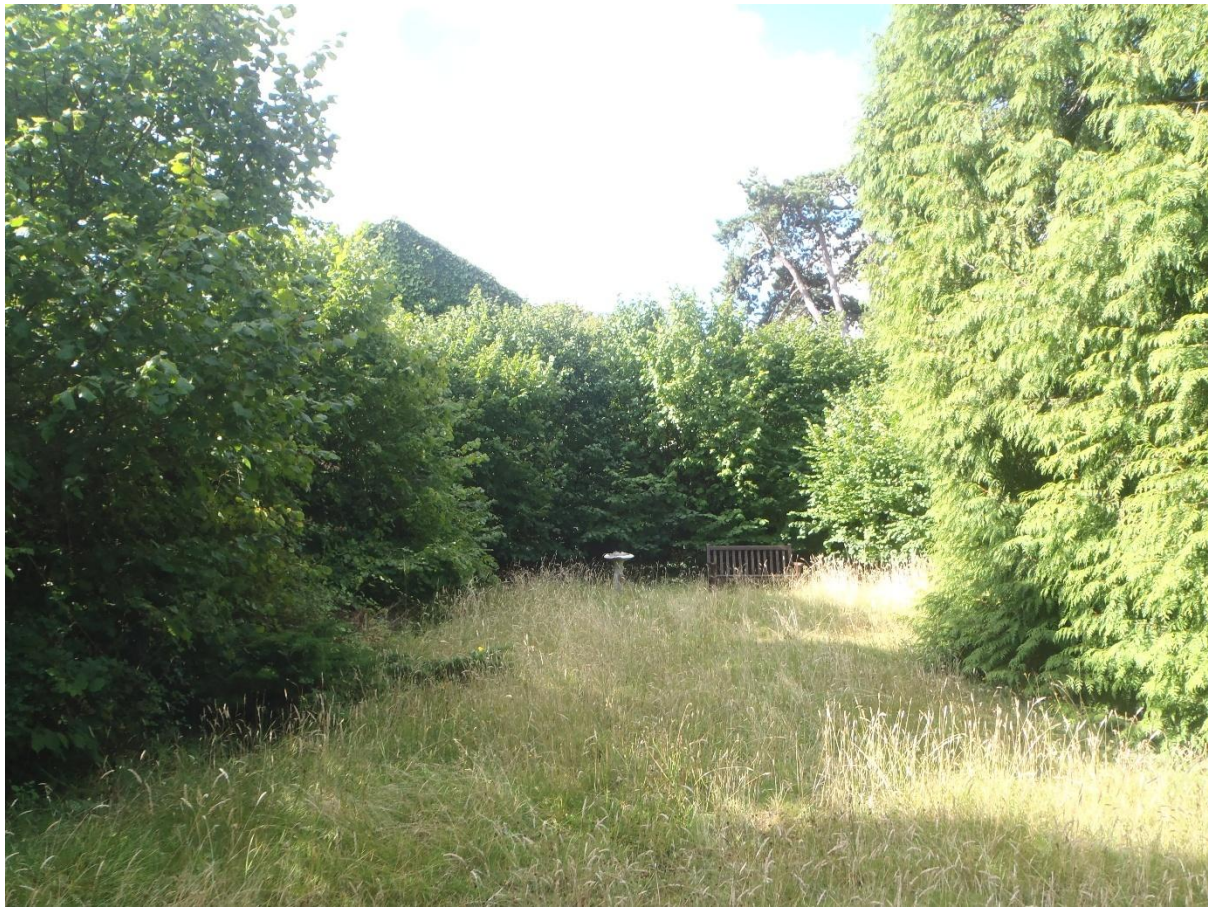
A small area of former amenity grassland is located around the building present to the north-east of the site. The grassland did not show any signs of recent management; however, piles of grass cuttings were found, indicating that some management is still being undertaken within the site. Species present here included perennial rye grass *Lolium perenne*, Yorkshire fog *Holcus lanatus*, white clover *Trifolium repens*, ribwort plantain *Plantago lanceolata*, ragwort and common vetch *Vicia sativa*.

*Photography 1: showing a view of the amenity grassland*

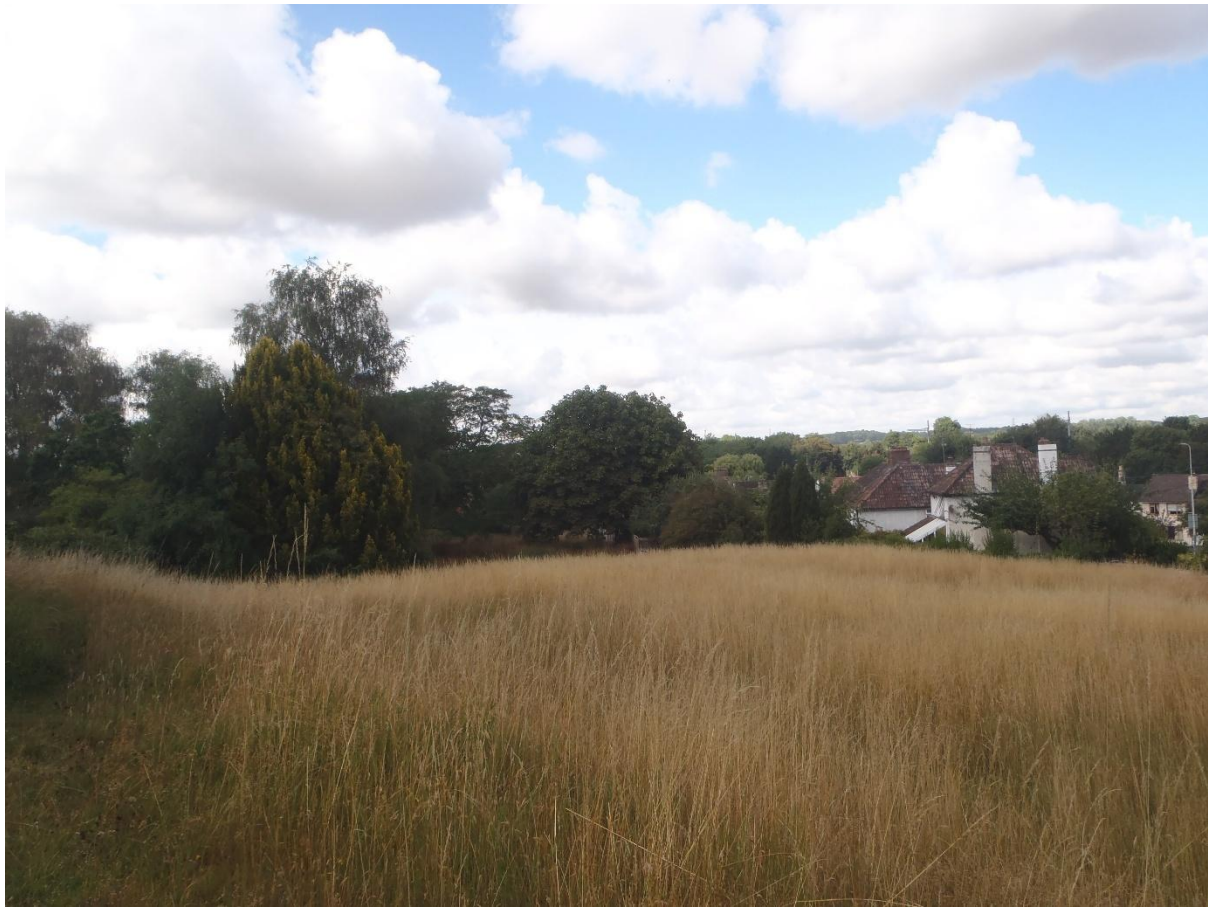
A large area of poor semi-improved grassland is present around the western side of the site and dominated the survey area. The grassland is species-poor with cock's-foot grass *Dactylis glomerata*, false oat-grass *Arrhenatherum elatius*, ribwort plantain, common vetch, creeping buttercup *Ranunculus repens*, dandelion *Taraxacum officinale* agg., red clover *Trifolium pratense* and white clover found here. At the south-western end of the grassland there are large stands of common nettle, and more tall ruderal species such as broad-leaved dock *Rumex obtusifolius* was found to be present.

No signs of recent management was found at the time of the survey; however, it is understood that the grassland was previously managed through mowing. Whilst the sward height was tall at the time of the survey, the grassland was found to be species-poor throughout.

*Photograph 2: showing a view of the poor semi-improved grassland (looking south)*

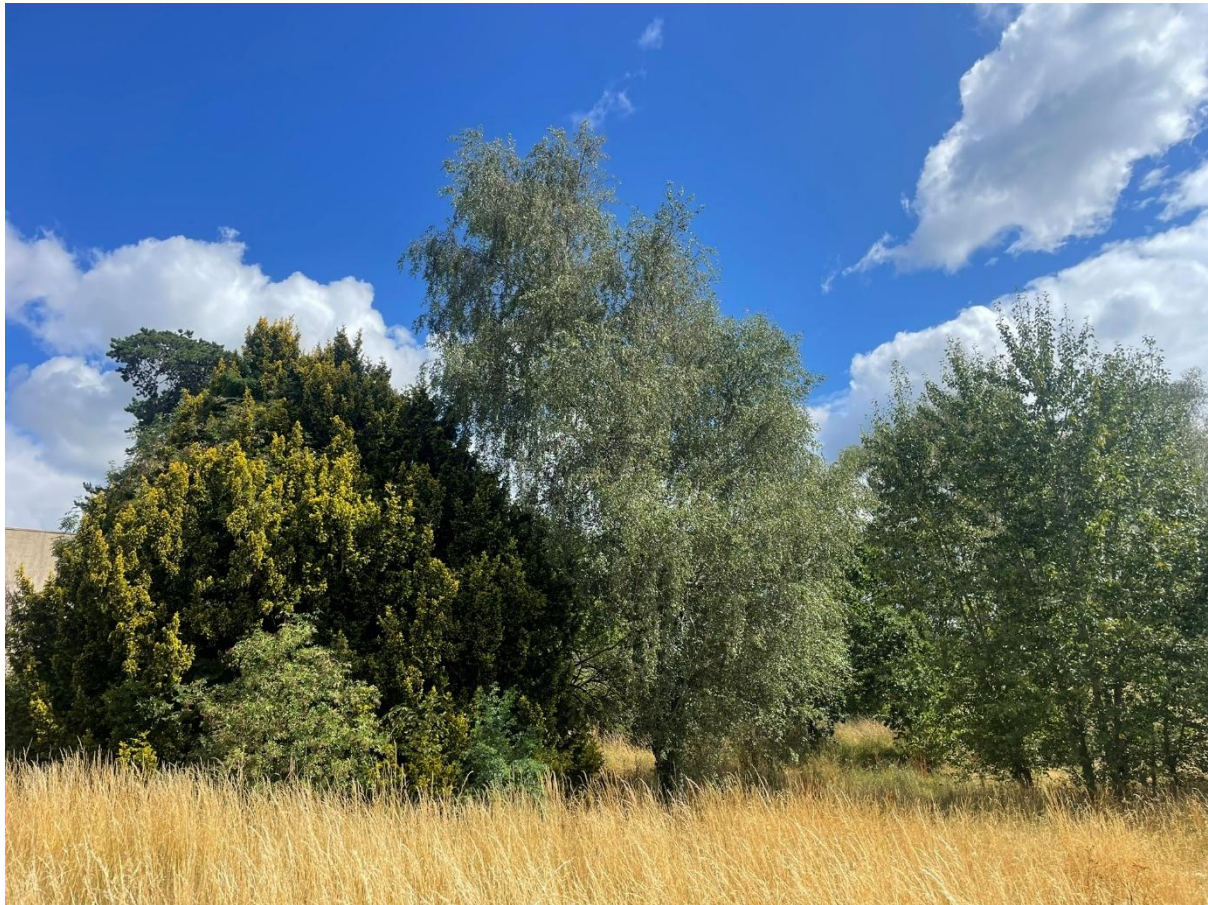
Scattered coniferous trees are located around the site and include Scot's pine *Pinus sylvestris*, cherry laurel *Prunus laurocerasus*, leylandii *Cupressus × leylandii* and yew *Taxus baccata*.

*Photograph 3: showing a view of the scattered trees within the site*

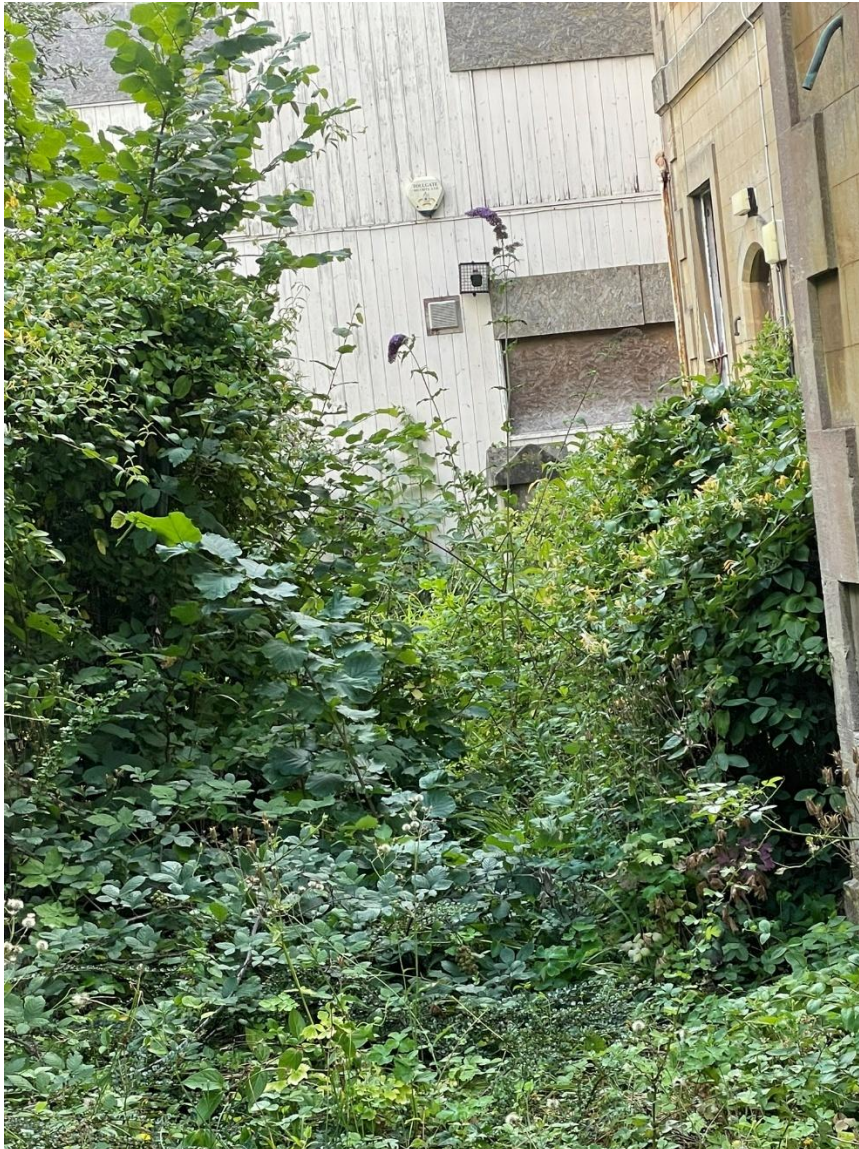
Patches of scrub are located around the site where trees have overgrown and include saplings of self-seeded trees and shrubs and some non-native planting along the former amenity areas/access routes. Species here included bramble *Rubus fruticosus* L. agg., dog-rose, hazel, common grape vine *Vitis vinifera*, ivy *Hedera helix*, willowherb, buddleia, Himalayan honeysuckle *Leycesteria Formosa*, cherry laurel and saplings of sycamore *Acer pseudoplatanus*, beech and ash.

*Photograph 4: showing a view of scrub within the site*

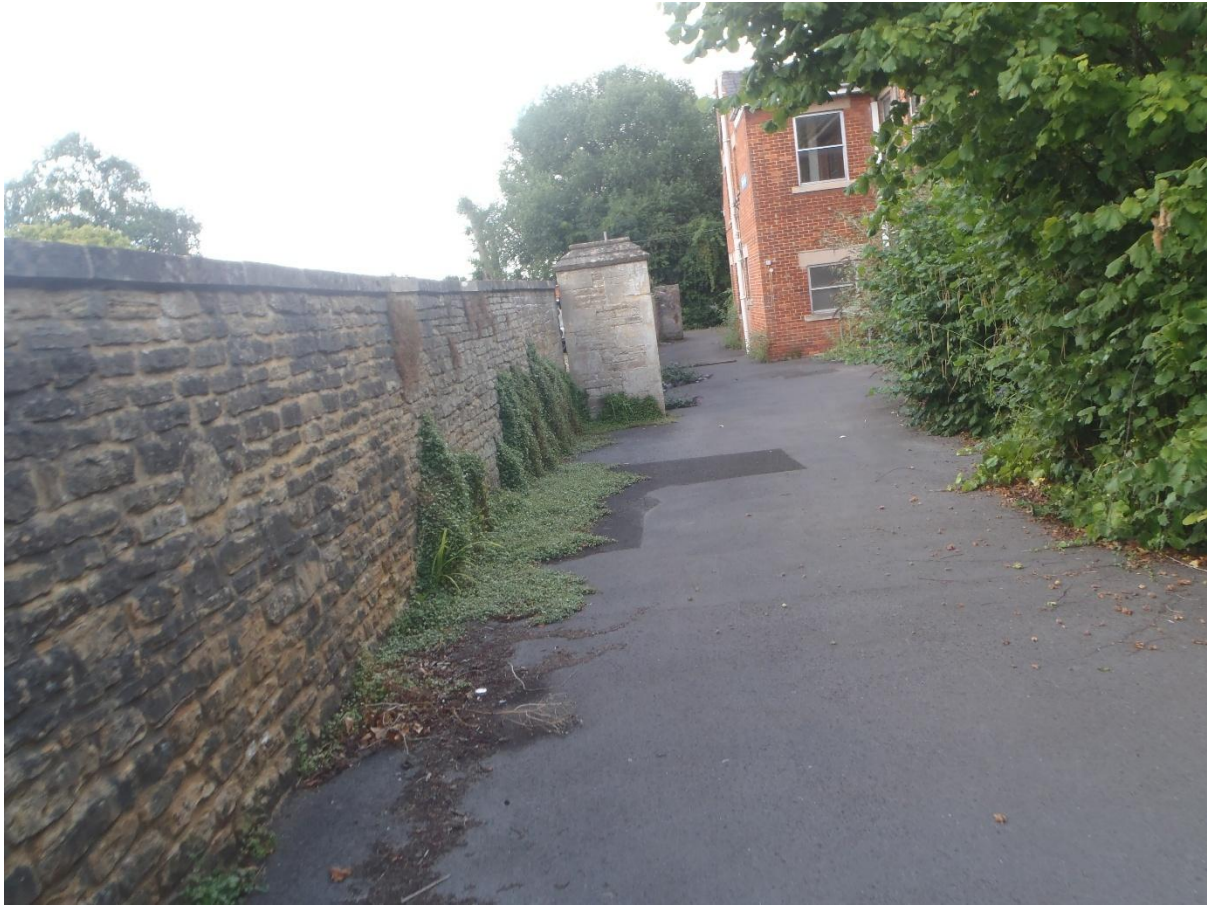
*Photograph 5: showing a view of the wall at the east of the site*

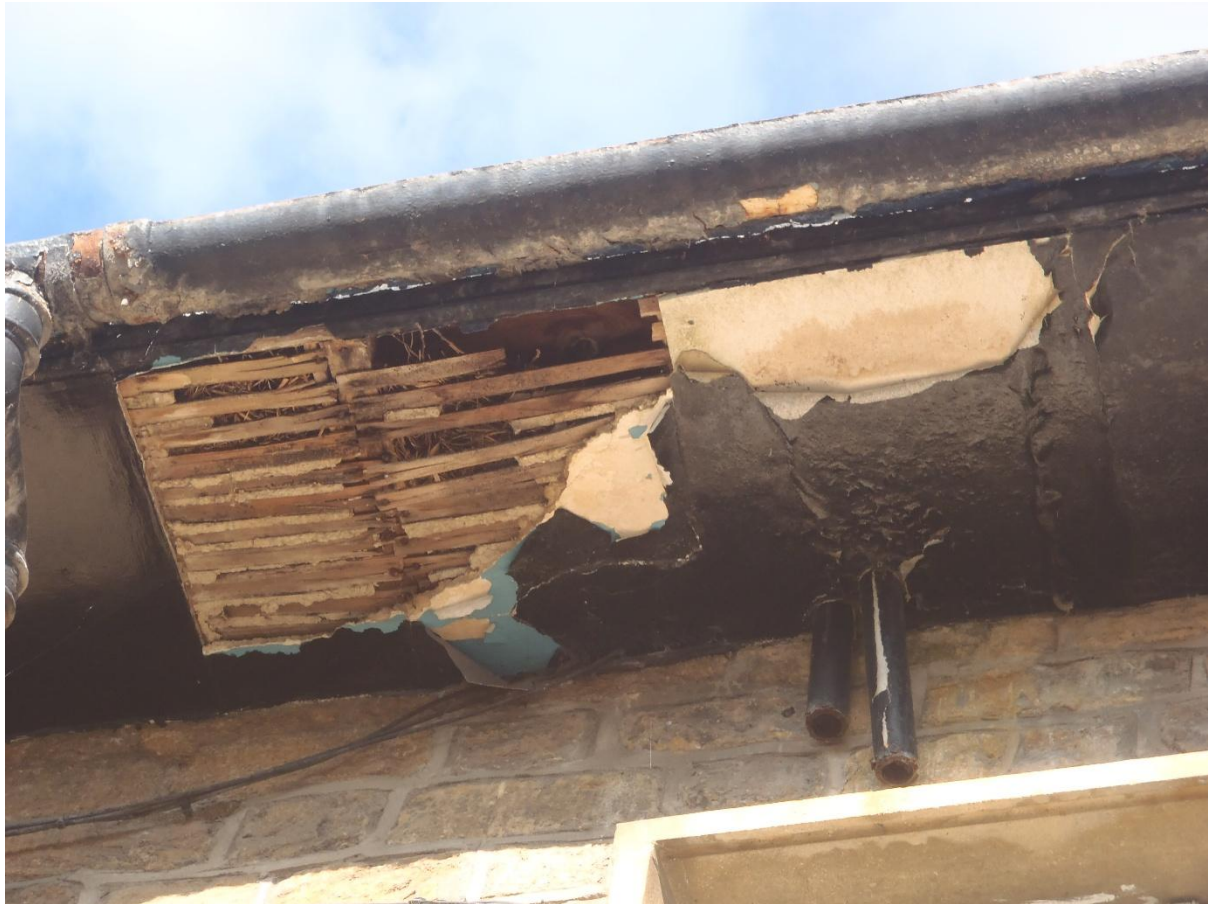
Gaps were found in the soffit of Building 51 and old nesting material was noted in these gaps. From the evidence collected at the site this is likely to be associated with wood pigeon *Columba palumbus*.

*Photograph 6: showing old nesting material in the soffit of Building 51*

The hedgerow, scattered trees and scrub habitat provide suitable nesting and foraging for birds and old nests were observed during the survey; however, these were not active. In addition, nests were found in the soffits of 51 Rowden Hill and are most likely wood pigeon.

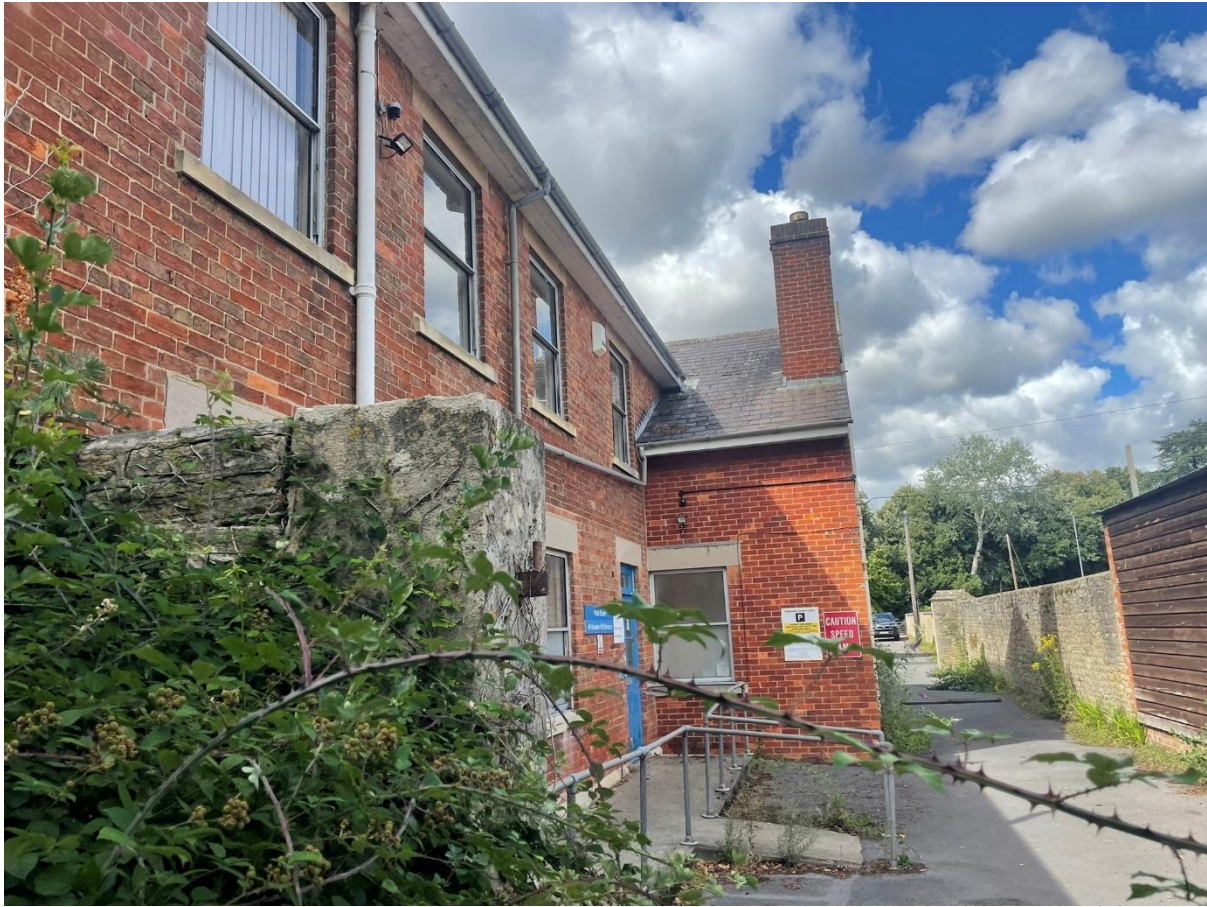
This building is located to the south of the site and is a brick building with a pitched roof covered in slates. Externally the walls of the building were found to be in a good condition with few gaps, crevices or missing mortar where bats could gain access for roosting. Some drill holes in the eastern wall of the building were noted and were inspected for evidence of bats; however, no evidence was found to indicate that these are being used for roosting.

*Photograph 7: showing a view of 49 Rowden Hill*

The windows, doors and soffits were also found to be in a good condition, with no broken panes or open areas which would allow bats to gain access to the internal spaces of the building for roosting.

Externally the roof of the building was found to be in a good condition with no missing, loose or lifted tiles. Some moss was present on the roof, indicating that it may be wet at certain times of the year. No evidence of bat activity was found on the external roof structure of the building.

Bitumen felt was found to be present and in a good condition with no rips or tears which would allow bats to gain access. Some water damage was noted on the timbers with evidence of damp, thus reducing the suitability for bats which prefer dry and stable conditions for roosting.

No evidence of bat activity such as droppings or feeding remains was found during the inspection of 49 Rowden Hill.

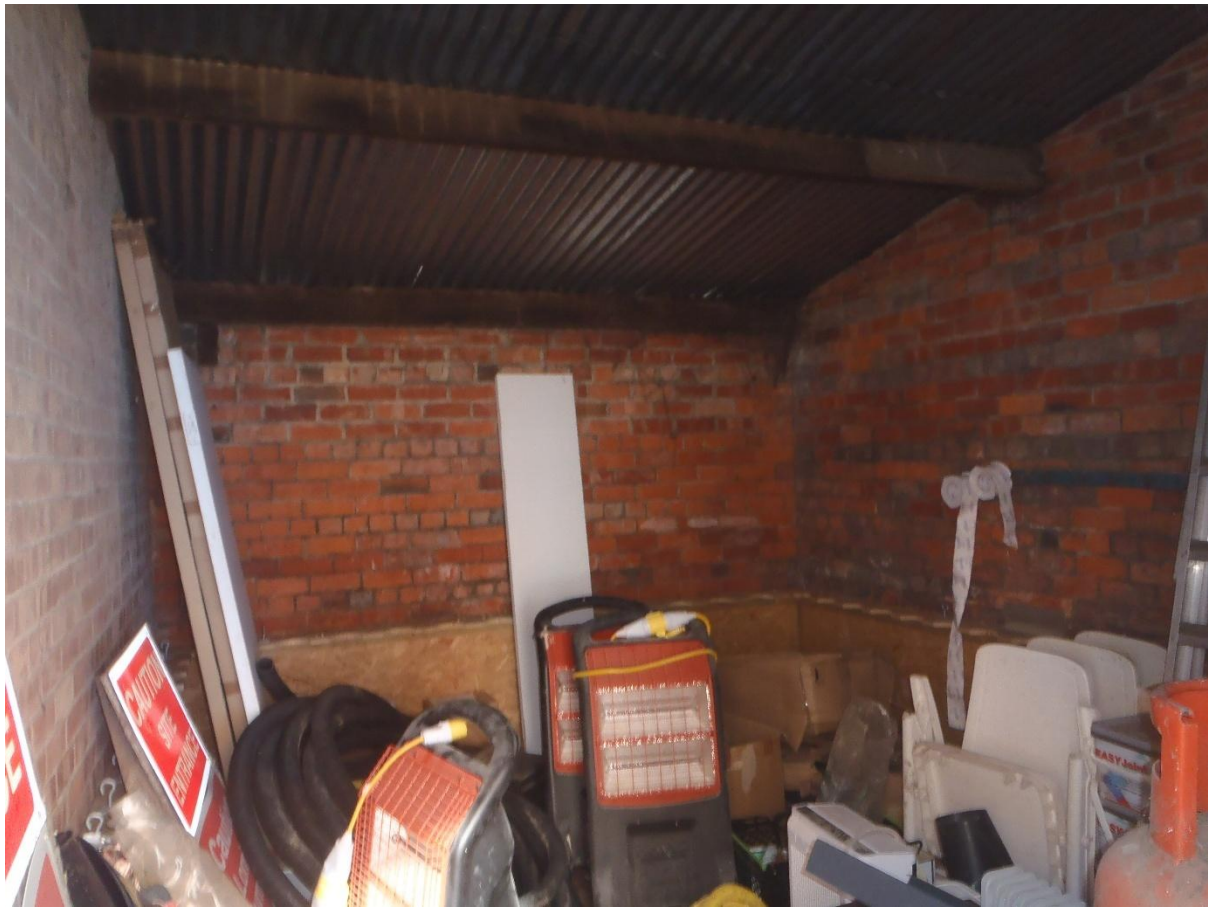
The sheds are constructed from brick and timber with a shallow pitch roof coved with corrugated metal sheets. Externally the walls of the sheds were found to be in a good condition and no gaps were found. Doors on the buildings were tight-fitting with no gaps around the top which would allow bats into the internal spaces. The roofs were found to be covered with a single layer of corrugated metal sheeting with some insulation found at the southern end of the buildings, some of which had fallen down.

Internally the buildings are used for storage of maintenance equipment for both the former hospital buildings and the amenity grassland areas and are regularly used. No evidence of bat activity such as droppings or feeding remains was found during the survey to indicate that bats are using the sheds for roosting. The sheds are considered to have low thermal properties which will deter bats from roosting and the high level of disturbance makes them less suitable for bats as they will be regularly disturbed when roosting.

*Photograph 8: showing a view inside of the storage sheds*

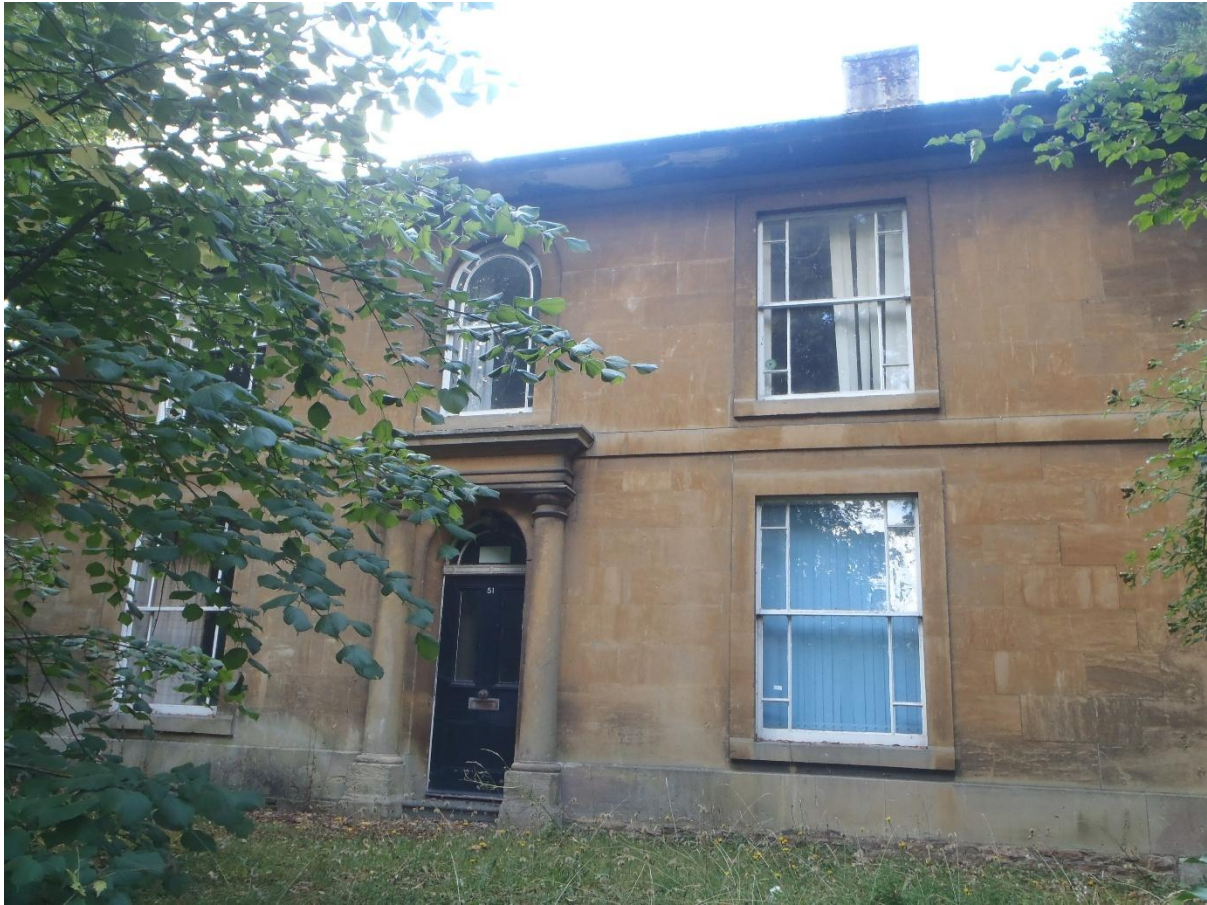
The building is a listed stone-built building located to the north-east of the site and is a two-storey structure. Externally the walls of the building were found to be in a good condition with no gaps, crevices or missing mortar where bats could gain access for roosting. No evidence of roosting bats was found on the external surface of the building such as droppings or staining.

Windows and doors were found to be in a good condition with no gaps where bats could gain access for roosting or gain access to the internal spaces of the building. Some gaps were noted in the soffits of the building where external plaster had fallen off. These gaps were filled with twigs indicating that nesting birds are present. This will make these areas unsuitable for bats, as bird species will deter bats and potentially predate them.

*Photograph 9: showing a view of 51 Rowden Hill*

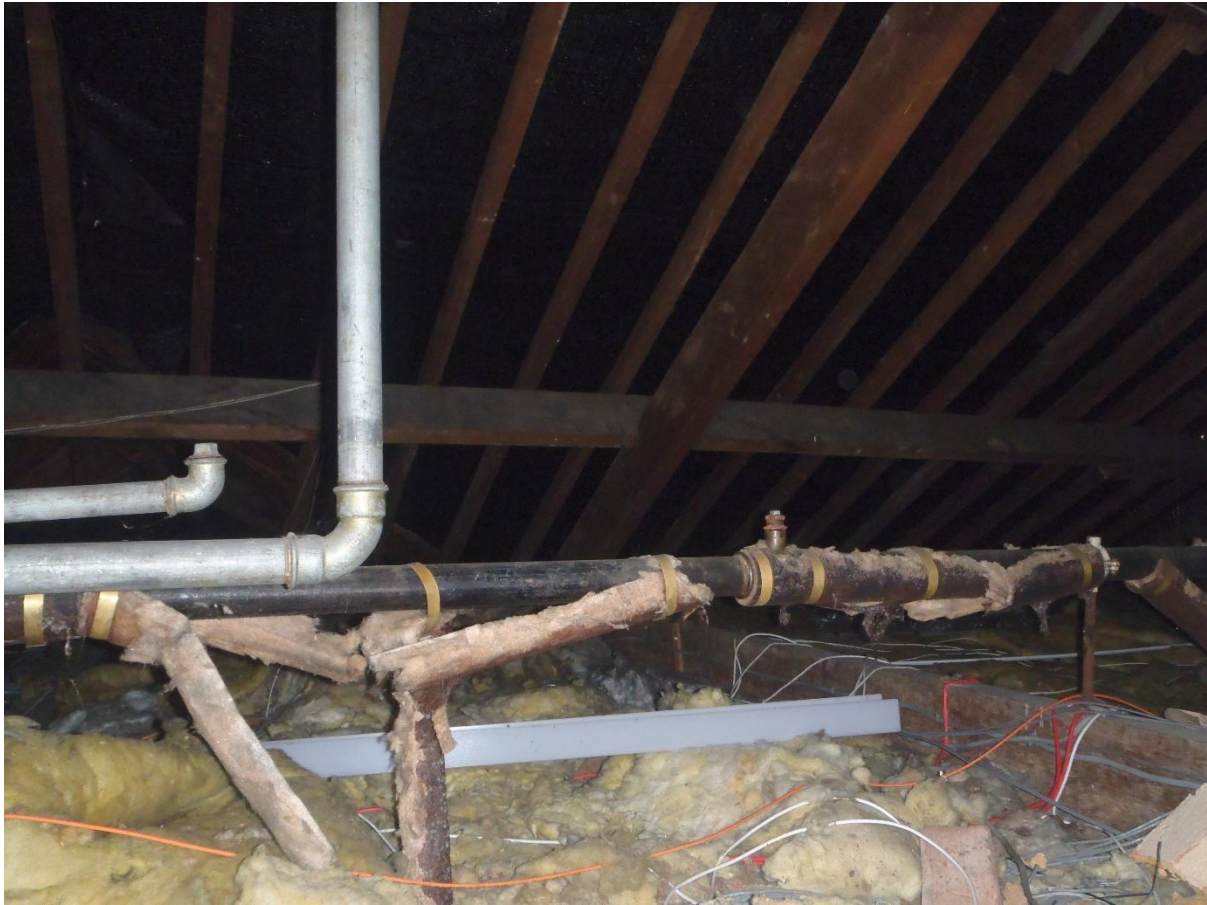
Internally a loft space is present and this was searched for evidence of bats. Roof felt was found to be in a good condition throughout the loft space with no rips or tears present that would allow bats to gain access to the internal space. Dense cobwebs were found on roof timbers, and some water damage was noted on the timbers indicating that water ingress occurs within the loft.

No evidence of bat activity such as droppings or feeding remains was found during the search of the loft spaces to indicate that bats are present. Mouse *Mus musculus* droppings were found within the loft spaces; however, these were not in large number.

*Photograph 10: showing a view of a loft space within 51 Rowden Hill*

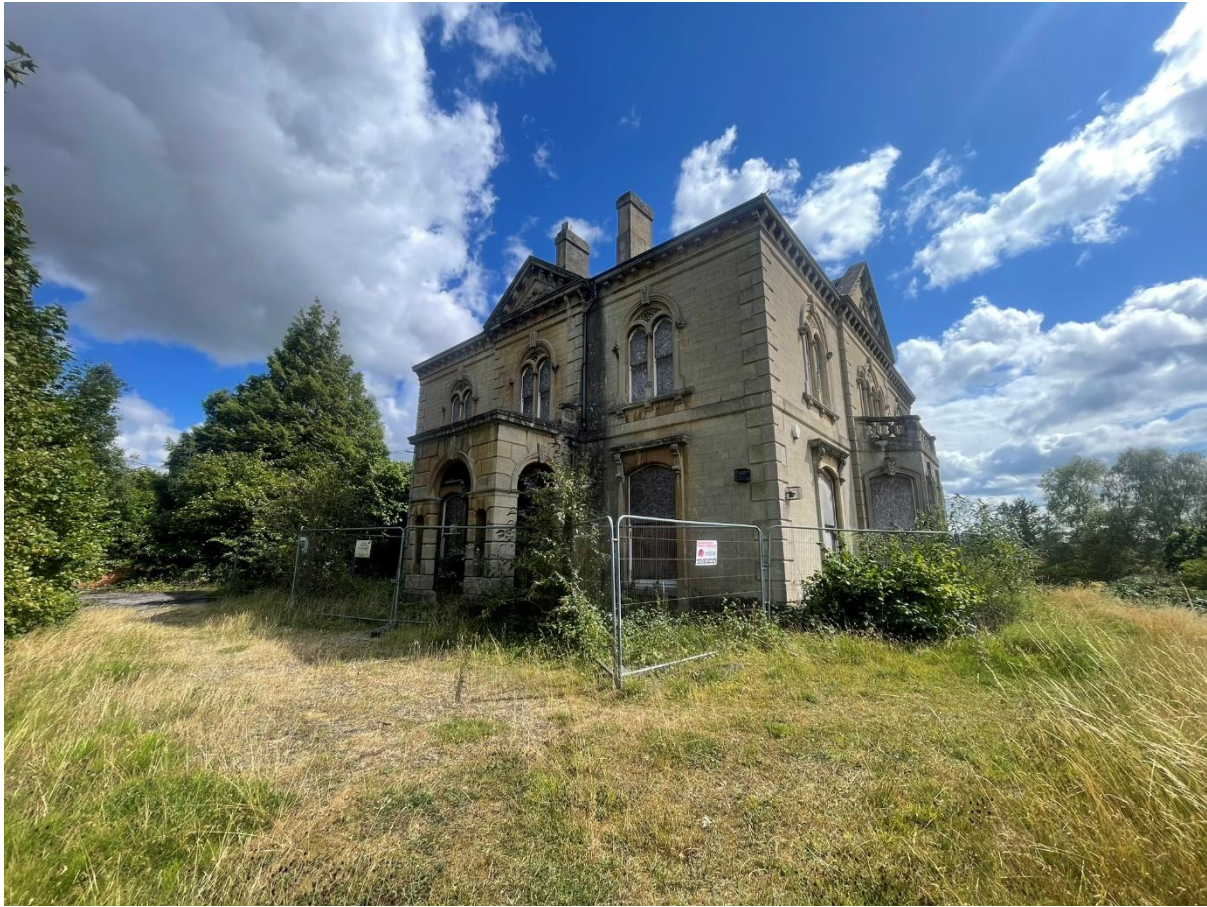
The building is a listed stone-built building located to the north of the site and is a two-storey structure. Some Heras fencing was noted around the building with sealed doors and windows on the ground floor due to some vandalism.

Externally the walls of the building were found to be in a good condition with no gaps, crevices or missing mortar where bats could gain access for roosting, and no evidence of roosting bats was found on the external surface of the building such as droppings or staining. Windows and doors were found to be in a good condition with no gaps where bats could gain access for roosting or gain access to the internal spaces of the building.

*Photograph 11: showing a view of 53 Rowden Hill*
