## **Shaw House, Wiltshire Heritage Statement**

Client: MR CRAIG & SUE BOND

AB Heritage Project No: 63595

Date: 18/11/2025

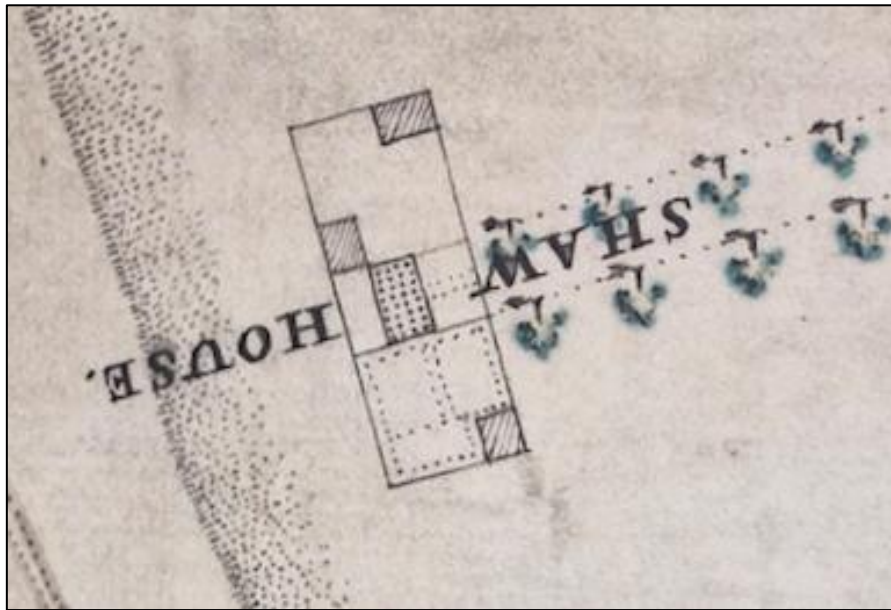
**Plate 3. 1742 Map of Shaw House (Wiltshire Archives Ref: 1742/8663)**

- 4.1.3 Plate 3 shows a map with a less detailed depiction of Shaw House and associated buildings in 1742. Leading up to Shaw House is a tree-lined avenue with the main building illustrated as a single block. Attached to the north west of the main House is what appears to be the existing building depicted in 1721.

- 5.2.2 Shaw Grange refers to the part historic and modern building attached to the north west of Shaw House and comprises a linear wing (depicted on early 18<sup>th</sup> century maps Plate 2 & 3) that is recorded in the Listing Description as possibly a 17<sup>th</sup> century building re-fronted in the 18<sup>th</sup> century.

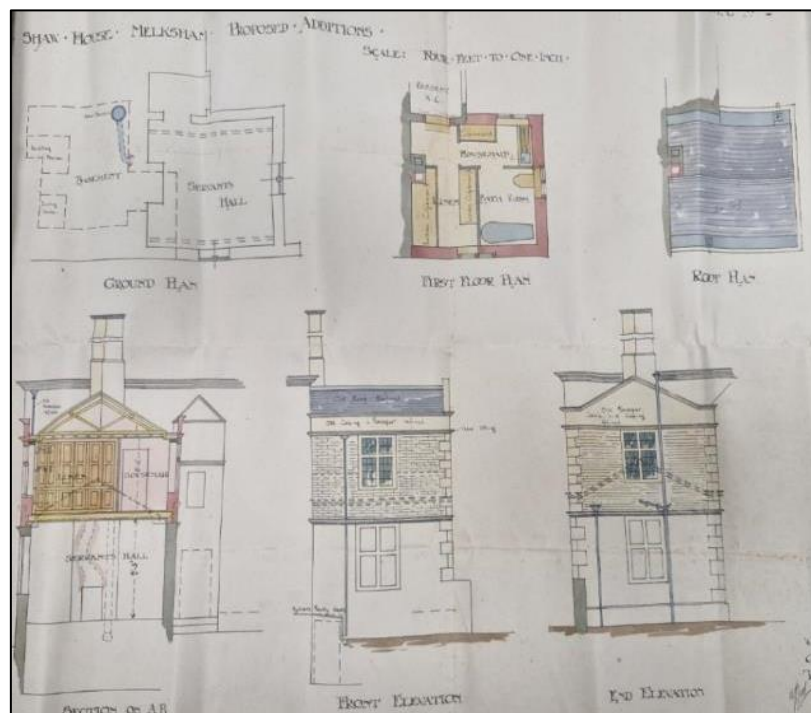
**Plate 6. Architectural Drawings of the North Extension (Wiltshire Archives Ref: 42/760/33)**

- 4.1.2 At some point between 1875 and 1881, Shaw House School reverted into a single residence with the 1881 census showing only 4 people were living at the House. This could be due to students transferring to the National School built in Shaw in the mid-19<sup>th</sup> century.
- 4.1.3 In 1920, the owner of Shaw House estate and a barrister, J. F. Stancomb died, and the Shaw House estate fell under another member of the Stancomb family (Pugh & Crittall, 1953). In the same year, a two-storey extension was constructed to the north of the House. The architectural drawings for the extension show that it accommodated a servant's hall on the ground floor, and a linen closet, bathroom and housemaid's closet on the first floor (Plate 6).

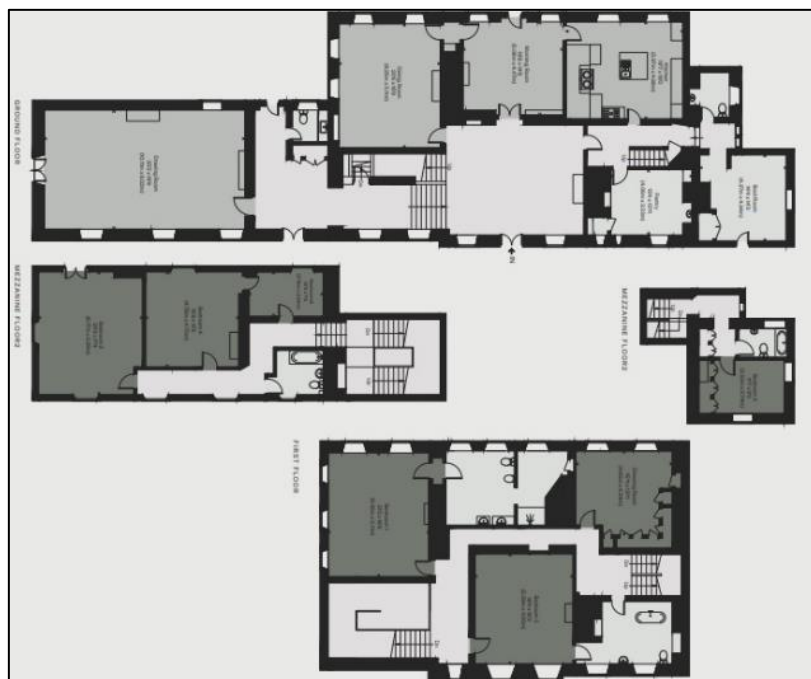
**Plate 10. Ground & First Floor plan of Shaw House in 2022 (Indigo, 2025)**

- 4.1.10 Plate 10 shows the floorplan of the ground and first floors of Shaw House in the sales brochure of 2022 prior to the current owners purchasing the property.

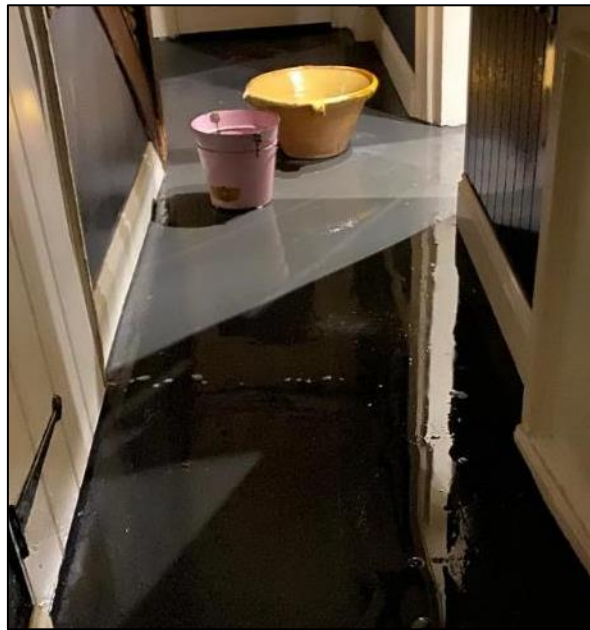
**Plate 11. Water damage at the northern end of the ground floor (Mr Craig & Sue Bond, 2025)**

- 4.1.11 In 2022, the current owners purchased the property and encountered a serious issues relating to the stability of the structure and water ingress throughout requiring urgent repairs to the roof. Plate 11 shows a photograph taken on the ground floor of Shaw House after a storm where the rain had penetrated the building from the roof giving an indication of the damage this persistent water ingress caused on all floors.

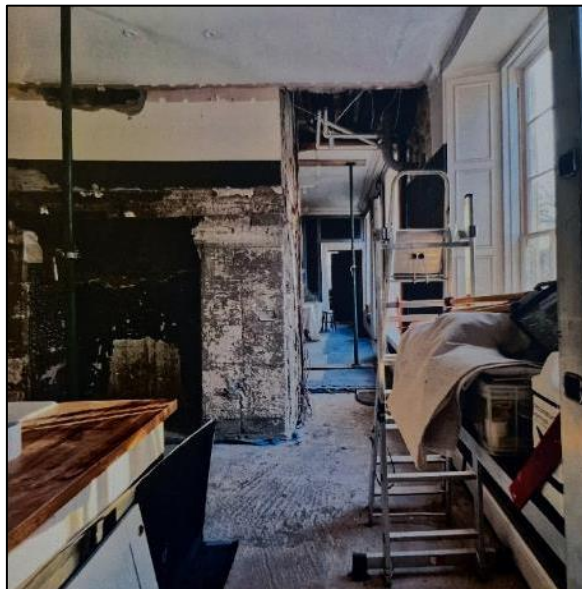
**Plate 12. Kitchen chimney breast removed as part of unconsented works**

4.1.12 Plate 12 shows a photograph of the kitchen when it was undergoing structural works. The demolished chimney breast can be seen in the centre and appears to be constructed of ashlar blocks with a timber lintel. The plaster above the fireplace and ceiling are modern plaster. The props seen in the photograph were inserted due to the structural instability of the beams including one above the chimney breast. The structure was also demolished on the first floor above.

- 6.4.2 The applicant has shown that the feature had become redundant, hidden and, as it transpired, badly damaged. Consequently, the redundant and damaged stack exerted a negative impact on the structural integrity of the house over two floors. The advice of a structural engineer was sought, and the damaged feature was removed, and the structural weaknesses were corrected by means of inserting steel beams.

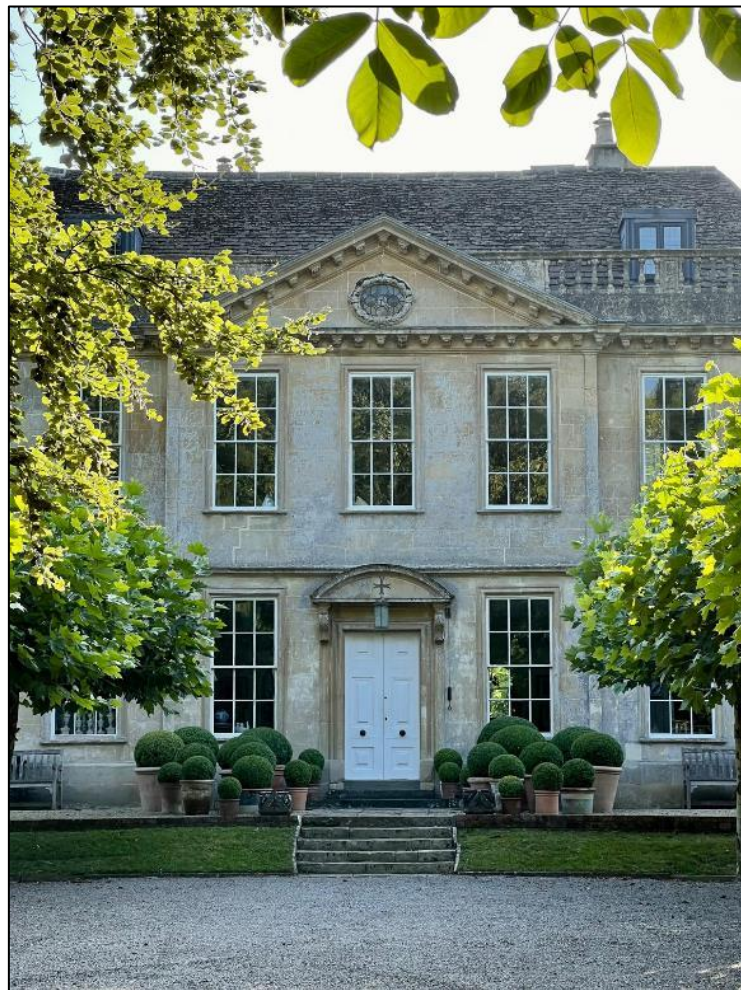
**Plate 13. Principal (east) elevation of Shaw House**

- 4.2.2 Shaw House is composed of a principal two-storey central building with a lower two-storey 1840s range to the south, and an early 20<sup>th</sup> century extension to the north. The principal building dates to 1711 and was designed in the classical style featuring a principal elevation exhibiting the classical principles of symmetry, proportion and order. The elevation features seven bays, the central three of which have a shallow projection with a pediment, oculus window and dentil cornicing above. The cornicing continues either side of the central bays below a balustraded parapet. The roof is hipped with stone tiles and two dormer windows. On the ground floor is a large central door set into a moulded architrave with segmental pediment above (Plate 13).

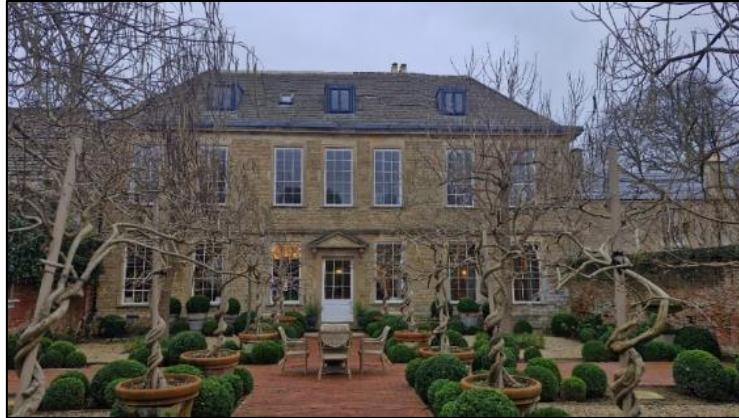
**Plate 14. Rear (west) elevation of Shaw House**

- 4.2.3 The rear elevation of the principal building carries the same classical design with a symmetrical frontage of sash windows and a central doorway with ashlar surround and pediment above. There are three dormer windows in the hipped roof (Plate 14).

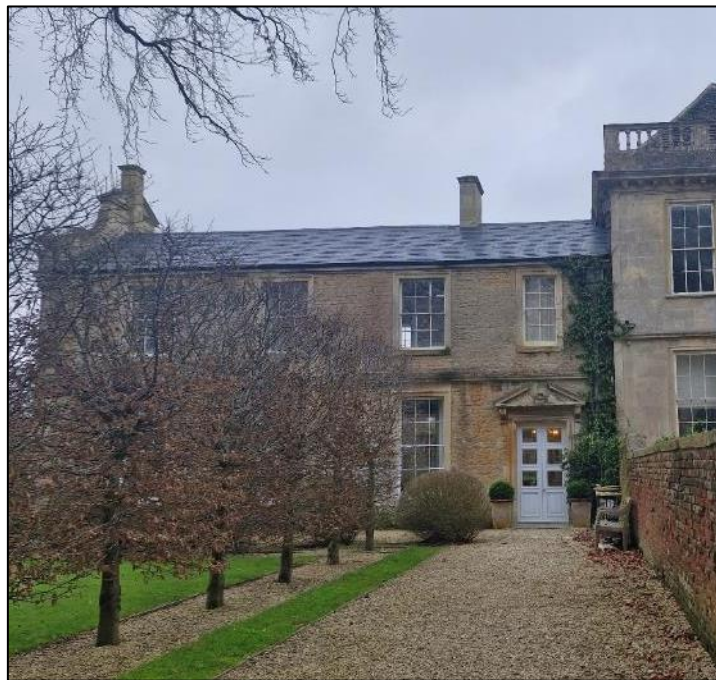
**Plate 15. Early 19<sup>th</sup> Century Wing**

- 4.2.4 The early 19<sup>th</sup> century wing was designed to emulate the principal building in a classical style but was executed more simplistically. It has a symmetrical frontage of sash windows in simple moulded surrounds and doorway to the north set in a simple moulded architrave topped with a broken pediment surmounted on moulded corbels (Plate 15).

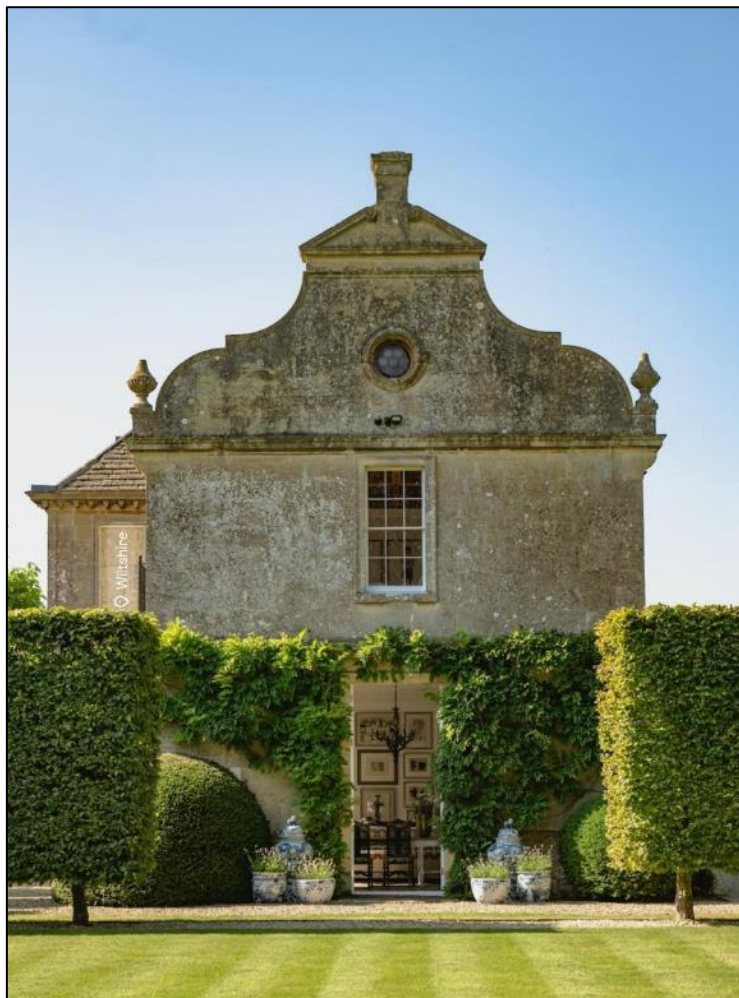
**Plate 16. South elevation of the early 19<sup>th</sup> century wing**

- 4.2.5 The south elevation of the early 19<sup>th</sup> century wing features a Dutch gable with a 20<sup>th</sup> century doorway on the ground floor, sash window above and an oculus window in the gable end. The decorative roof features collared urns on either side and chimney stack breaking through a pediment at the apex of the gable (Plate 16).

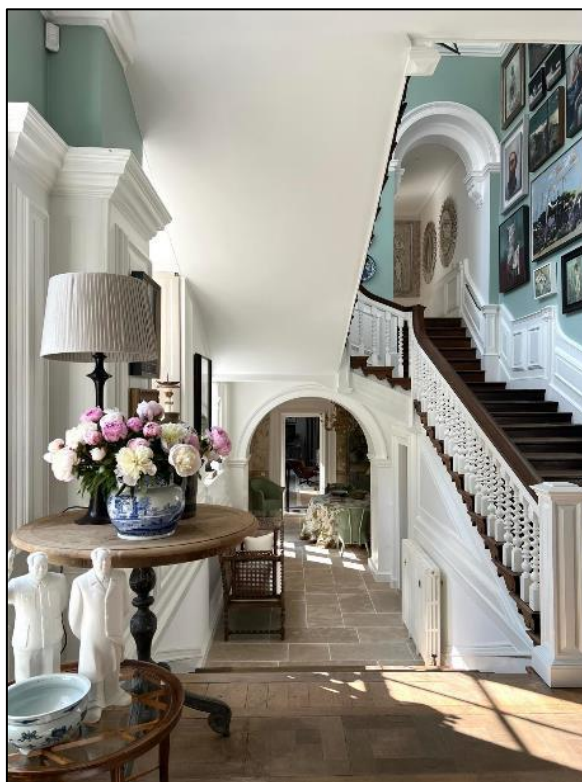
**Plate 19. Main Staircase**

- 4.2.8 On the south side of the hallway is a grand staircase leading up to the first floor of the main house and early 19<sup>th</sup> century wing (Plate 19). The staircase also leads down to a lower level where the drawing room of the early 19<sup>th</sup> century wing is situated. The staircase features barley sugar turned balustrading and shallow steps allowing the graceful movement of women in gowns fashionable in the Georgian period. Panelling leading up the staircase had been removed by a former owner but is to be reinstated as part of the forthcoming application.

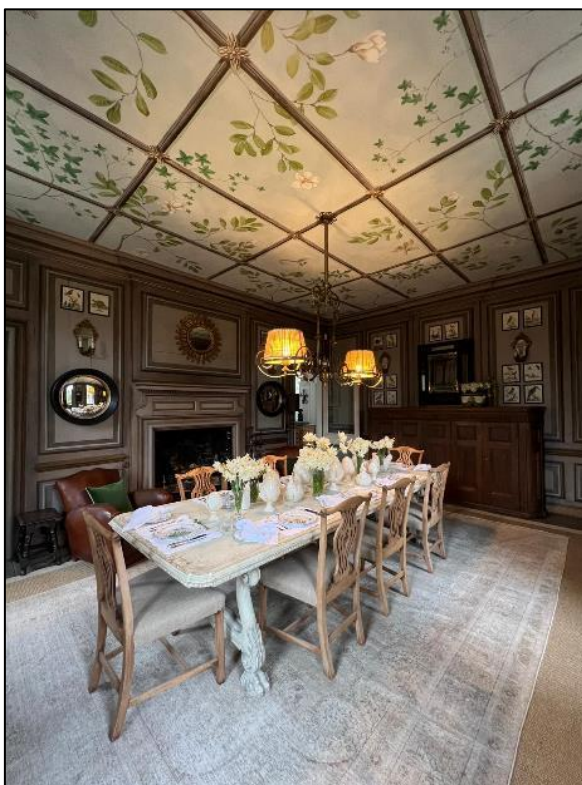
**Plate 20. Dining Room**

4.2.9 Plate 20 shows the dining room that features historic panelling and floor.

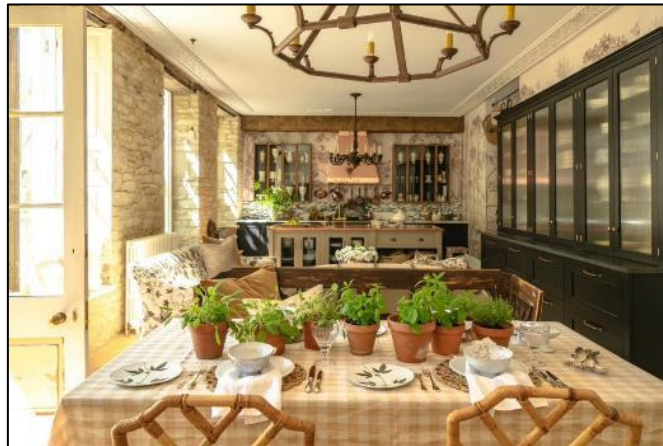
**Plate 21. Kitchen/Lounge**

- 4.2.10 Plate 21 shows the newly created open plan kitchen/lounge area. This is the area in which the chimney breast was removed, and steel supports were inserted into the ceiling to ensure the stability of the structure (see Plate 13). The water damaged plaster from the west wall of the Room was removed during the works, left to dry out and repointed with lime mortar. As well as reinstating the chimney breast, the Local Planning Authority seeks the replastering of the Bath stone walls. The insertion of wooden shutters to the two windows in the kitchen are currently in the process of being undertaken.

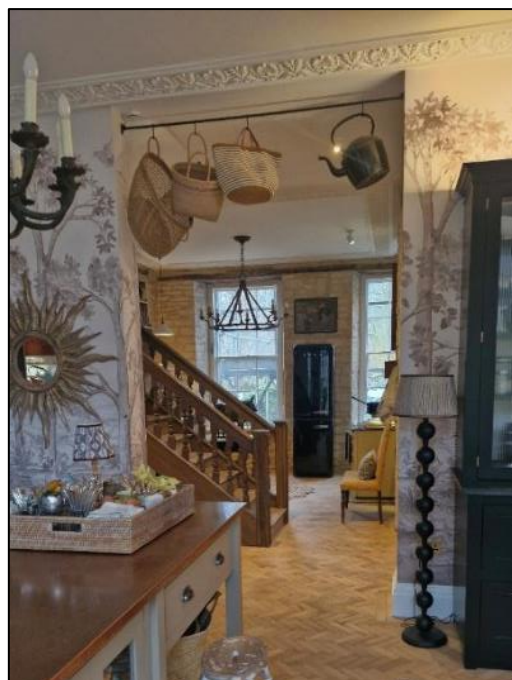
**Plate 22. Enlarged Kitchen Opening**

- 4.2.11 Plate 22 shows the enlarged opening created between the kitchen and former butler's pantry which was undertaken in conjunction with the insertion of a steel supporting beam to reinforce a lack of structural stability in this area of the house. The LPA seeks the reinstatement of the single doorway previously in this location.

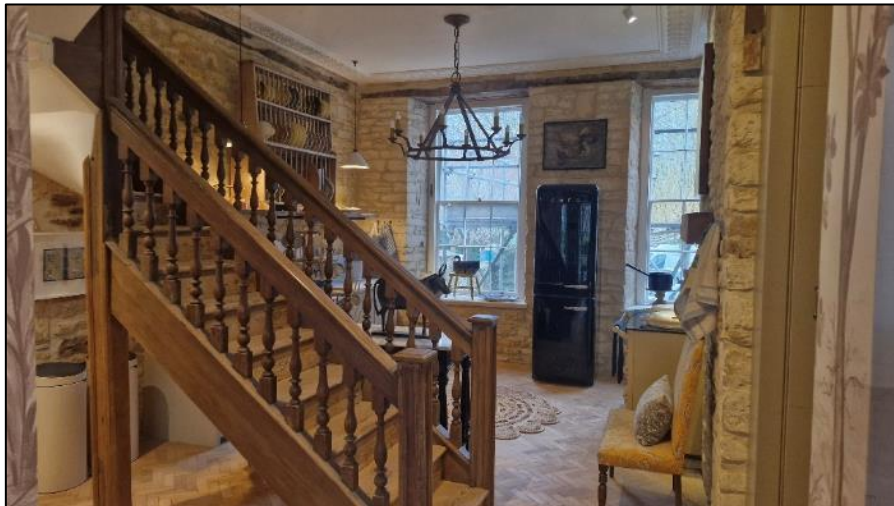
**Plate 23. Former Butler's Pantry and Service Staircase**

- 4.2.12 Plate 23 shows the former butler's pantry and service staircase providing access to all levels and exclusively to the attic. LPA concerns here relate to the removal of what was thought to be a historic wall but which the client correspondence and a photograph has shown was modern plasterboard. The wall is, however, seen on mid-20<sup>th</sup> century floorplans. The main concern is that the removal of the wall elevates the status of the staircase. Compared with the main, grand staircase in the entrance hallway however, it is still legible as a secondary, service staircase.

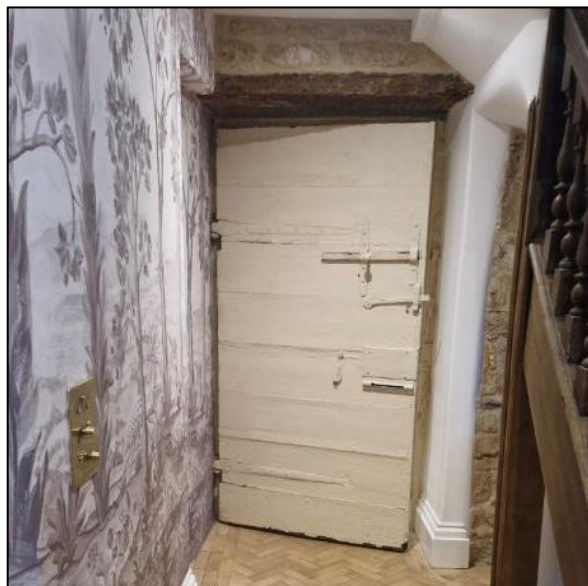
**Plate 24. Original External Service Door**

- 4.2.13 The original service door, which prior to the 1920 extension was external and linked to the service yard, survives in good condition (Plate 24).

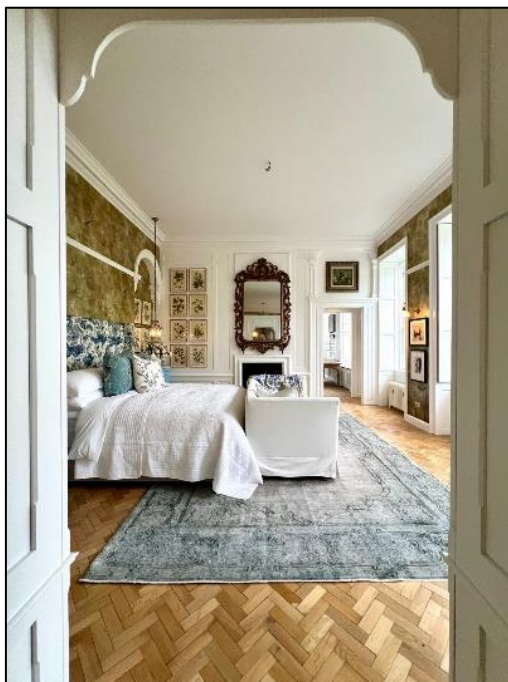
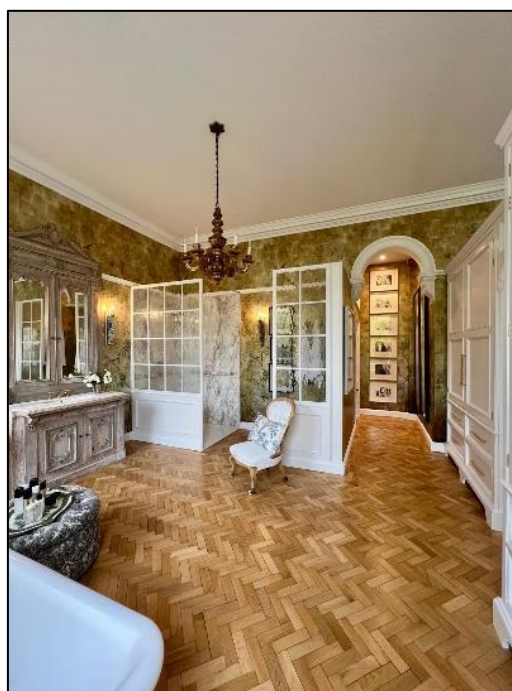
**Plate 25. Open plan bedroom and ensuite**

- 4.2.14 On the first floor, is a new open plan bedroom and ensuite (Plate 25 & 26). This room was created in conjunction with the removal of the chimney stack above the kitchen, and modern partitions thought to be inserted during the remodelling of the house as it became a care home. The chimney stack was situated roughly where the cupboards are now (Plate 25).

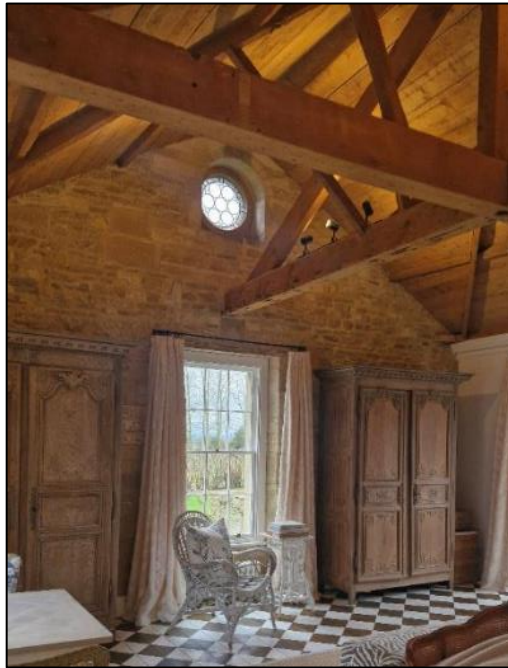
**Plate 27. Southernmost Bedroom in the early 19<sup>th</sup> century wing**

- 4.2.15 In the southernmost bedroom of the early 19<sup>th</sup> century wing, the wall plaster was stripped and modern plasterboard ceiling removed due to water ingress (Plate 27). The walls were dried out and repointed with lime mortar, and the roof timbers were treated and left exposed. The oculus window was reglazed with the same design as the oculus window on the principal elevation. The LPA have requested the wall be replastered and ceiling be restored with lath and plaster – such a measure would block any light from and views to the oculus window.

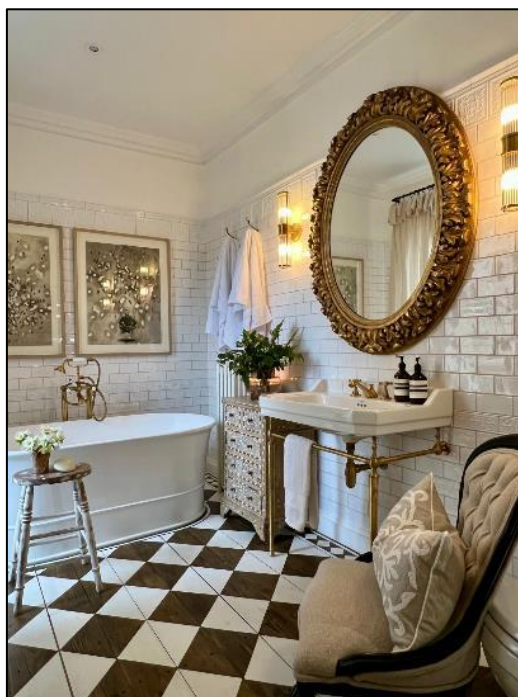
**Plate 28. Newly created bathroom in the 19<sup>th</sup> century wing**

- 4.2.16 Plate 28 shows the newly created ensuite bathroom in the early 19<sup>th</sup> century wing. The door which has been blocked off was roughly where the mirror is. The access is now from the bedroom which was indicated as a previously blocked up doorway on the 1949 floor plans (Plate 9). The LPA are seeking the reinstatement of the blocked-up doorway.

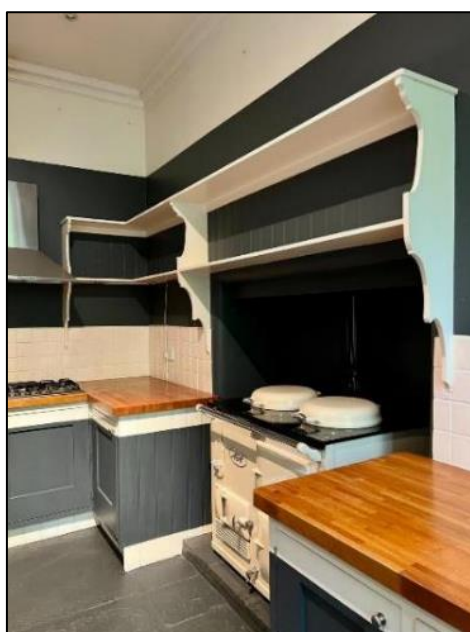
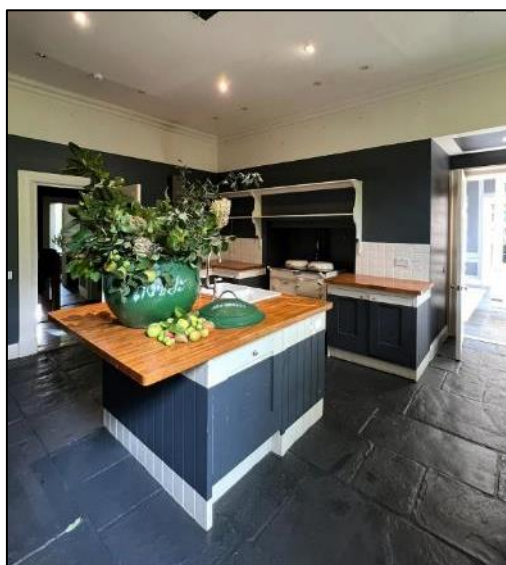
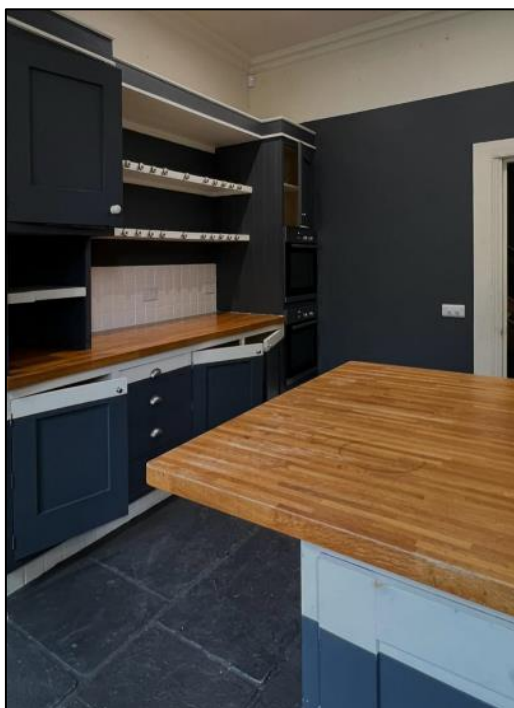
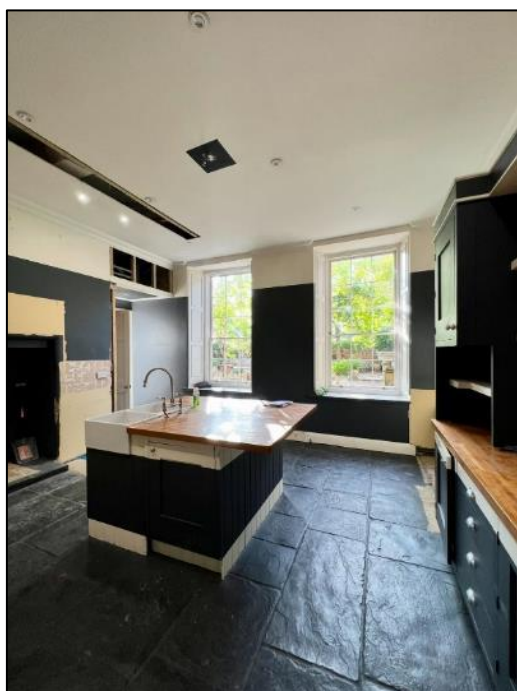
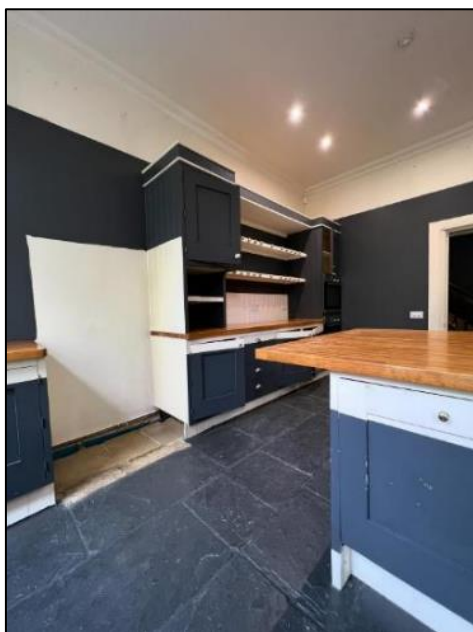
The Kitchen in 2022, prior to works

*When Shaw House was purchased in October 2022, the first major concern raised by the builders, plumbers, and electricians was the condition of the floor above the kitchen. The floor between the main bathroom, shower room, and dressing room on the first floor was noticeably bouncy, uneven, and bowed, making it difficult and unsafe for tradespeople to work in that area.*

*To investigate, the floorboards were removed. This exposed the remains of a disused internal chimney stack, along with extensive water-seepage damage down its stonework and across the south-facing wall. The team also uncovered a 1970s plumbing stack on the south side and two large original oak beams. One beam had been repeatedly cut through over several decades to accommodate new plumbing, electrical, and intercom systems installed during the 1960s–1980s. The other beam showed severe historical fire damage—almost burned through at one point—likely from when it once sat above an active fireplace. These issues left the floor with very little meaningful support, explaining its instability.*

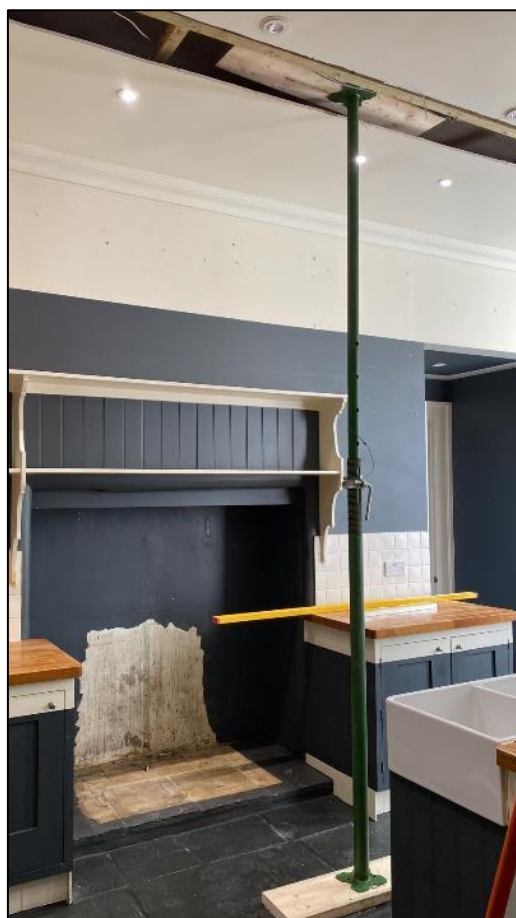
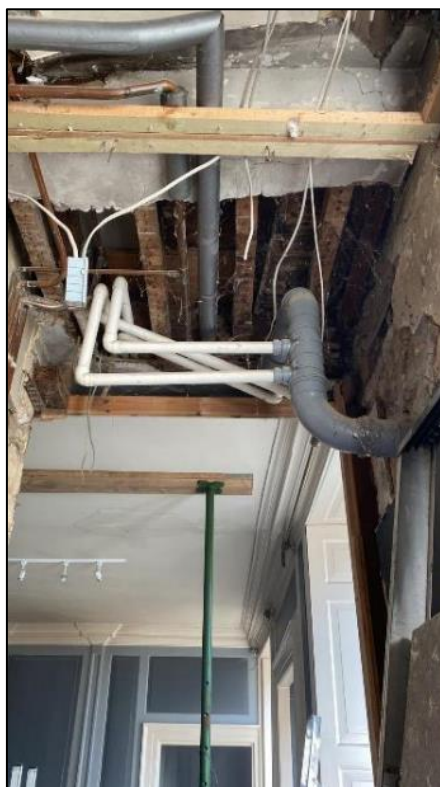
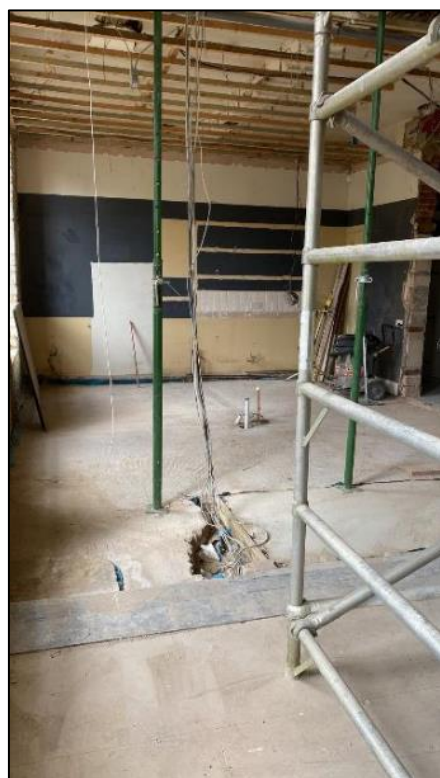
The Kitchen in 2023, during the works

*Because the chimney stack was completely boxed in with plasterboard, material samples were taken to determine whether it included asbestos. When tests confirmed it was only modern plasterboard, the cladding was removed. This revealed a distorted, rough stone chimney stack that was no longer providing structural support; instead, its condition suggested that it was exerting downward drag on the surrounding structure. No active fireplaces connected to this chimney were found, and it appeared to have been out of use for many decades. In addition, stone had been removed from the stack between floors—likely during the installation of new ceilings in the 1970s–80s—further compromising its integrity. Temporary props were therefore installed to stabilise the area while long-term options were assessed.*

*The consulting structural engineer confirmed that the installation of two new structural beams (see attached report) would stabilise the floor, remove the unnecessary structural load caused by the chimney stack, and significantly improve the overall integrity of the building. With this assurance, the owners proceeded with the recommended structural works and began planning a new ground-floor kitchen that would provide modern functionality while remaining sympathetic to the Georgian and Victorian character of Shaw House.*

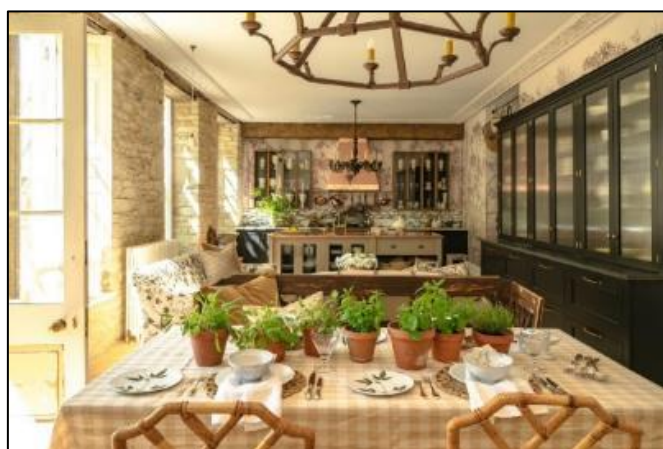
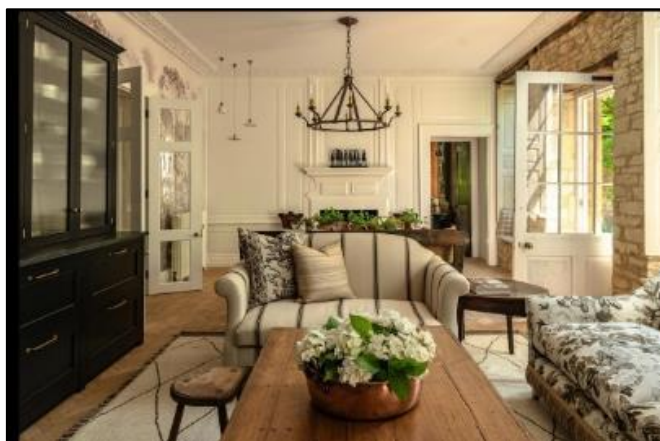
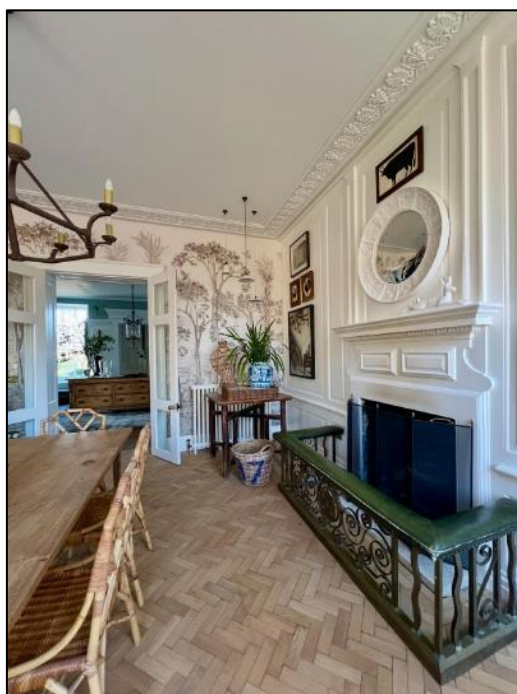
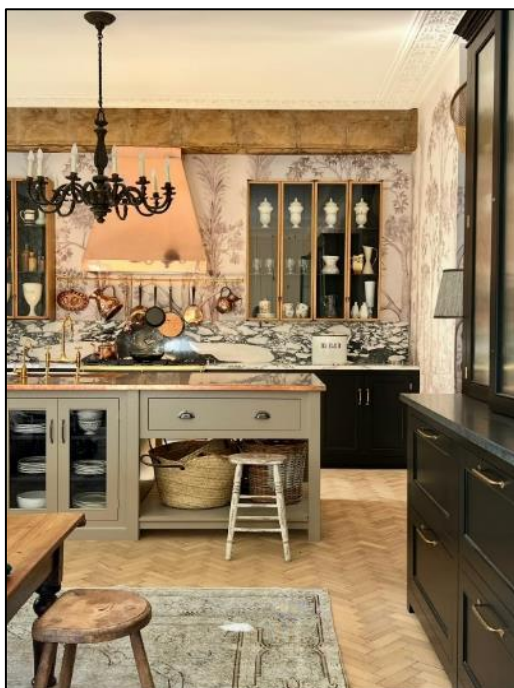
The Kitchen in 2025, after the works

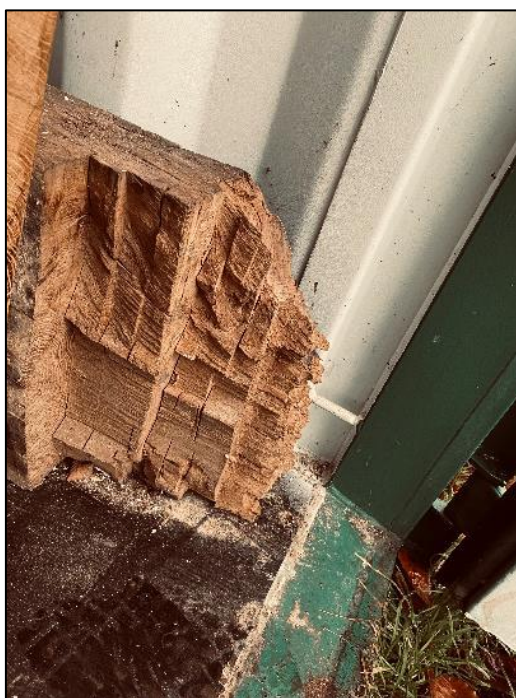
**Plate 42. Sawed beam from 1970s**

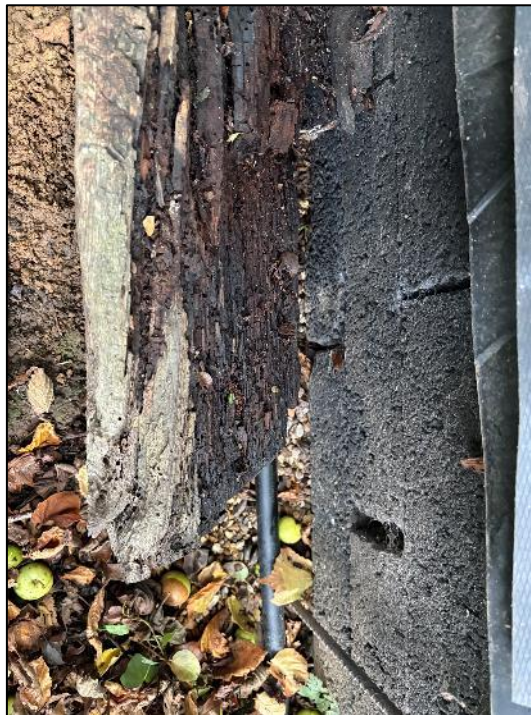
**Plate 43. Burnt beam**
