# PRELIMINARY ROOST APPRAISAL REPORT

STOP FARM, FONTHILL GIFFORD,  
WILTSHIRE

stark ecology<sup>ltd</sup>

NOVEMBER 2025

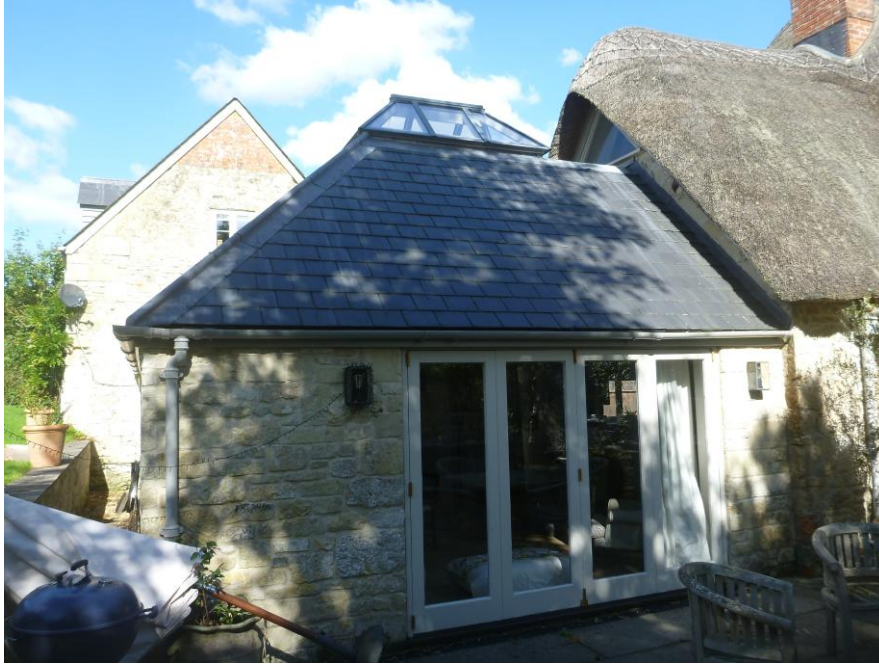
The roof of the more western extension, added in 2015, is slate and there is a glazed dome at the apex of the roof. The ridge and hips are sealed with lead which is tight fitting and not lifted in any area.

**Fig 2:** The more western extension to Stop Farm has a slate roof with a glazed portion at the ridge.

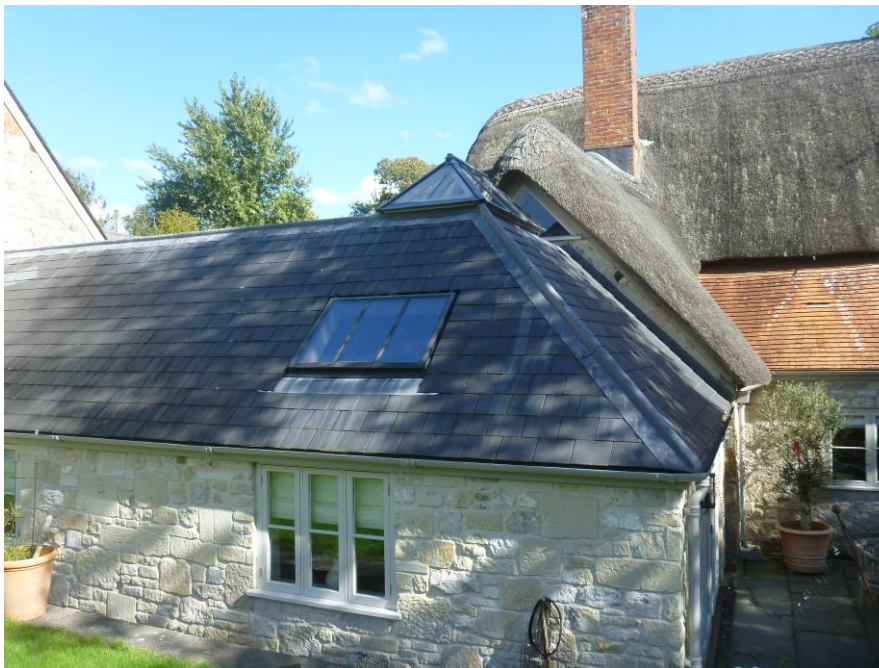
**Fig 3:** The slate roof of the western extension is tightly sealed.

Externally the two single storey extensions to Stop Farm that will be affected by the new extension proposals are well sealed with no gaps identified in the roofs, at the eaves or in the stone walls. The roof slates and clay roof tiles are tight fitting and there are no gaps or crevices where the single storey extensions ties into the two storey walls of the property.

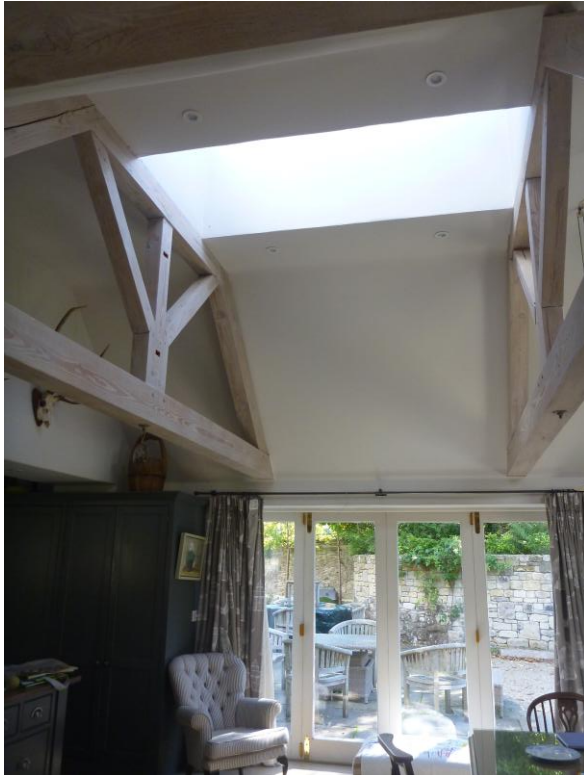
Internally this area of the property is converted to the roof and has a vaulted ceiling with some roof lights installed.

**Fig 4:** The western extension has a vaulted ceiling.

Internally, the more western extension has a vaulted ceiling with no separate loft space. The smaller extension has an inaccessible loft space but the roof and eaves of this part of the property are so well sealed that bats would not be able to gain access to this area of the building to roost.

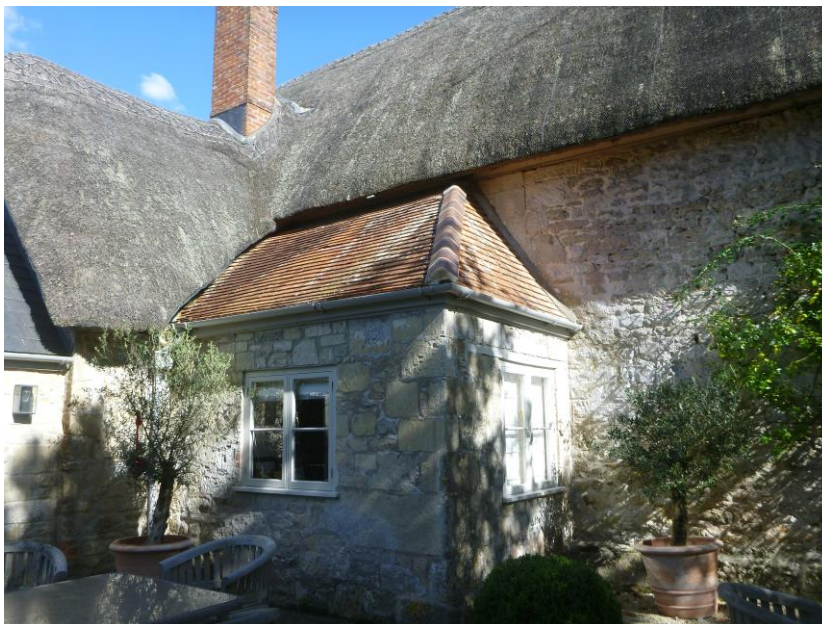
The other extension that will be affected by these proposals has a clay tile roof which is also tightly sealed. None of the roof tiles were noted to be lifted, slipped, damaged or missing and the ridge tiles at the roof hip are also well sealed with the mortar noted to be in a good state of repair. There were no crevices at the eaves in this area of the property.

**Fig 5:** The other extension has a clay tile roof.

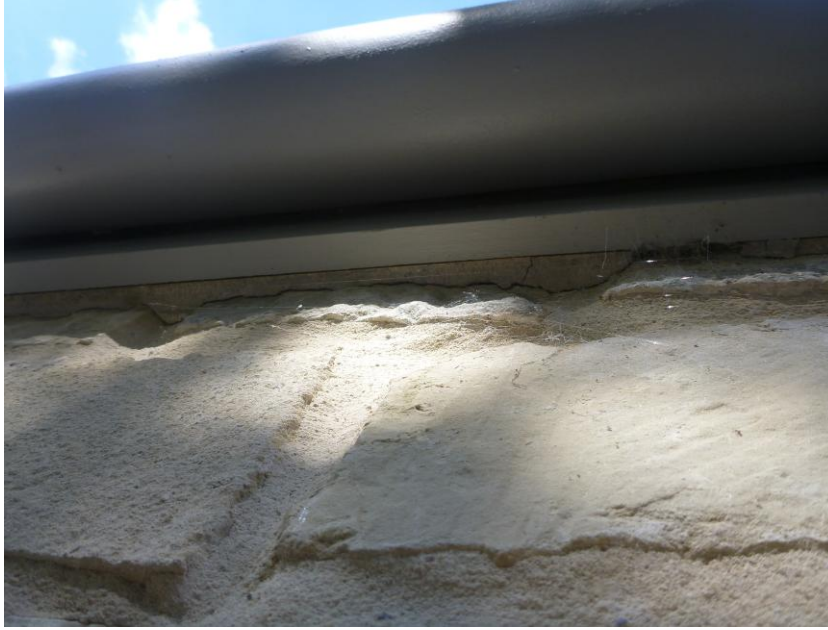
**Fig 6:** The eaves of the smaller extension are well sealed.

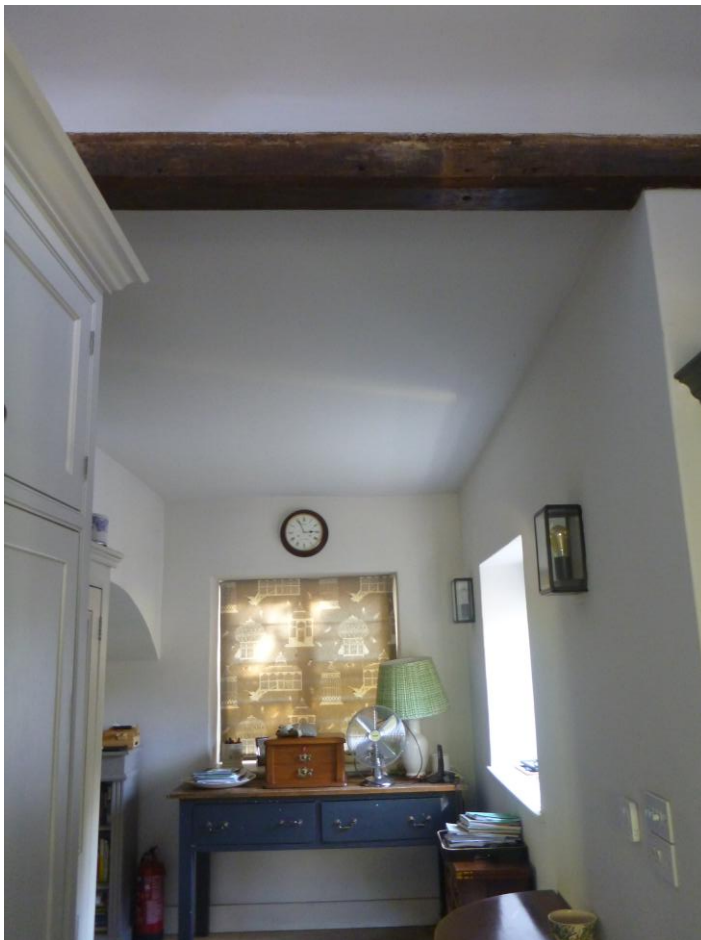
In this area of the property there is a separate loft space but there is no access to it, it is entirely self-enclosed.

**Fig 7:** There is an inaccessible loft space above the smaller extension that will be affected by the new extension proposals for Stop Farm.
