MELKSHAM COMMUNITY HOSPITAL

COMBINED GEO-ENVIRONMENTAL & GEOTECHNICAL  
GROUND INVESTIGATION REPORT (GIR)

NHS Property Services

C13010-GIR

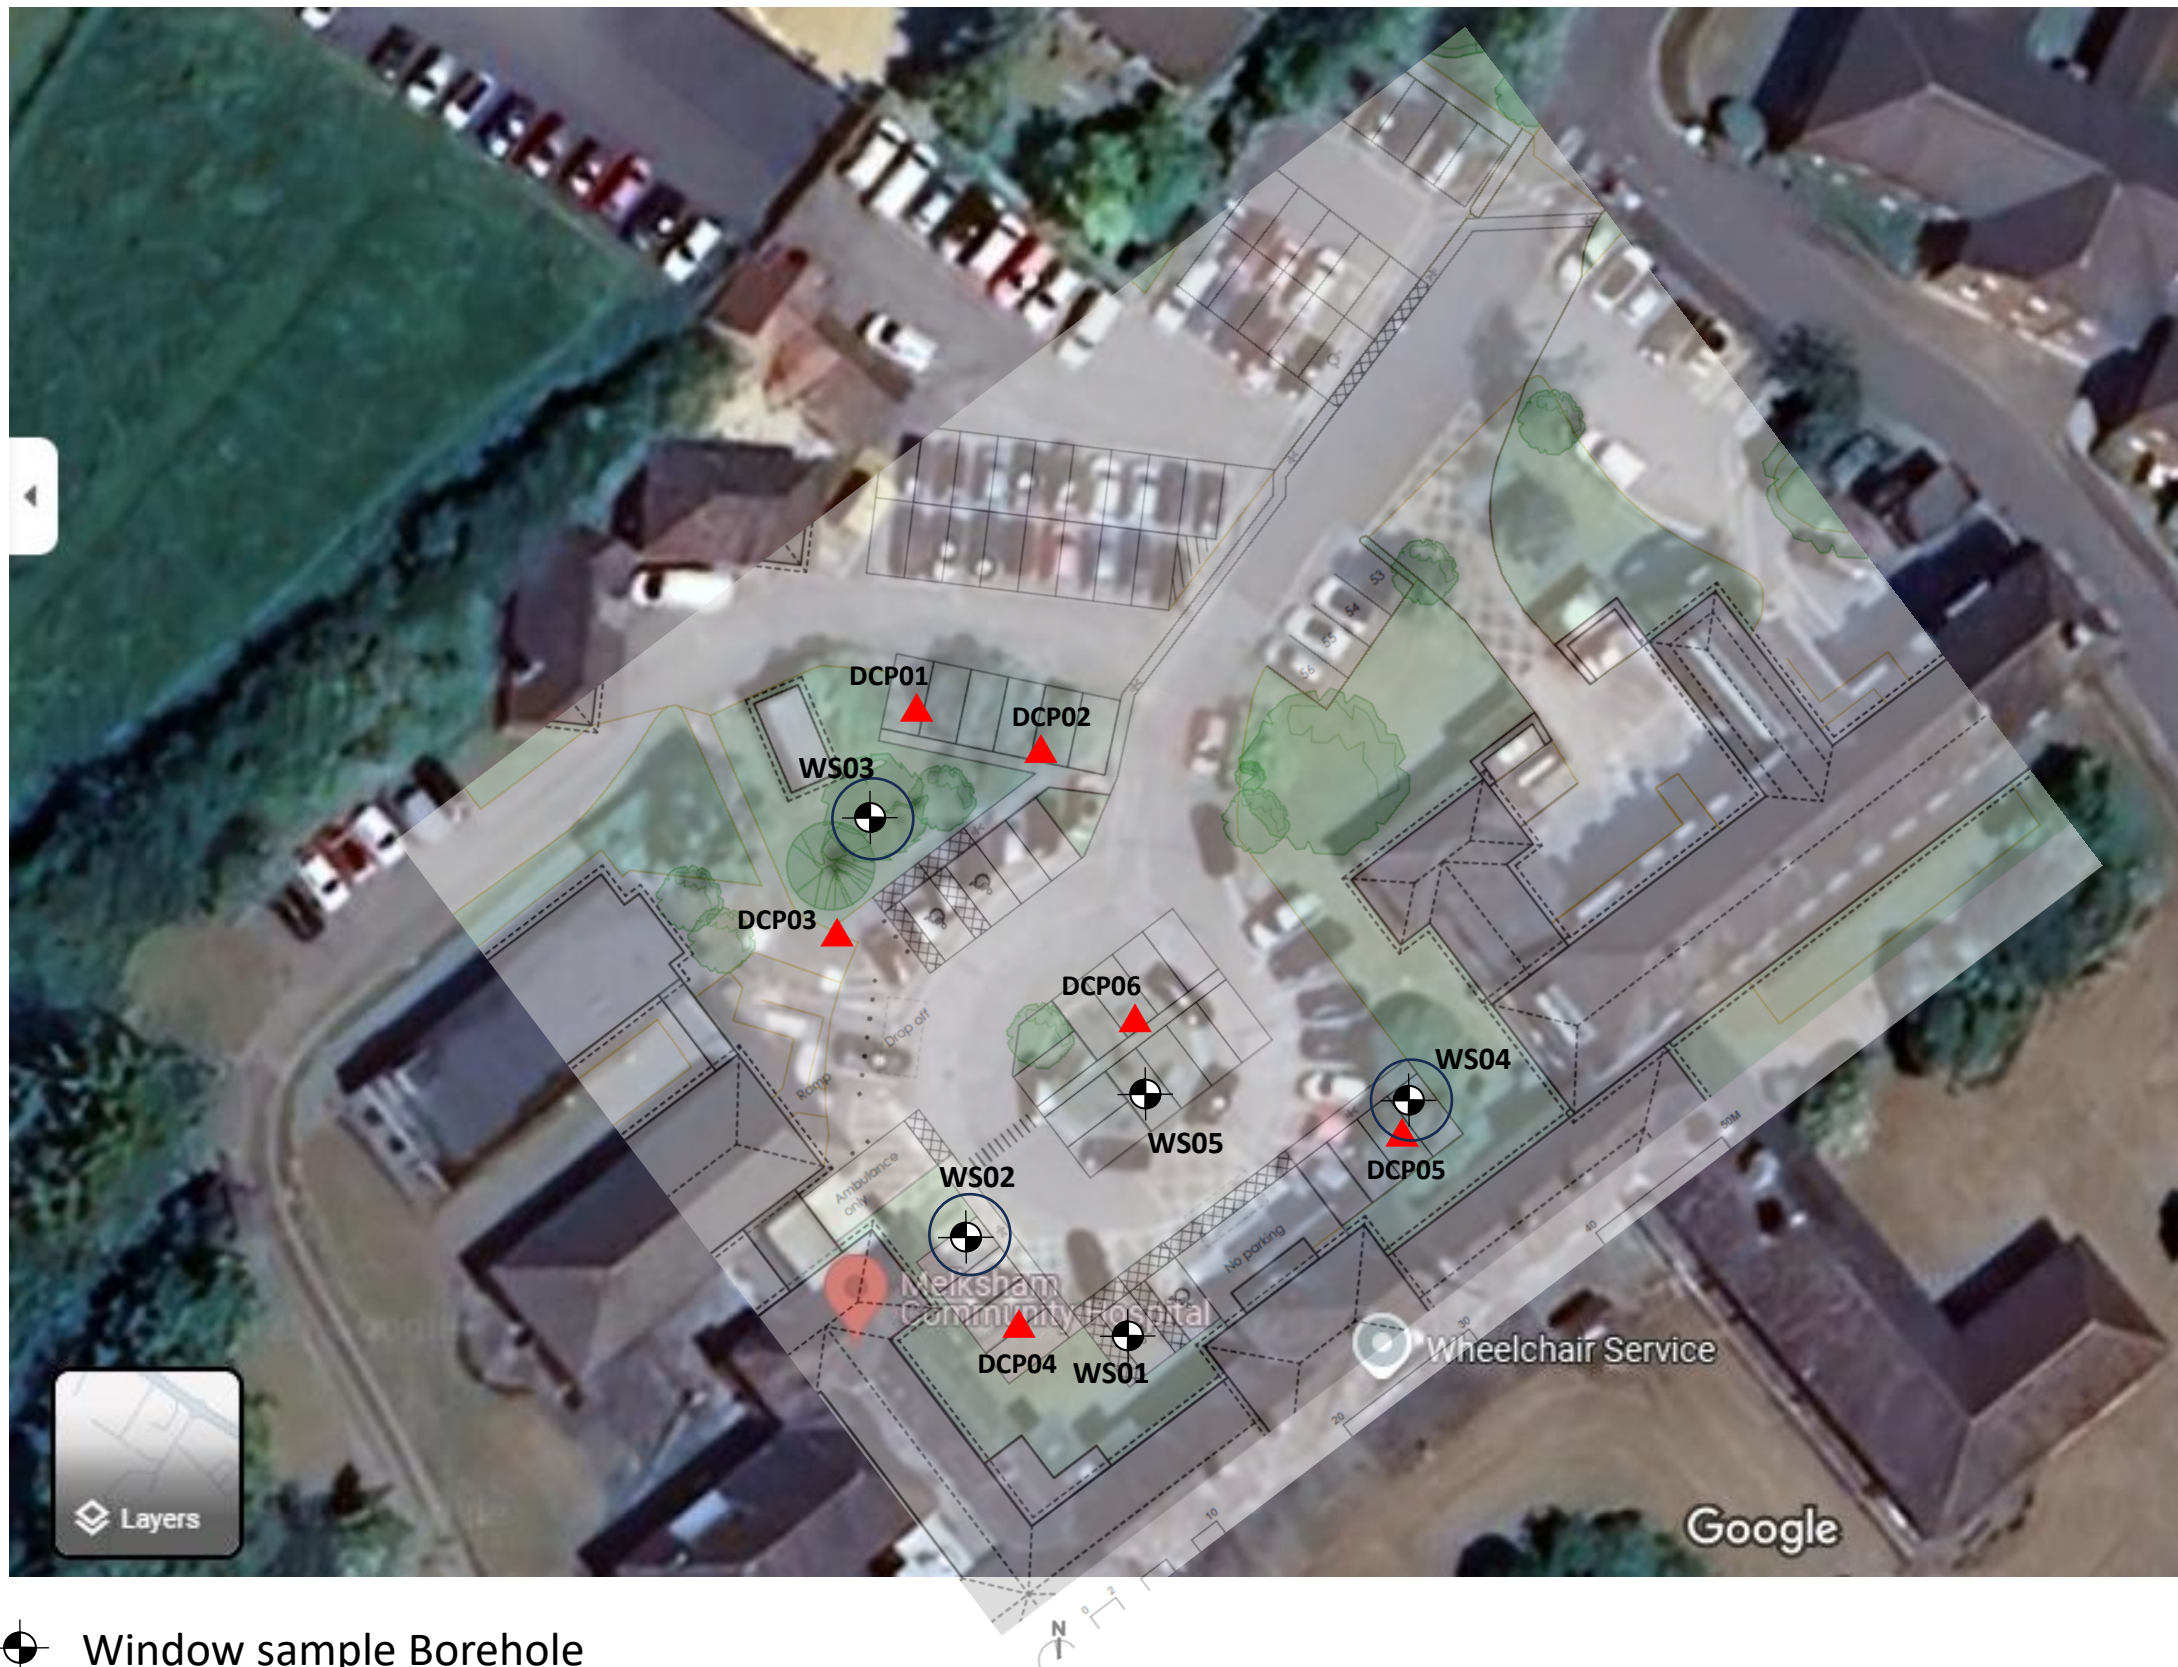
## Appendix A. EXPLORATORY HOLE LOCATION PLAN

The locations of the exploratory holes are shown on the Exploratory Hole Location Plan, enclosed as Appendix A.

The development proposals comprise redeveloping the roundabout outside the entrance, creating more car parking spaces. This will involve replacing the center of the roundabout with parking spaces, and modifying the existing parking layout, increasing space. An outline of the proposals is shown on the exploratory hole location plan, enclosed in Appendix A.
