PRELIMINARY ECOLOGICAL APPRAISAL

FIELD HOUSE, CLYFFE PYPARD, WILTSHIRE

stark ecology<sup>ltd</sup>

NOVEMBER 2025

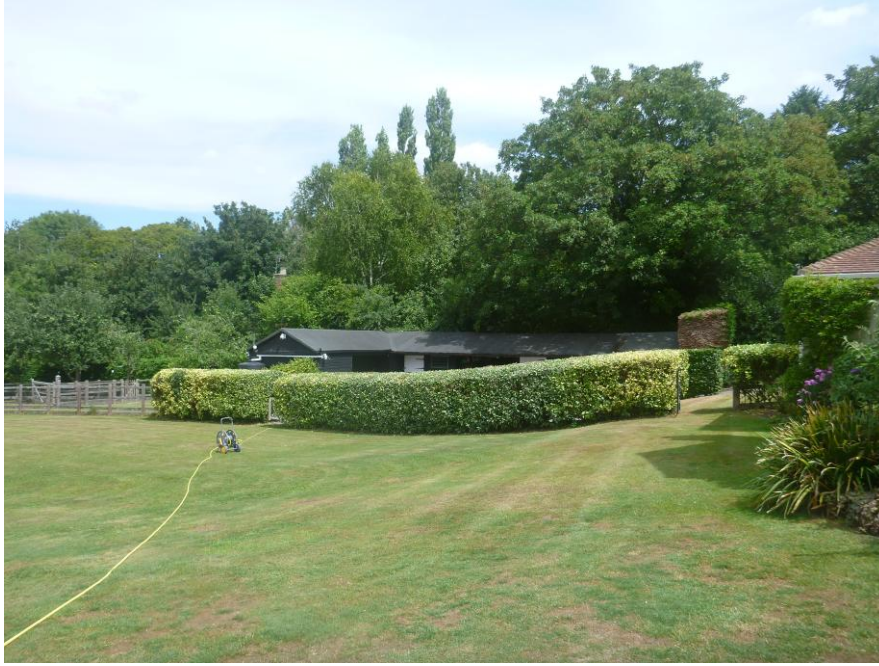
Field House will be extended onto an area of the garden that is tightly mown amenity lawn.

**Fig 2:** Field House will be extended onto an area of close-mown amenity lawn.

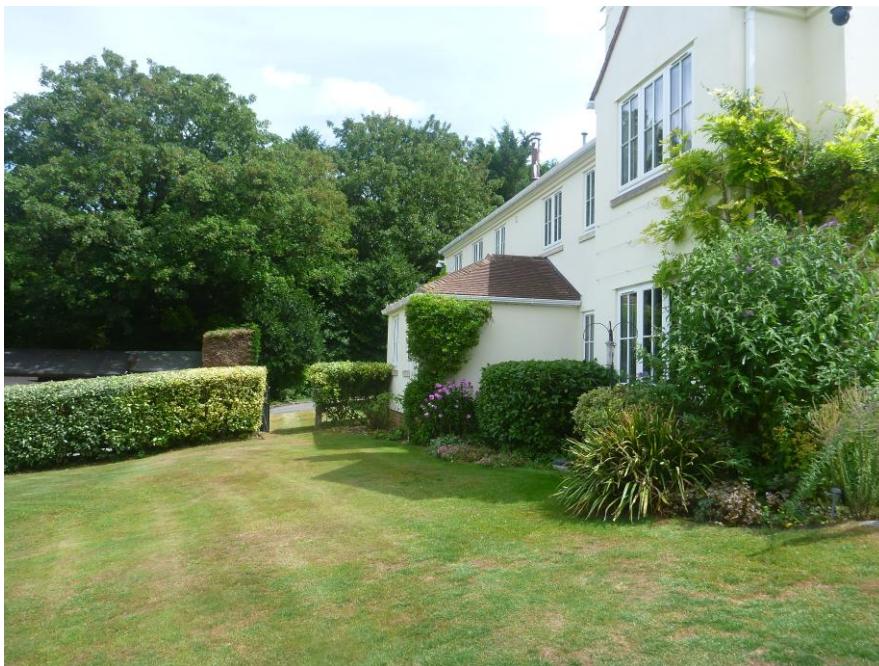
There are areas of introduced amenity shrubs which surround the house and some will need to be removed to make way for the new extension.

**Fig 3:** Small areas of introduced shrubs will be removed when the property is extended.

The base of amenity shrubs are suitable for reptiles to use over the winter hibernation period. Where any shrub removal is required, clearance of the roots of the vegetation must be carried out outside the winter hibernation period in order to avoid harm or disturbance. These areas of habitat are also suitable for hedgehogs to use for shelter over the winter months and so steps taken to protect reptiles will also protect hedgehogs from harm.

The amenity shrubs are suitable for use by nesting birds so, given the protection afforded to all breeding birds, their nests, eggs and young it is strongly recommended that any removal of, or disturbance to, vegetation that offers potential nesting habitat for breeding birds, should be undertaken between October and February, inclusive, outside of the main bird breeding season (as noted above, the roots should be removed outside the hibernation period).

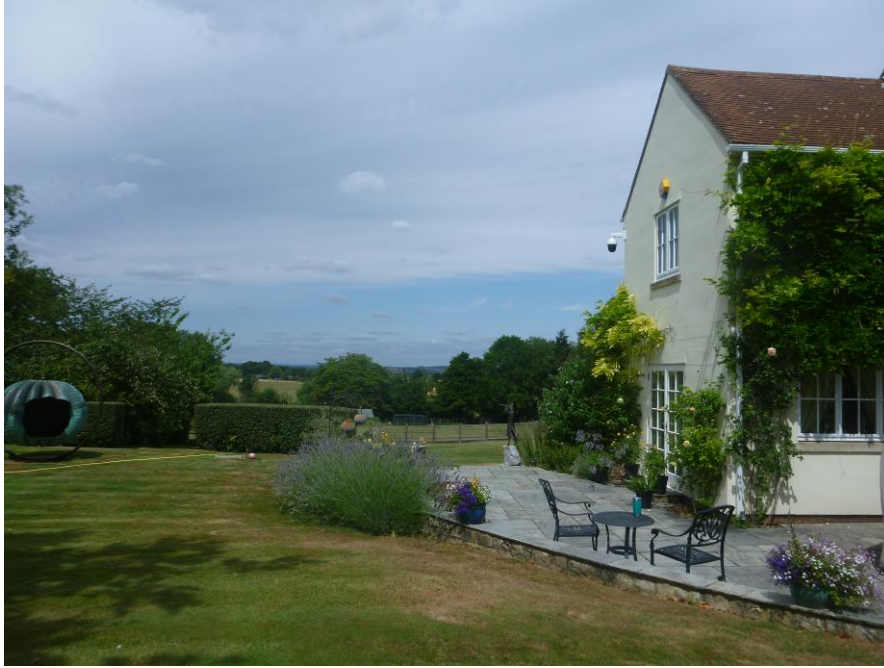
The extension will also affect an area of patio to the west of the house.

**Fig 4:** An area of patio to the west of the house will be affected by the extension.

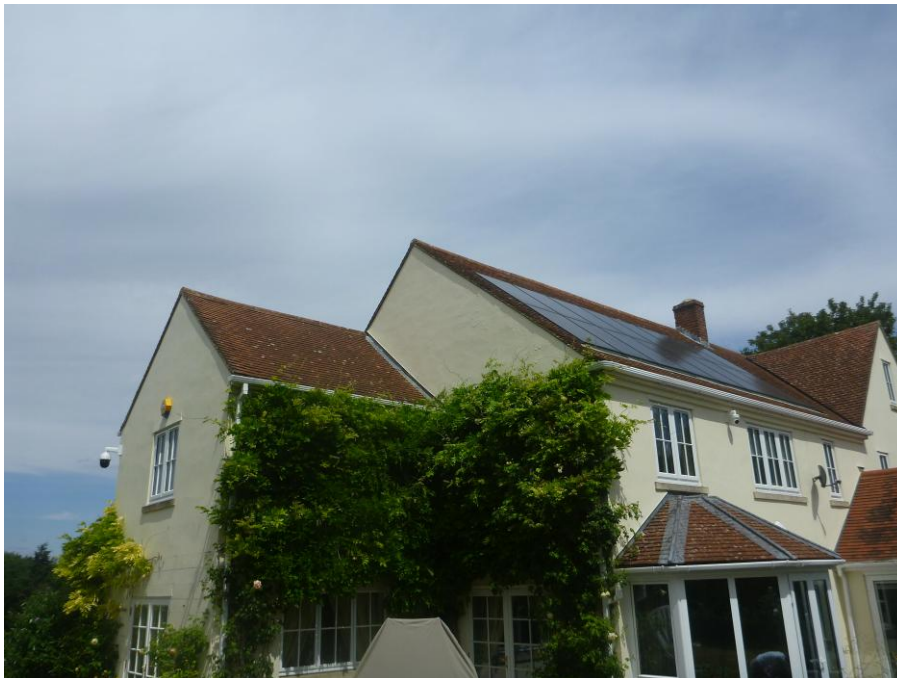
Field House is a rendered two-storey block building which has a clay tile roof. The roof tiles are all tight fitting with none noted to be lifted, slipped, damaged or missing in any area of the property. The ridge is also well sealed in all areas with no missing mortar, cracks, crevices or other gaps noted. The mortar at the roof verges is also in good condition with no gaps identified.

**Fig 5:** The roof and walls of Field House support no gaps or crevices.

- Roof and ridge tiles are tight fitting with no lifts, missing mortar or other areas which could provide shelter for roosting bats.
- The walls of the house are rendered and there are no crevices in the render which could provide access for bats to cavities or crevices.

Field House is considered to have Negligible potential to support roosting bats. The roof materials are tight fitting in all areas and the walls and other areas of the property are similarly well sealed. No potential access points to roost features were noted and when inspected internally no evidence of bats was found in any part of the loft space.

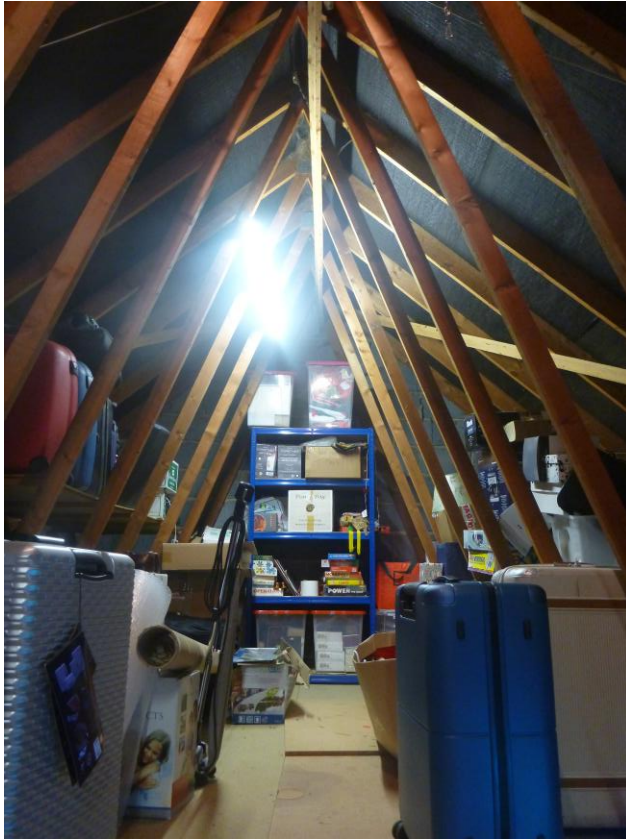
The roof of the house is lined with bitumen felt and the loft space, which is boarded in most areas, is insulated with fibreglass material. The loft space is used for storage and is accessed regularly.

**Fig 6:** The loft space of Field House is boarded and used for storage. The roof is lined with bitumen roofing felt.

Internally no evidence of bats was found in the loft space of the house, including on the floor, wall, roof timbers or stored items.

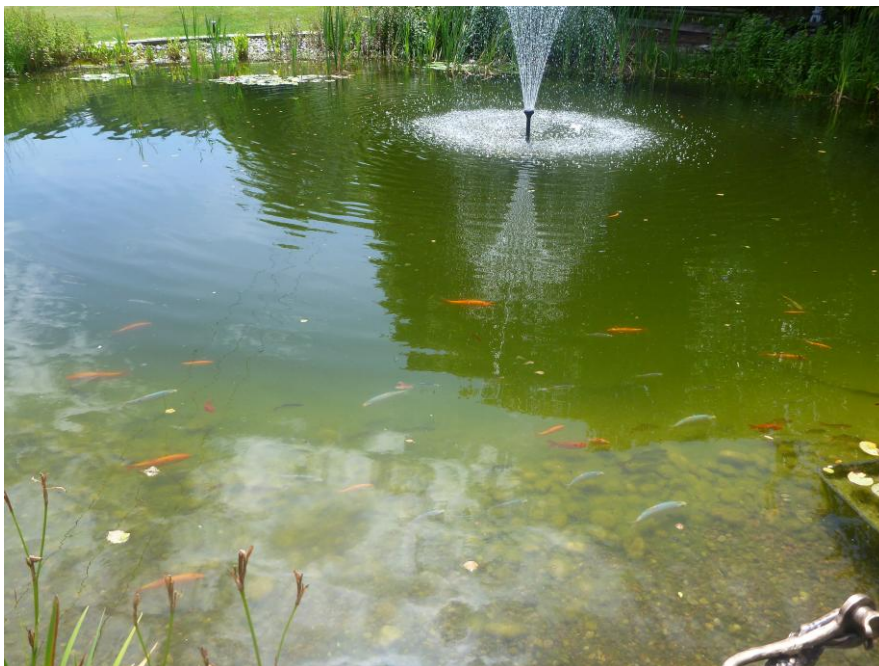
There is a network of ponds in the landscape surrounding Field House, including a fishpond in the northwest corner of the garden (c.80m from the proposed extension). Great crested newts *Triturus cristata* are known to be present in the landscape surrounding Clyffe Pypard but the fishpond in the garden of the property is considered unlikely to support them as it has quite a large fish population and supports limited aquatic vegetation.

**Fig 7:** The fishpond in the garden of Field House.
