## Bat Emergence and Re-Entry Surveys (BERS)

Land at Spin Hill, Market Lavington, Devizes, Wiltshire SN10 4NS

14<sup>th</sup> August 2025

Use of land for the stationing of caravans for residential use and the laying of hardstanding and erection of a dayroom ancillary to that use.

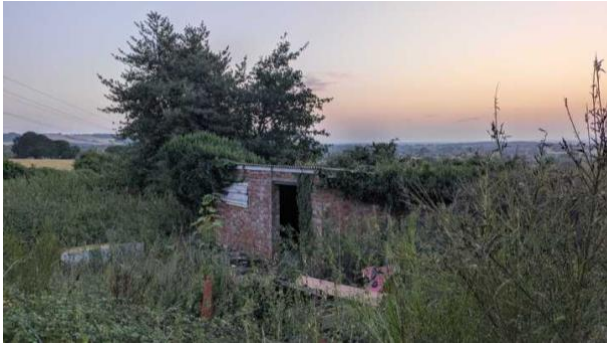
| Surveyor 1 | <p><b>No Emergences or re-entries observed</b></p> <p>Summary of general activity:<br/>The first bat activity was a soprano pipistrelle heard not seen (HNS) at 22:00. Intermittent common pipistrelle (CP) activity was observed from 22:13 until the end of the survey (22:54) with constant activity was observed from 22:39-39. Main CP commuting lines included north to south and southeast to northwest. A serotine was seen commuting from south-east to northwest at 22:50 along the treeline to the west of B1.</p> | <p>Full elevation photo showing surveyors view.</p> |

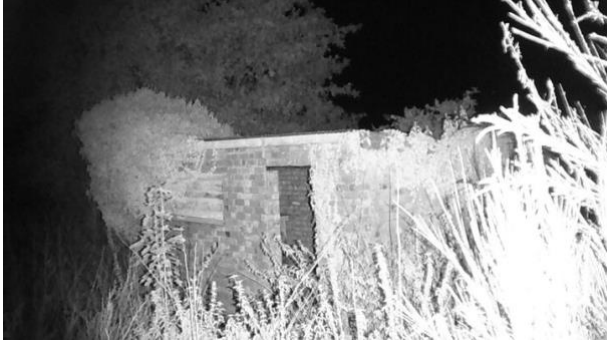
| IR position 1 | <p>Camera position: observing Western elevation of B1<br/>Emergences observed: N</p> <p>No emergences were observed and the footage was in line with the observations of surveyor 1 with no additional activity.</p> | <p>Screenshot of darkest part of survey.</p> |

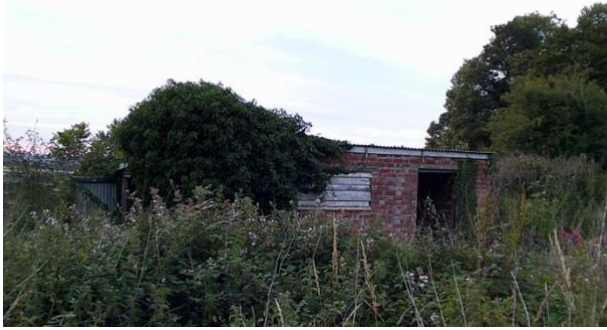
| Surveyor 2 | <p><b>No Emergences or re-entries observed</b></p> <p>Summary of general activity:<br/>The first bat activity was two faint noctule calls HNS at 21:53 and 21:55. A soprano pipistrelle was HNS infrequently between 22:01 until 22:18 and a further call was recorded at 22:45. A common pipistrelle was seen commuting southwest to northeast at 22:31, northeast to southwest at 22:32 and northeast to southwest at 22:51. A serotine was HNS at 22:36, 22:37 and 22:48. Serotine commuting behaviour was observed at 22:50 and 22:51 flying southeast to northwest and southwest to north. The last bat activity was a faint noctule call at 22:52.</p> | <p>Full elevation photo showing surveyors view.</p> |

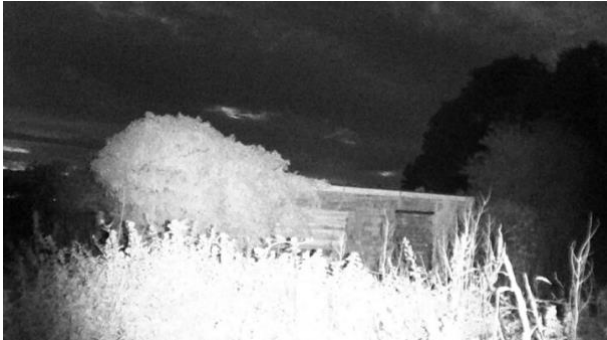
| <i>IR position 2</i> | <p>Camera position: observing Southeastern elevation of B1</p> <p>Emergences observed: N</p> <p>No emergences were observed and the footage was in line with the observations of surveyor 1 with no additional activity.</p> | <p>Screenshot of darkest part of survey.</p> |

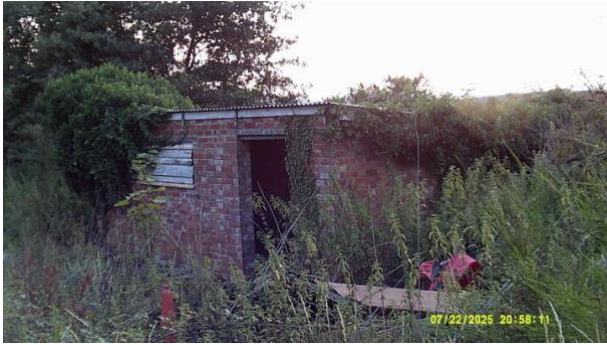
| <p><i>Surveyor 1</i></p> | <p><b>No Emergences or re-entries observed</b></p> <p>Summary of general activity:<br/>The first bat activity recorded was a distantly commuting from west to east over the cropland to the north of B1. Serotine commuting and foraging behaviour was observed throughout the survey with lines including east to west along the southern elevation, northeast to southwest diagonally over B1 with a foraging stint in the vegetation to the east of B1 at 22:17. At 21:53 a common pipistrelle was observed foraging to the fore of B1 flying east to west, this same behaviour was observed again at 21:58. Further intermittent common pipistrelle HNS activity was recorded until the end of the survey (22:39)</p> | <p>Full elevation photo showing surveyors view.</p> |

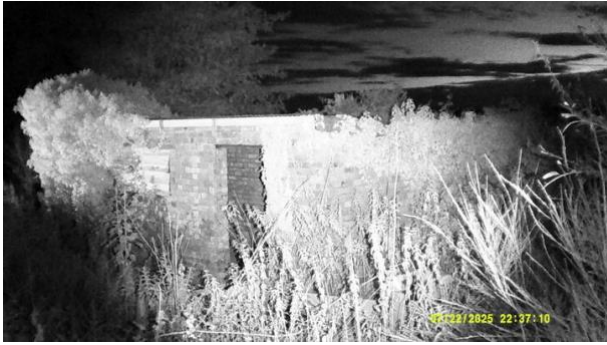
| <p><i>IR position 1</i></p> | <p>Camera position: observing Western elevation of B1<br/>Emergences observed: N</p> <p>No emergences were observed and the footage was in line with the observations of surveyor 1 with no additional activity.</p> | <p>Screenshot of darkest part of survey.</p> |

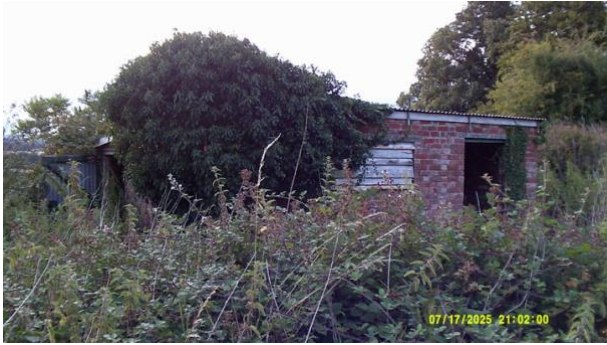
| <p><i>Surveyor 2</i></p> | <p><b>No Emergences or re-entries observed</b></p> <p>Summary of general activity:<br/>First bat activities were noctule calls, heard not seen, at 21:23 up to 21:36. At 21:49 an unidentified bat flew north from the south. Shortly after, a common pipistrelle was seen flying east from the west across the southern elevation. More common pipistrelles were then heard not seen between 22:07 and 22:13. At 22:15 a soprano pipistrelle flew east to west over the roof. A serotine was heard at 22:17 then seen flying north to south to grouping of trees. Serotines were then continuously heard but not seen from 22:20 to 22:35 where two were then seen flying north to south over the building. At 22:36 a common pipistrelle was heard not seen then finally a serotine was heard not seen at 22:37.</p> | <p>Full elevation photo showing surveyors view.</p> |

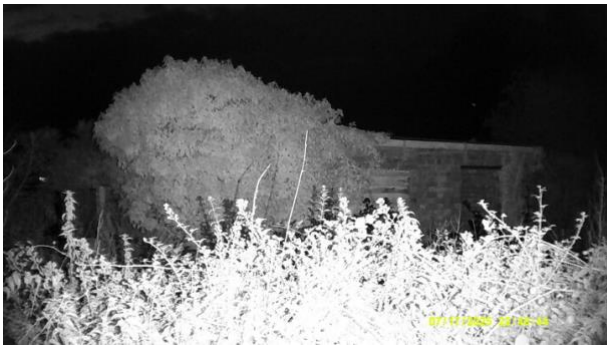
| <p><i>IR position 2</i></p> | <p>Camera position: observing Southeastern elevation of B1<br/>Emergences observed: N</p> <p>No emergences were observed and the footage was in line with the observations of surveyor 1 with no additional activity.</p> | <p>Screenshot of darkest part of survey.</p> |

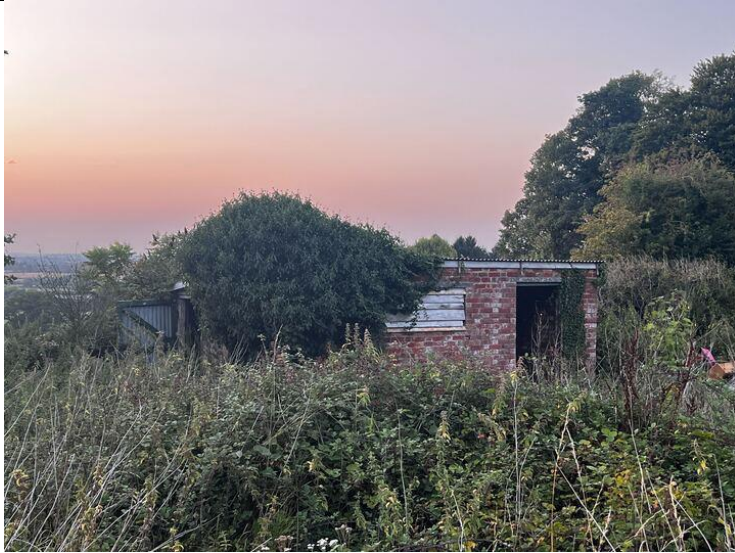
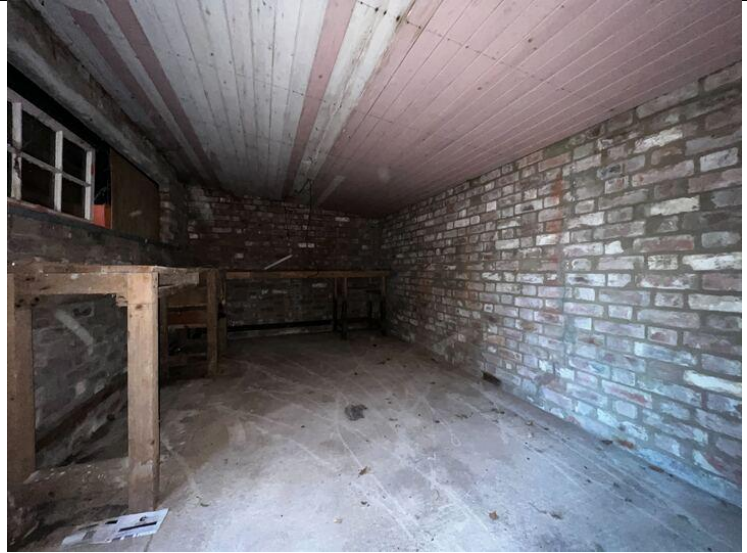
| Field Survey | | |
|---|---|---|
| | B1&B2 external: No evidence found | B1 internal: No evidence found |

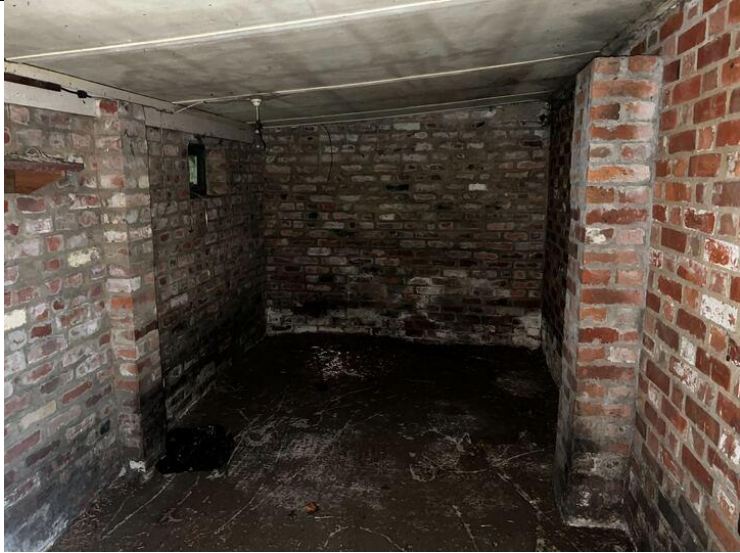
| | B2 internal: No evidence found | | | | |

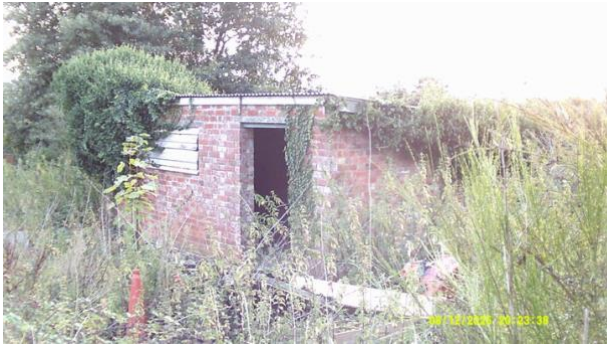
| Results | | |
|---|---|---|
| Surveyor 1 | <p><b>No Emergences or re-entries observed</b></p> <p>Summary of general activity:<br/>The first bat activity recorded was a serotine HNS at 21:31. At 21:33 a soprano pipistrelle was HNS. Two occurrences of myotis species HNS behaviour were recorded at 21:34 and 21:39. The final bat activity recorded was a noctule and a serotine call which was HNS.</p> | <p>Full elevation photo showing surveyors view.</p> |

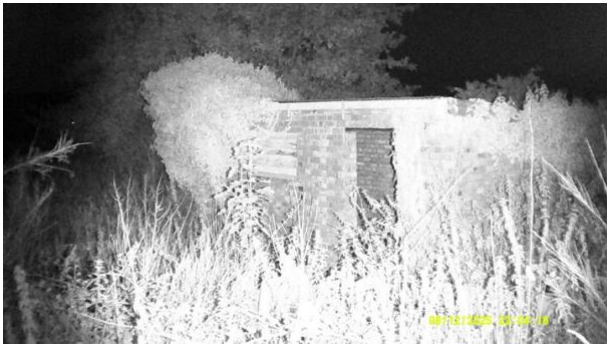
| Results | | |
|---|---|---|
| IR position 1 | <p>Camera position: observing Western elevation of B1<br/>Emergences observed: N</p> <p>No emergences were observed and the footage was in line with the observations of surveyor 1 with no additional activity.</p> | <p>Screenshot of darkest part of survey.</p> |

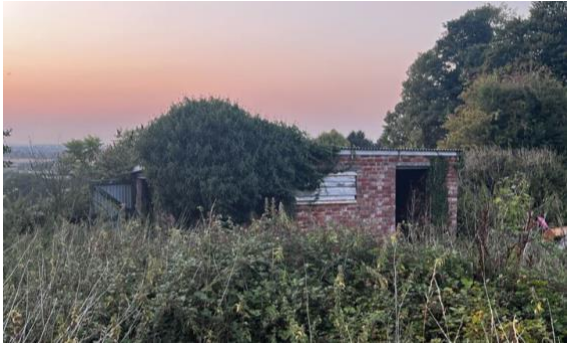
| <p><i>Surveyor 2</i></p> | <p><b>No Emergences or re-entries observed</b></p> <p>Summary of general activity:<br/>The first bat activity was recorded at 21:12, comprised of a distant noctule foraging far behind the site in the north-western distance. A soprano pipistrelle was then heard not seen at 21:31, following which frequent foraging, commuting and social calls were heard and seen until 21:40, utilising the south of the site and eastern tree lines. Several myotis sp. were also seen throughout this time, commuting south to north. Finally, a noctule and serotine were both heard not seen at 21:54 and 22:03.</p> | <p>Full elevation photo showing surveyors view.</p> |

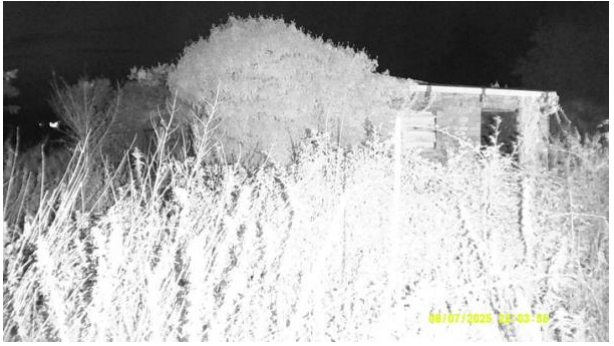
| <p><i>IR position 2</i></p> | <p>Camera position: observing Southeastern elevation of B1<br/>Emergences observed: N</p> <p>No emergences were observed and the footage was in line with the observations of surveyor 1 with no additional activity.</p> | <p>Screenshot of darkest part of survey.</p> |
