## Design, Access and Heritage Statement

**Listed Building Consent - December 2025**

Tisbury Hub, Place Farm Courtyard, Court Street, Tisbury, Salisbury, Wiltshire. SP3 6LW

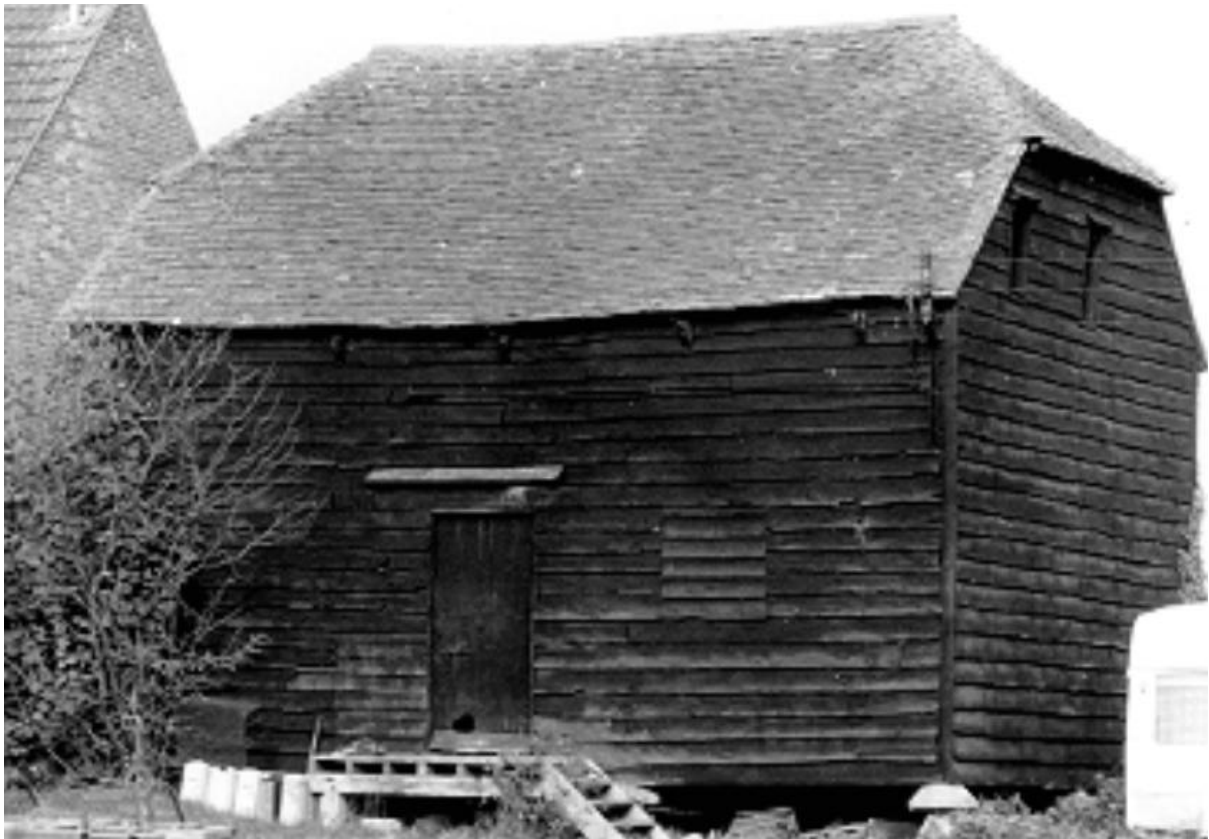
*Figure 3 - East elevation from National Trust Vernacular Building Survey 2000*

*The weatherboarded structure was originally lined internally by horizontal flush boarding as were the grain bins. Some of the boarding remains, although most to the walls of the structure has been replaced by metal sheeting. There were openings towards the top of the transverse walls; 1 to the N elevation, and 2 to the south. There is a blocked window opening at ground floor level of the W wall, probably not an original opening.*

*Originally grain bins were positioned against the N and S walls of each floor, with a central corridor giving access, and storage space. The central area on the first floor retains large wooden brackets on which equipment was once stored. The grain partitions remain on the first floor and to the N side at ground floor level. A small wooden shutter in the E wall indicates the original means of external ground floor openings.*

The condition at this time is described as poor.

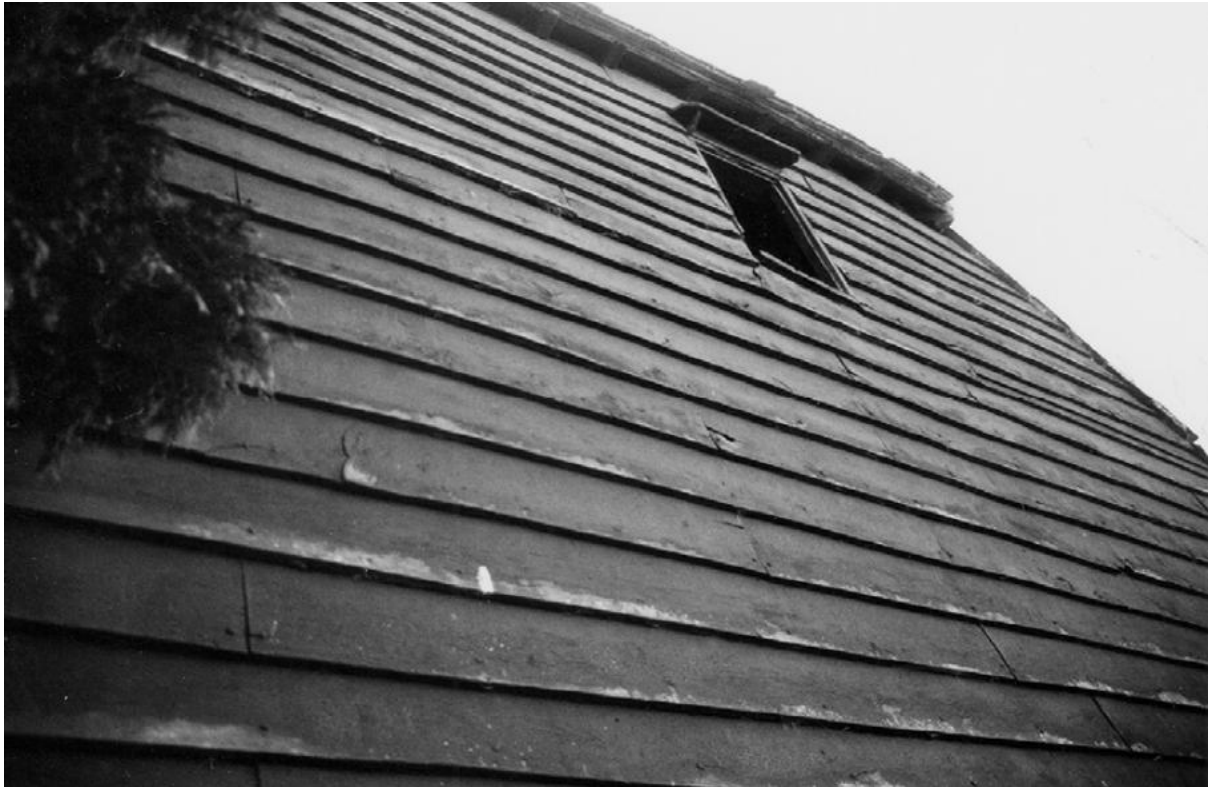
*Figure 4 - South Elevation timber boarding from Vernacular Building Survey 2000*

The survey describes the weatherboarding as “much repaired”. On this photograph of the south elevation, the timber looks quite regular, and likely to be modern replacements:

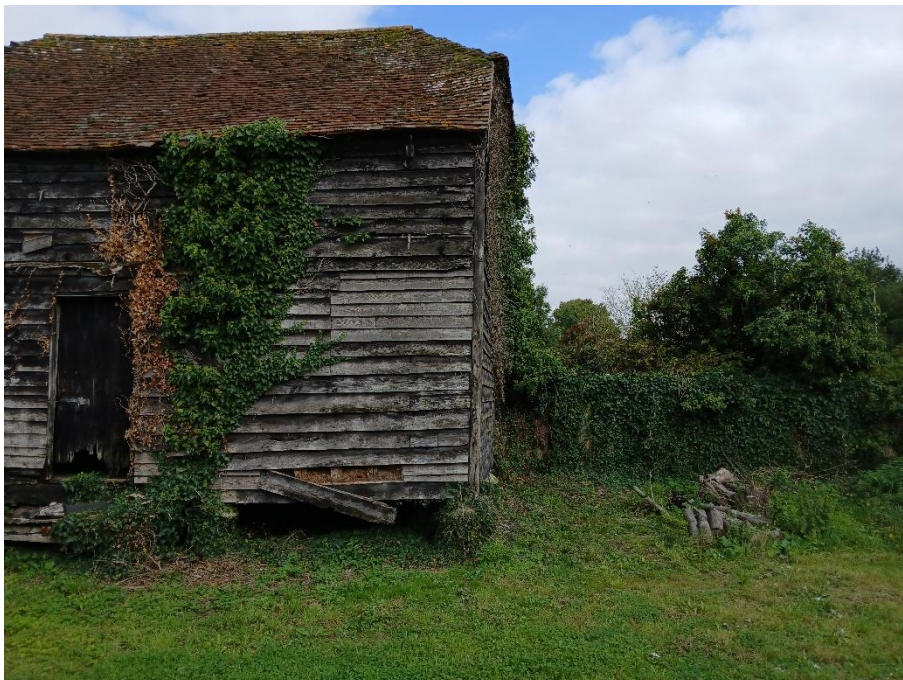
*Figure 5 - Small granary*

The small granary is in a poor condition. The roof tiles are coming loose, with verge tiles missing and other tiles slipping.

Due to the poor condition of the small granary, it is considered that removing the failed roof coverings and assessing the condition from above would be more effective than trying to support the building to allow further assessment.

Scaffolding will be erected around the building, providing temporary support if necessary. The roof coverings will then be removed and stored in the neighbouring barns for re-use.

At this stage it will be possible to carry out further assessment from above. If the structure allows, it would be expected that the cladding timbers are removed starting at the top, to allow continued timber assessment. If necessary, further dismantling of the structure may be necessary to allow safe access.

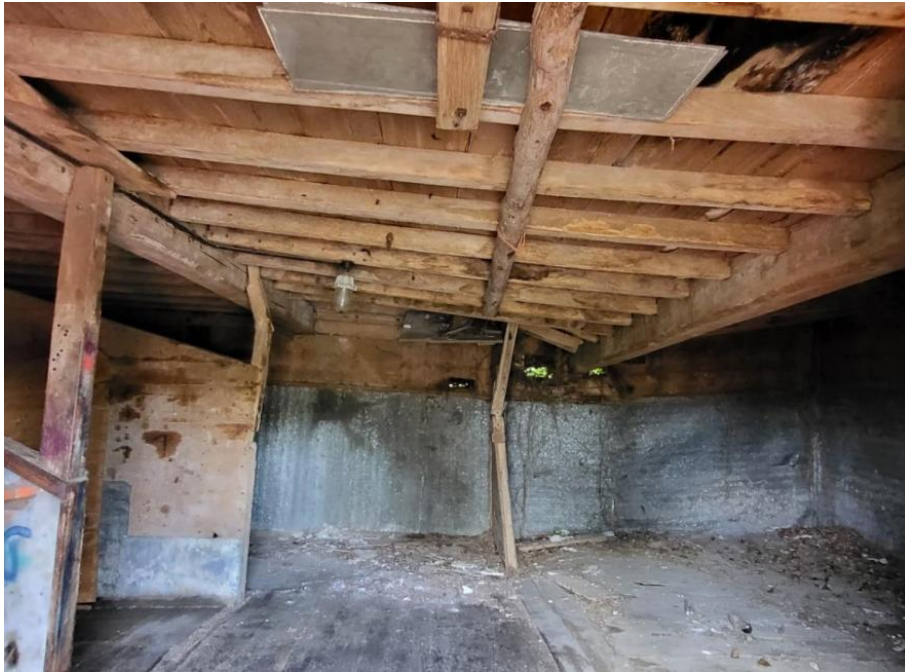
*Figure 6 - Failed beam in small granary*

The main beam of the first floor has failed and is no longer supported:

This means that it is not safe to enter the building so further assessment of the structure is not possible.

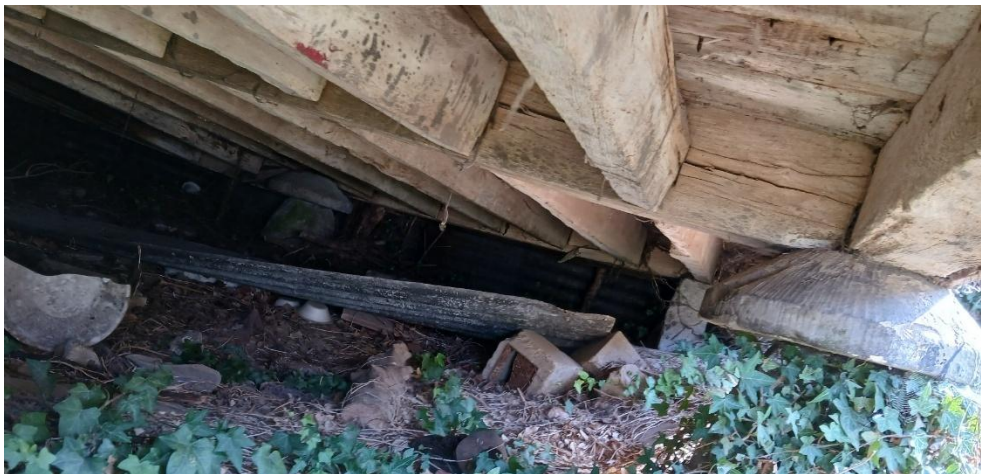
*Figure 7 - Failed timber base structure*

There is also failure visible to the base structure, with a failed beam no longer sitting on the saddle stone.
