# ***Gasper Farmhouse, Stourton with Gasper***

**Bat & Bird Scoping Report**

**Date: November 2025**

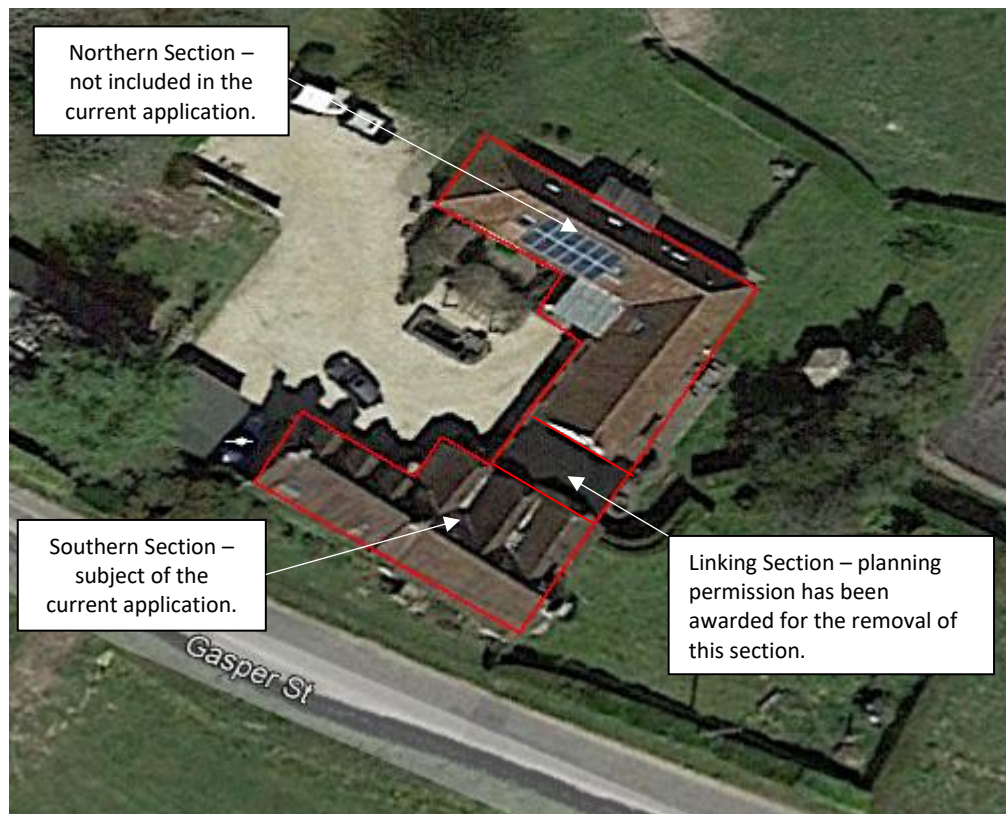
**Figure 3: Building Layout (Google Earth, 2021)**

The Site layout is presented below in Figure 3. farmhouse comprised three sections: Section 1, Section 2 and the Linking Section (Figure 2).

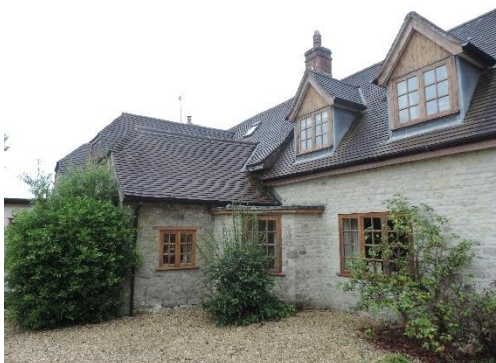
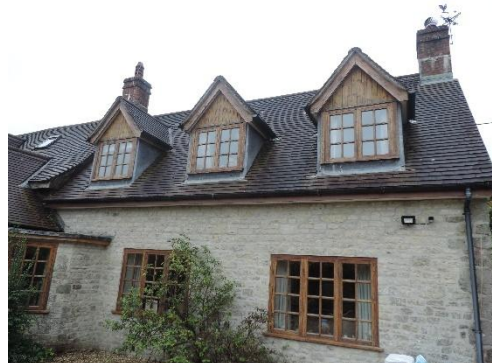
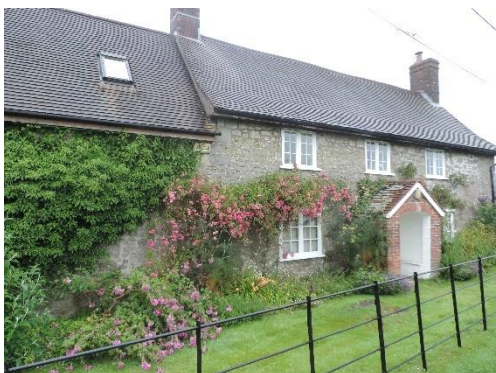
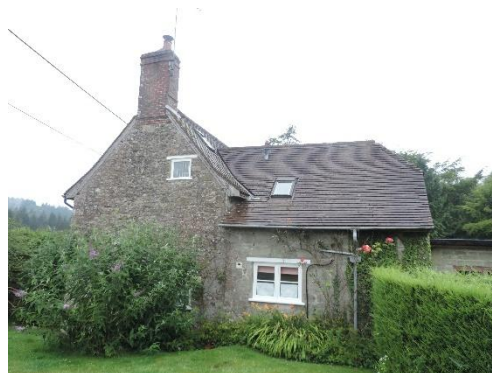
The Southern Section included two-stories with exposed stone walls (Plates 1 – 4). Intact doors and windows were present throughout. Climbing plants were affixed to the southern aspect. Intact wooden soffit boxes were flush with the wall tops. The roof included pitched and hipped sections both of which were clad in clay tiles. Dormer windows were present on the northern aspect. A small number of broken tiles were noted on the southern and northern aspects; however, these did not lead to any gaps beneath the tiles. Moreover, no works to the roof are proposed. A small (1.9 m tall), flat-roofed boiler room was present. The walls were constructed from exposed stone and were in a good condition.

Overall, Gasper Farmhouse was assessed as having Negligible BRP. The property lacked external potential roost features or access points to the property's interior. No historical signs of bats were recorded from the loft void.

The Southern Section of Gasper Farmhouse was assessed as having Negligible Bat Roost Potential. The property lacked external roost locations and access to the property's interior. No historical signs of bat activity were recorded in the loft void. As such, the proposed works will not adversely affect roosting bats and, as the works will be restricted to the existing footprint and its immediate surrounds, there is no risk of habitat fragmentation. Bat roosts can be highly transient, moving location both within and between years. If no works have been undertaken within two years of this report, a resurvey is recommended. In the highly unlikely event that a bat is discovered, all works will stop and a bat ecologist will be contacted.

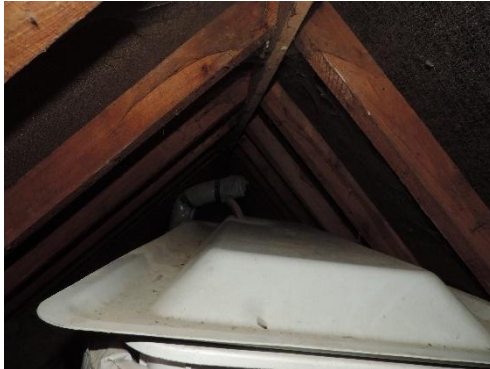
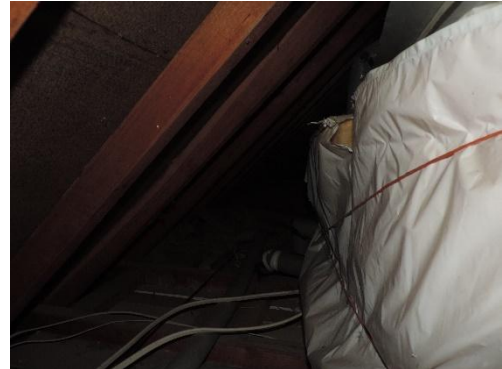
The property included a small (5 m x 2 m x 1 m) loft void (Plates 5 & 6). The roof was lined with bitumen felt and supported by a sealed wooden frame. The roof was coated in a dense layer of cobwebs. A water tank filled much of the loft void. No historical signs of bats were recorded.
