**Nos 22-24 Market Place  
WARMINSTER  
Wiltshire**

**Heritage Statement**

**Report reference: MH3921-2v3**

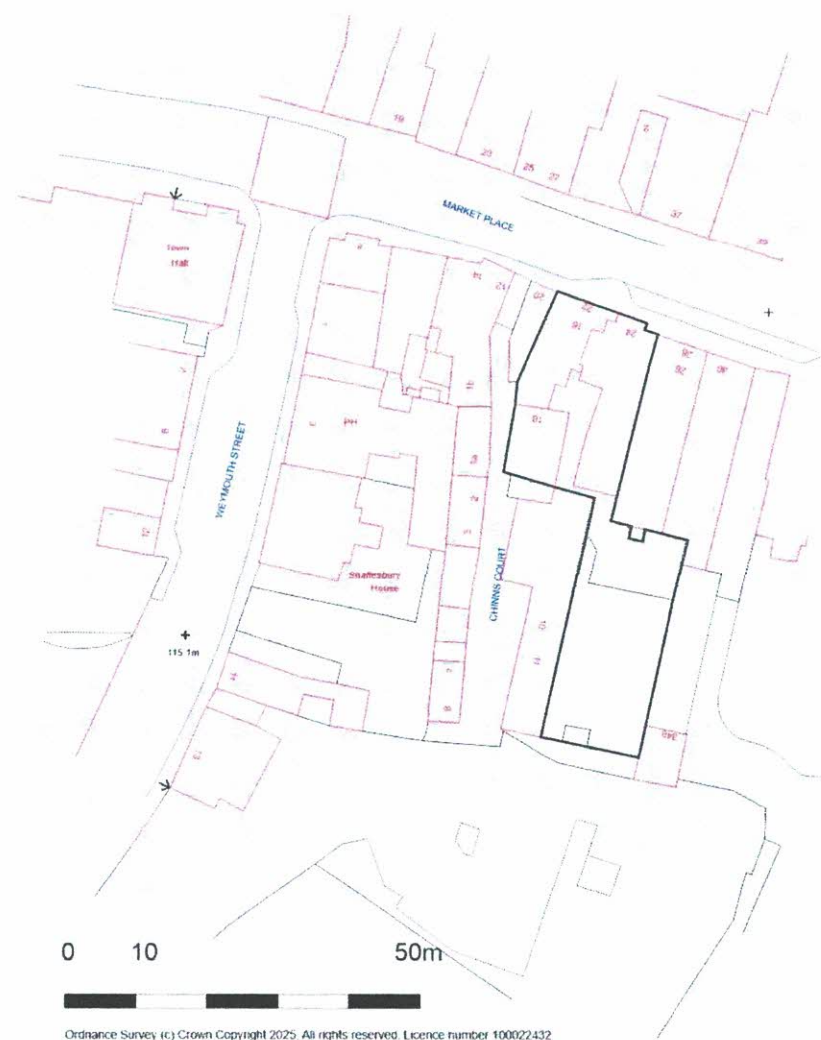
Figure 1

- 2.1.1 Nos 22 and 24 are two partially conjoined buildings on the south side of The Market Place in Warminster, close to its junction with Weymouth Street, centred on NGR 387478 / 145052. They are linear, multi-cell buildings of slightly irregular alignment that extend from The Market Place southwards to the Chinns Court public car park.
- 2.1.2 The applicants seek consent for demolition of the southernmost ground floor cell of No 24 and reinstatement of the shopfronts of Nos 22 and 24 to their historically separate forms.
- 2.1.3 The locality and layout of the buildings and details of the affected parts are presented in the architect's drawings and written planning statements, to which this report is appended.

Site

Analysis

- 2.3.4 The buildings and their plot boundaries at the west end of the south side of Market Place were reconfigured in c. 1836<sup>11</sup> when Weymouth Street was created<sup>12</sup>. Comparison of cadastral surveys of 1783 and 1838 (Figure 1) reveals that plots along the west and east sides of the newly created street were regularised, the former Town Hall (Plot 793 in 1838) and Literary Institute (Plot 784) constructed over the footprints of pre-existing buildings and the Market Place frontages moved forward and therefore re-built. The outlines of Nos 22 and 24 appear to have remained essentially unaltered, but ancillary buildings at the rear of No 24 were demolished, others built and the Market Place frontages of Nos 20-24 re-faced.

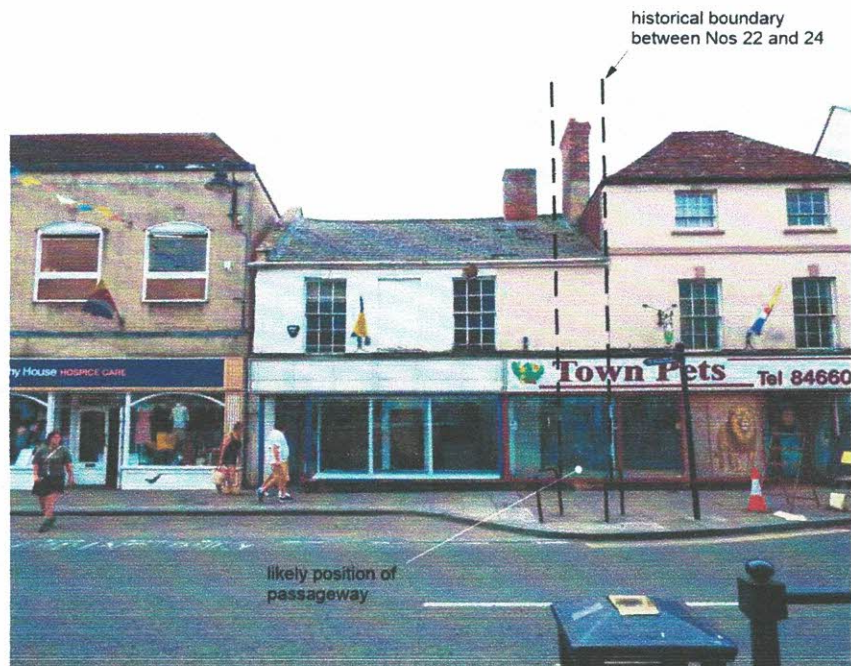
- 3.2.1 The present shopfronts of Nos 22 and 24 are of a single unified design that extends across the whole front of the two buildings without a break. It is of simple design comprising slender, machine-turned softwood spindles of baluster type with plain heads and bases, between plain base and top rails and with a plain fascia above. Multiple scarf joints in the rails indicate multiple repairs. The framework supports large sheets of thick float glass and rests on dwarf walls of fletton bricks bonded in OPC mortar.

- 3.2.2 The display spaces behind the shopfronts are of similar, plain form and late 20<sup>th</sup> century materials, principally plasterboard. The two display spaces are separated by plasterboard partitions that dog-leg to the west around the bases of chimney stacks, to align with a passageway that leads through the retail space of No. 22 to the courtyard between the two buildings. Dismantling of the display space of No. 22 for utilities works has revealed the base of an earlier party wall of two skins of Bath stone blocks in an ash-lime mortar, aligned on the first floor boundary between Nos 22 and 24 evident in the front elevation.

North elevations of Nos 22 and 24

- 4.2.1 Reinstatement of the shopfronts of Nos 22 and 24 as two separate entities, each of similar design to the present and separated by a clear division related to the historical boundary between them, would enhance the aesthetic and historical significance of No 22 and 24 and the conservation area in general, without affecting any archaeologically significant fabric. This would cause no harm to the significance of Nos 22 and 24, neighbouring Listed Buildings or the conservation area in general. On the contrary, it would enhance that significance.

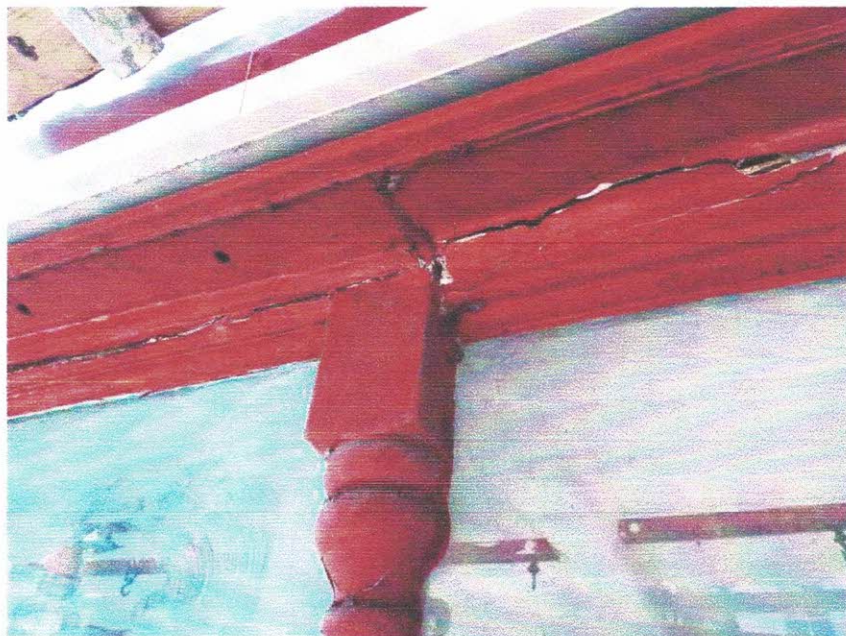
Joinery detail of No. 22
