**FERNLEA  
THE COMMON  
MINETY  
MALMESBURY  
WILTSHIRE  
SN16 9RH**

**ECOLOGICAL SURVEY REPORT (BATS)**  
**(Preliminary Roost Assessment/DBW)**

**Prepared for:**  
**Mr E. MUSSELWHITE.**  
**Date: 10/11/25.**  
**Ref: NWP/ESR-10/11/25-version 1.**

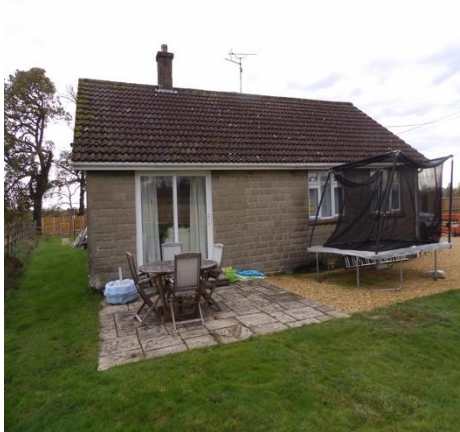
Figure 1. Main dwelling.

The application site comprises of detached single storey brick dwelling with an attached garage. Figure 1/2.

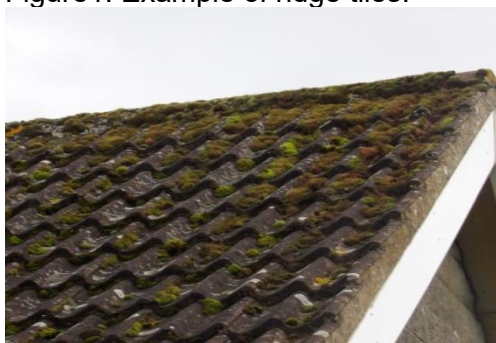
Figure1. Example of ridge tiles.

The ridge tiles were in good condition with a no significant missing mortar. Figure 1.

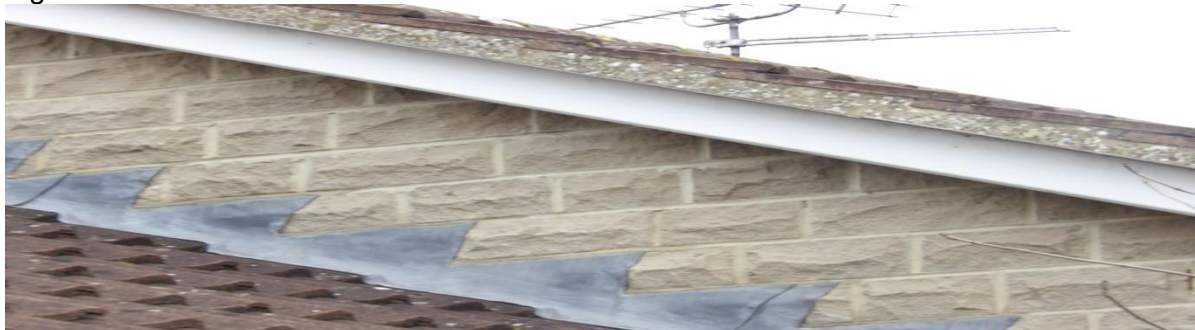
Figure 4. Eaves tiles

The eaves tiles were complete, there was no significant missing mortar. Figure 4.

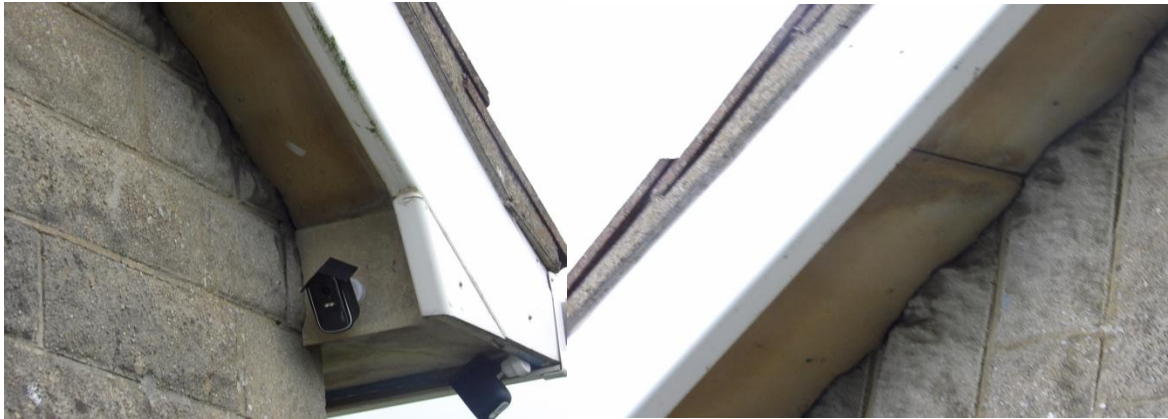
The soffits and fascia were a mix of wood and U.P.V.C, they were in good condition with no significant splits/openings that bats could exploit. Figure 5/6.

FERNLEA, THE COMMON, MINETY, MALMESBURY, WILTSHIRE SN16 9RH  
Figure 5/6. Soffitts and Fascias.

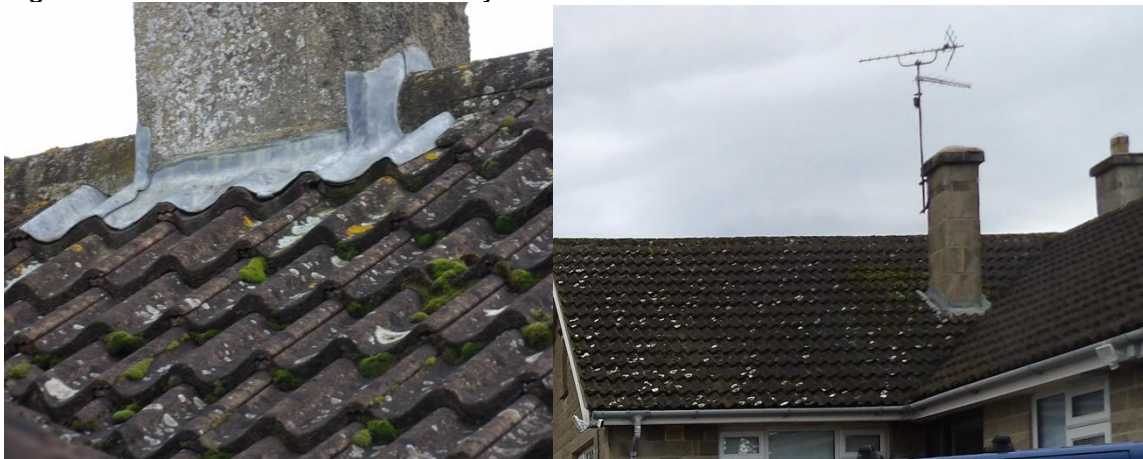
Figure 7/8. Leadwork around chimneys.

There was 2 chimneys, the leadwork was complete and close fitting. Figure 7/8.

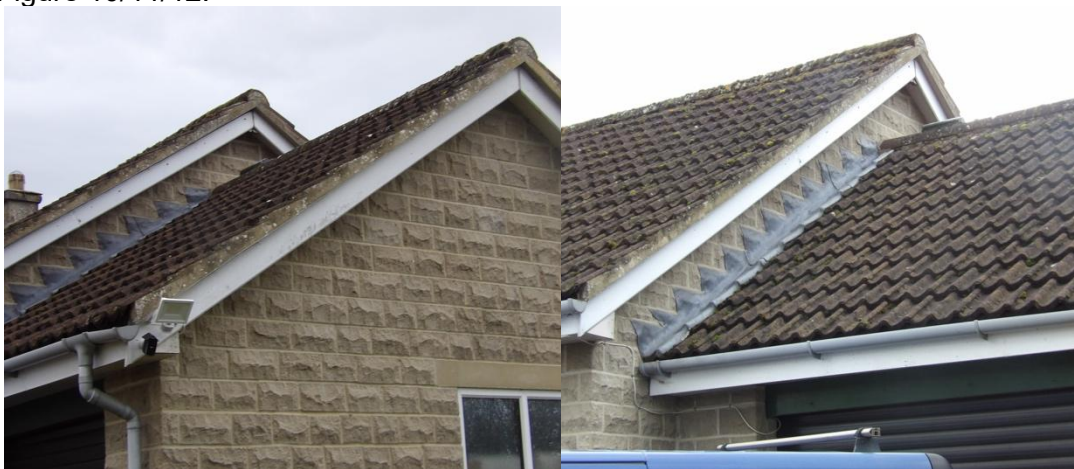
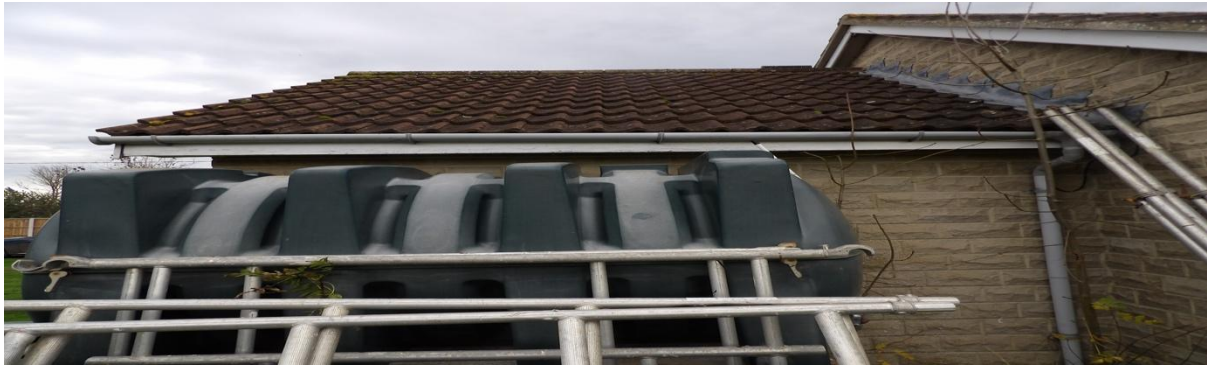
The garage was single skin brick construction.

The ridge tiles were in good condition with a no significant missing mortar.

The roof was covered with tiles, there were no visible slipped/broken/missing tiles.

The soffits and fascia were in good condition, close fitting with no significant gaps/splits.

No bats or evidence of bats was recorded during the external inspection of the garage.

Figure 10/11/12. show external condition/structure of the garage.

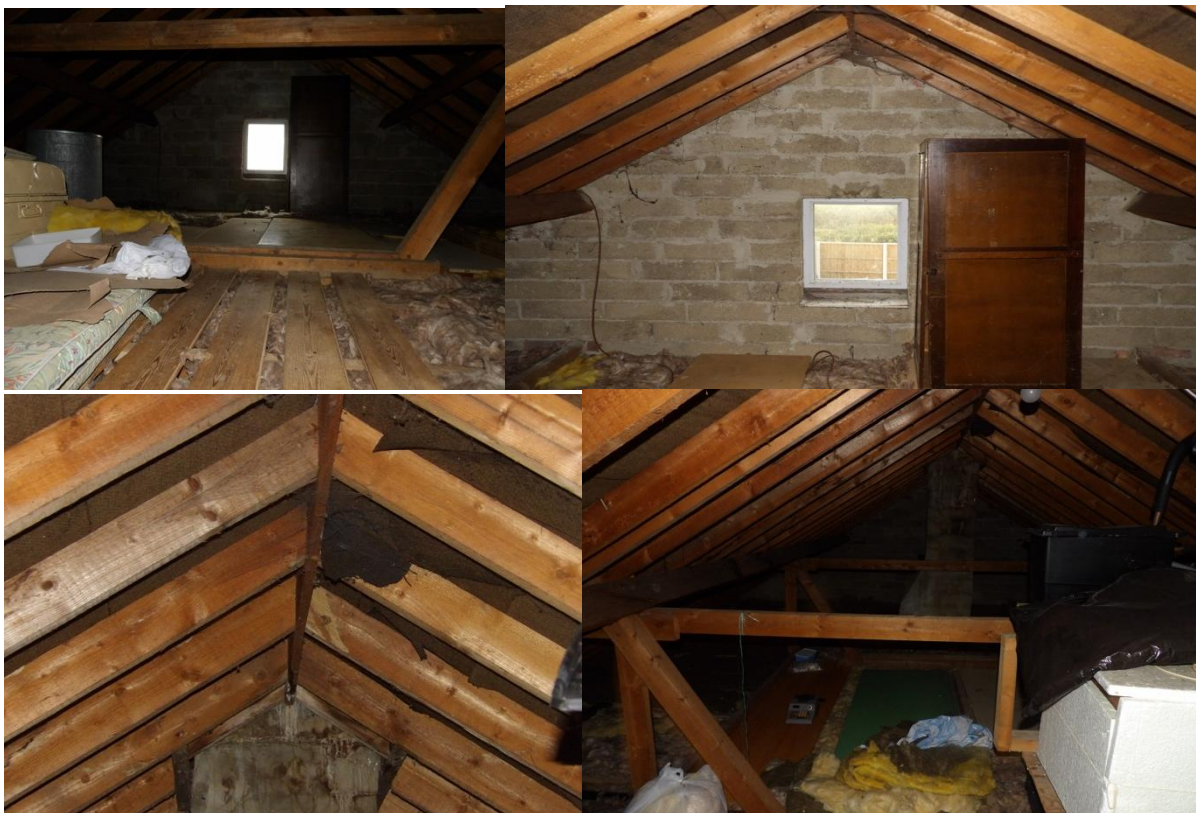
The void was insulated.

The underside of the tiles were lined with bitumen felt, it appeared in good condition.

The roof void was lit.

There was light ingress due to a large window.

Figure 1/2/3/4. Show general structure and condition of the roof void in the main dwelling.

No evidence of bats was recorded during the internal inspection of the main dwelling.

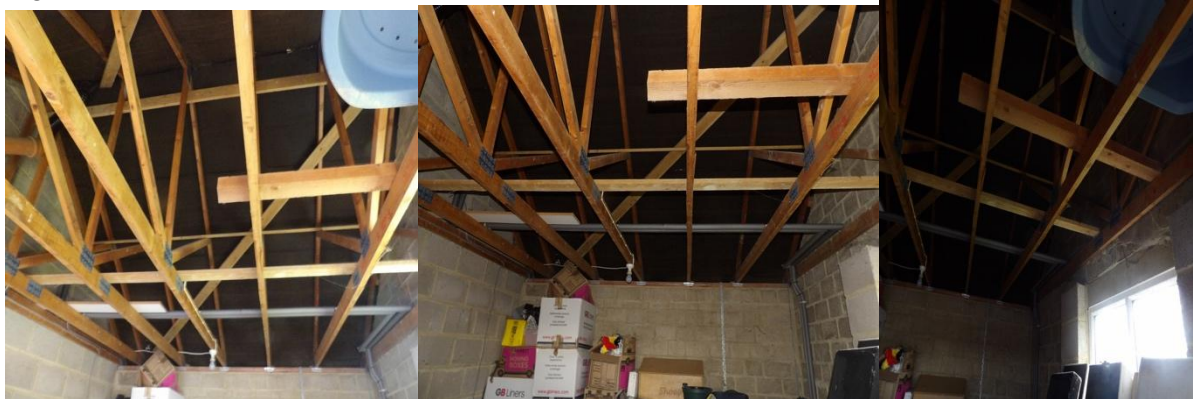
Figure 5/6/7.

There was no roof void in the garage.

The roof was of timber construction, the tiles were lined with a bitumen membrane.

Figure 5/6/7 shows internals and roof structure of the garage.

No evidence of bats was recorded during the internal inspection of the garage.
